Presque Isle Wilderness Waters Program

Aquatic Plant Management Plan – Big Lake

White Water Associates, Inc.
Dean Premo, Ph.D.
429 River Lane, P.O. Box 27
Amasa, Michigan 49903

Date: 2021

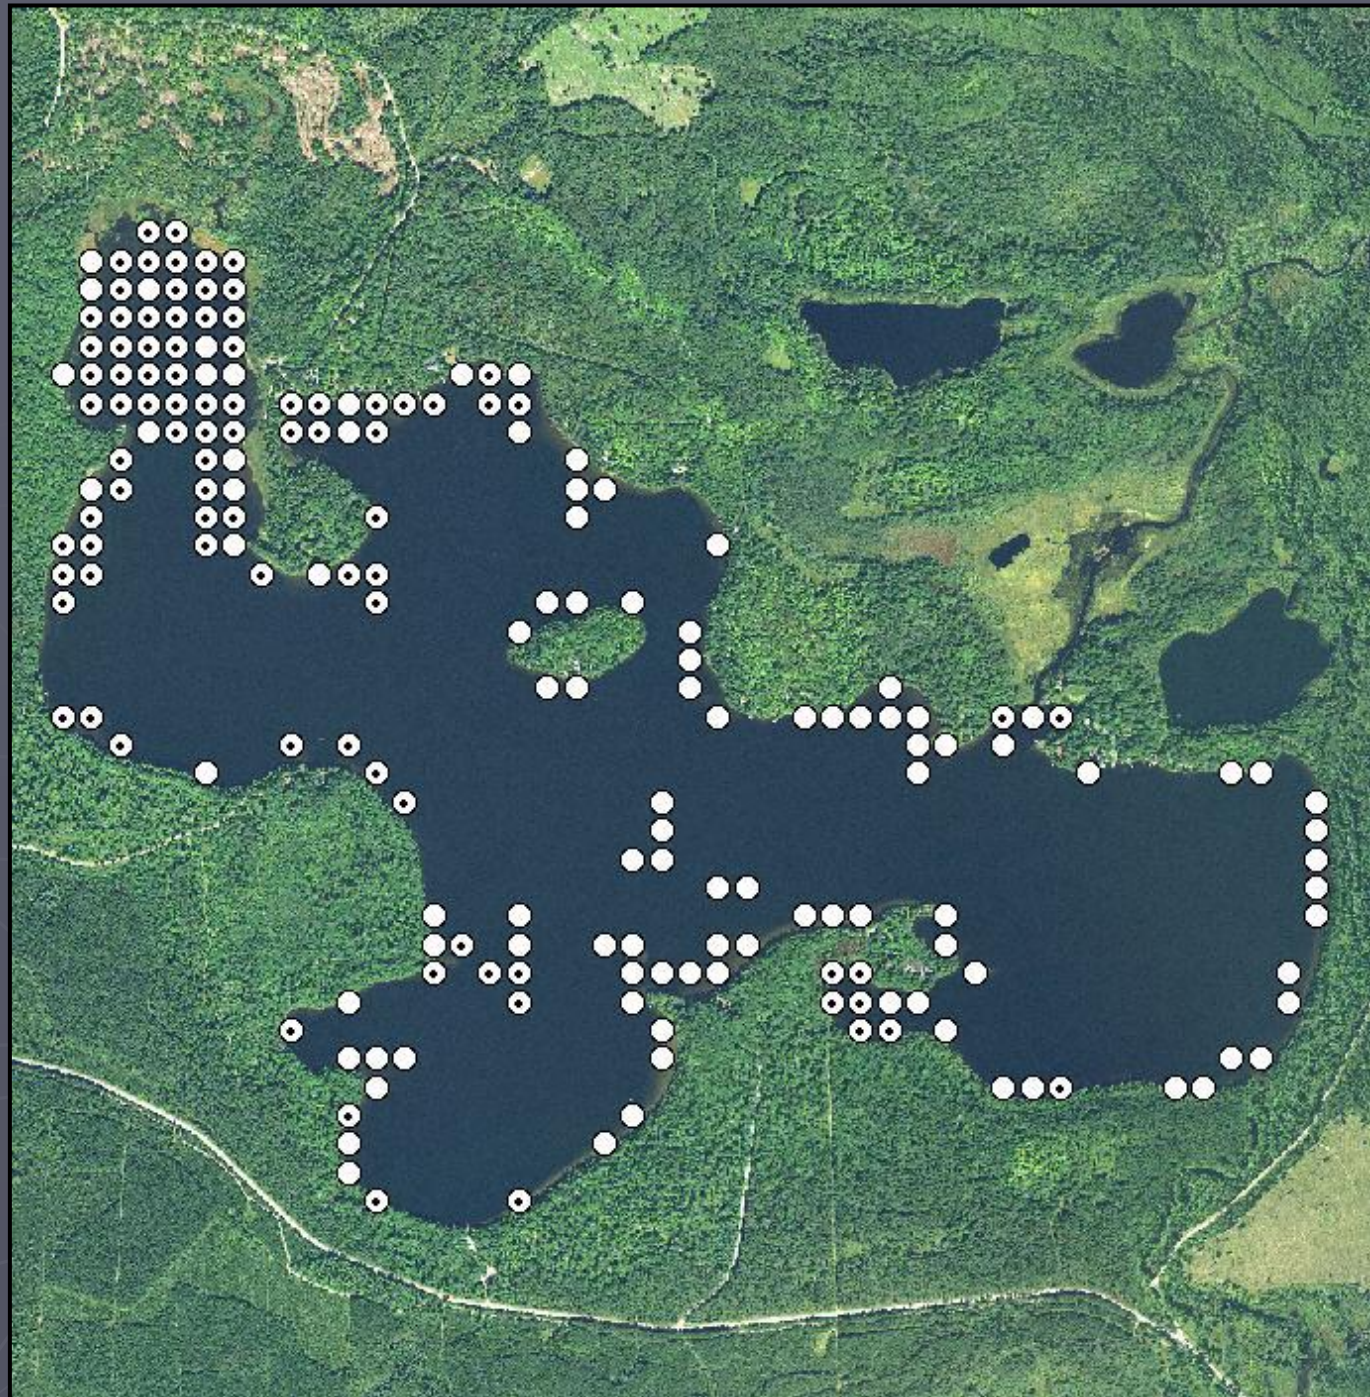
Figure 4. Big Lake sampling sites less than or equal to maximum depth of rooted vegetation (2020).

- Site less than or equal to maximum depth of plant colonization (MDC).
- ◉ Plant find(s) at site less than or equal to MDC.

The maximum depth of plant colonization in 2020 was 14.5 feet (Table 1 and Figure 3). Rooted vegetation was found at 90 of the 189 sample sites with depth \leq the maximum depth of plant colonization (47.62 % of sites). These sites are displayed as a black dot within a circle on Figure 4. This indicates that although availability of appropriate depth may limit the distribution of plants, it is not the only habitat factor involved. Substrate is another feature that influences plant distribution (e.g., soft substrate often harbors more plants than hard substrate). Figure 5 presents the substrates encountered during the aquatic plant survey (mud, sand, or rock).

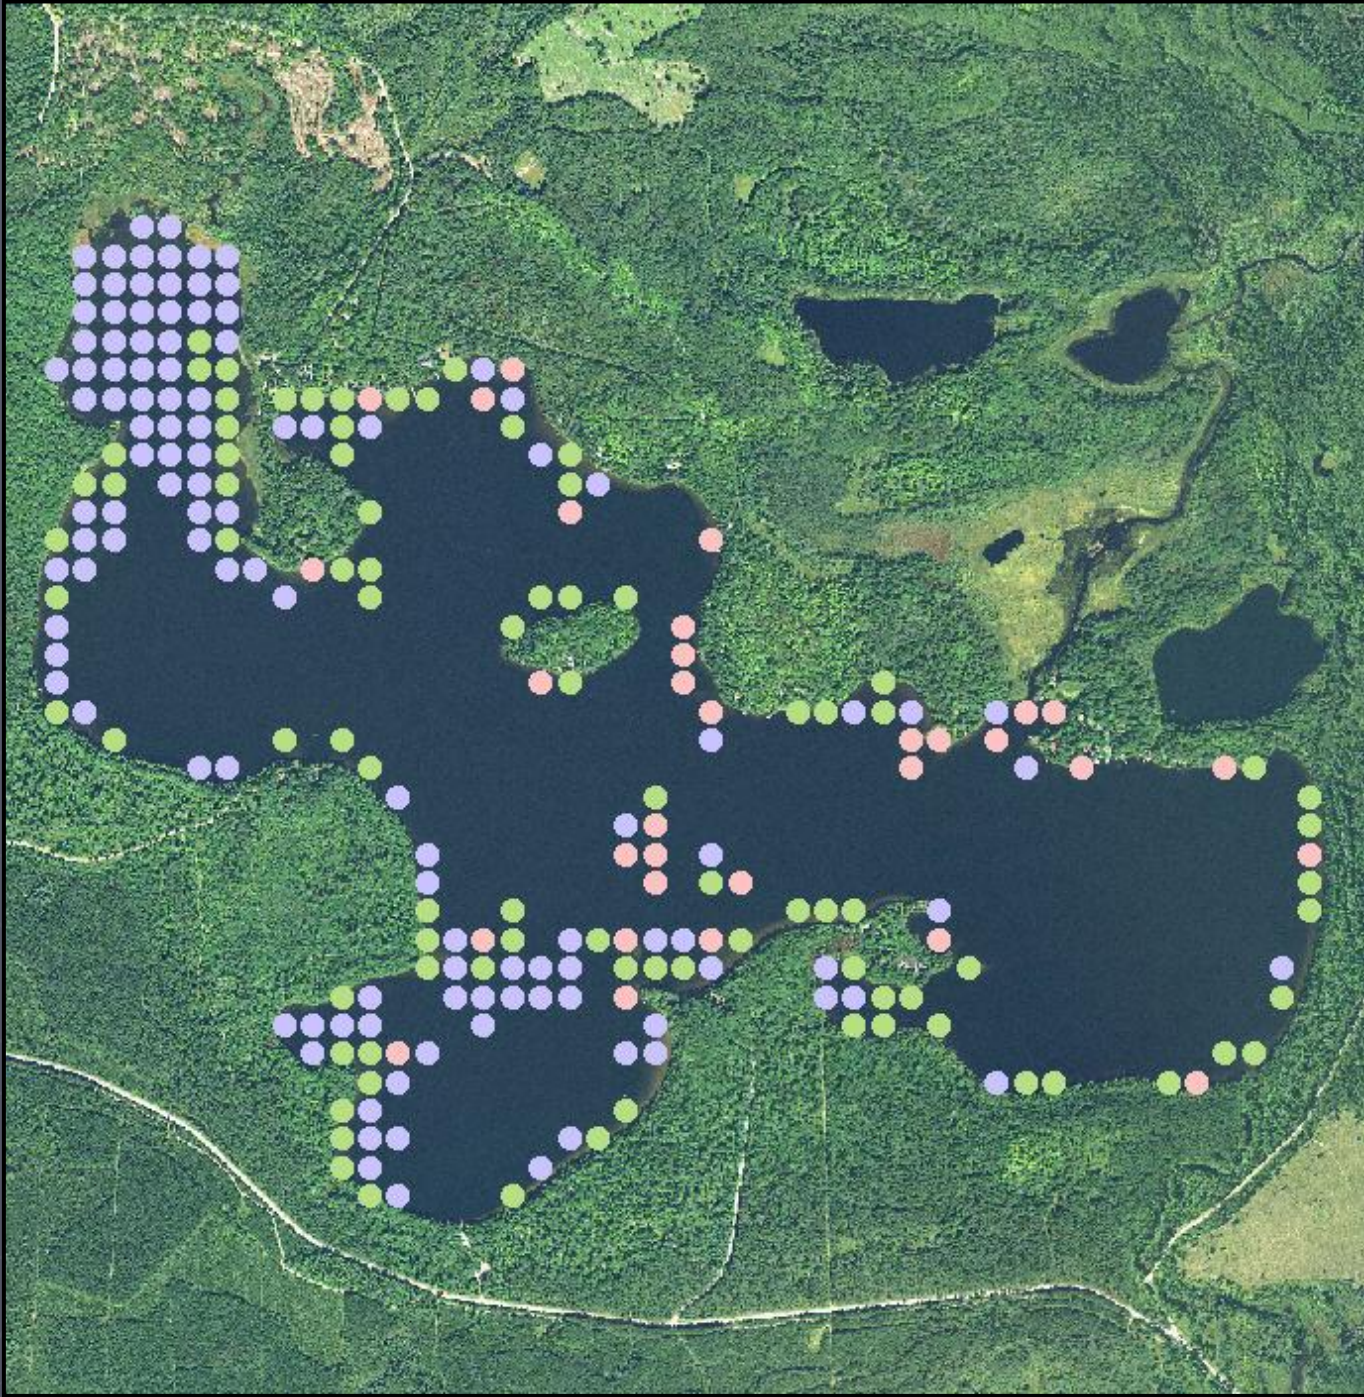
Figure 5. Big Lake substrate encountered at point-intercept plant sampling sites (2020).

- Muck
- Rock
- Sand

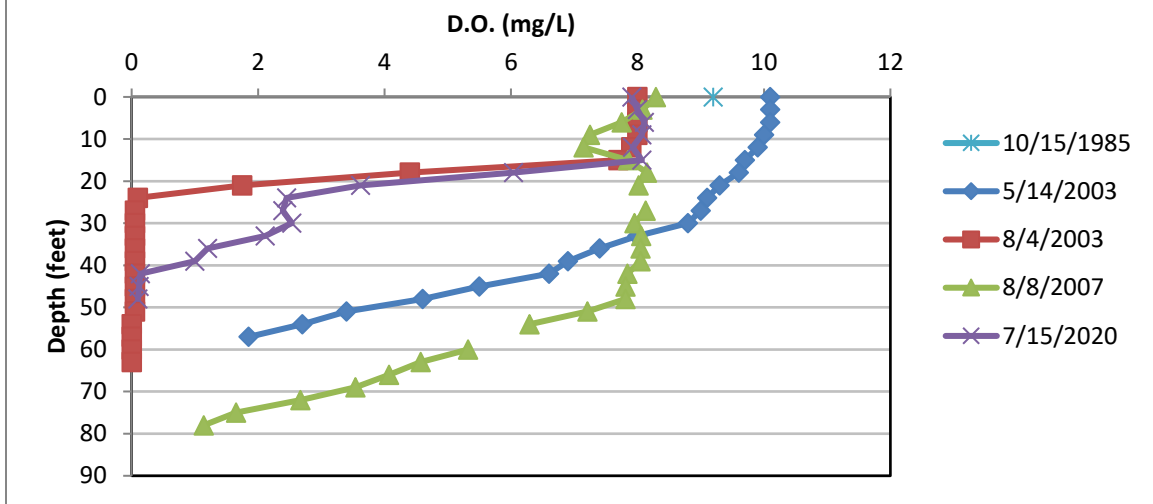
Figure 7. Big Lake dissolved oxygen profiles.

The dissolved oxygen (D.O.) content of lake water is vital in determining presence of fish species and other aquatic organisms. Dissolved oxygen also has a strong influence on the chemical and physical conditions of a lake. The amount of dissolved oxygen is dependent on the water temperature, atmospheric pressure, and biological activity. Oxygen levels are increased by aquatic plant photosynthesis, but reduced by respiration of plants, decomposer organisms, fish, and invertebrates. The amount of dissolved oxygen available in a lake, particularly in the deeper parts of a lake, is critical to overall health. Dissolved oxygen was taken at the surface once in 1985 and a profile was taken twice in 2003 and once in 2020 (Figure 7). The levels were between 8 mg/L and 10 mg/L at the surface.

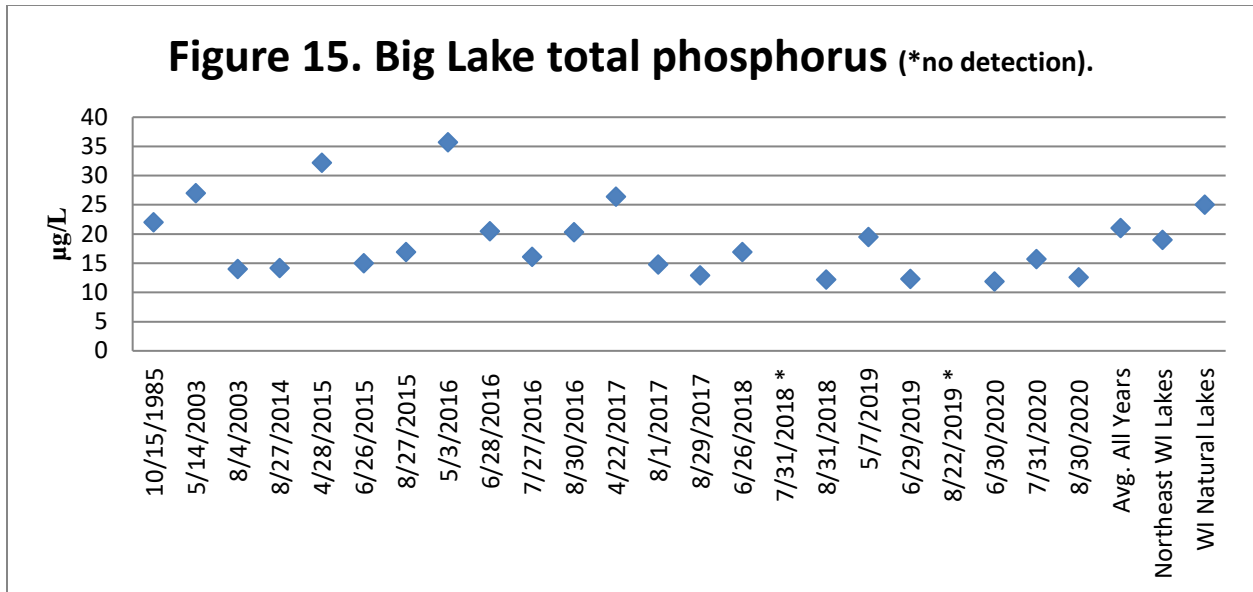
Big Lake total phosphorus ranged from 27 µg/L to 14 µg/L, with an average of 21 µg/L (Figure 15). According to Figure 16, the average total phosphorus for Big Lake classifies it as “good.”

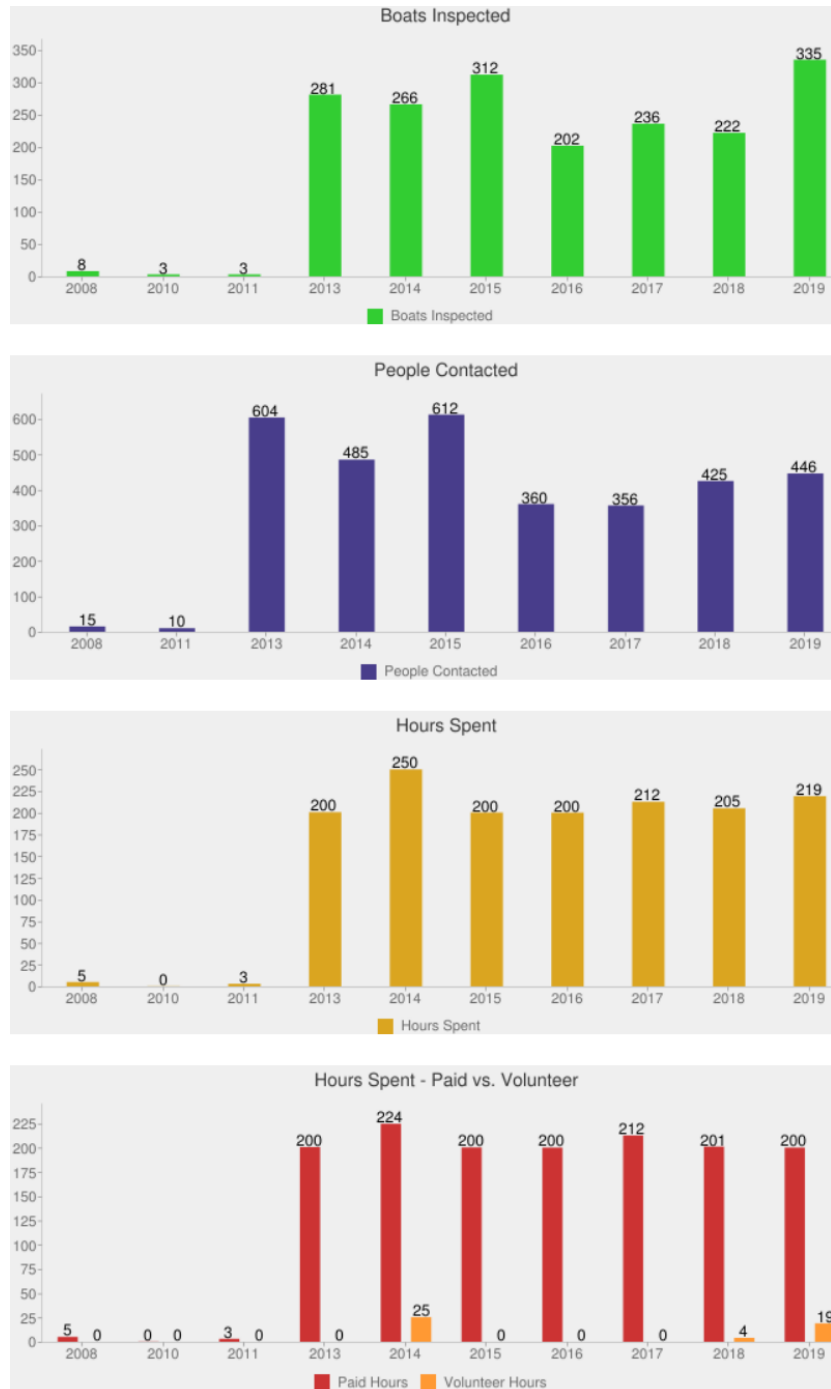
Figure 23. Big Lake (Hwy K Access) Clean Boats Clean Waters data (WDNR, 2021).

Boats, Clean Waters inspected 335 boats in 2019 at Big Lake with 446 people being contacted (Figure 23). It would be beneficial for Big Lake to continue the CBCW program.

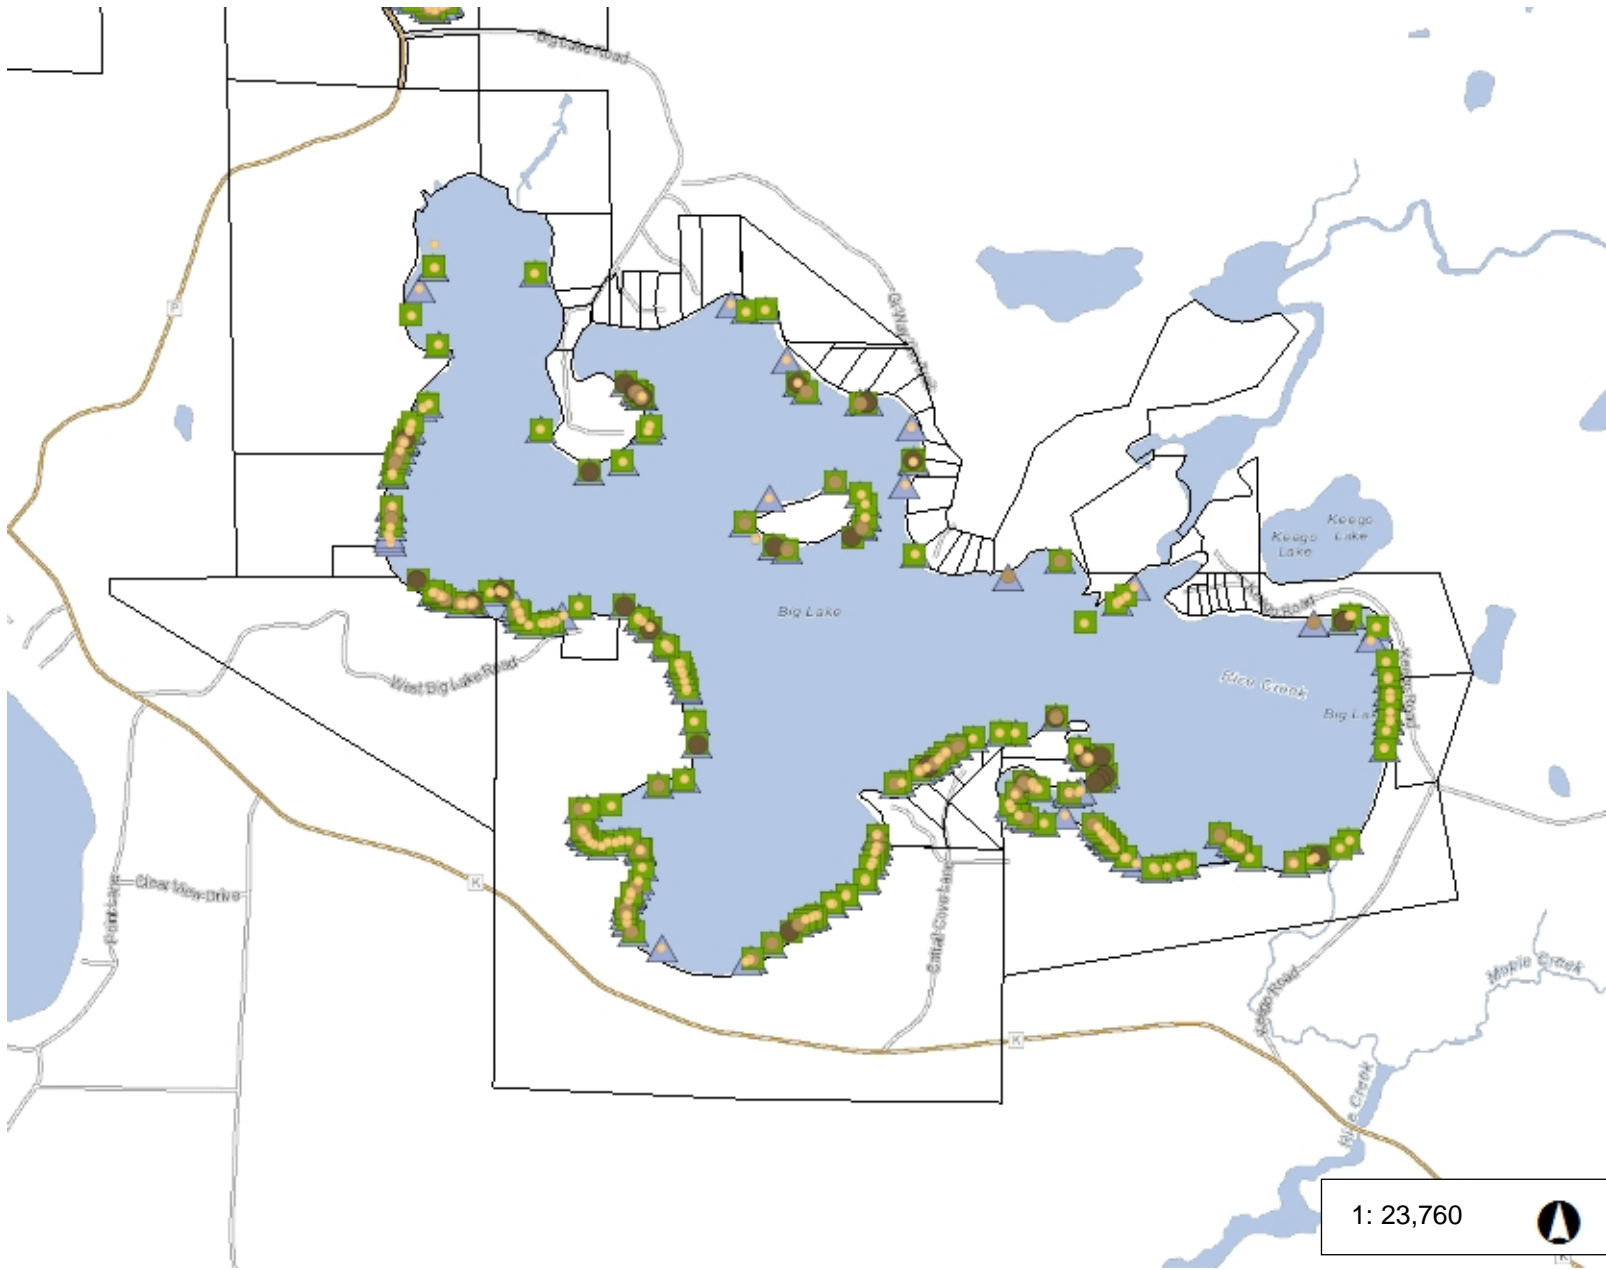
Exhibit 13. Big Lake Woody Habitat - 2020

The woody habitat component of the assessment was conducted on a separate circumnavigation of the lake. Before starting, a Secchi depth was measured. The protocol specifies that if the Secchi depth is less than two feet, no woody habitat survey will be conducted due to poor visibility (WDNR 2016). In addition to the Secchi depth, lake water level was documented relative to the lake's *high water level* (HWL). As the lake was circumnavigated, large wood was enumerated. The protocol defines "large wood" as wood greater than 4 inches in diameter somewhere along its length and at least 5 feet long. Eligible large wood was that which was located between the high water level and the 2 foot depth contour and the large wood section must be in the water or below the high water level. Tree "branchiness" ranking was recorded as "0" (no branches), "1" (few branches), or "2" (tree trunk with full crown). Additional details on eligible large wood are provided in the protocol document (WDNR 2016). A GPS was used to document each eligible piece of large wood. A datasheet entry corresponded to each large wood piece. An example datasheet is provided as Exhibit 3.

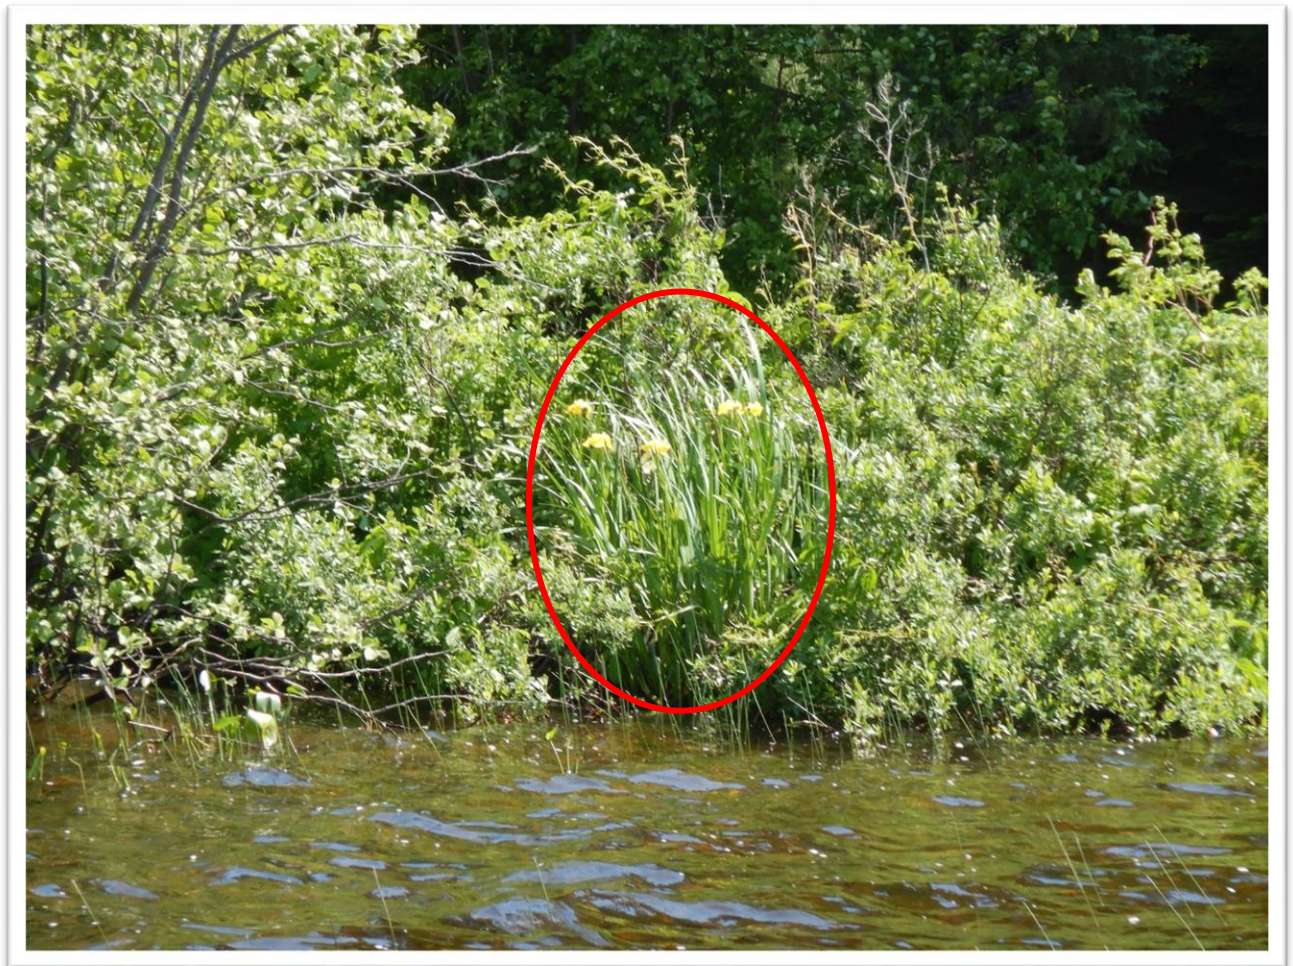
Exhibit 4. Yellow Flag Iris 2020 (White Water Associates, photo).

The yellow iris (*Iris pseudacoris*) is a perennial aquatic plant native to Europe, western Asia and North Africa. It was first introduced to North America in the 1800s as an ornamental plant. Over time, the plant has spread to many wetlands and proliferated to the detriment of native plants and animals. Yellow iris is present on numerous Wisconsin lake margins and the Wisconsin Department of Natural Resources has listed this species as “Restricted” which prevents its sale, transfer, transportation and intentional cultivation. Yellow iris can reduce habitat needed by fish and waterfowl (Thomas, 1980).

There are five known AIS that are established in Big Lake prior to this survey. The banded and Chinese mystery snail, rusty crayfish, narrow-leaf cattail, and purple loosestrife. During the survey two new invasive plants were noted including the Aquatic Forget-Me-Not (*Myosotis scorpioides*) and the Yellow Iris (*Iris pseudacoris*) (Exhibit 4). Both species were documented during the meander search (Exhibit 1, 4, and 5). A voucher specimen of both the aquatic forget-me-not and the yellow iris were collected during the aquatic plant survey and sent to Dr. Freckmann (U.W. Steven's Point) and they were both confirmed in November, 2020. Site 2 had no AIS present.

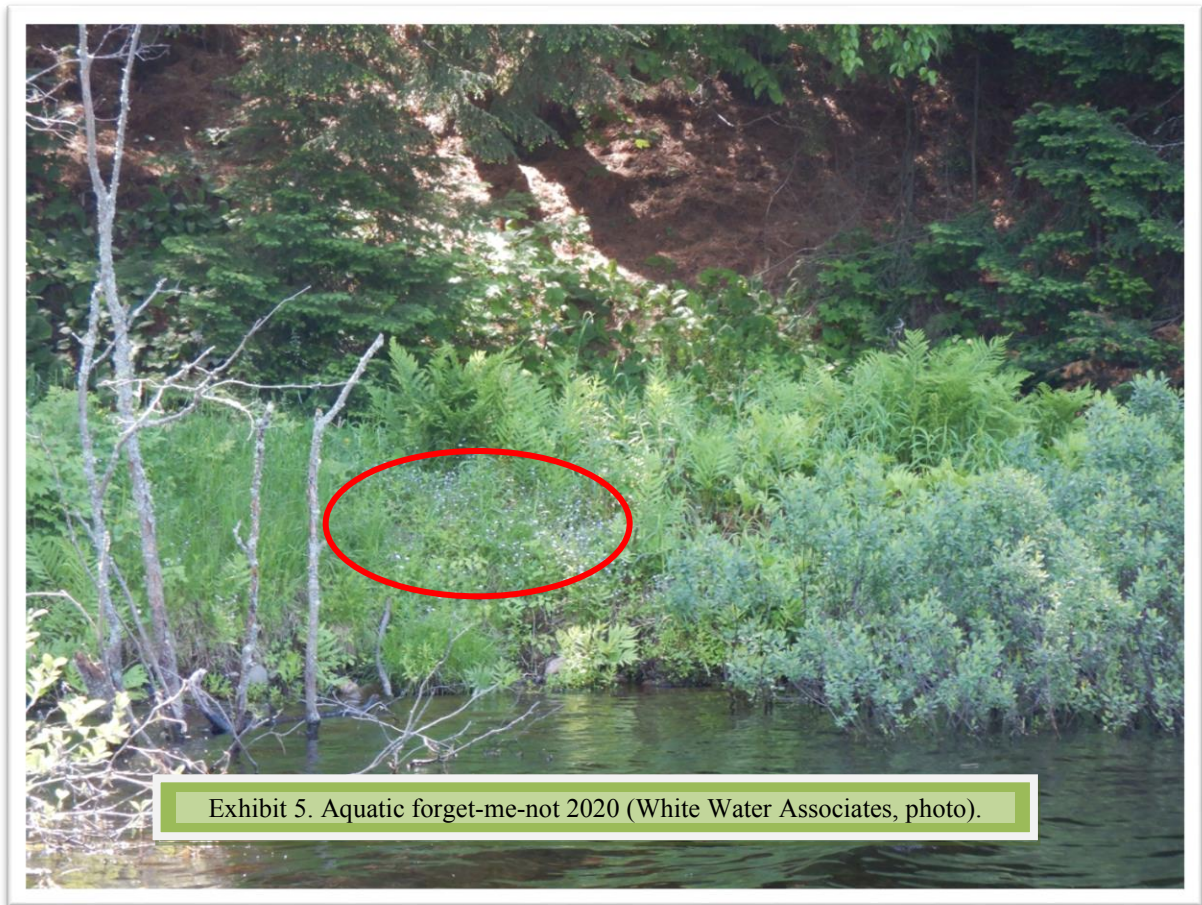
Aquatic Forget-me-not (*Myosotis scorpioides*) grows in shallow water along the shoreline. It is an aggressively growing plant that can crowd out native plant species. It can form large monocultures, especially in situations where it is in or near a stream (WDNR, 2019). This plant is restricted in Wisconsin.
