Upper Eau Claire Lake Critical Habitat Designation Report

Bayfield County, WI

April 2013

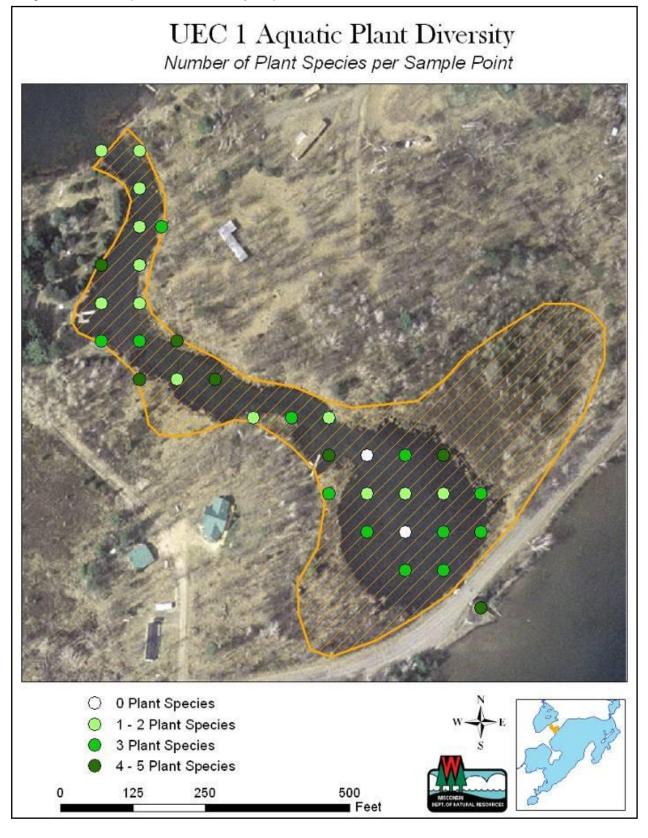
Figure 4. UEC1 Aquatic Plant Diversity Map

Aquatic Plants were sampled using a standardized Point Intercept method and a summary of the results can be found in Tables 3 and 4. Table 5 summarizes the current management practices within the Setback, Riparian, Bank and Littoral Zones of UEC1.

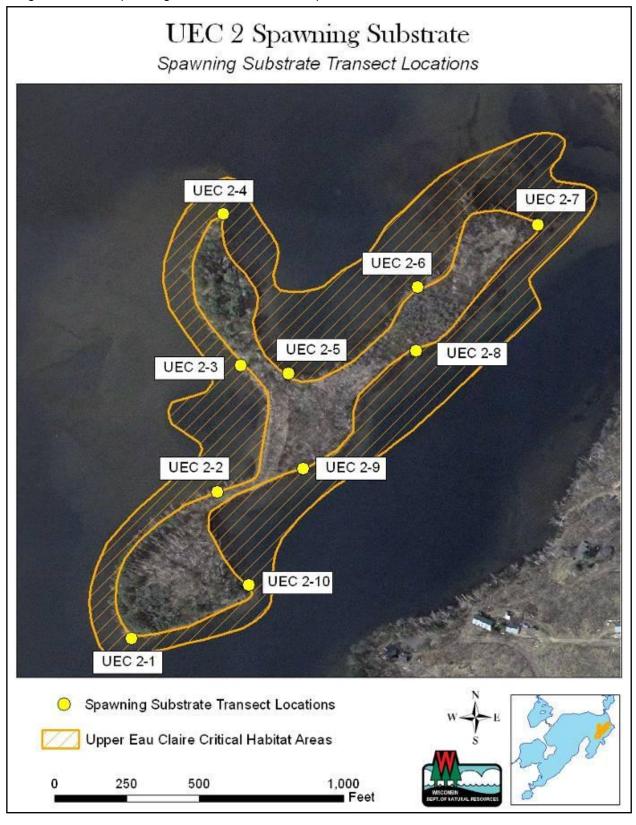
Figure 7. UEC2 Spawning Substrate Transects Map

Aquatic Plants were sampled using a standardized Point Intercept method and a summary of the results can be found in Tables 6 and 7. Spawning substrate was sampled using a standardized transect method and the results can be seen in Table 8. Table 9 summarizes the current management practices within the Setback, Riparian, Bank and Littoral Zones of UEC2.

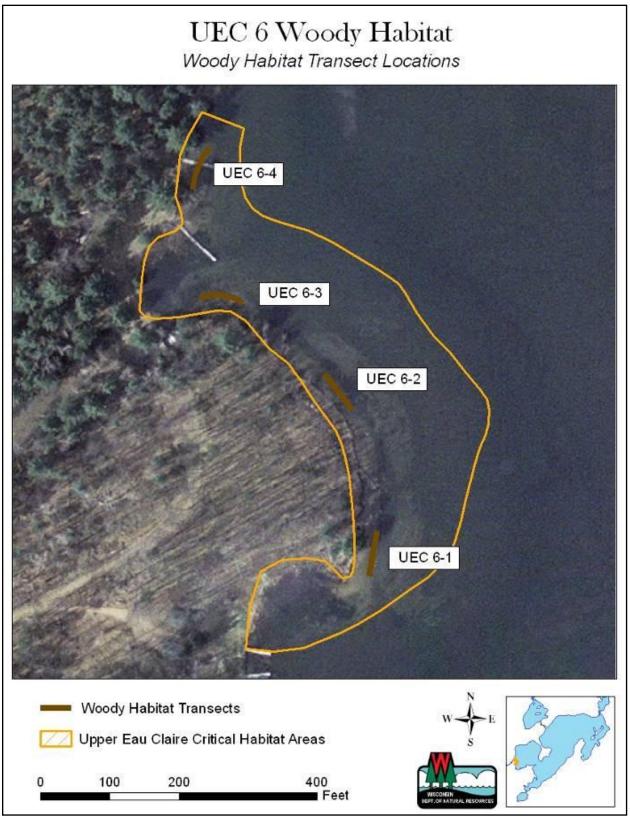
Figure 15. UEC6 Woody Habitat Transects Map

Aquatic Plants were sampled using a standardized Point Intercept method and a summary of the results can be found in Tables 17 and 18. Woody Habitat was sampled using a standardized transect method and a summary of the results can be found in Table 19. Big logs are defined as being greater than 10 cm (3.9 inches) in diameter and 150 cm (59 inches) in length. Small logs are defined as being 5-10 cm (2-3.9 inches) in diameter and greater than 150 cm (59 inches) in length. Table 20 summarizes the current management practices within the Setback, Riparian, Bank and Littoral Zones of UEC6.

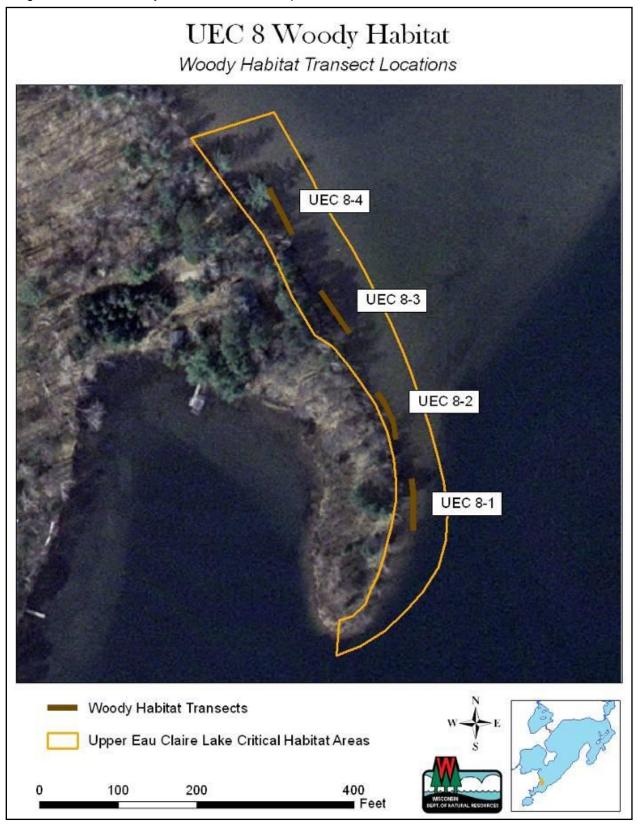
Figure 17. UEC8 Woody Habitat Transects Map

Woody Habitat was sampled using a standardized transect method and a summary of the results can be found in Table 24. Big logs are defined as being greater than 10 cm (3.9 inches) in diameter and 150 cm (59 inches) in length. Small logs are defined as being 5-10 cm (2-3.9 inches) in diameter and greater than 150 cm (59 inches) in length. Spawning Substrate was sampled using a standardized transect method and a summary of the results can be found in Table 25. Table 26 summarizes the current management practices within the Setback, Riparian, Bank and Littoral Zones of UEC8.

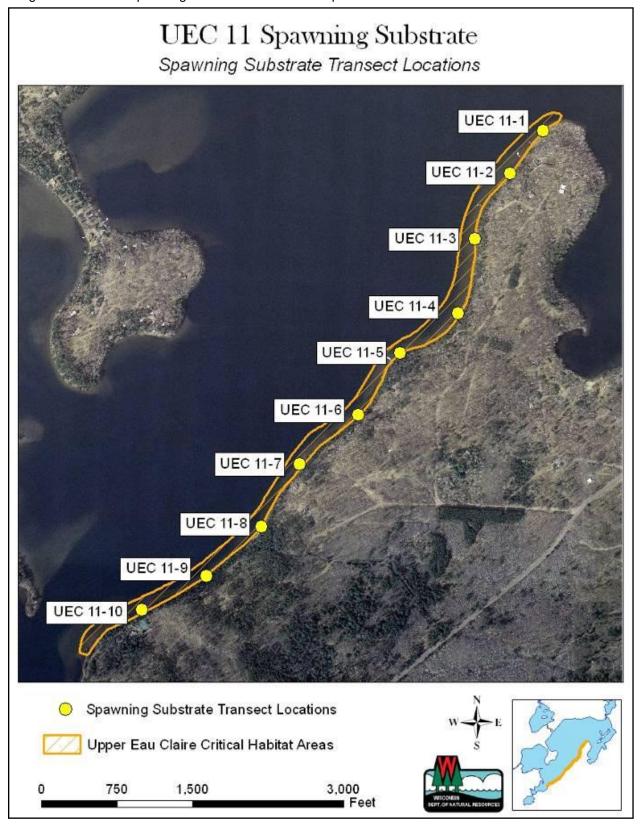
Figure 21. UEC11 Spawning Substrate Transects Map

Spawning Substrate was sampled using a standardized transect method and a summary of the results can be found in Table 33. Table 34 summarizes the current management practices within the Setback, Riparian, Bank and Littoral Zones of UEC11.

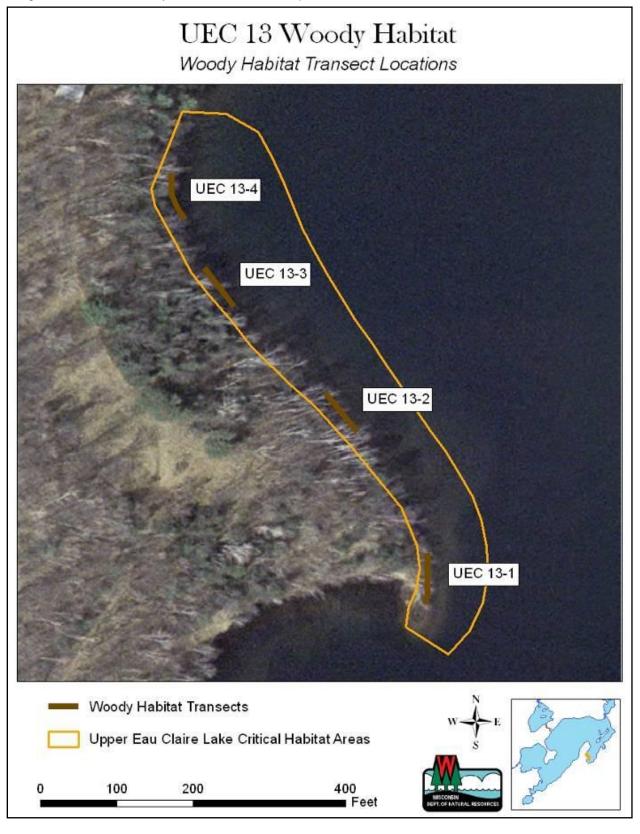
Figure 24. UEC13 Woody Habitat Transects Map

Woody Habitat was sampled using a standardized transect method and a summary of the results can be found in Table 38. Big logs are defined as being greater than 10 cm (3.9 inches) in diameter and 150 cm (59 inches) in length. Small logs are defined as being 5-10 cm (2-3.9 inches) in diameter and greater than 150 cm (59 inches) in length. Spawning Substrate was sampled using a standardized transect method and a summary of the results can be found in Table 39. Table 40 summarizes the current management practices within the Setback, Riparian, Bank and Littoral Zones of UEC13.
