***CRITICAL HABITAT DESIGNATION REPORT  
CROOKED LAKE  
ADAMS COUNTY, WI***

***May 24, 2006***

**Submitted by Reesa Evans  
Adams County Land & Water Conservation Department**

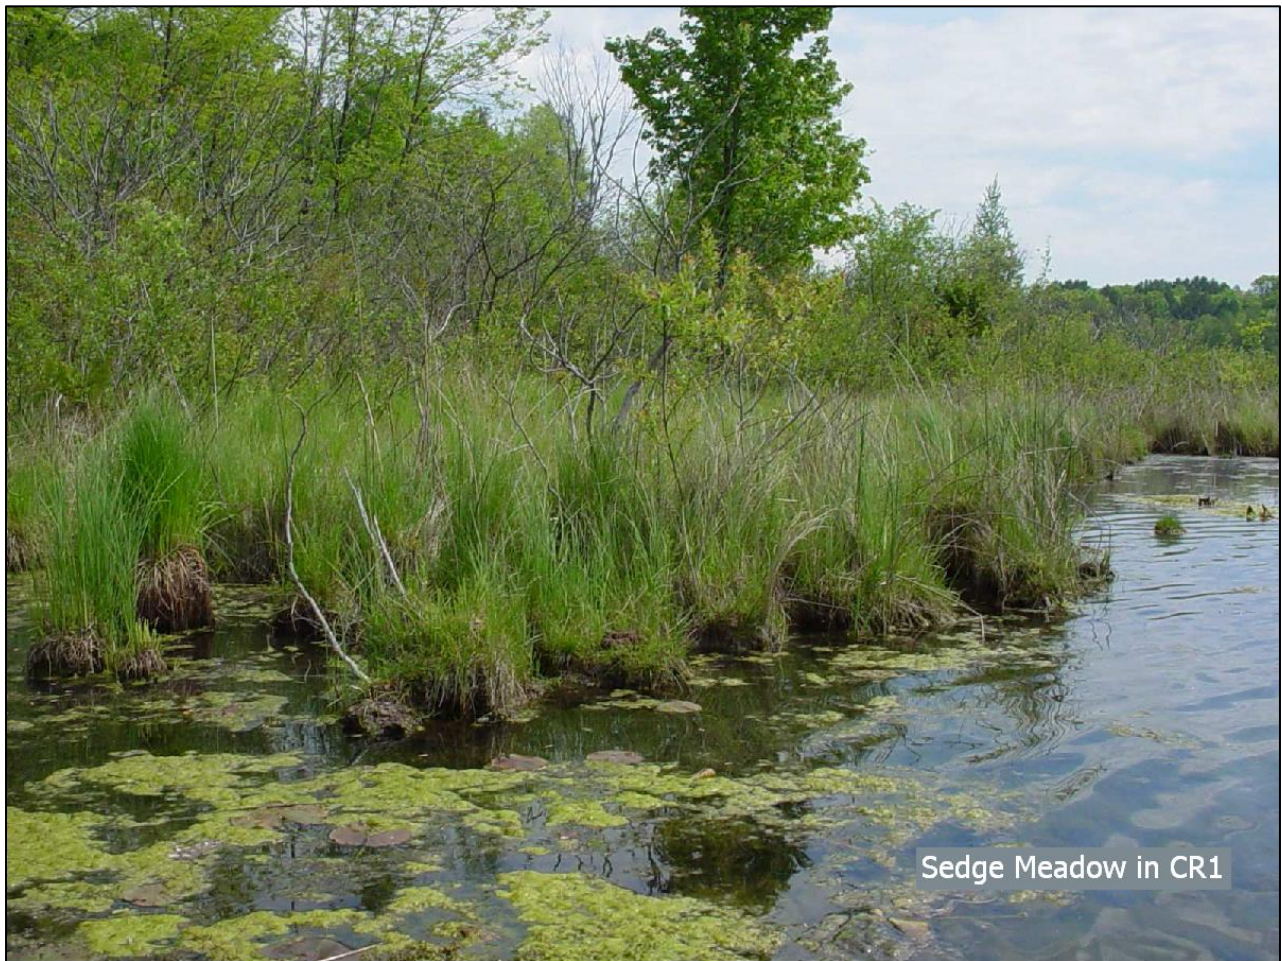
### **SEDGE MEADOW in CR1**

This area extends along approximately 4200 feet of the shoreline. Sediment includes marl, muck, peat, sand, silt and mixtures thereof. 24% of the shore is wooded; 27% has shrubs; 49% is native herbaceous cover. Several types of wetlands are found along this shoreline: shallow marsh; deep marsh; sedge meadow; shrub-carr; and tamarack bog. Large woody cover is common for habitat. With virtually no human disturbance along this shoreline, the area has natural scenic beauty.

- (1) Maintain current habitat for fish and wildlife.
- (2) Do not remove fallen trees along the shoreline.
- (3) No alteration of littoral zone unless to improve spawning habitat.

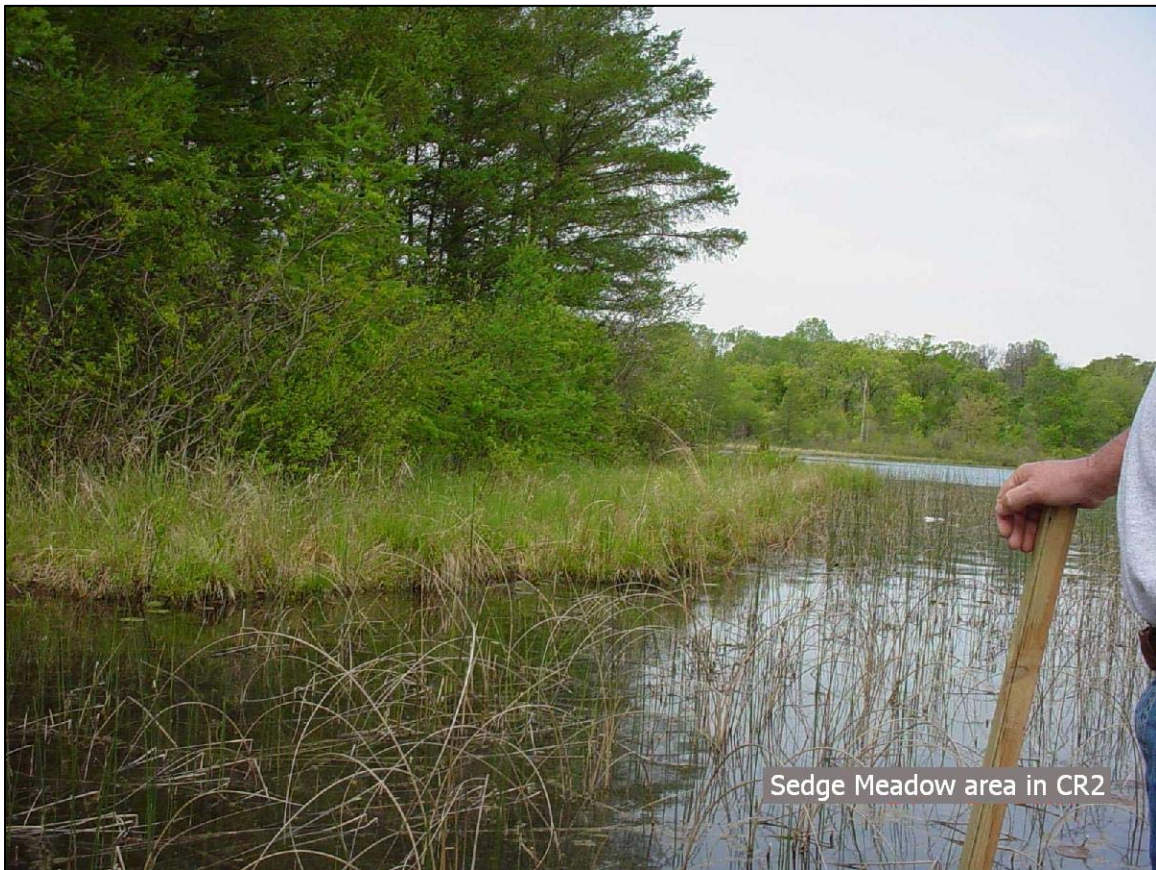
**SEDGE MEADOW AREA IN CR2**

This area extends along approximately 2900 feet of the shoreline. Sediment includes marl, peat, silt and mixtures thereof. 40% of the shore is wooded; 10% has shrubs; 50% is native herbaceous cover. Sedge meadow and tamarack bog wetlands are found along this shoreline. Large woody cover is abundant for habitat. With little human disturbance along this shoreline, the area is has natural scenic beauty.

- (1) Maintain current habitat for fish and wildlife.
- (2) Do not remove fallen trees along the shoreline nor logs in the water.
- (3) No alteration of littoral zone unless to improve spawning habitat.

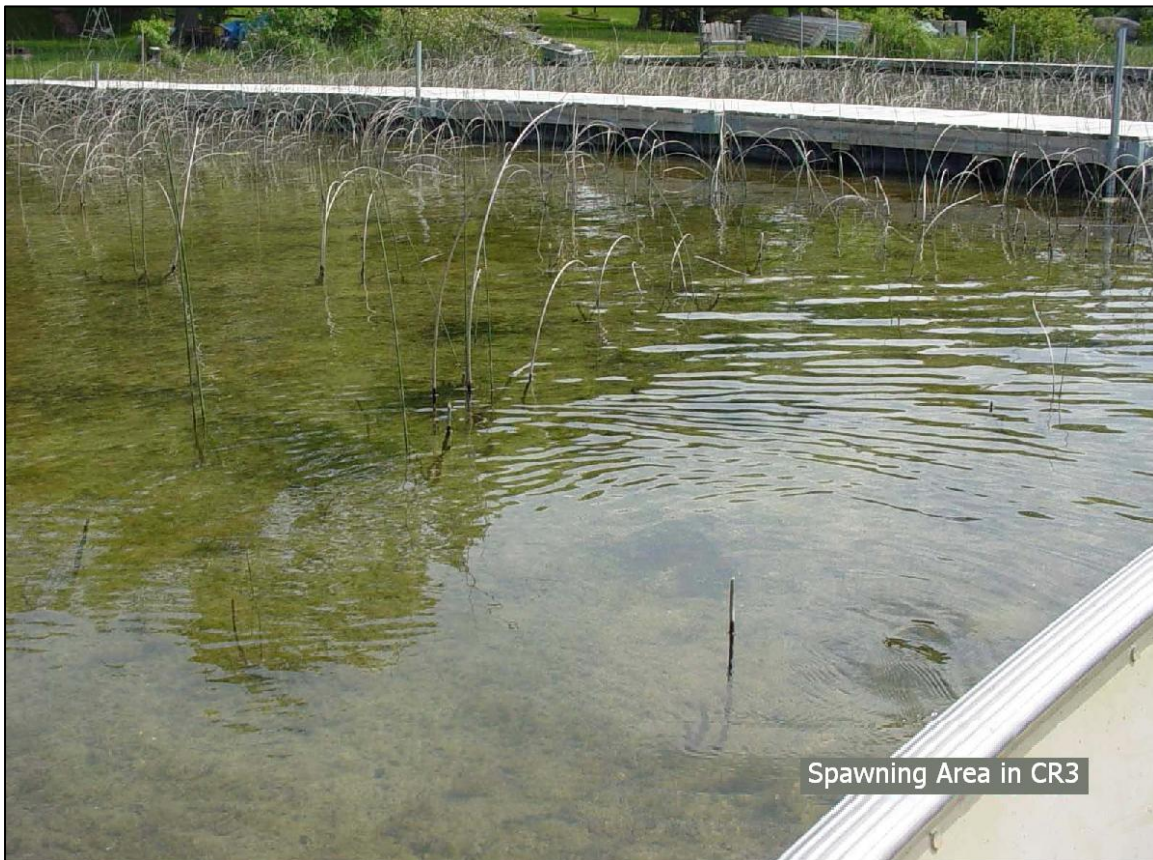
Spawning Area in CR3

This area does still provide spawning and nursery areas for many types of fish: northern pike; largemouth bass; bluegill; pumpkinseed; yellow perch; crappie;

- (4) Seasonal protection of spawning habitat.
- (5) Maintain snag/cavity trees for nesting.
- (6) Maintain wildlife corridor in some areas and increase in more developed areas.

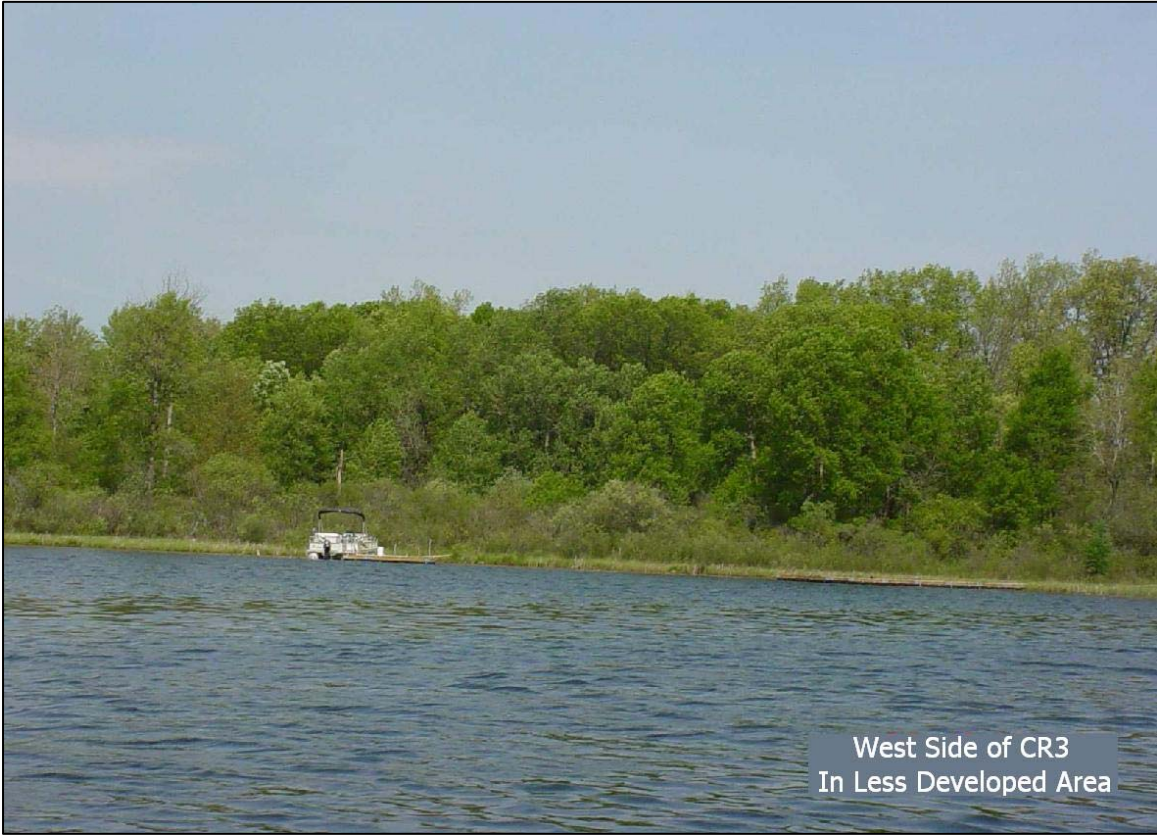
West Side of CR3  
In Less Developed Area

This area extends along approximately 3300 feet of the shoreline. Sediment includes marl, muck, peat, sand, silt and mixtures thereof. 7% of the shore is wooded; 20% has shrubs; 57% is native herbaceous cover—the remaining 21% is cultivated lawn. This sensitive area includes the most developed area of Crooked Lake. However, there are areas of wetlands: shallow marsh; sedge meadow; conifer swamp. Large woody cover is present, but not as much as in the other two sensitive areas. Scenic beauty in part of the area is lessened due to the human development.

- (7) Establish shore buffers of native vegetation in areas now in cultivated lawn.
- (8) Maintain buffer of shoreline vegetation where there is currently a buffer.
