Oneida County Phragmites Rapid Response Project

Final Report

Project ID: AIRR24219

Project Dates: June 1, 2018 – December 31, 2022

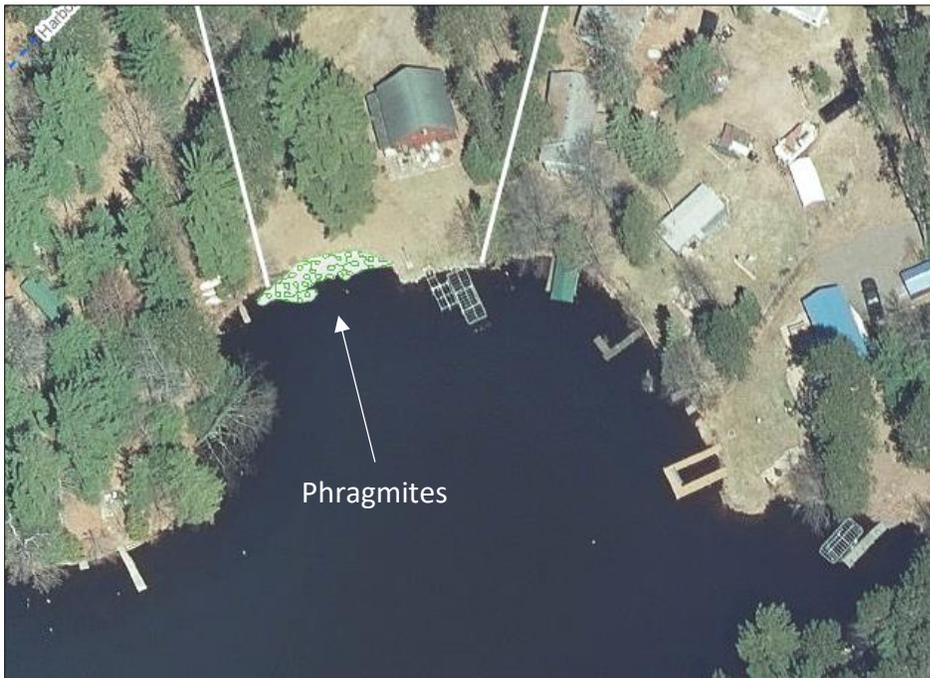
Figure 2. Aerial view of the phragmites site

The phragmites site is located at 3984 Harbor Drive, Rhinelander, which is situated in a bay at the southeast end of the Rhinelander Flowage, Oneida County, Wisconsin (Figure 2). The Rhinelander Flowage is a 1372-acre drainage impoundment of the Upper Wisconsin River, located within the Rhinelander Flowage watershed. It has a maximum depth of 10 feet. The substrate consists of 75% sand and 25% muck. There are five public boat launches. The Flowage is a popular and busy recreational waterbody, both in the summer and winter. Musky, panfish, largemouth bass, smallmouth bass, northern pike and walleye inhabit the lake. Special features include wild rice beds, wetlands, upland forests, and habitats that support abundant wildlife. Eagle and osprey nests are common, loons and a variety of waterfowl, shorebirds, and wading birds use the lake for migration and nesting. Over 250 dwellings, one resort, and three bars are located on the shoreline. The Rhinelander hydroelectric dam, owned by Expera Specialty Solutions, maintains the water levels. There is not an active lake association on the Rhinelander Flowage.

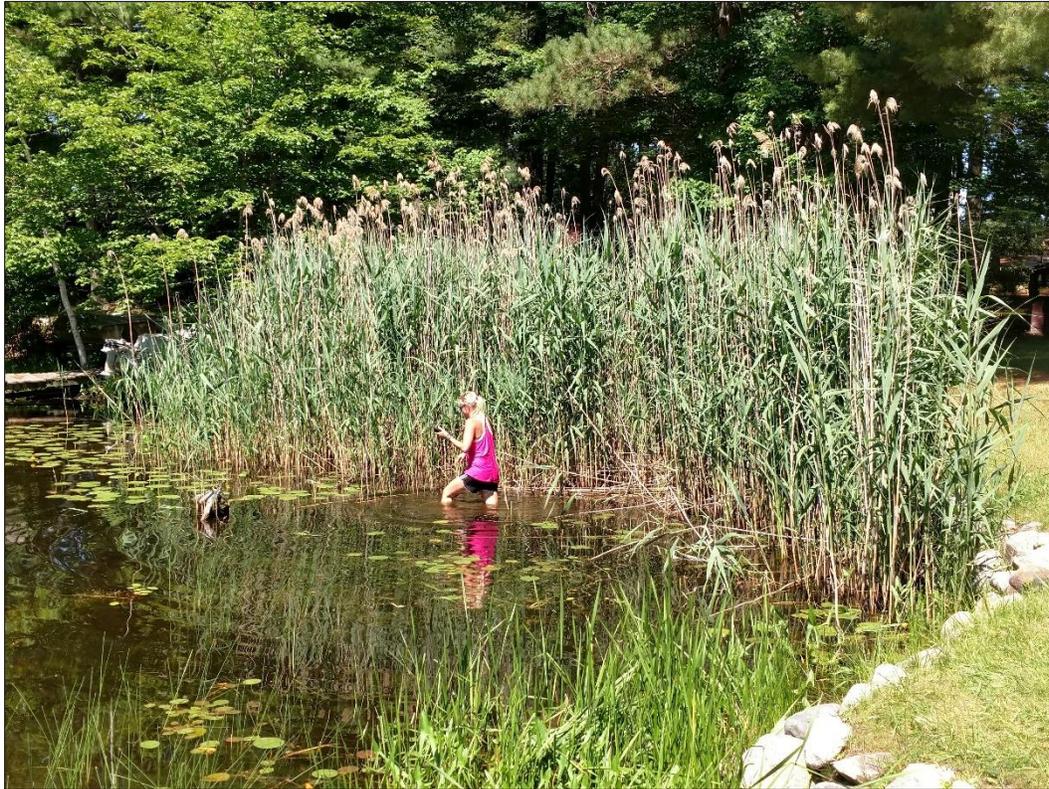
Figure 3. Photo taken during the initial site visit on 6-28-18. Photo credit Stephanie Boismenu

On June 28, 2018, the LWCD's AIS Team made their initial visit to the Rhinelander Flowage phragmites site and were amazed by the maturity and density of the stand. They obtained quantitative data on stem density, native species diversity, littoral zone characteristics, and GPS coordinates around the outer perimeter of the stand (Figure 3 & 4). Photos were taken at key locations to assist in visually tracking changes through time. In addition, they walked along the rest of the landowner's shoreline and dock to

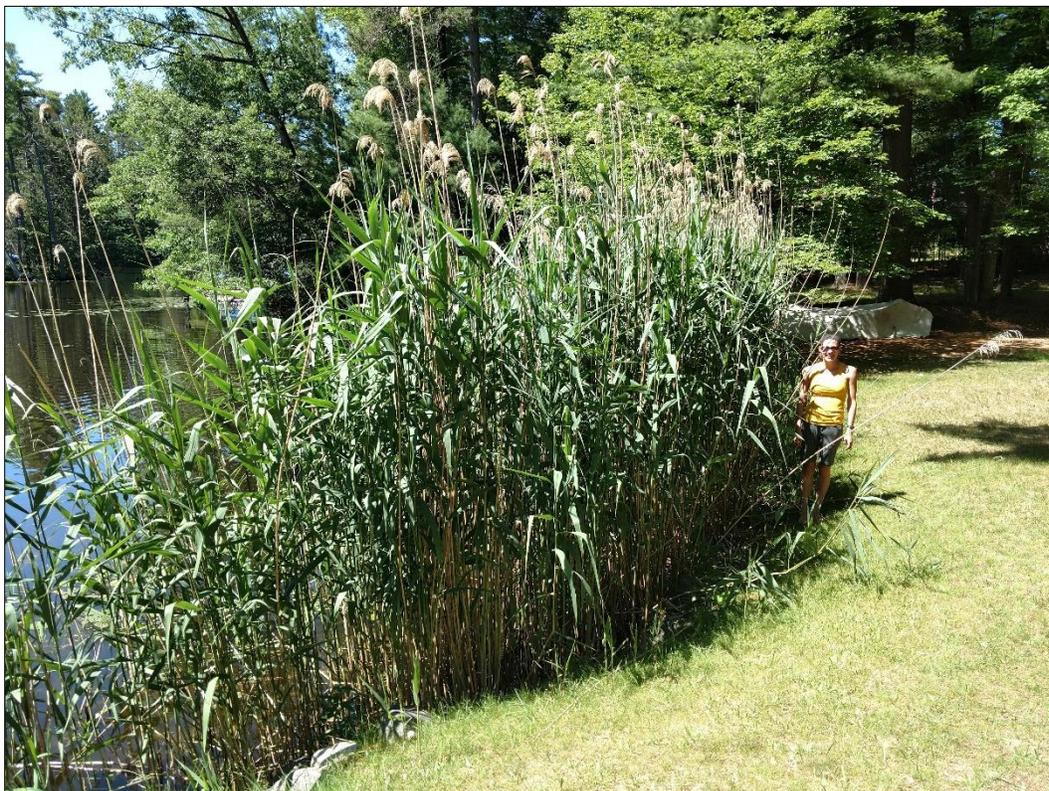
Figure 4. Photo taken 6-28-18 showing the plants height. Photo credit Stephanie Boismenu

Three fourths of the plants were in standing water, and one quarter of the plants were on land. The entire stand runs parallel along the landowners riprap shoreline for 60 feet and extends about 1 foot onto the neighbor's property to the west. The dimensions around the stand resulted in an oblong polygon and measured 643.81 square feet (.02 acres). The plants in the littoral zone extended water ward for 10 feet with a maximum water depth of 2 feet and stem density was 75%-100% coverage. On the landward side of the stand, individual and small clumps (5 stems or less) of phragmites emerged between the rock riprap and through the mowed lawn. A diverse mix of native submerged, emergent, and floating leaf aquatic plants were present around the outer edge of the stand and a few were scattered throughout the phragmites stand (Figure 5). Several frogs were observed in amongst the rock riprap.

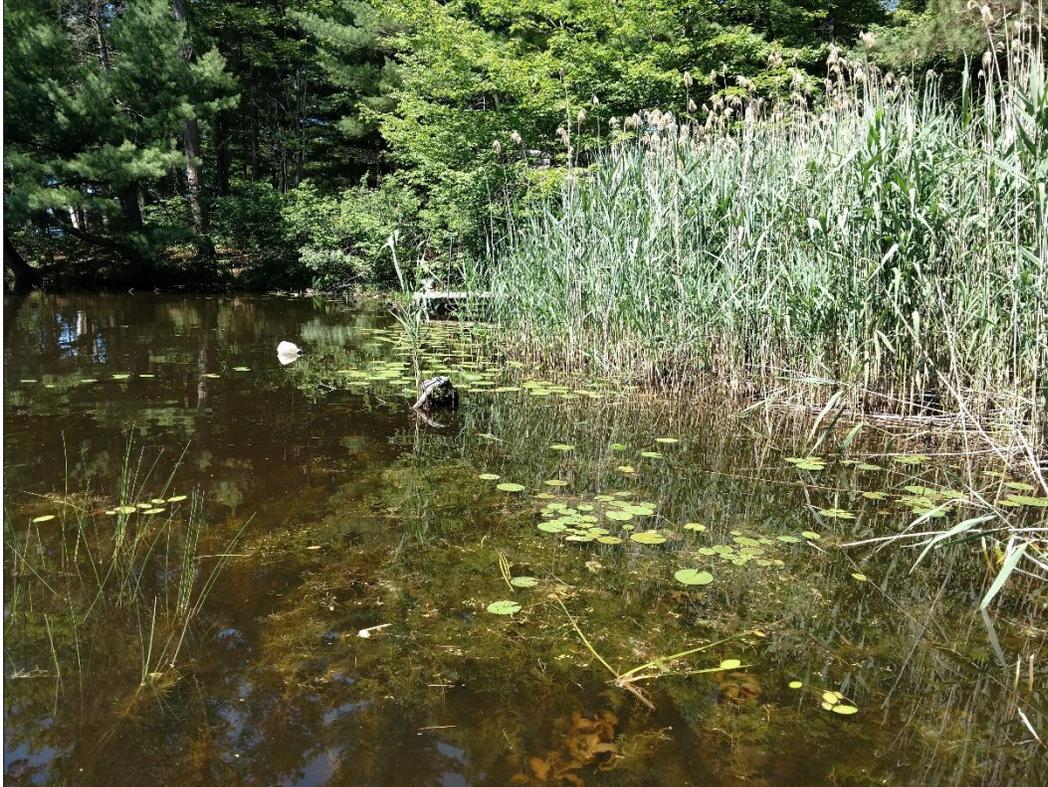
Figure 5. Photo taken 6-28-18 showing a diverse mixture of native aquatic vegetation and the invasive phragmites. Photo credit Stephanie Boismenu

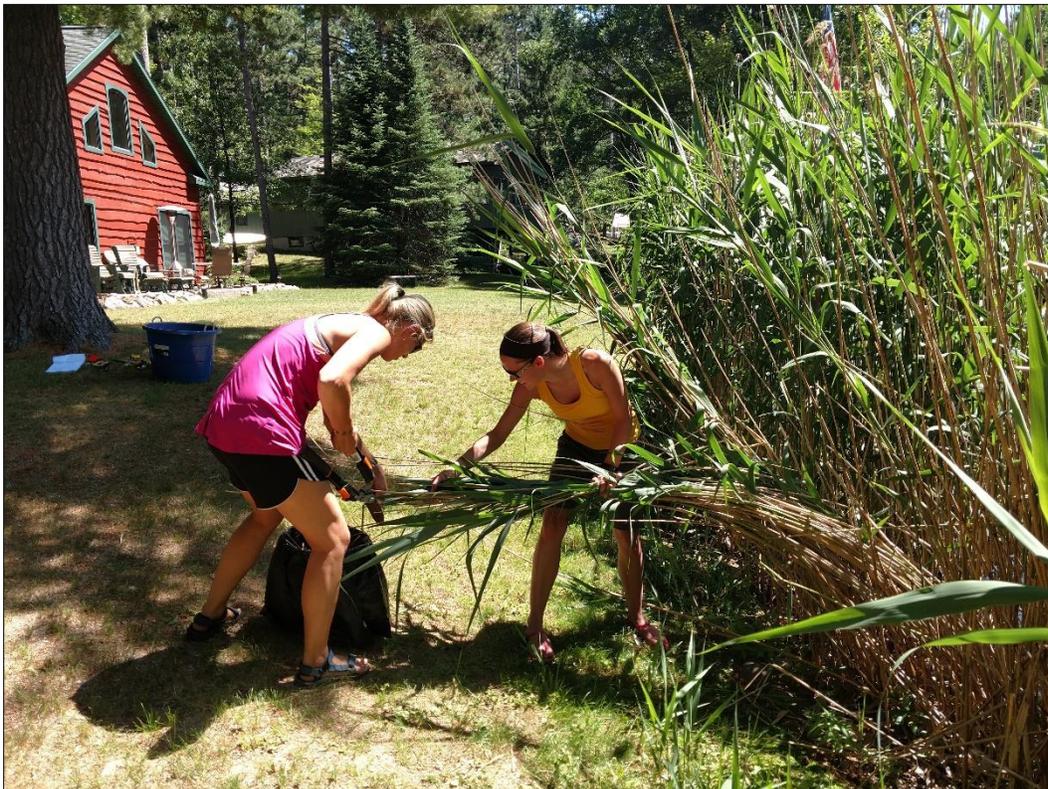
Figure 6. Oneida County AIS Program staff removing seed heads on 6-28-18. Photo credit Stephanie Boismenu

During this site visit, the Team cautiously and carefully cut off the seed heads to prevent seed dispersal via wind and water, and starting on the outer perimeter of the stand and working to the center of the stand (Figure 6). The cut plant material was deposited directly into large Rubbermaid containers lined with clear, heavy duty contractor trash bags (Figures 7 & 8). Dead standing biomass was removed and phragmites litter on the lawn and littoral zone was cleaned-up and bagged as well. All trash bags were labeled "Invasive plants – approved by DNR for landfilling" and disposed of in an approved dumpster at the Oneida County Courthouse.

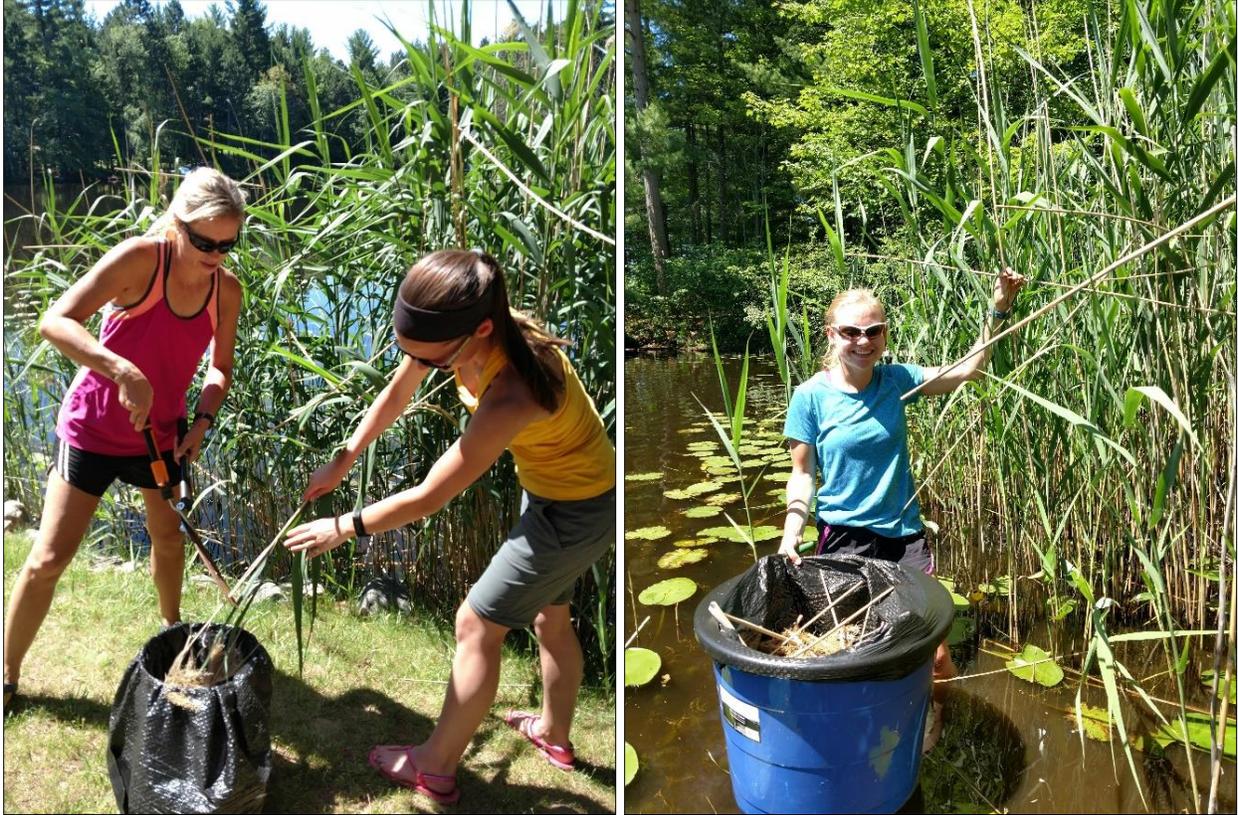
Figures 7 & 8. Oneida County AIS Program staff removing seed heads on 6-28-18. Photos credit Stephanie Boismenu

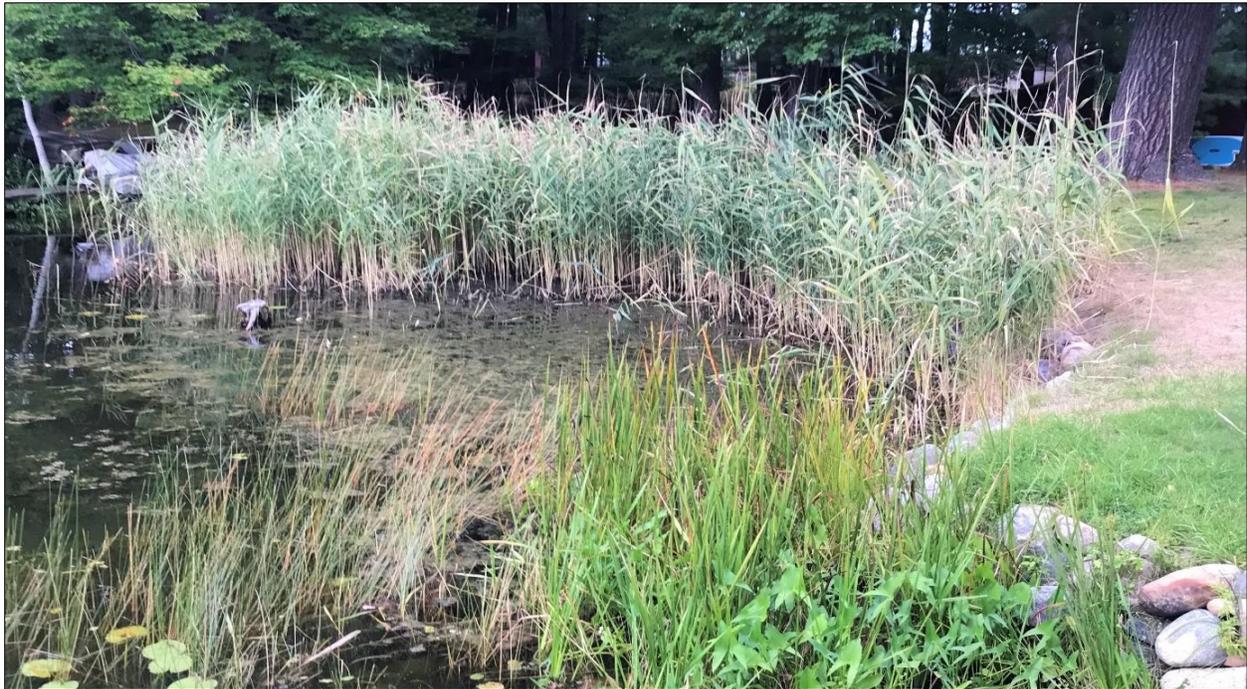
On September 1, 2019, the landowner contacted LWCD to report the top half of the plants were still green and the culms appeared dead. This news raised concerns that the herbicide treatment may not have work. The landowner provided photos as well that showed exactly what he described (Figure 9). LWCD contacted the DNR to discuss the issue and determined that another treatment should be applied this fall.

Figure 9. Photo taken 9-1-19, approximately one month post herbicide treatment. Photo credit James Karow

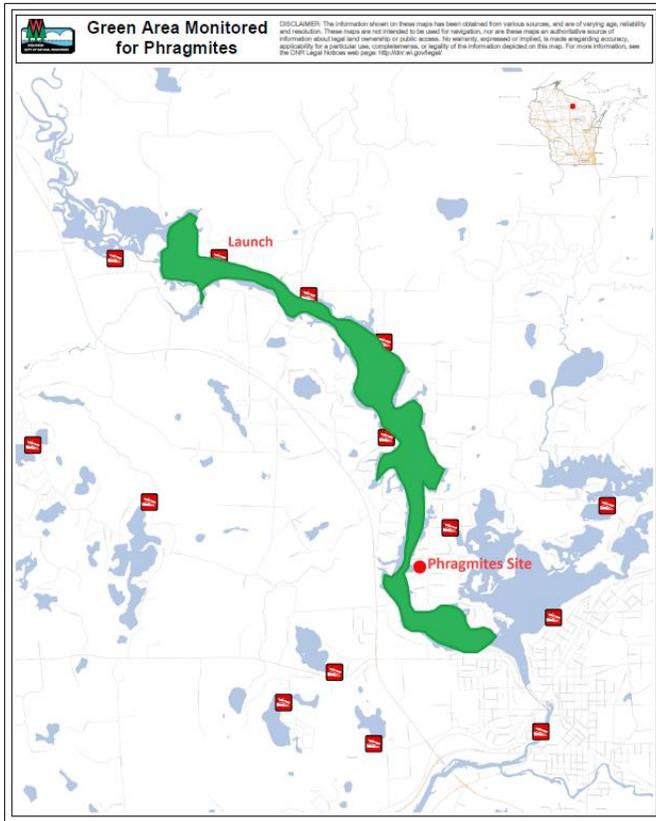
On October 18, 2019, approximately 12 weeks after the herbicide treatment, LWCD staff took a boat out on the Rhinelander Flowage to search for additional occurrences of non-native phragmites (Figure 10). Findings: Other than the existing phragmites site, no additional occurrences were observed.

Figure 10. Area in green was monitored for phragmites on 10-18-19.

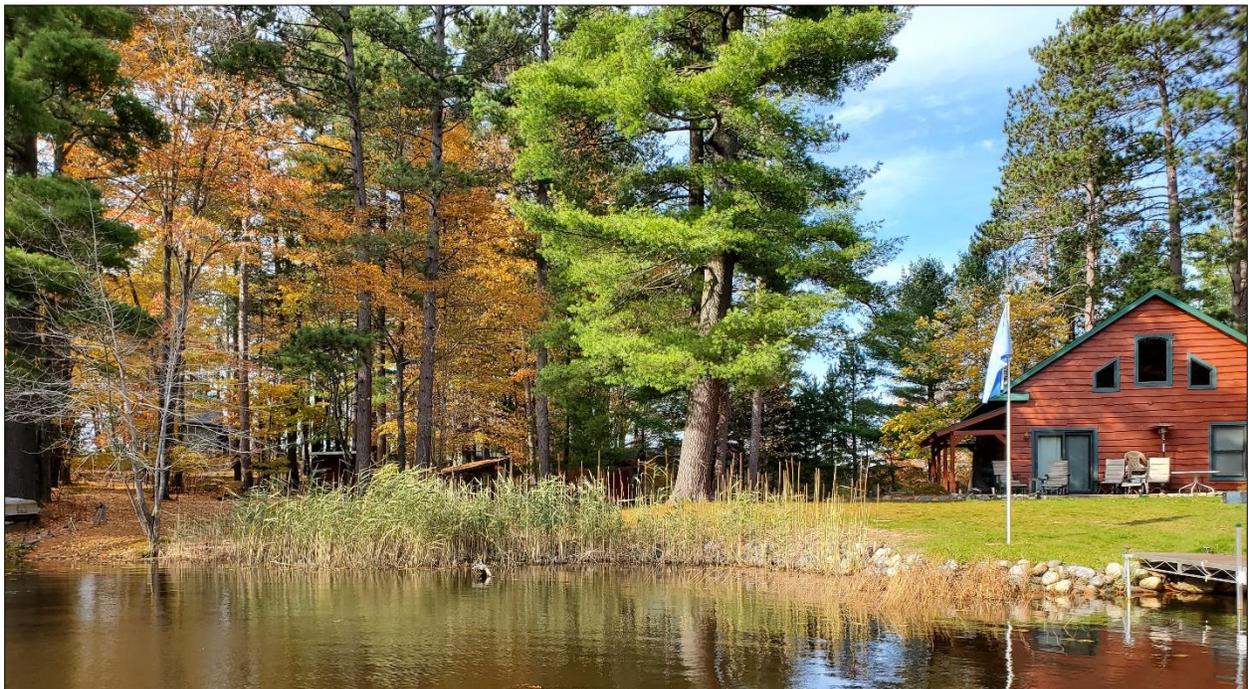
As they headed north along the eastern shoreline, they stopped by the existing phragmites to see how it looked after the July 31 treatment. However, due to low water and emerging stumps, they observed the stand from about 75 yards away and noted very little die-back compared to the landowners photo submitted on September 1st. The top of the plants were still green and the lower clum's appeared dead (Figures 11).

Figures 11. Photo taken 10-18-19, approximately 12 weeks post herbicide treatment. Photo credit Stephanie Boismenue

On October 23, 2019, Lee Shambeau of 4-Control, Inc., applied a second herbicide application. The following year it was determined the treatment reduced the cover 100%.

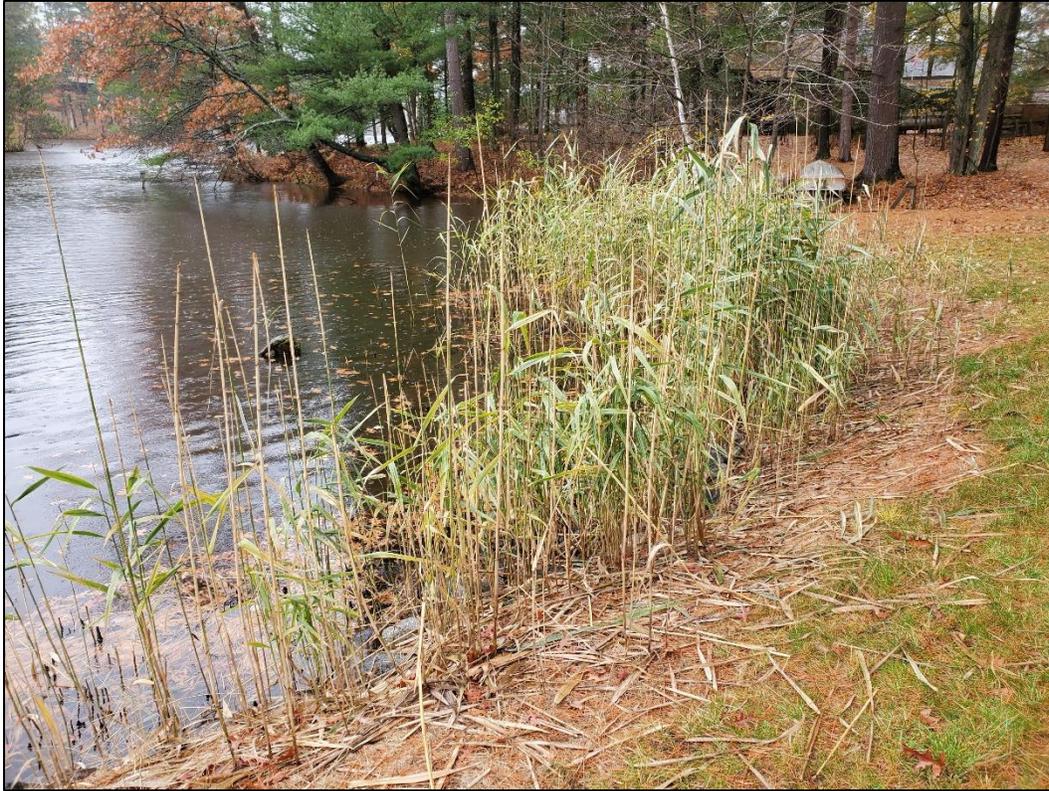
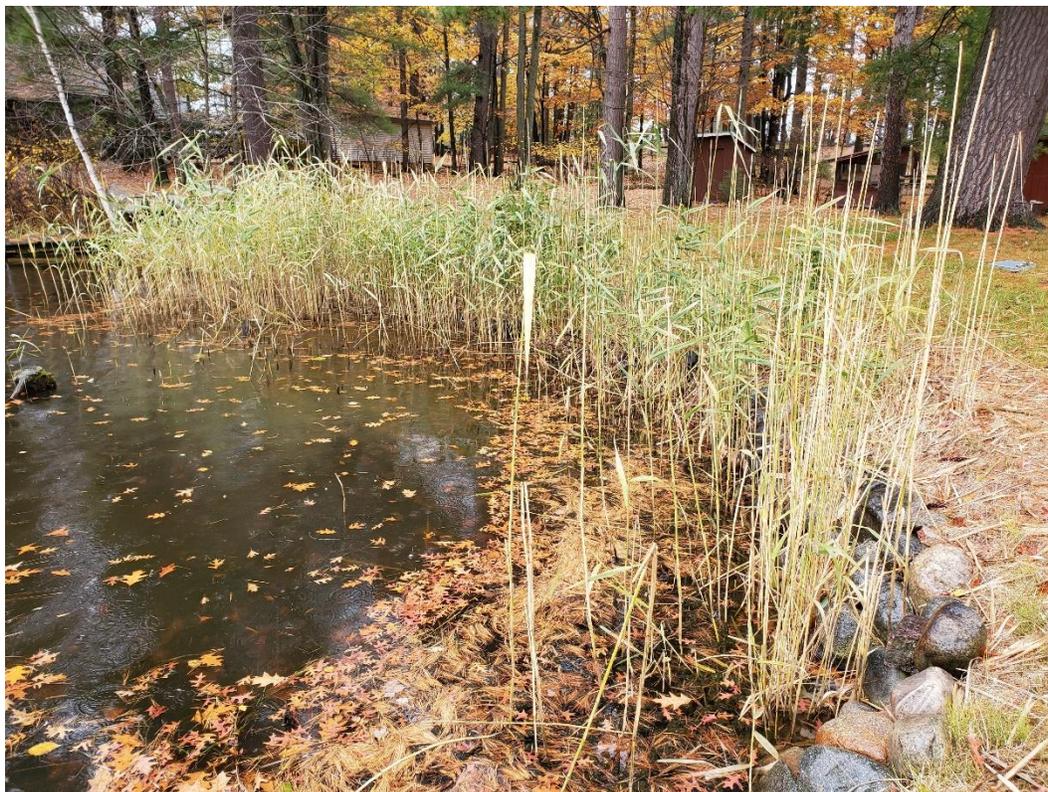
On October 22, 2019, LWCD visited the site for a twelve weeks post herbicide application check. Most of the leaves were beginning to turn yellow, which could be a result of fall dieback and/or the herbicide application. All of the plants on land were dead and dead biomass litter was scattered on the ground

(Figures 12 & 13). The majority of the plants standing in the water appeared to have some amount of dieback, but a few plants that were clearly alive as noted by the green leaves and stems (Figures 14, 15 & 16).

Figure 12. Photo take 10-22-19 showing the site twelve weeks post herbicide application. Photo credit Stephanie Boismenu

Figure 13. Photo taken 10-22-19 at twelve weeks post herbicide. Photo credit Stephanie Boismenu

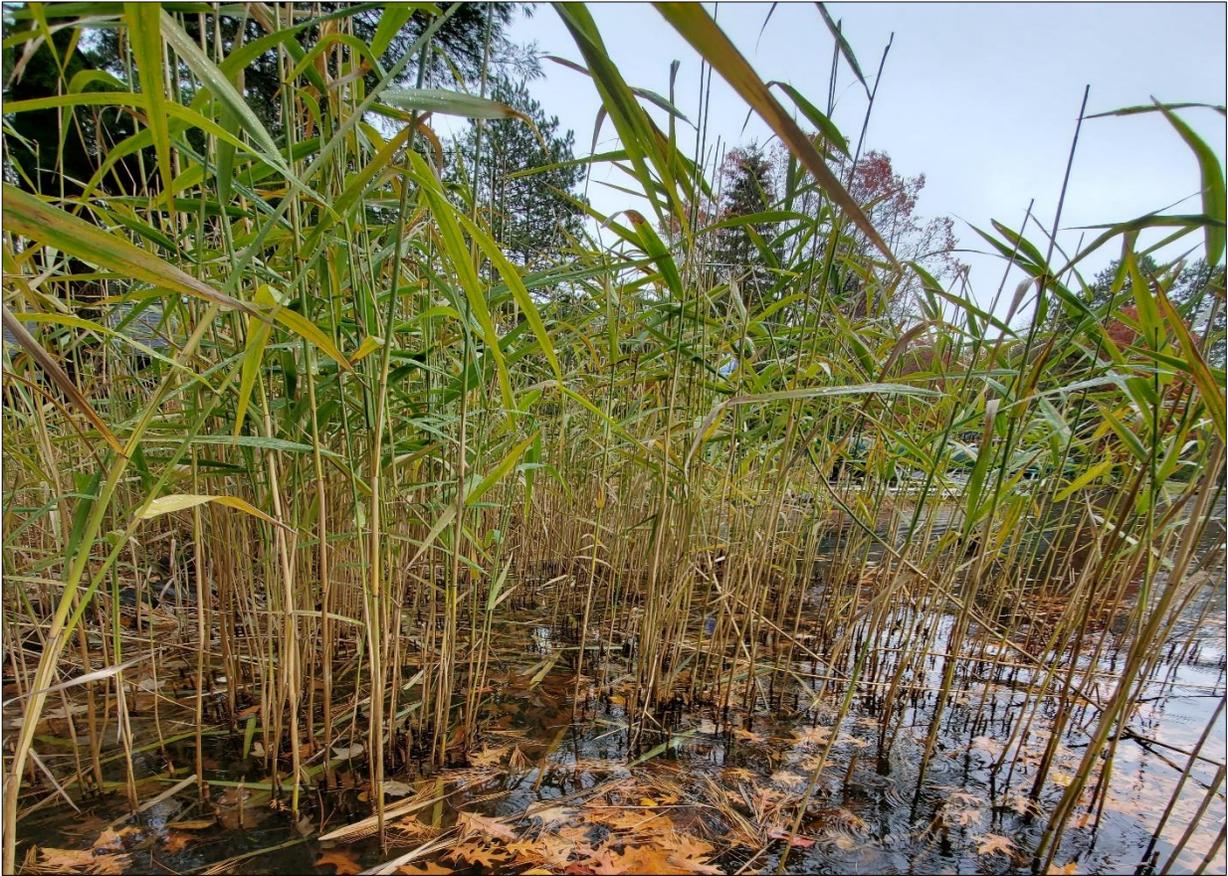
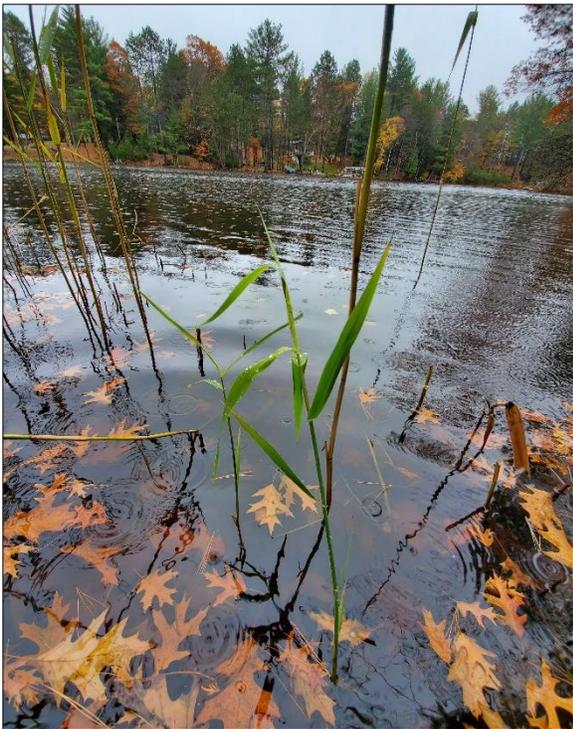
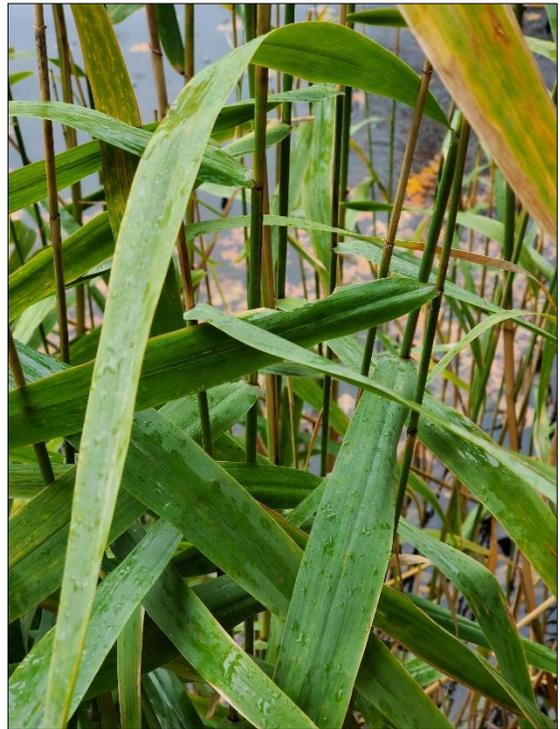
Figure 14. Photo taken 10-22-19 at twelve weeks post herbicide application. Photo Credit Stephanie Boismenu

Figure 15 & 16. Photo taken 10-22-19 at twelve weeks post herbicide application. Photo Credit Stephanie Boismenu

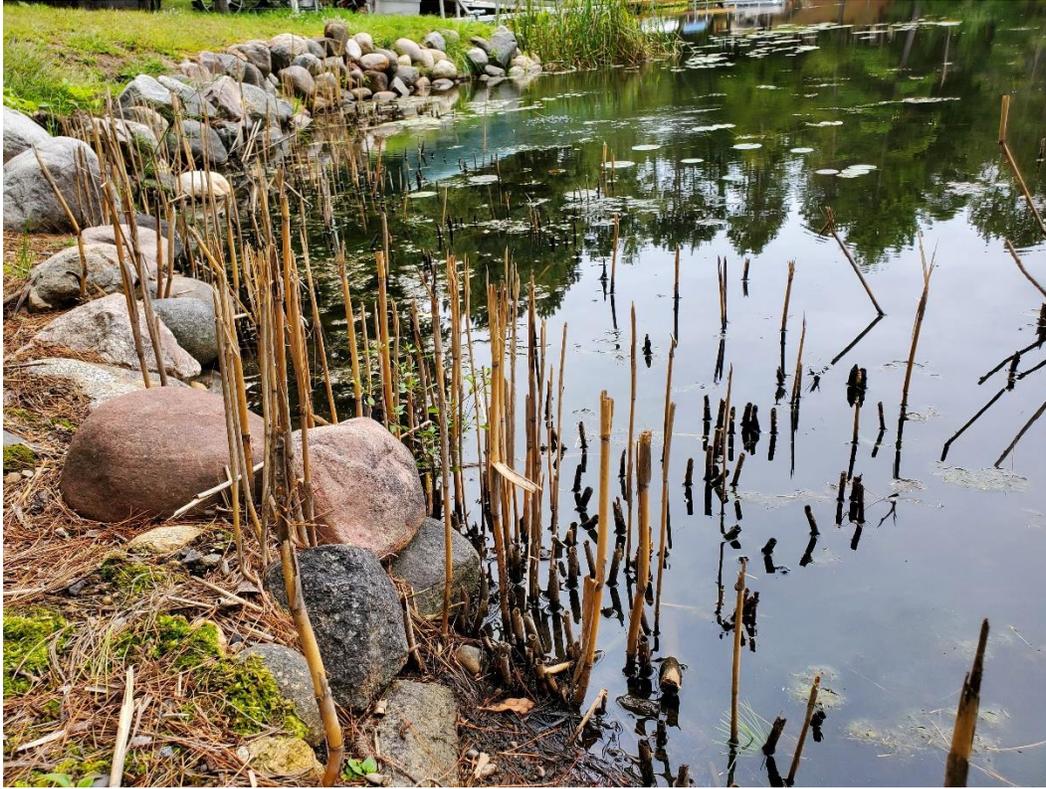
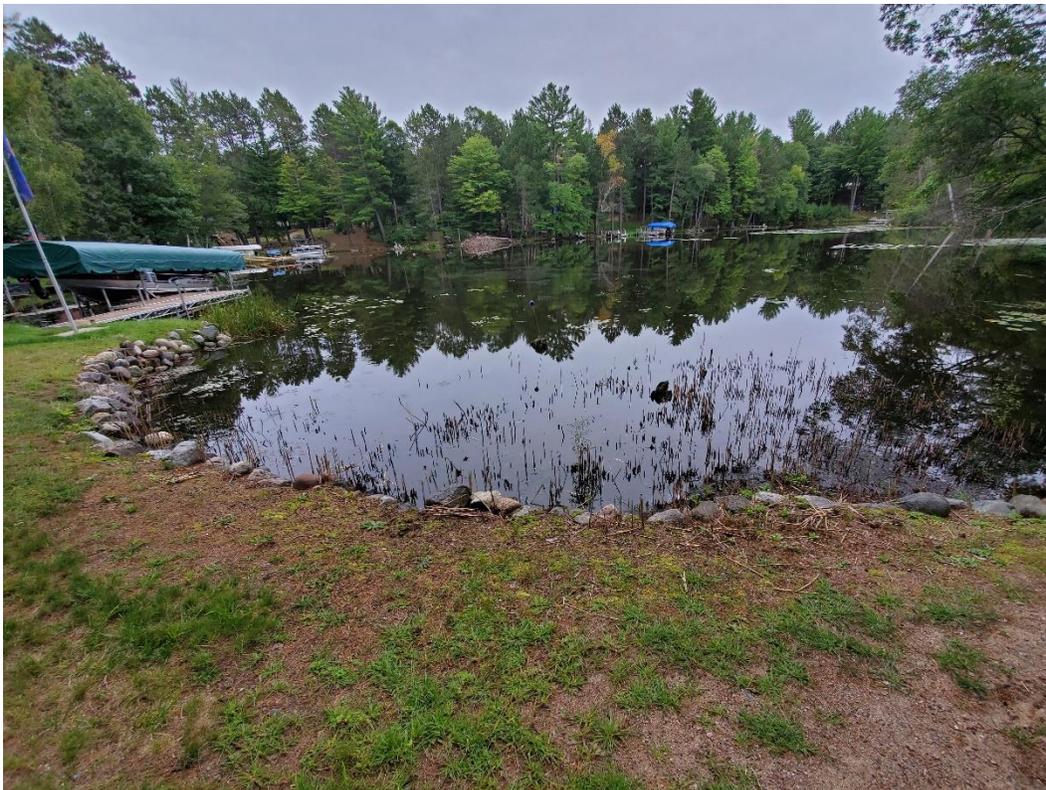
On September 8, 2020, LWCD monitored the site to check on the progress from the second herbicide application. The majority of dead biomass had been removed by landowner and all that remained were dead stems sticking out of the ground and littoral zone (Figure 17 & 18). The team pulled 50 dead stems out of the ground and all of the plant parts were dead. In addition, 10 stems, including their rhizomes and stolons, were carefully dug out of the littoral area and all plant parts were dead.

Figure 17. Photos taken 9-8-2020. Photo credit Stephanie Boismenu

Figure 18. Photos taken 9-8-2020. Photo credit Stephanie Boismenu

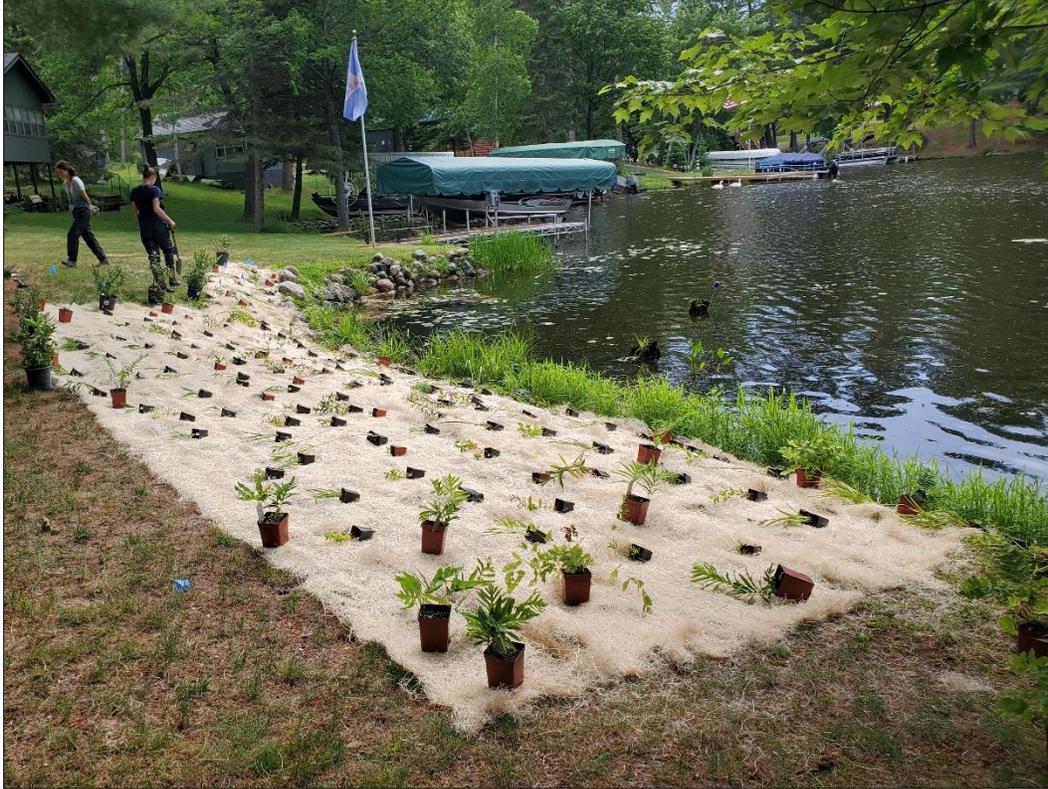
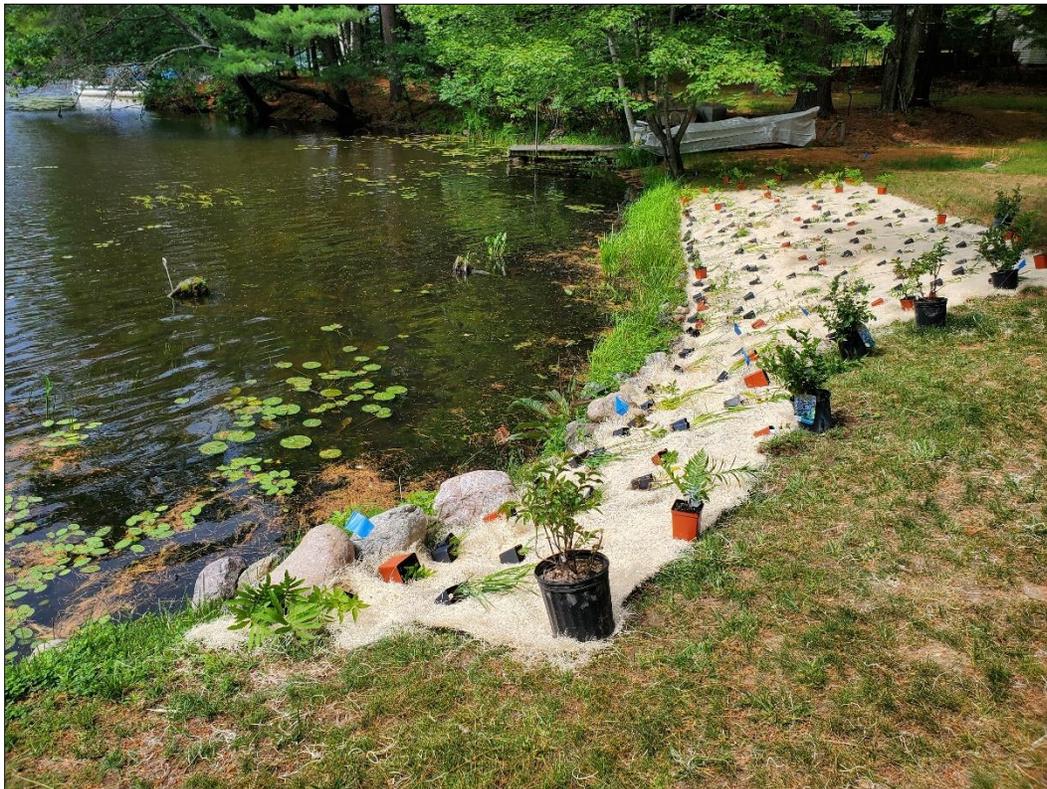
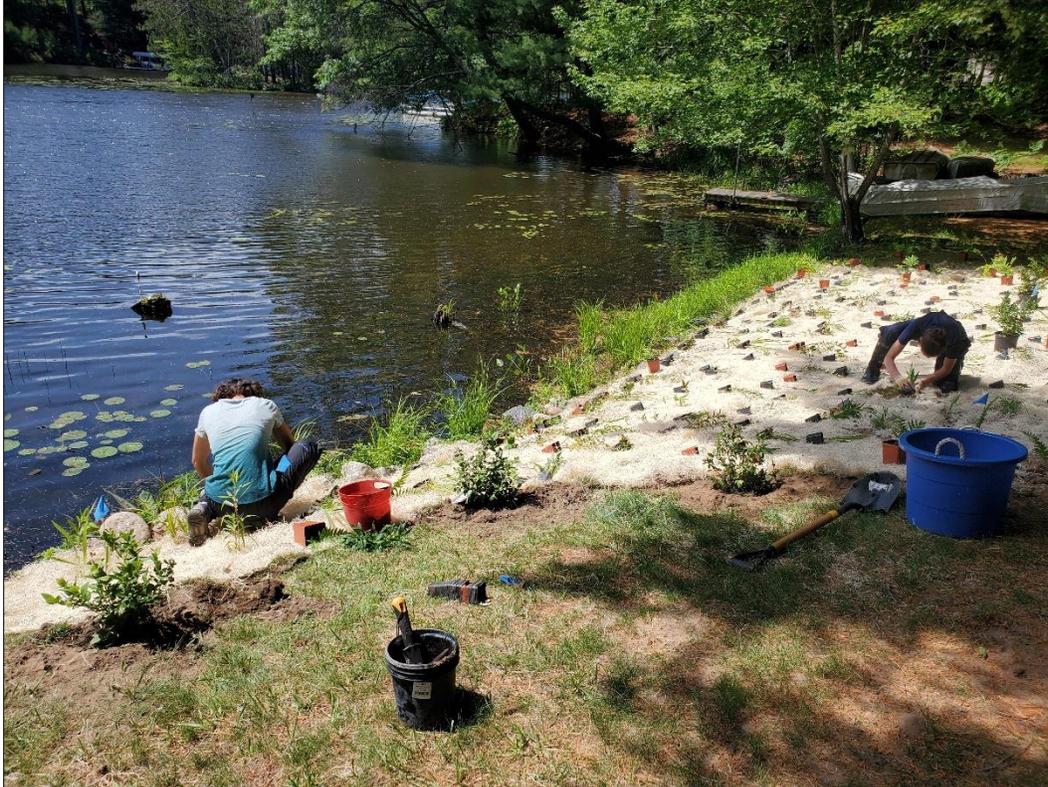
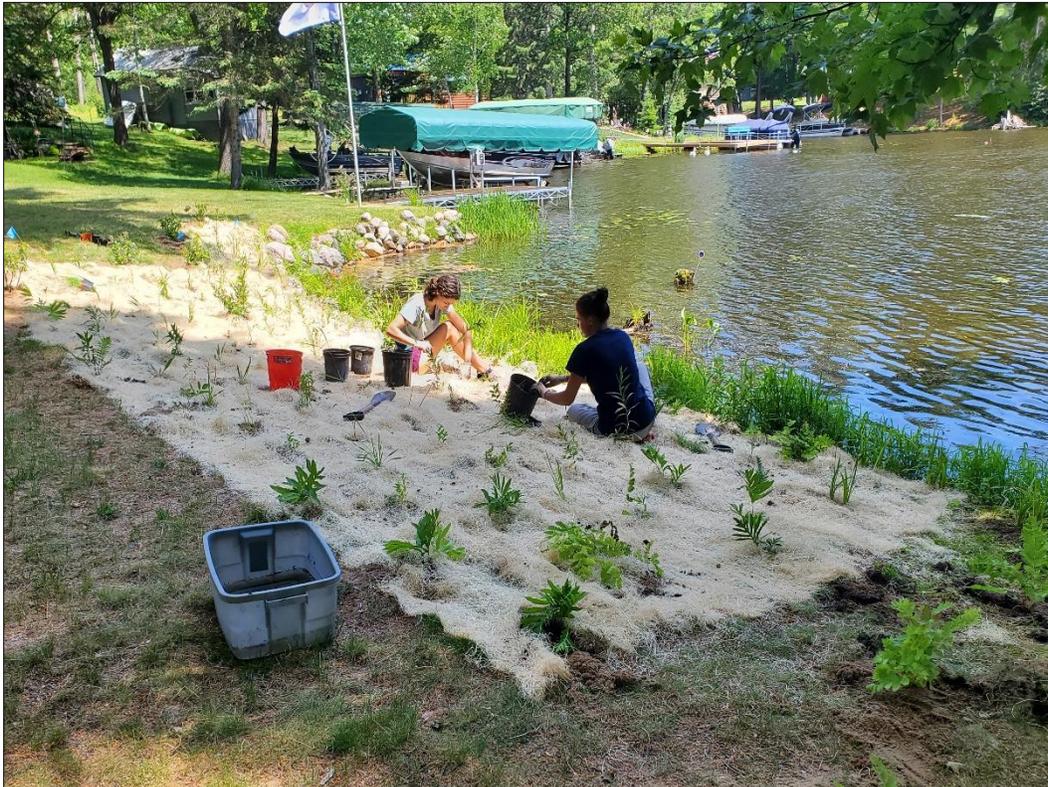
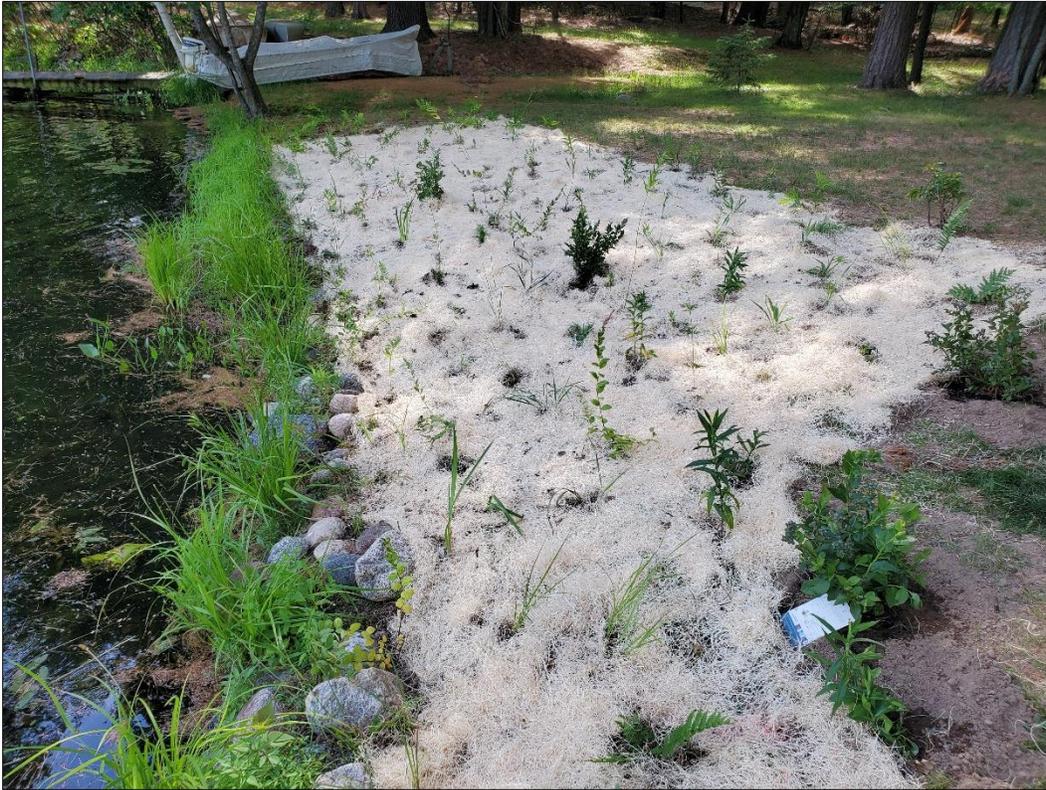
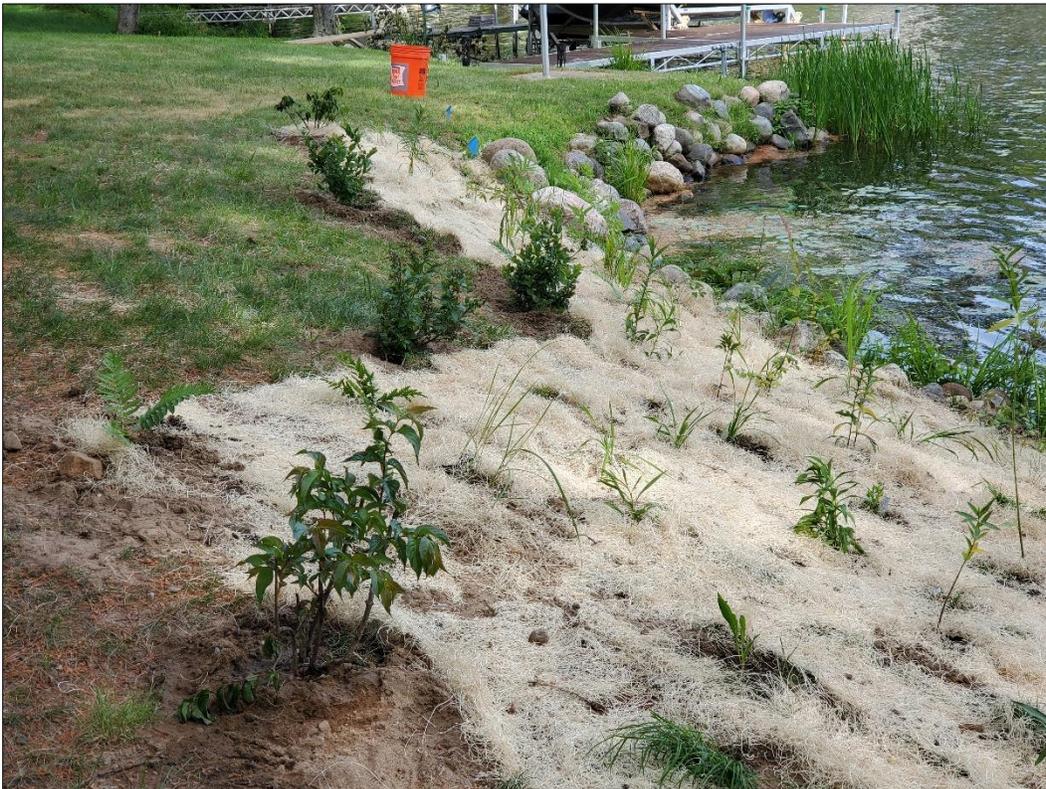
Figure 19. Photos taken 6-30-22 showing the progression of the shoreland habitat restoration project. Photo credit Stephanie Boismenu

Figure 20. Photos taken 6-30-22 of the shoreland habitat restoration project. Photo credit Stephanie Boismenu

Figure 21. Photos taken 6-30-22 of the shoreland habitat restoration project. Photo credit Stephanie Boismenu

Figure 22. Photos taken 6-30-22 of the shoreland habitat restoration project. Photo credit Stephanie Boismenu

Figure 23. Photos taken 6-30-22 of the completed shoreland habitat restoration project.
Photo credit Stephanie Boismenu

Figure 24. Photos taken 6-30-22 of the completed shoreland habitat restoration project.
Photo credit Stephanie Boismenu

On June 30, 2022, the LWCD restored 450 square feet of shoreland habitat using a diverse mixture of native shrubs and herbaceous ground cover, totaling 260 plants (Figures 19-24). The planting area started behind the existing rock riprap, followed the natural contour of the shoreline for 45 feet, and expanded landward for a maximum of 10 feet. Before planting the plants, Curlex NetFree Erosion Control Blanket (100 % biodegradable) was installed in the planting area to protect plants and topsoil from wind and water erosion, while simultaneously promoting ideal growing conditions. The native plants were planted within the Curlex and filled in with compost. The landowner is responsible for watering and maintenance.

The LWCD followed the Natural Resource Conservation Services' Shoreland Habitat Practice Standard #643A and 'Wisconsin Biology Technical Note 1' to establish the planting densities and standards used for this project. Plant numbers were calculated based on the area in square feet to be reestablished and the appropriate density. A total of 260 native plants were chosen based on the sites soil, moisture, light, and existing native vegetation in the area, and the herbaceous ground cover comprised of a minimum of 30% grasses and/or sedges (Figure 25). The planting plan included:

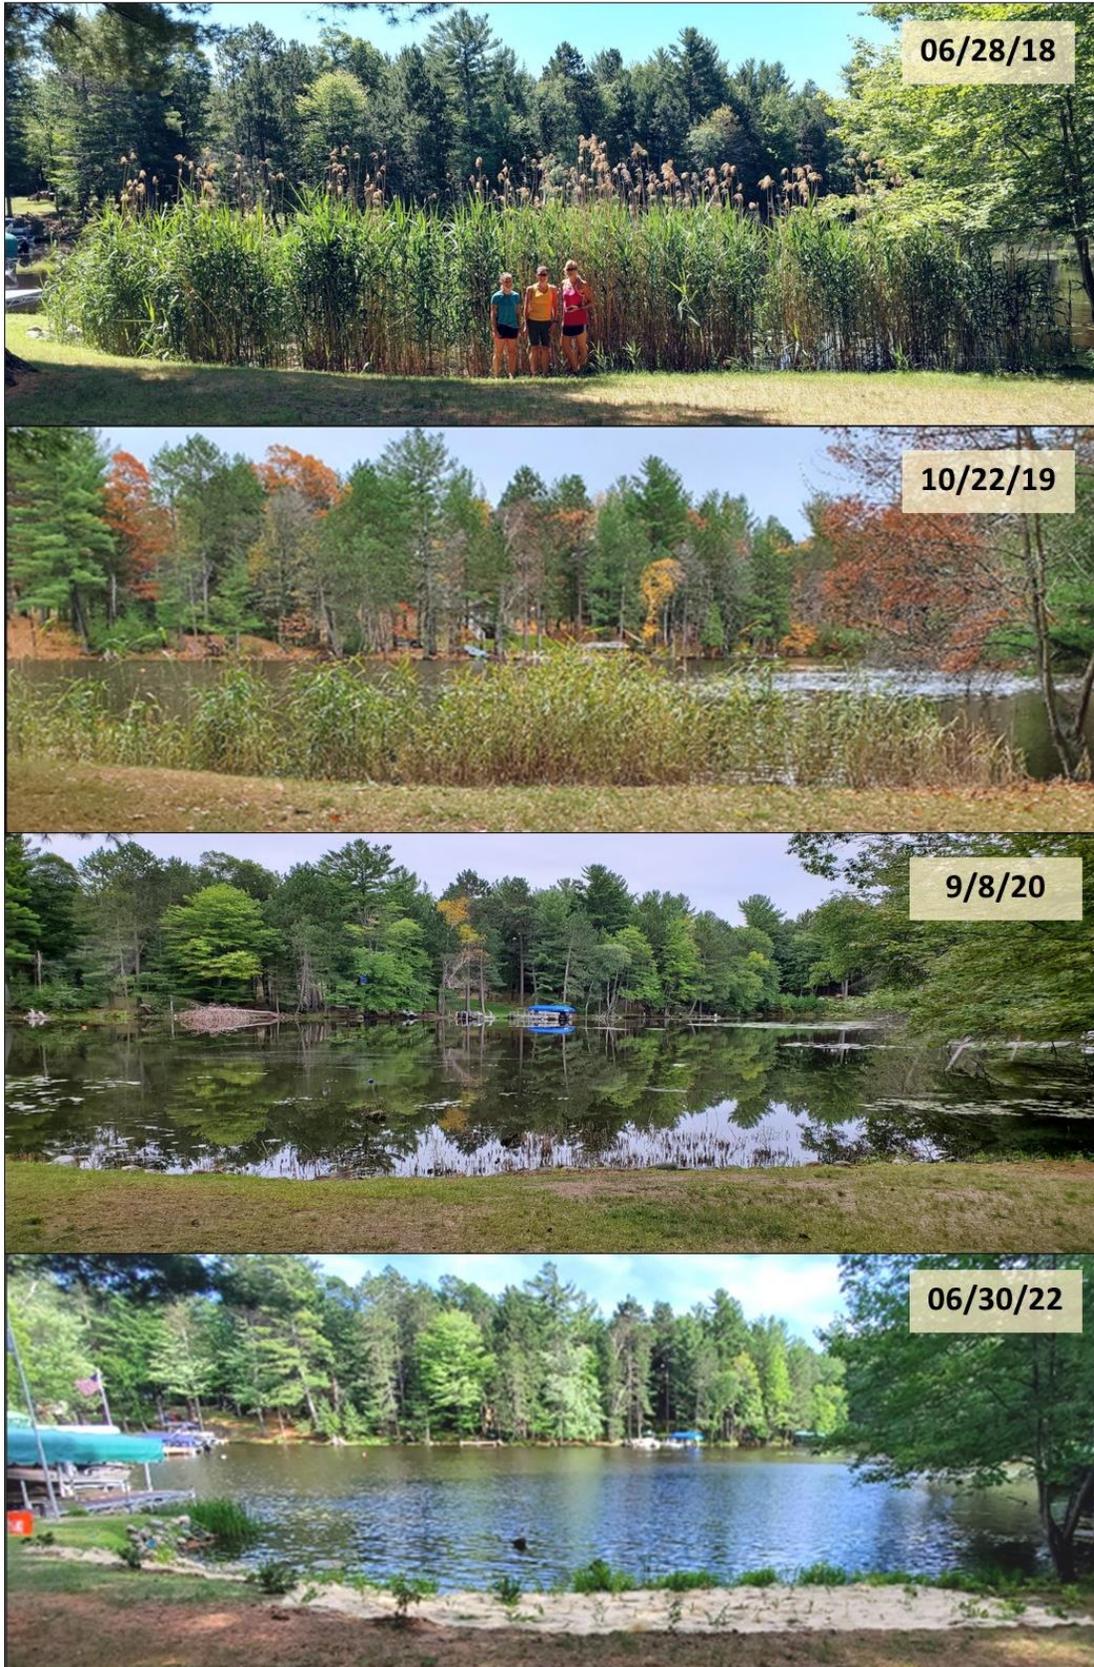
Figure 26. Photo collage showing the progression of the phragmites site. Photo credit Stephanie Boismenu

I am pleased to say that the Rhinelander Flowage phragmites site has been 100% eradicated and the shoreland habitat has been restored with native vegetation. This Furthermore, tracking the changes through time, as shown in Figure 26, has been exciting and gives me hope that similar phragmites projects can have the same success. Factors that may have contributed to the success of this project include:
