2010 Water Quality Management Plan Update

Buffalo-Trempealeau Basin, Wisconsin

August, 2010

Elk Creek Watershed

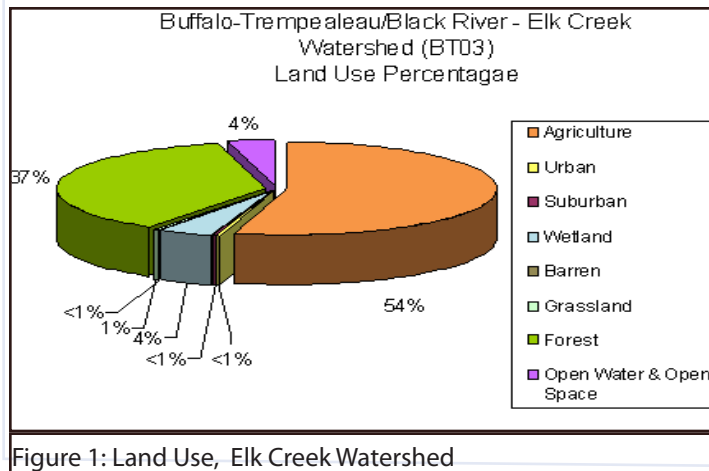
Figure 1: Land Use, Elk Creek Watershed

Figure 1 below shows watershed land use data from the 2001 National Land Cover Inventory dataset, which illustrates the domination of agriculture and forests in the watershed.

Wetlands make up a considerably large component of the water resources in this watershed (3,311 acres), or 4% of the total land area, compared to lakes which cover 47 acres of the landscape. The primary land use in this watershed is agriculture (54% of the land) followed by forest, encompassing roughly 34% of the total acreage of the watershed. The communities of Elk Creek Watershed include the towns of Chimney Rock, Hale, Burnside, Lincoln and Sumner and at the outlet of the watershed is the City of Independence.

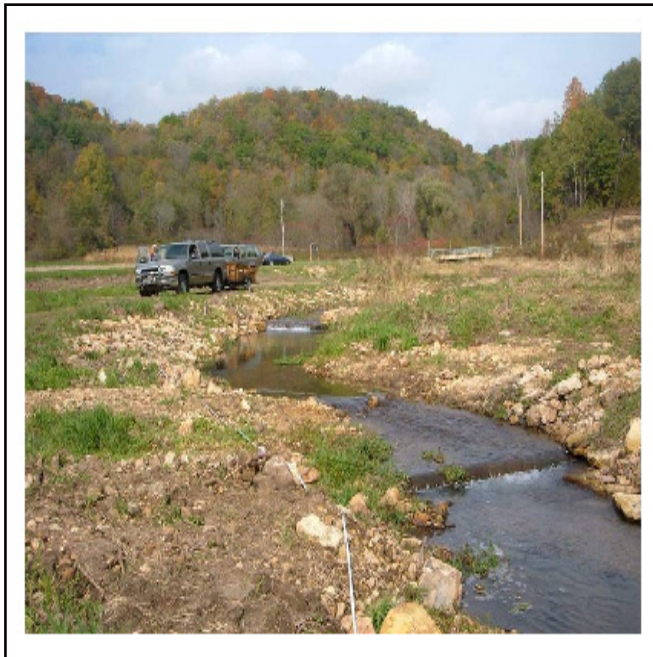
Trout Unlimited restoration work on Elk Creek involved enhancing brook trout habitat. From the TU website.

With sustainable cold water temperatures documented in a majority of Elk Creek tributaries, the limiting factor for excellent cold water fisheries appears to be habitat. Many of these streams are highly entrenched as improved farming practices have reduced the sediment load to the stream, and the stream cuts through the historically deposited sediments. With high and steep banks, the streams are not well connected to their historical floodplain, which results in increased scour and bank erosion. In-stream habitat projects along State-owned portions of **Borst Valley Creek** and **Bruce Valley Creek** have reduced and stabilized some bank erosion. The habitat work coupled with the stocking of feral (native) trout strains have improved the trout fisheries in these two streams over the last decade.

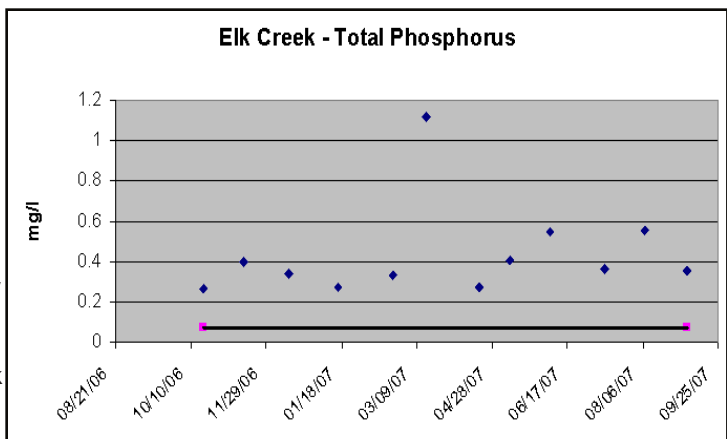
Figure 2: Elk Creek Total Phosphorus at Swede Valley Road

Total phosphorus concentration collected from Elk Creek at Swede Valley Road are very high compared to statewide averages (Figure 2). The solid line is the 2010 proposed phosphorus standard for wadeable streams (0.075 mg/l). Additional monitoring is required to

determine if background or ambient groundwater phosphorus concentrations are naturally high or if the elevated phosphorus concentrations observed in Elk Creek are a result of the agriculturally dominated watershed.

Monthly water chemistry samples were collected in 2007 from Elk Creek as part of the Statewide Watershed Rotation stream monitoring network. Water chemistry sites are generally selected near the mouth of main-stem streams to document nutrient concentrations in surface water leaving the watershed. Elk Creek has the highest median total phosphorus concentration of 55 sites surveyed to date in the West Central Region. The growing season median total phosphorus concentration was over 5 times higher than the proposed water quality standard.

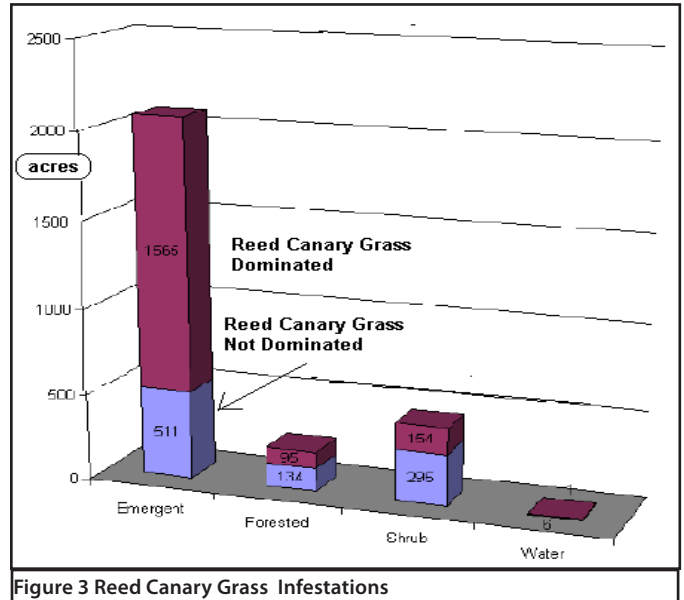
Figure 3 Reed Canary Grass Infestations

Little is known about the condition of the remaining wetlands but estimates of reed canary grass infestations, an opportunistic aquatic invasive wetland plant, into different wetland types has been estimated based on satellite imagery. This information shows that reed canary grass dominates 86% of the existing emergent wetlands and 8% of the remaining shrub wetlands. Reed Canary Grass domination inhibits successful establishment of native wetland species.
