### Park Lake County Park Shoreline Restoration Project Summary

### PARK LAKE COUNTY PARK—FINISHED

**BEFORE PICTURES OF PARK LAKE COUNTY  
PARK/BOAT LAUNCH**

**FINISHED PICTURES OF PARK LAKE COUNTY  
PARK/BOAT LAUNCH**

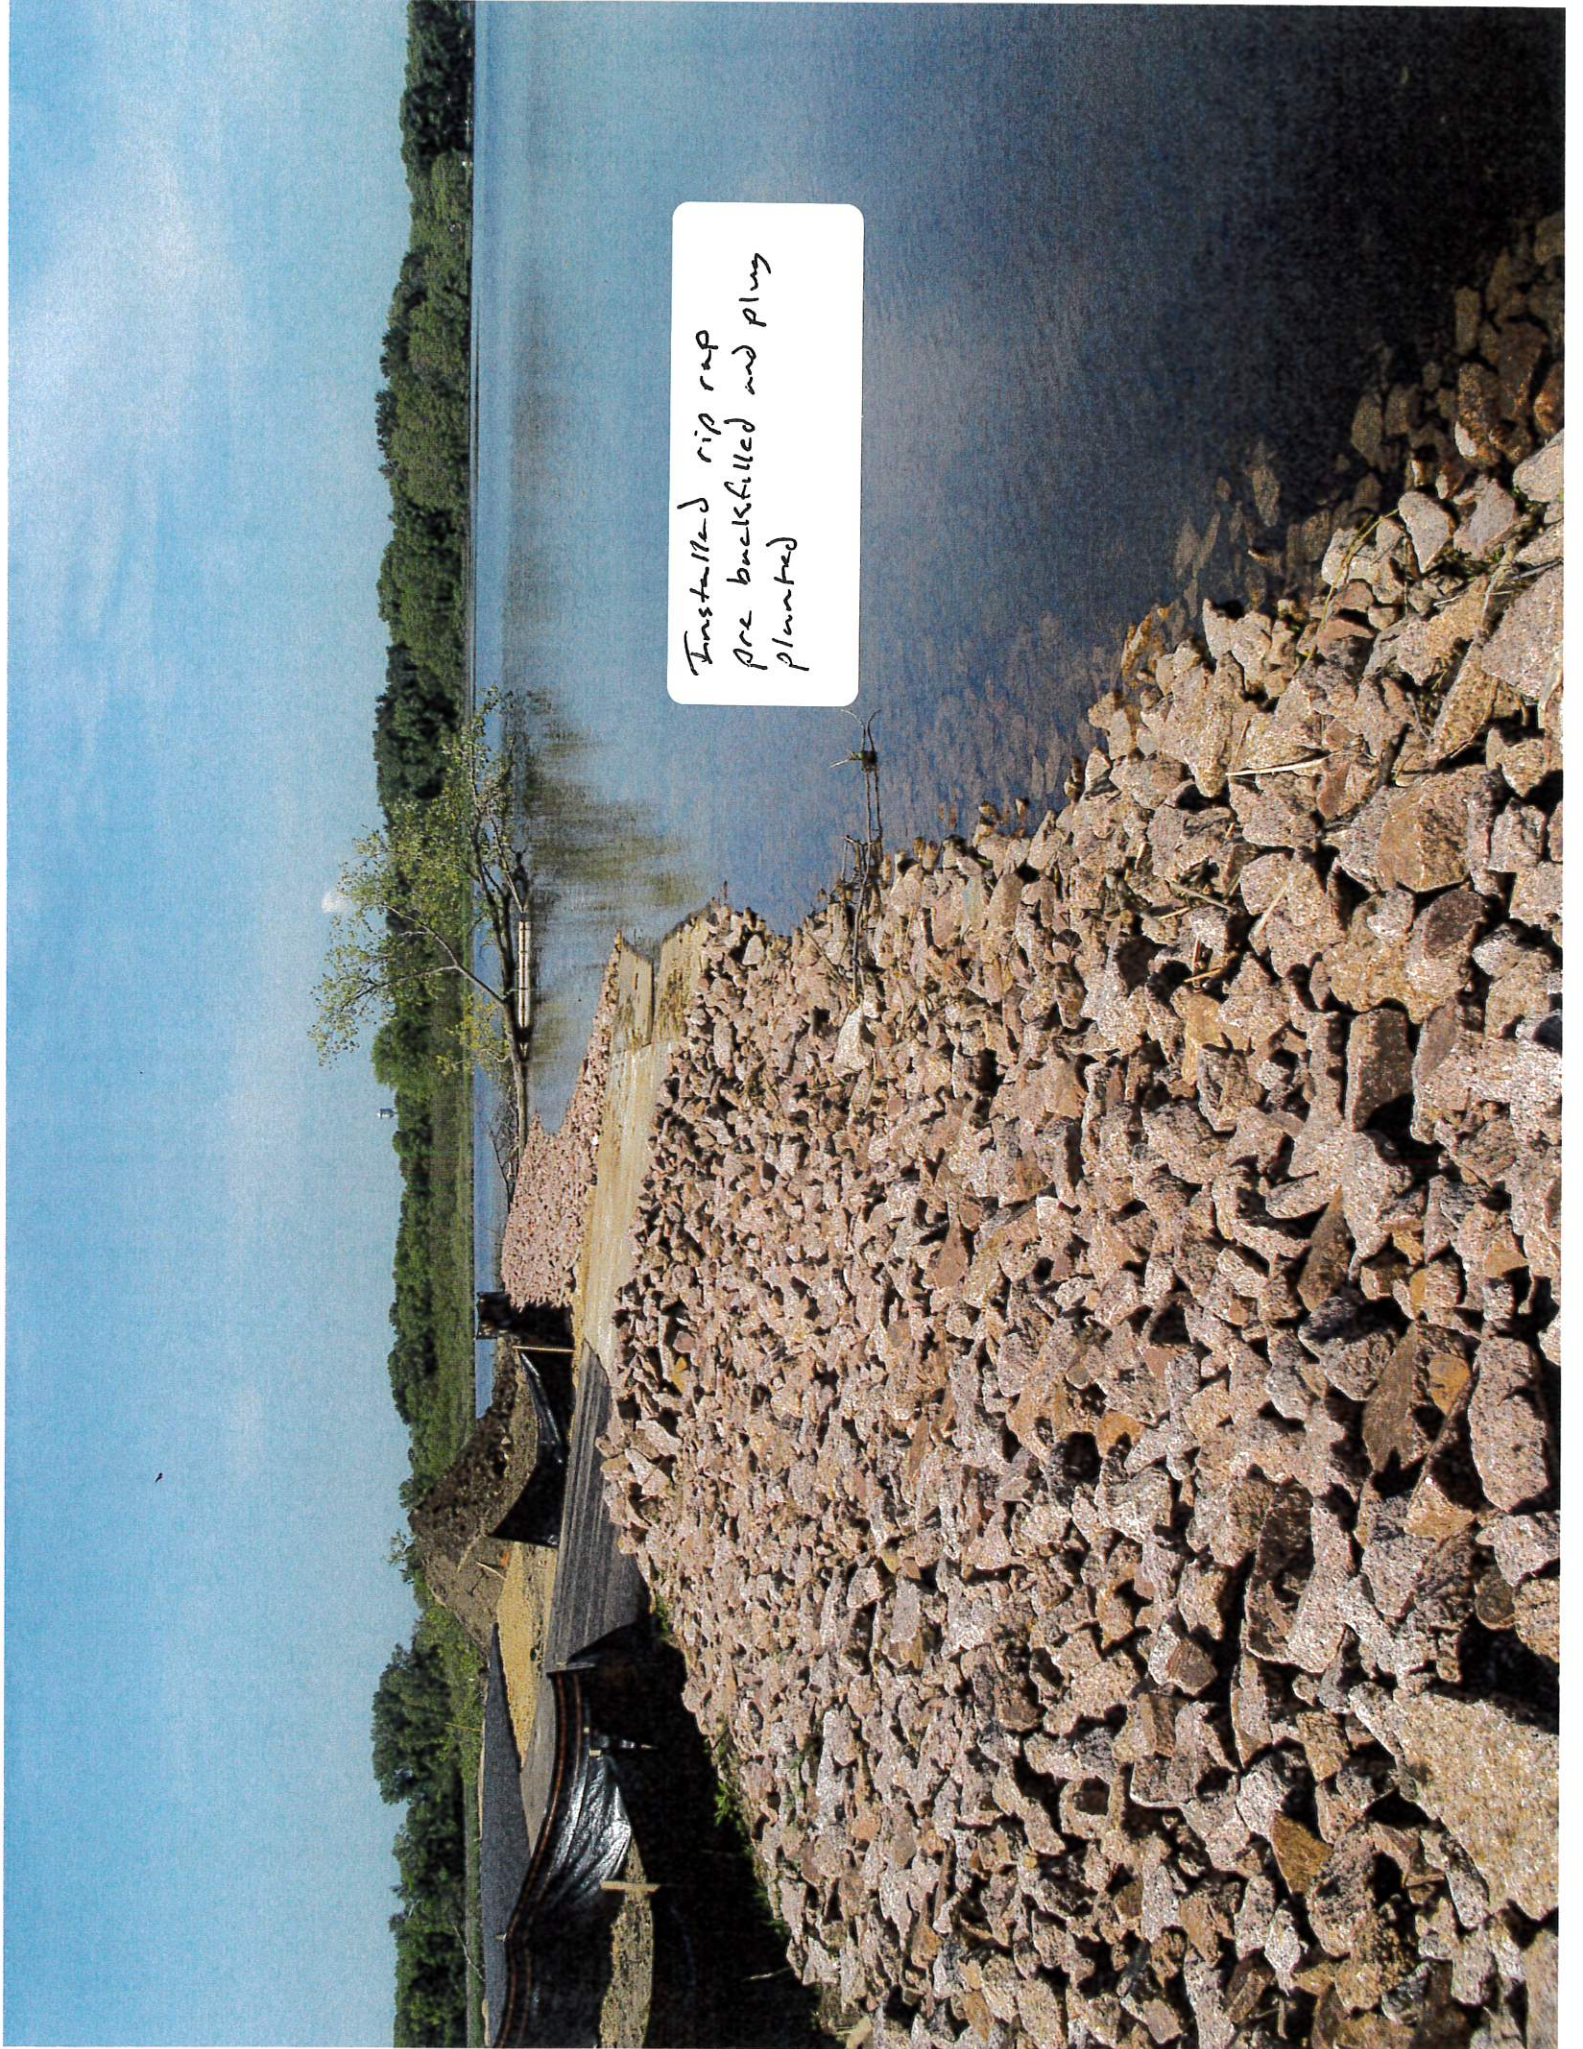
Installed rip rap  
pre backfilled and plug  
planted

- 1. Rip rap** 160' feet of rip rap was installed in three sections of shoreline near the boat launches. The rip rap was installed according to the plan. The rip rap was then backfilled with native soil to an elevation of 1' above the ordinary highwater mark. This backfilled area was then planted with native plant plugs at a density of 1 plug per sq. ft. An additional 340' of coconut log with sedge plugs was also installed as additional protection on the shoreline that was not rip rapped (not in plan).

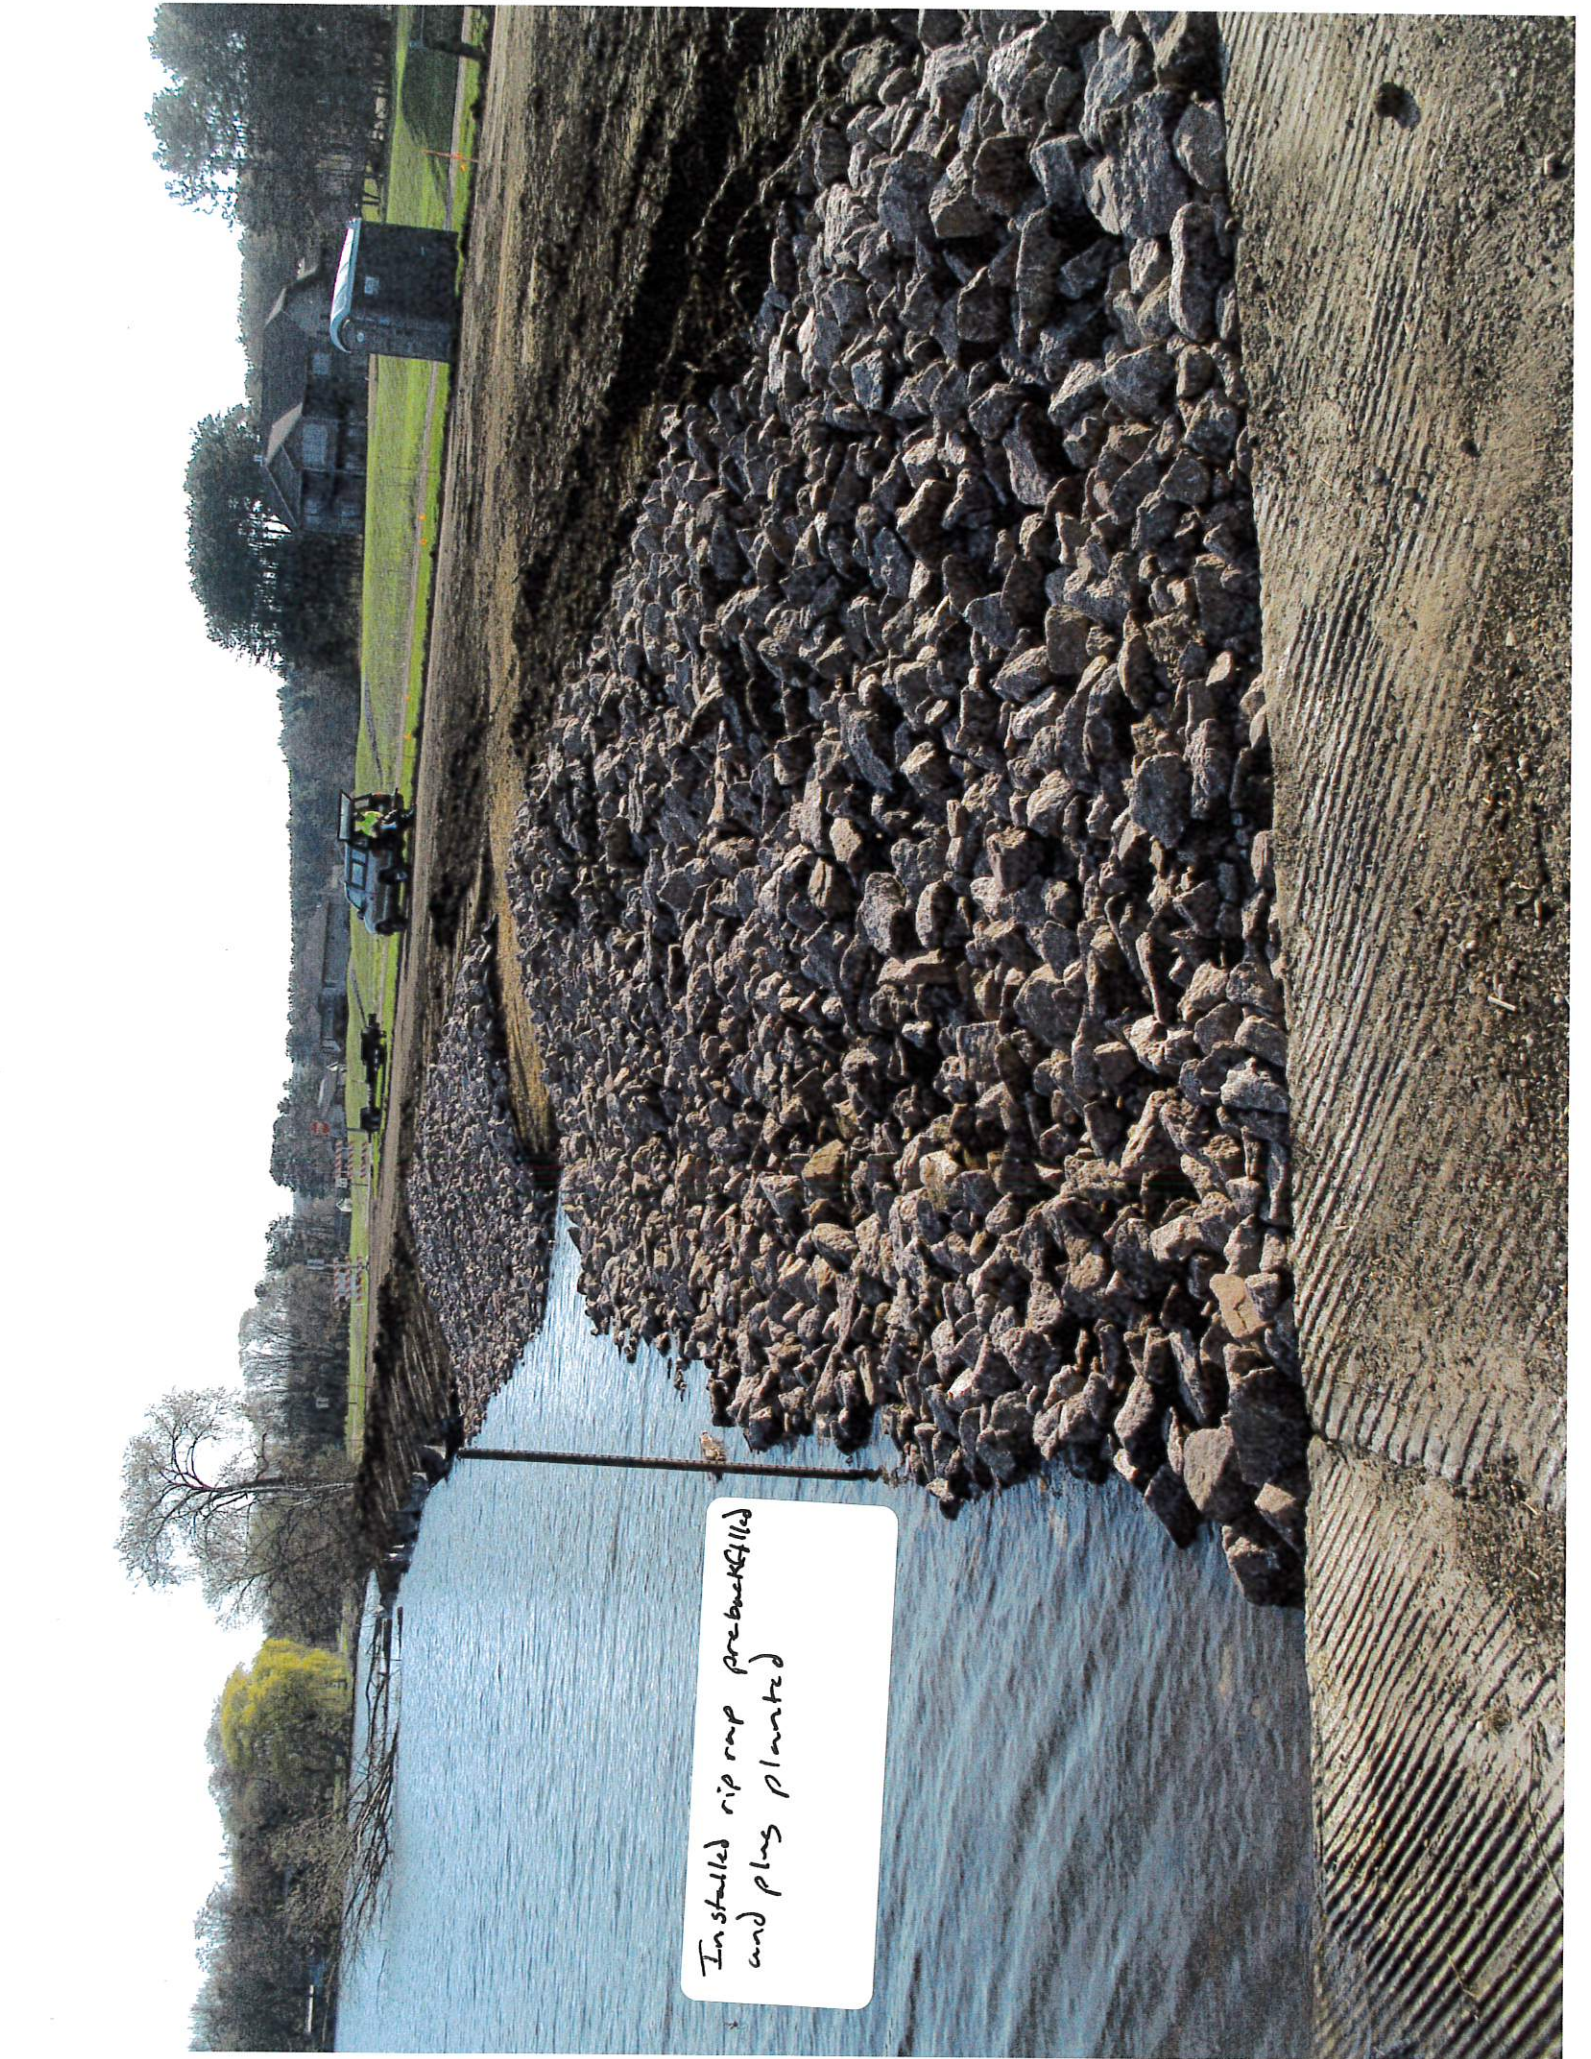
Installed rip rap pre-bucket filled  
and plugs planted

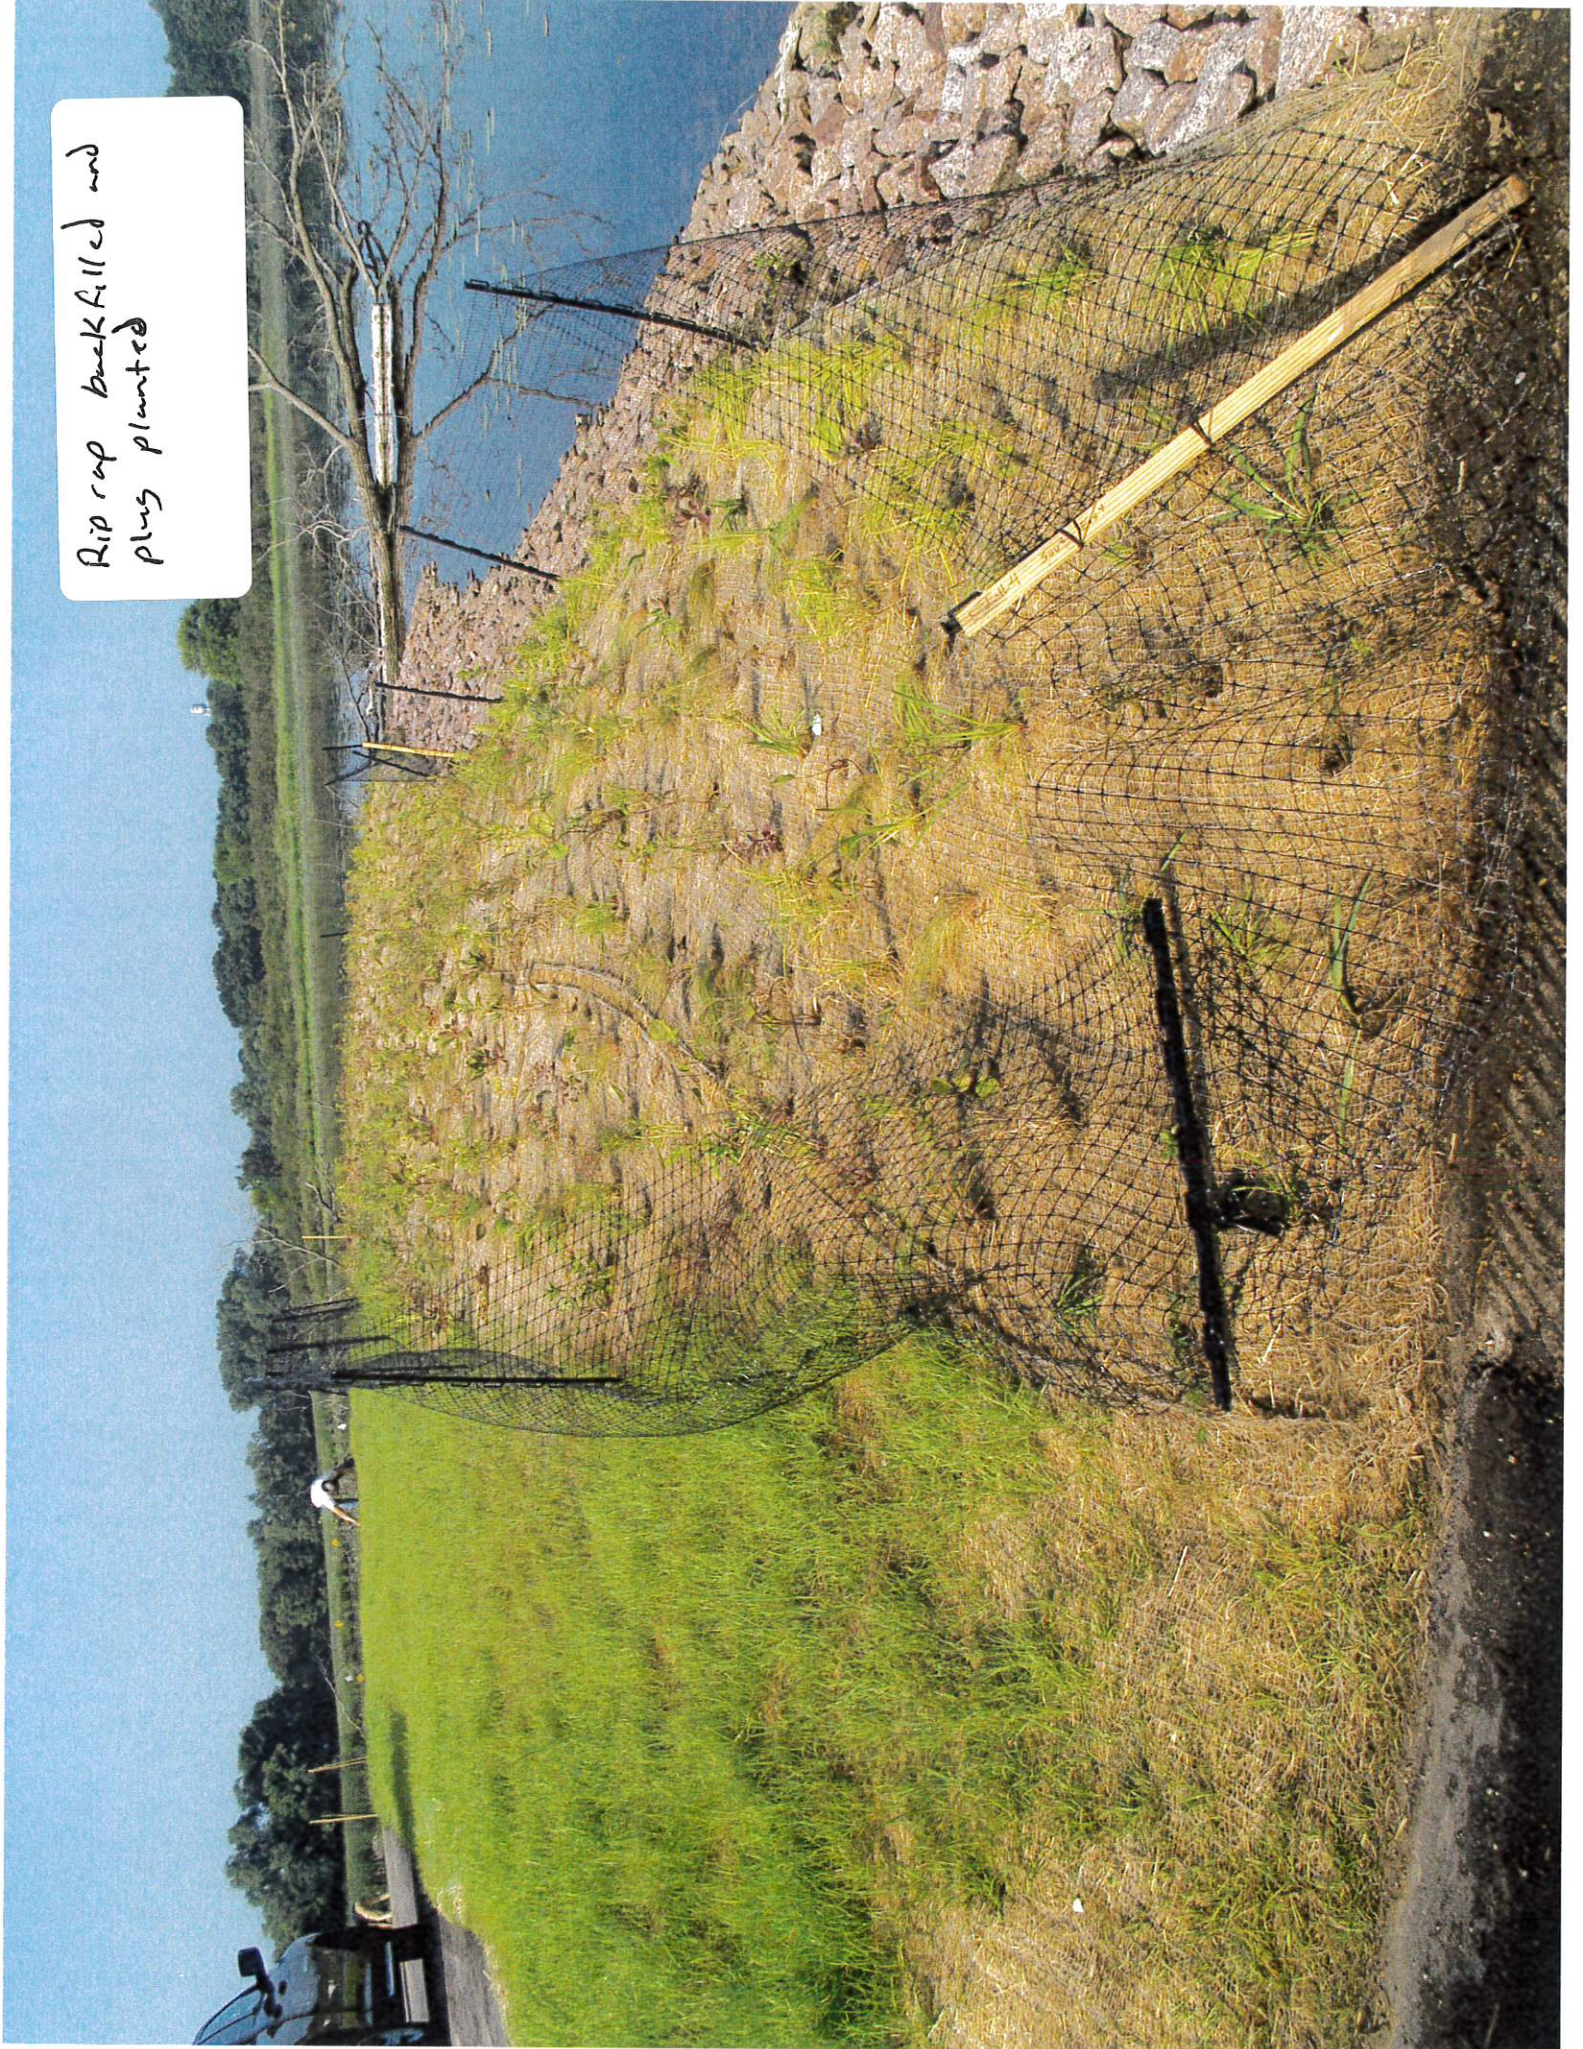
Rip rap bank filled and  
plus planted

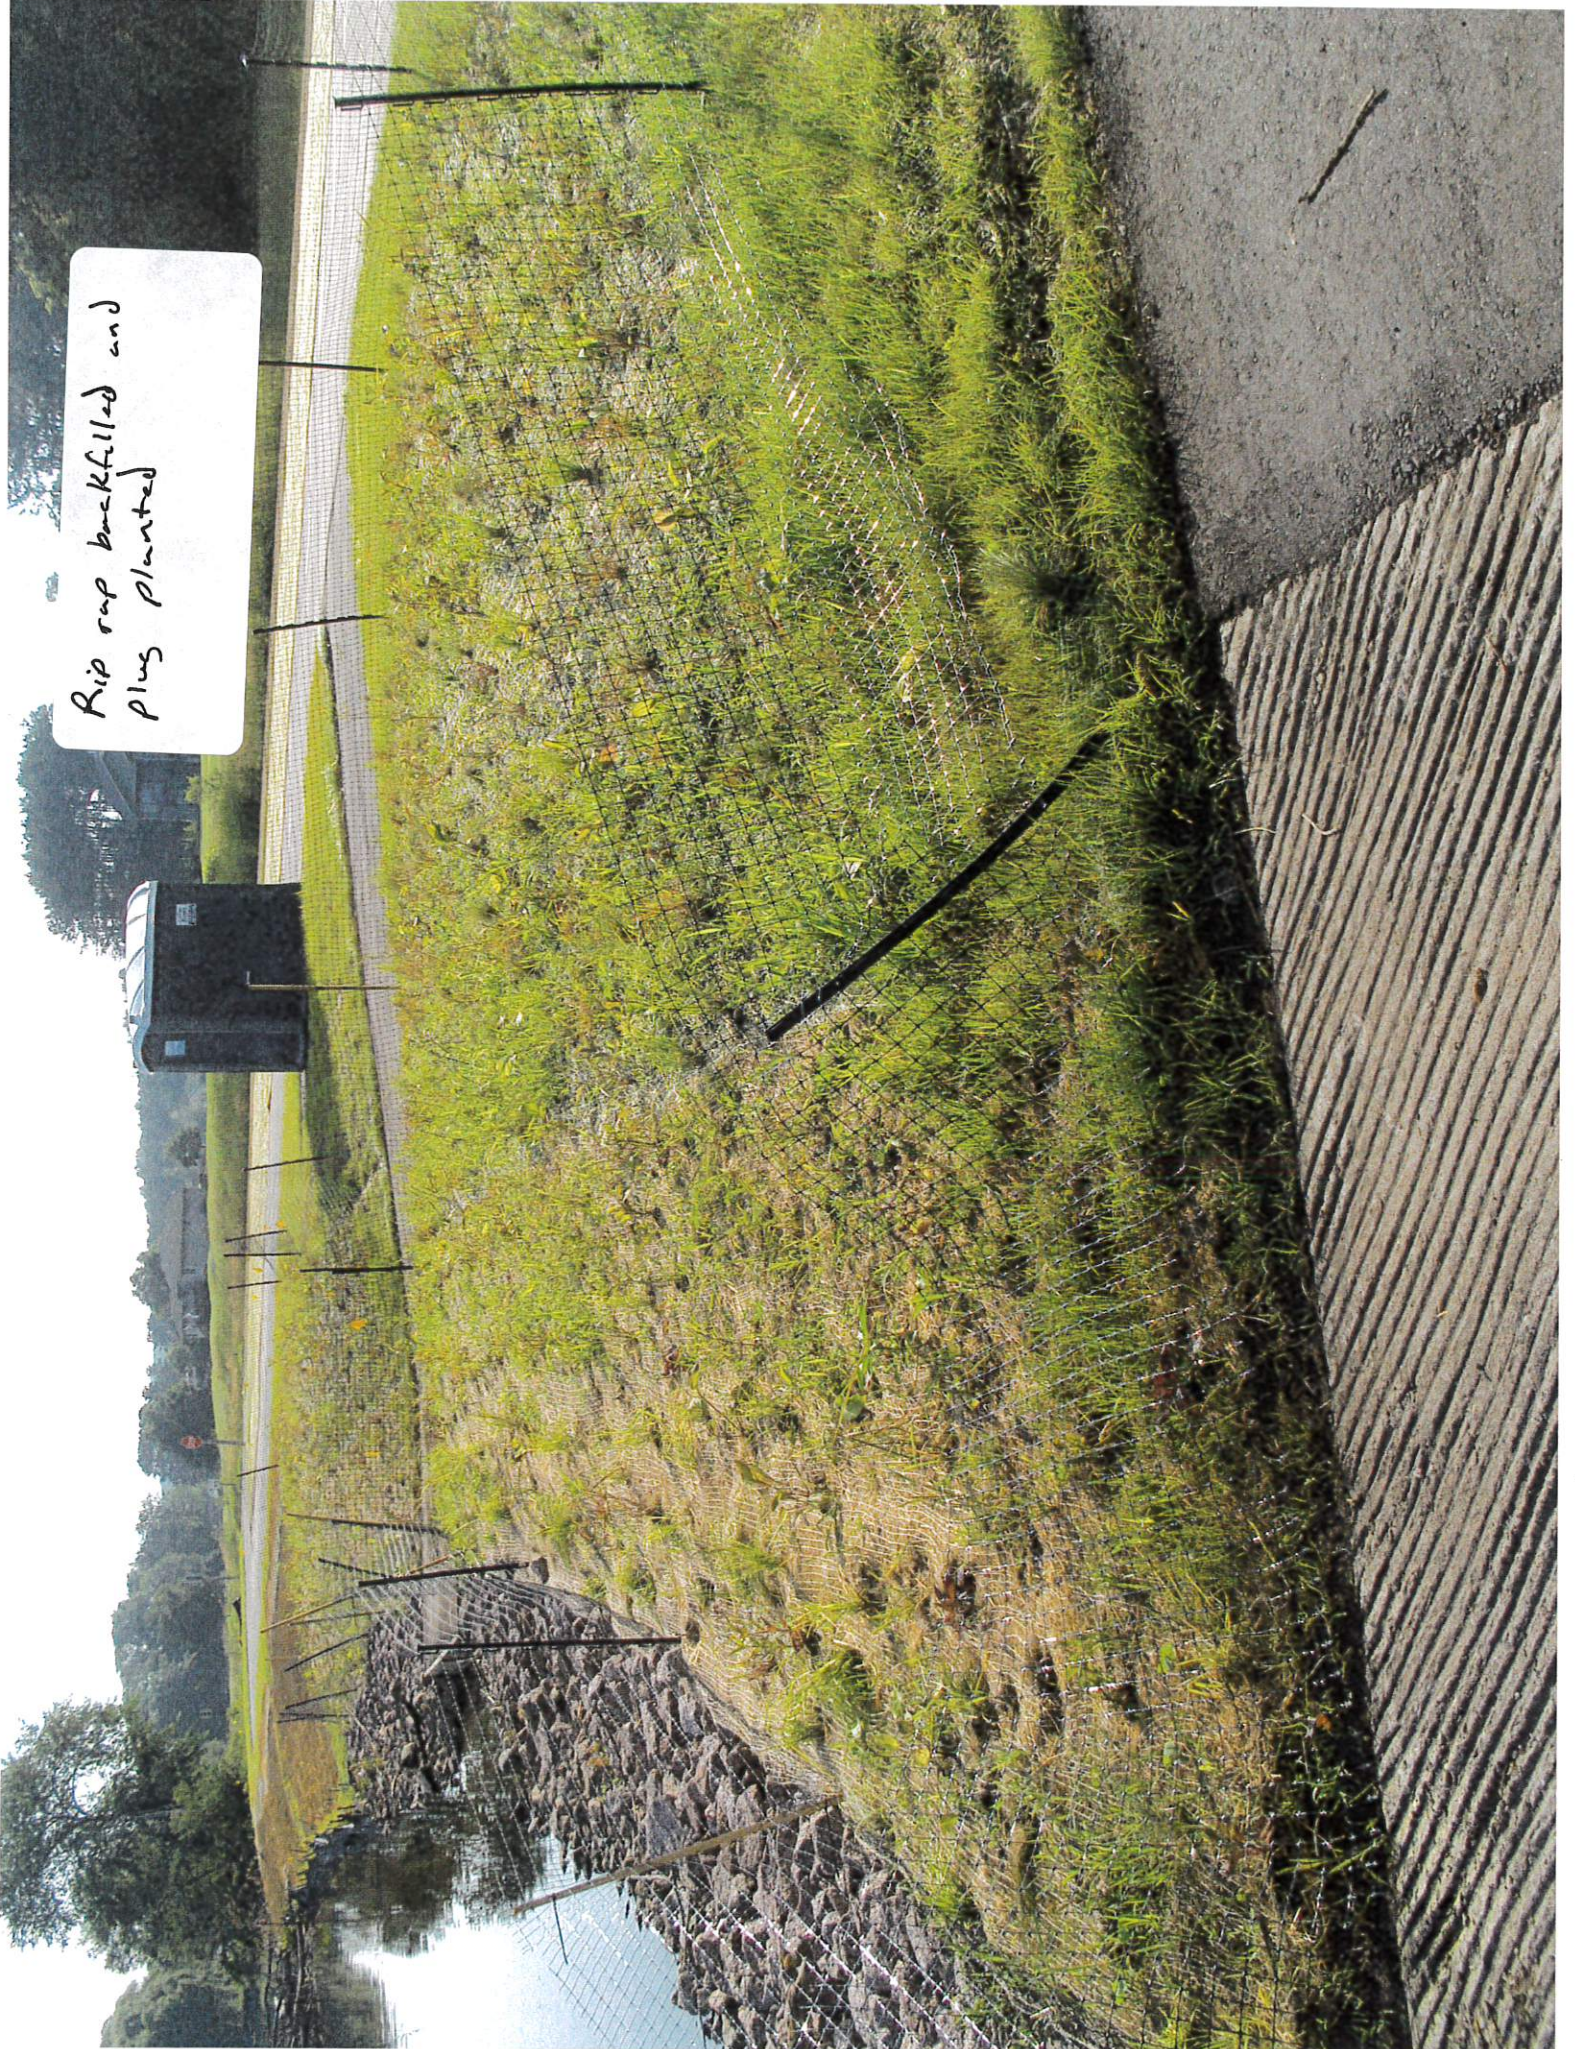
Rip rap backfilled and  
plus planted

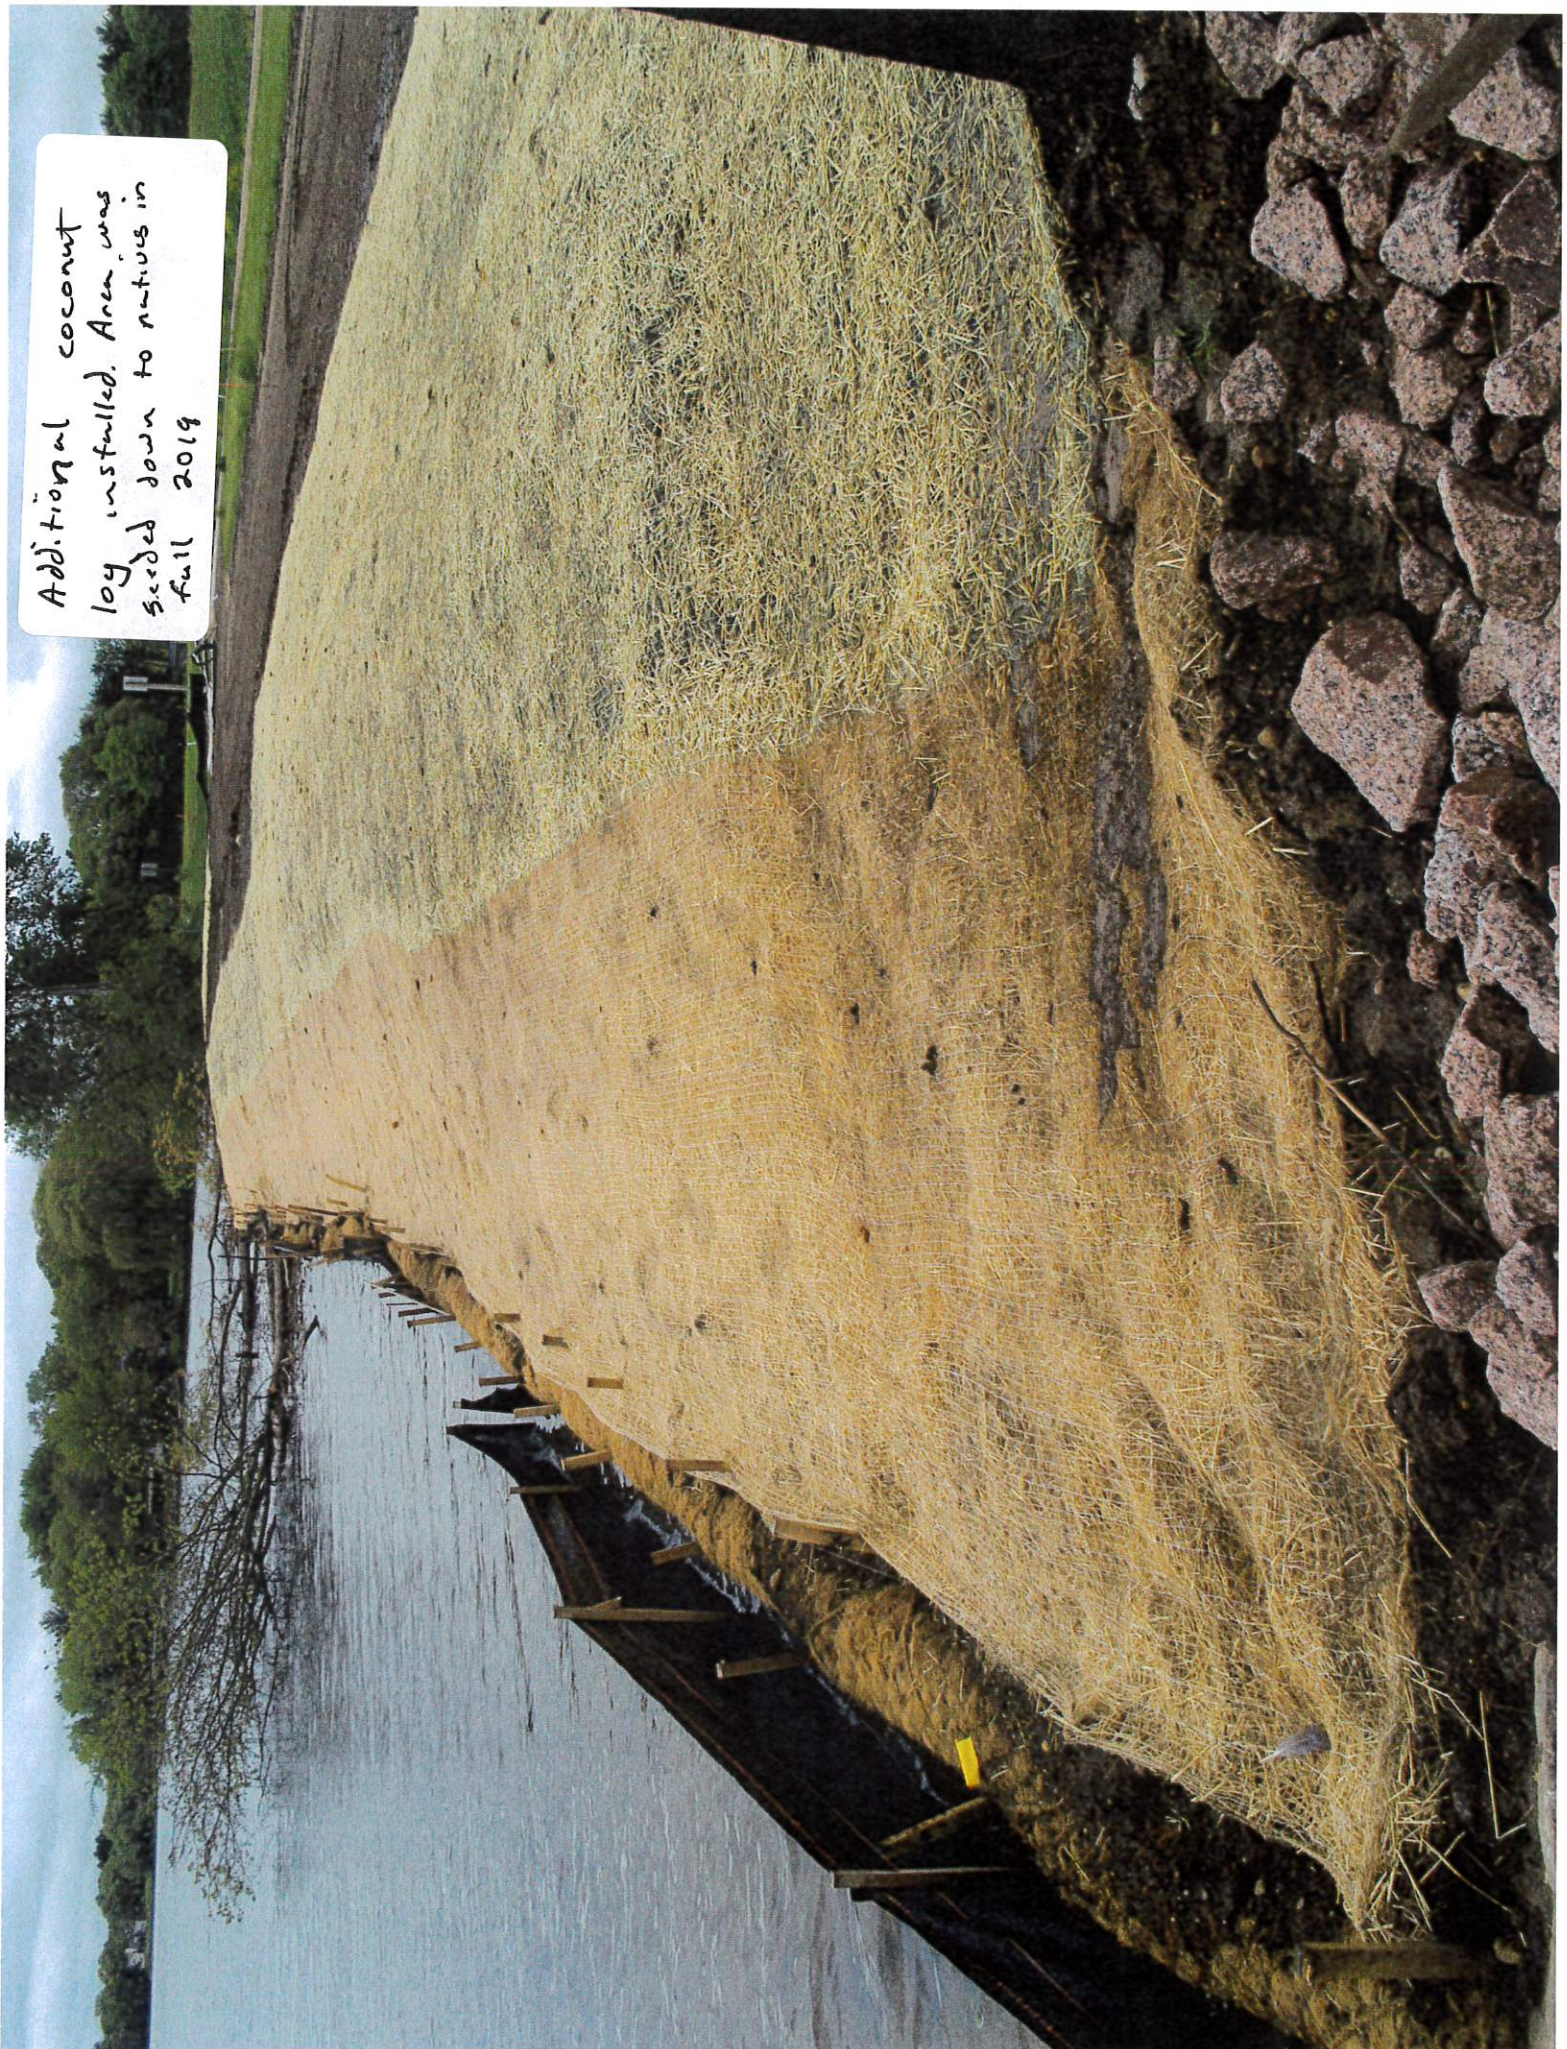
Additional coconut  
log installed. Area was  
seeded down to natives in  
fall 2019

- 2. Native plant shoreline restoration/stabilization** A total area of 9585 sq. ft. of native shoreline was installed. The installation of native shoreline was accomplished through the installation of native plugs, native plant mats (not in plan) and a frost seeding done in November of 2019. A total of 10 12-20 trees were also installed. The shrubs weren't installed as they will be installed in the spring of 2020. The shrub stock will be obtained from our annual tree sale in the spring. The rain garden area was also not planted with natives due to wet conditions during the seeding and is planned to be seeded in 2020. No photos of 2019 frost seeding included as seeds will not germinate until the spring of 2020.

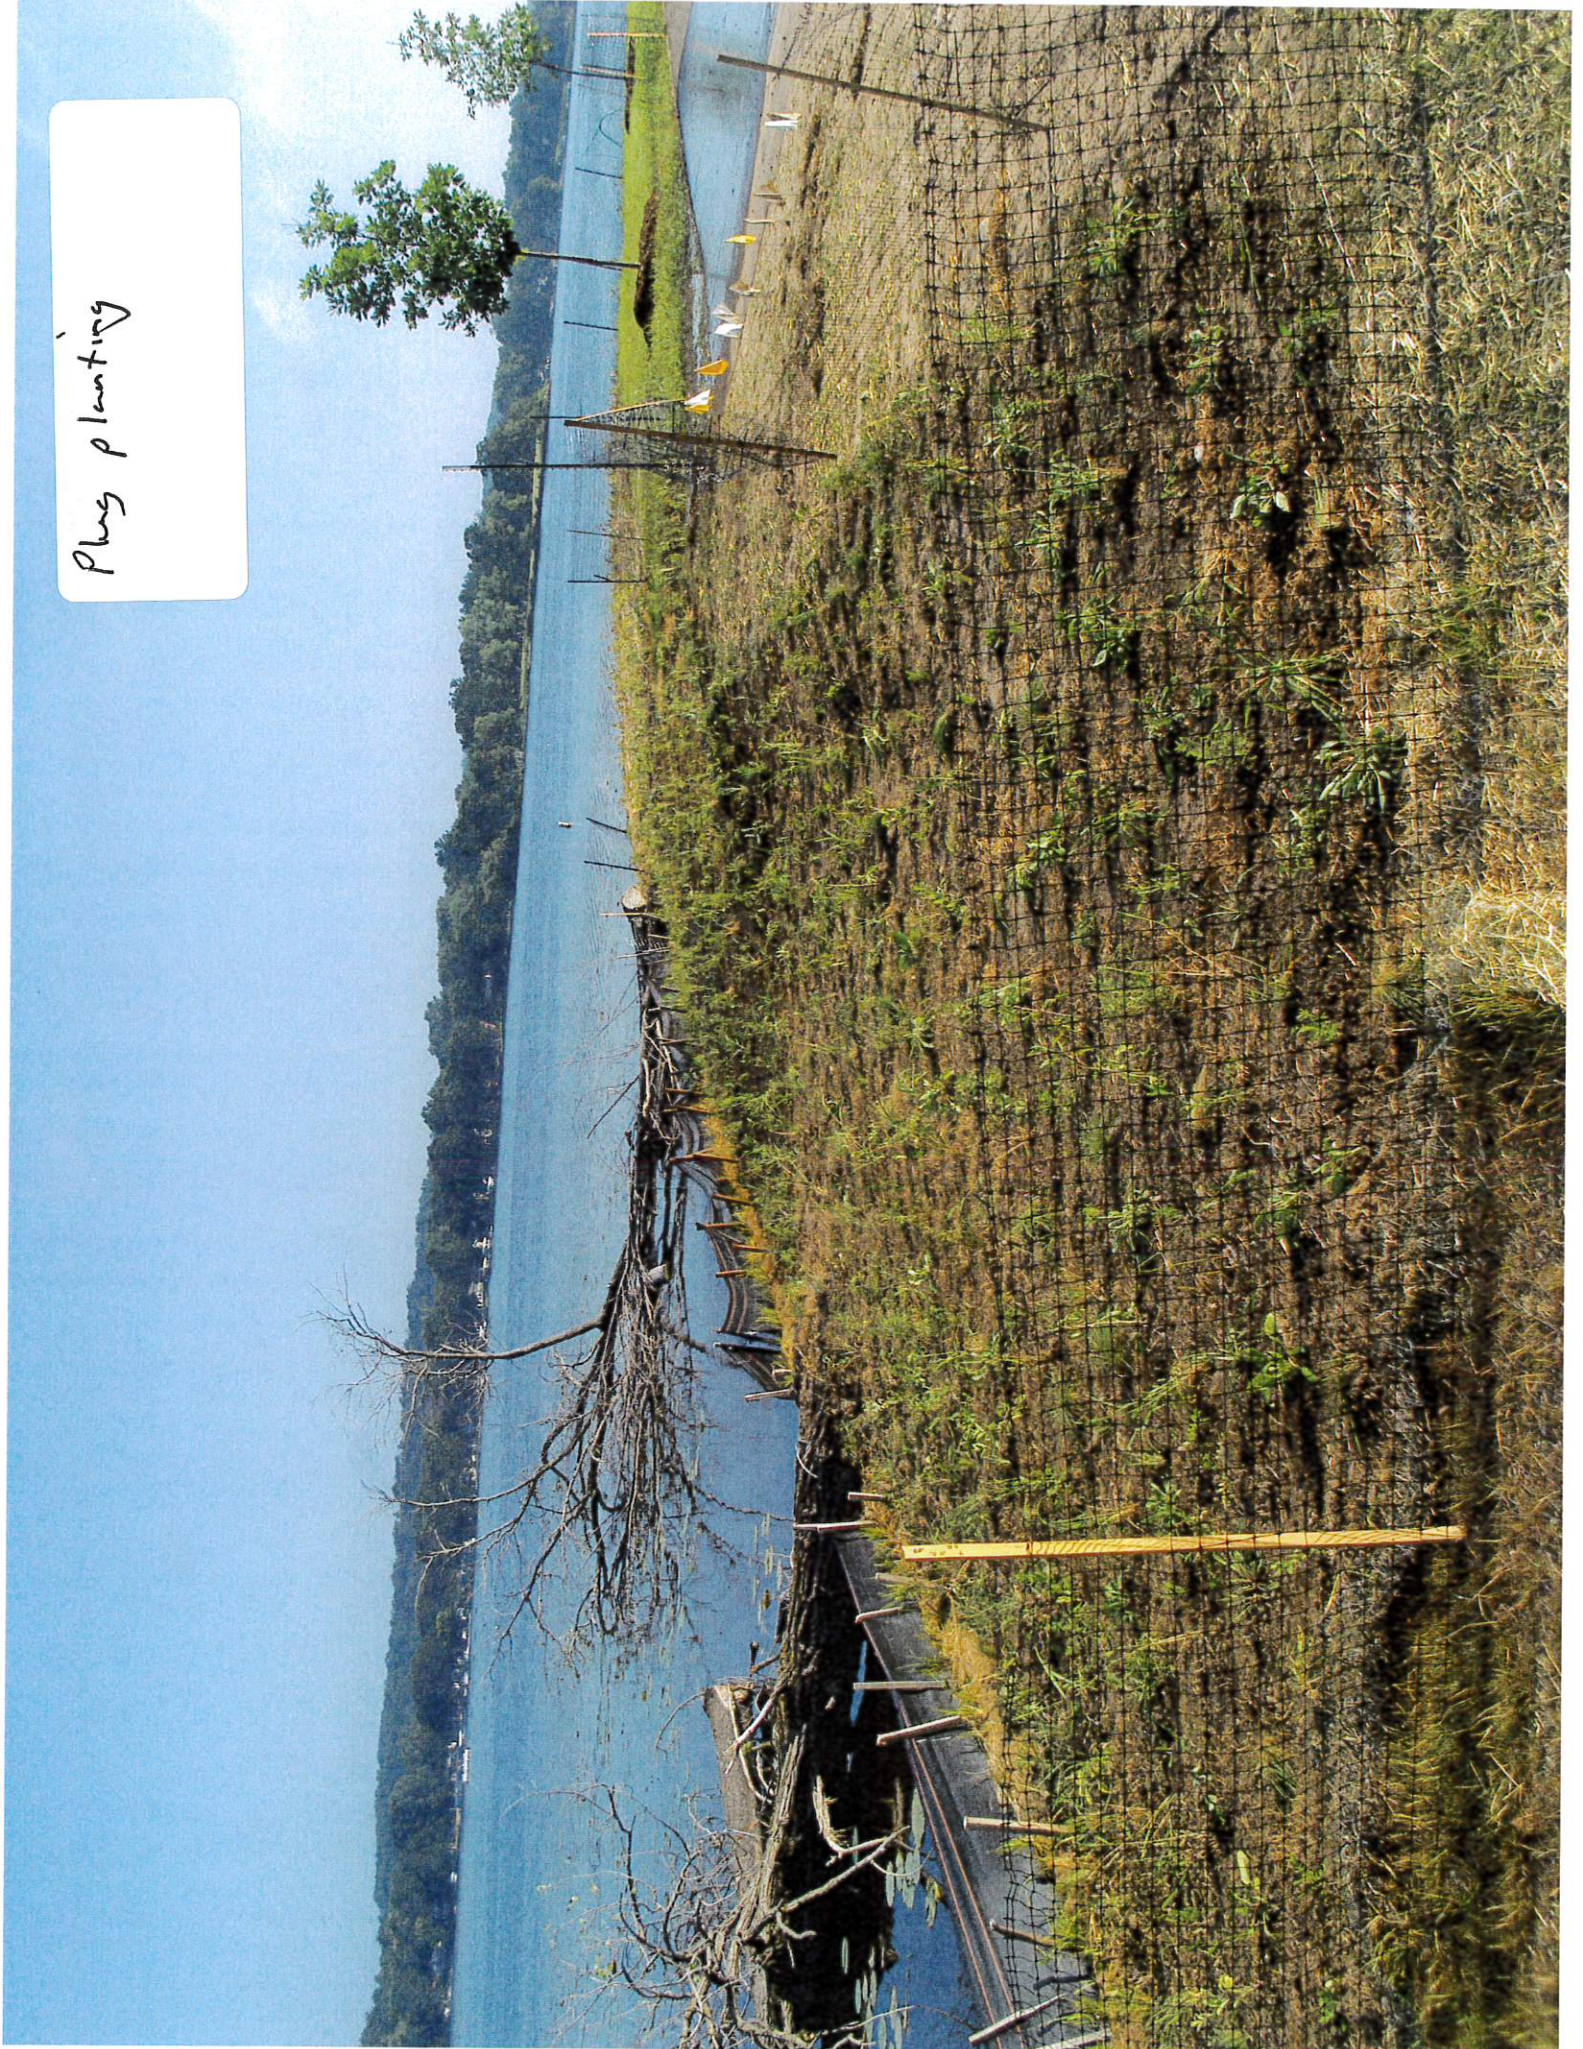
Plug planting

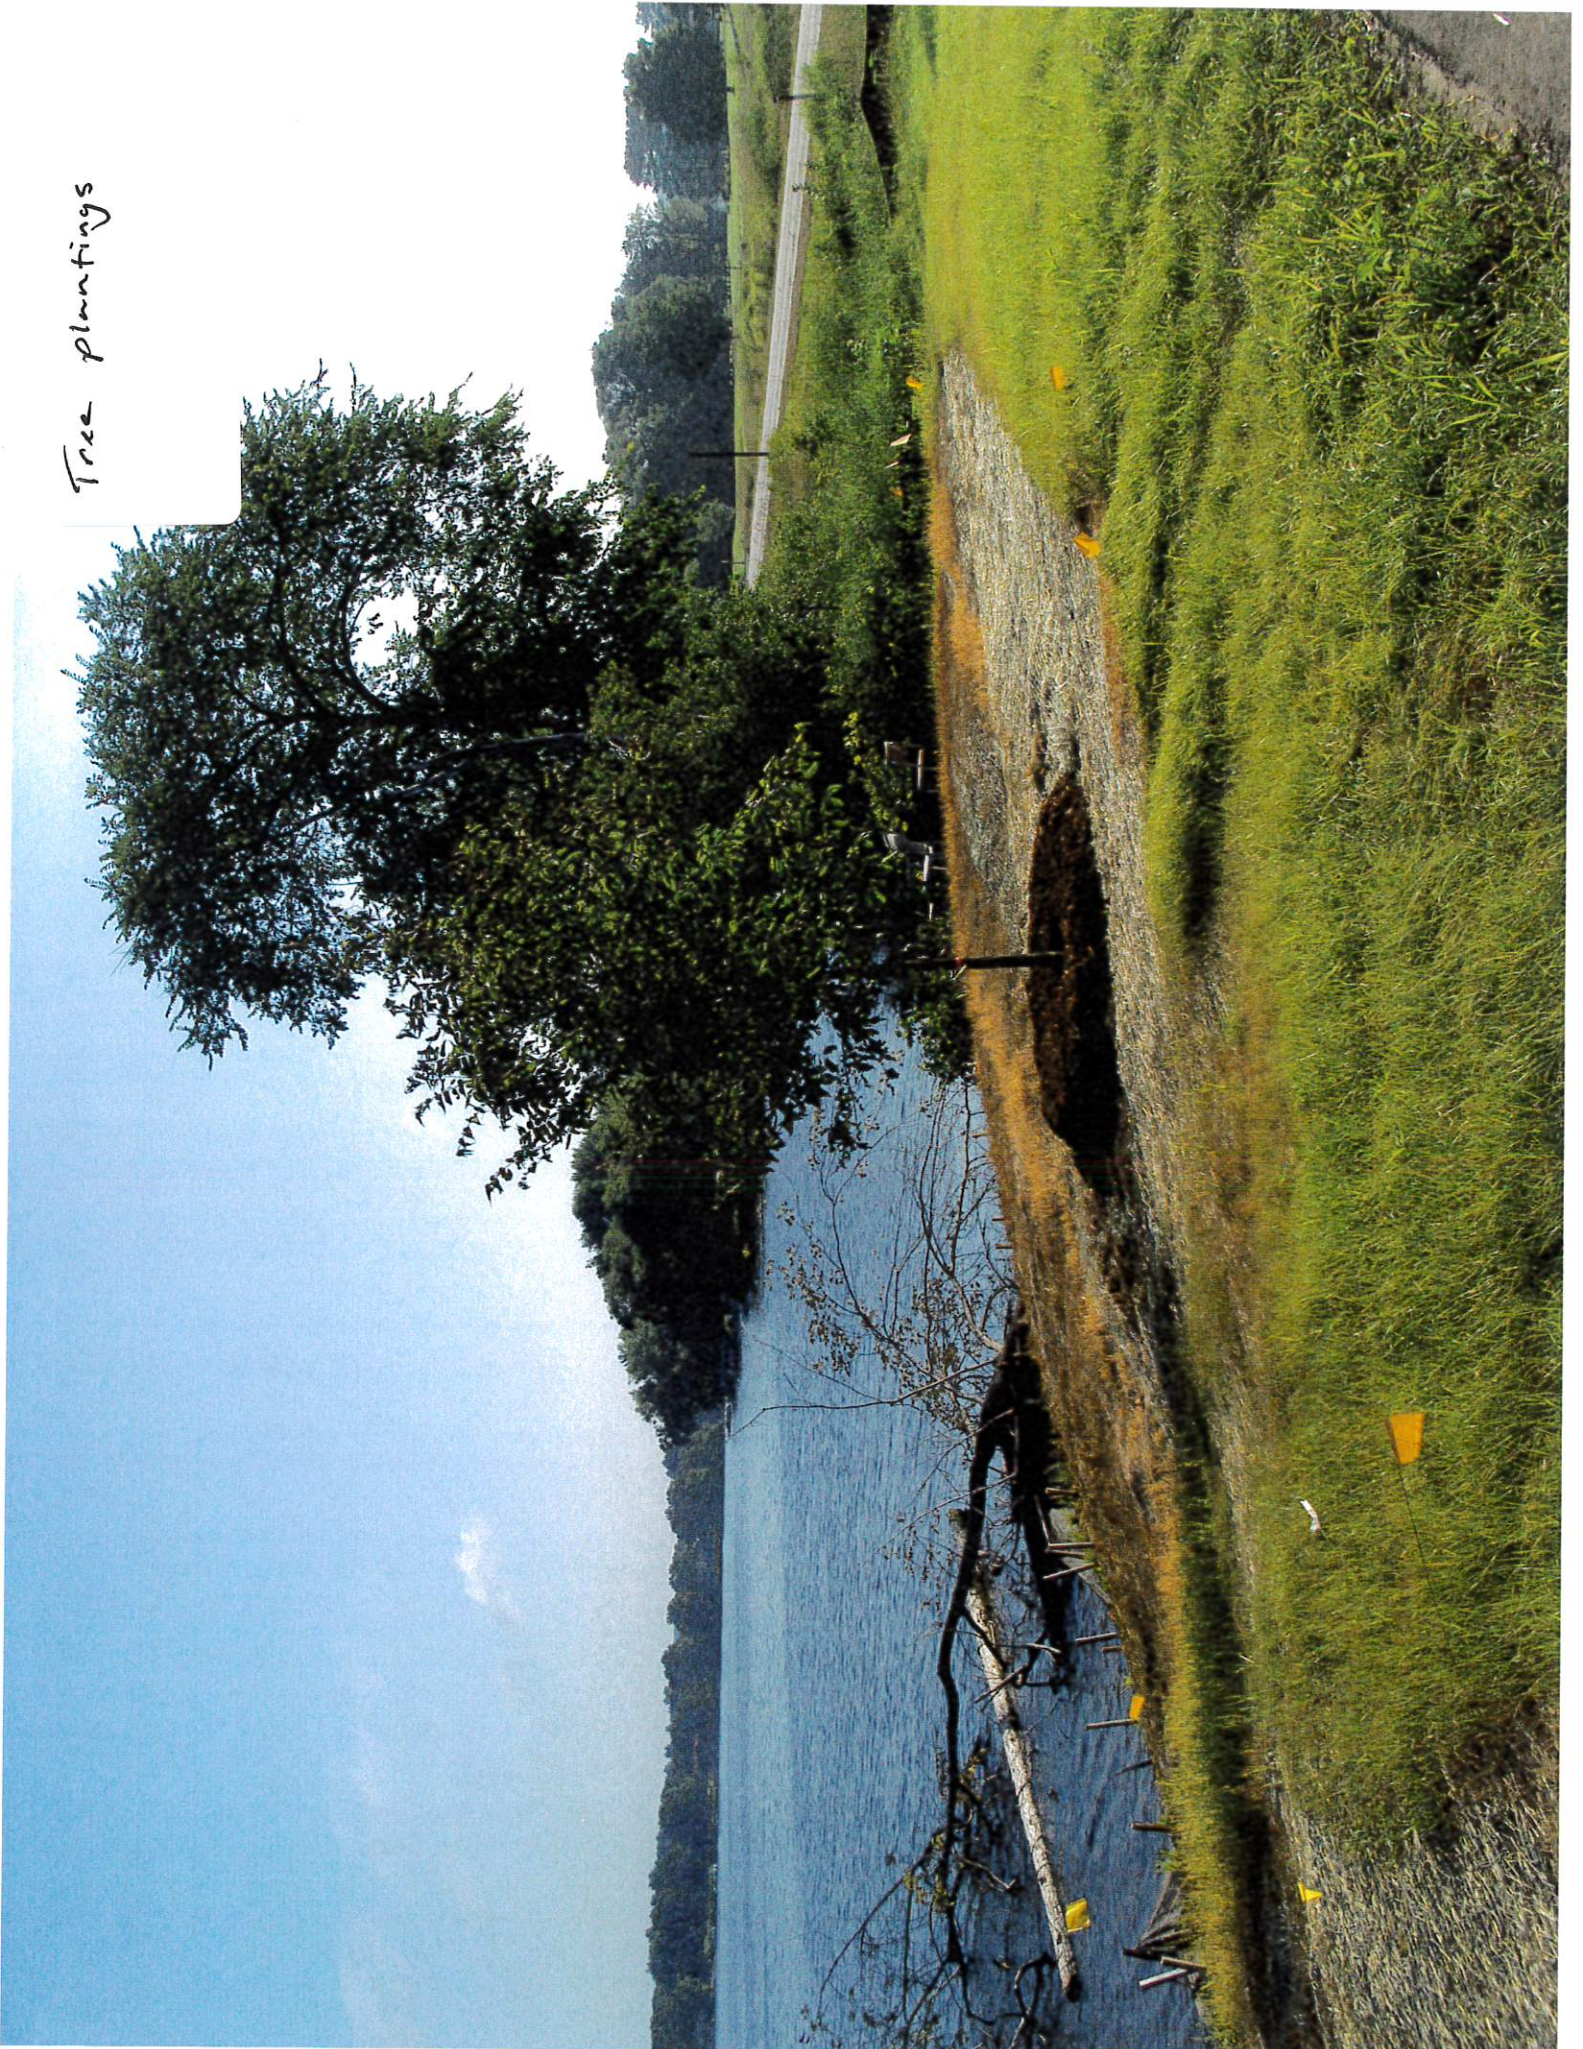
Tree plantings
