Curlyleaf Pondweed Delineation for Big Round Lake, Polk County, WI, 2020

Aquatic Plant Surveys Conducted on May 27, 2020

Prepared for:
Big Round Lake Protection
and Rehabilitation District,
Polk County, Wisconsin

Prepared by:
Steve McComas and
Jo Stuckert
Blue Water Science with
assistance from the
Big Round Lake District

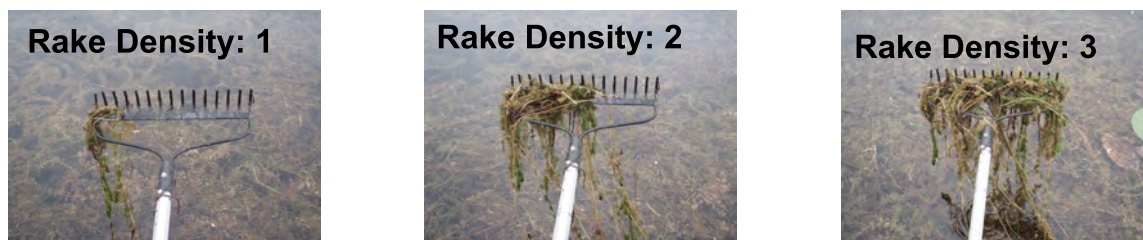
Chart of Aquatic Plant Density Ratings

Figure 2. Aquatic plant density ratings.

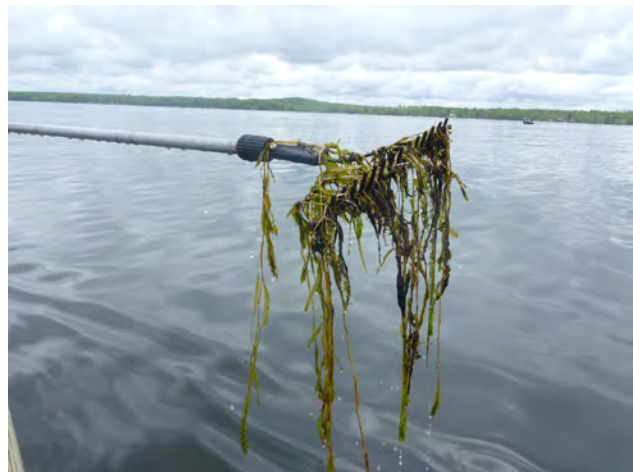
Curlyleaf pondweed sampled on May 27, 2020 in Big Round Lake.

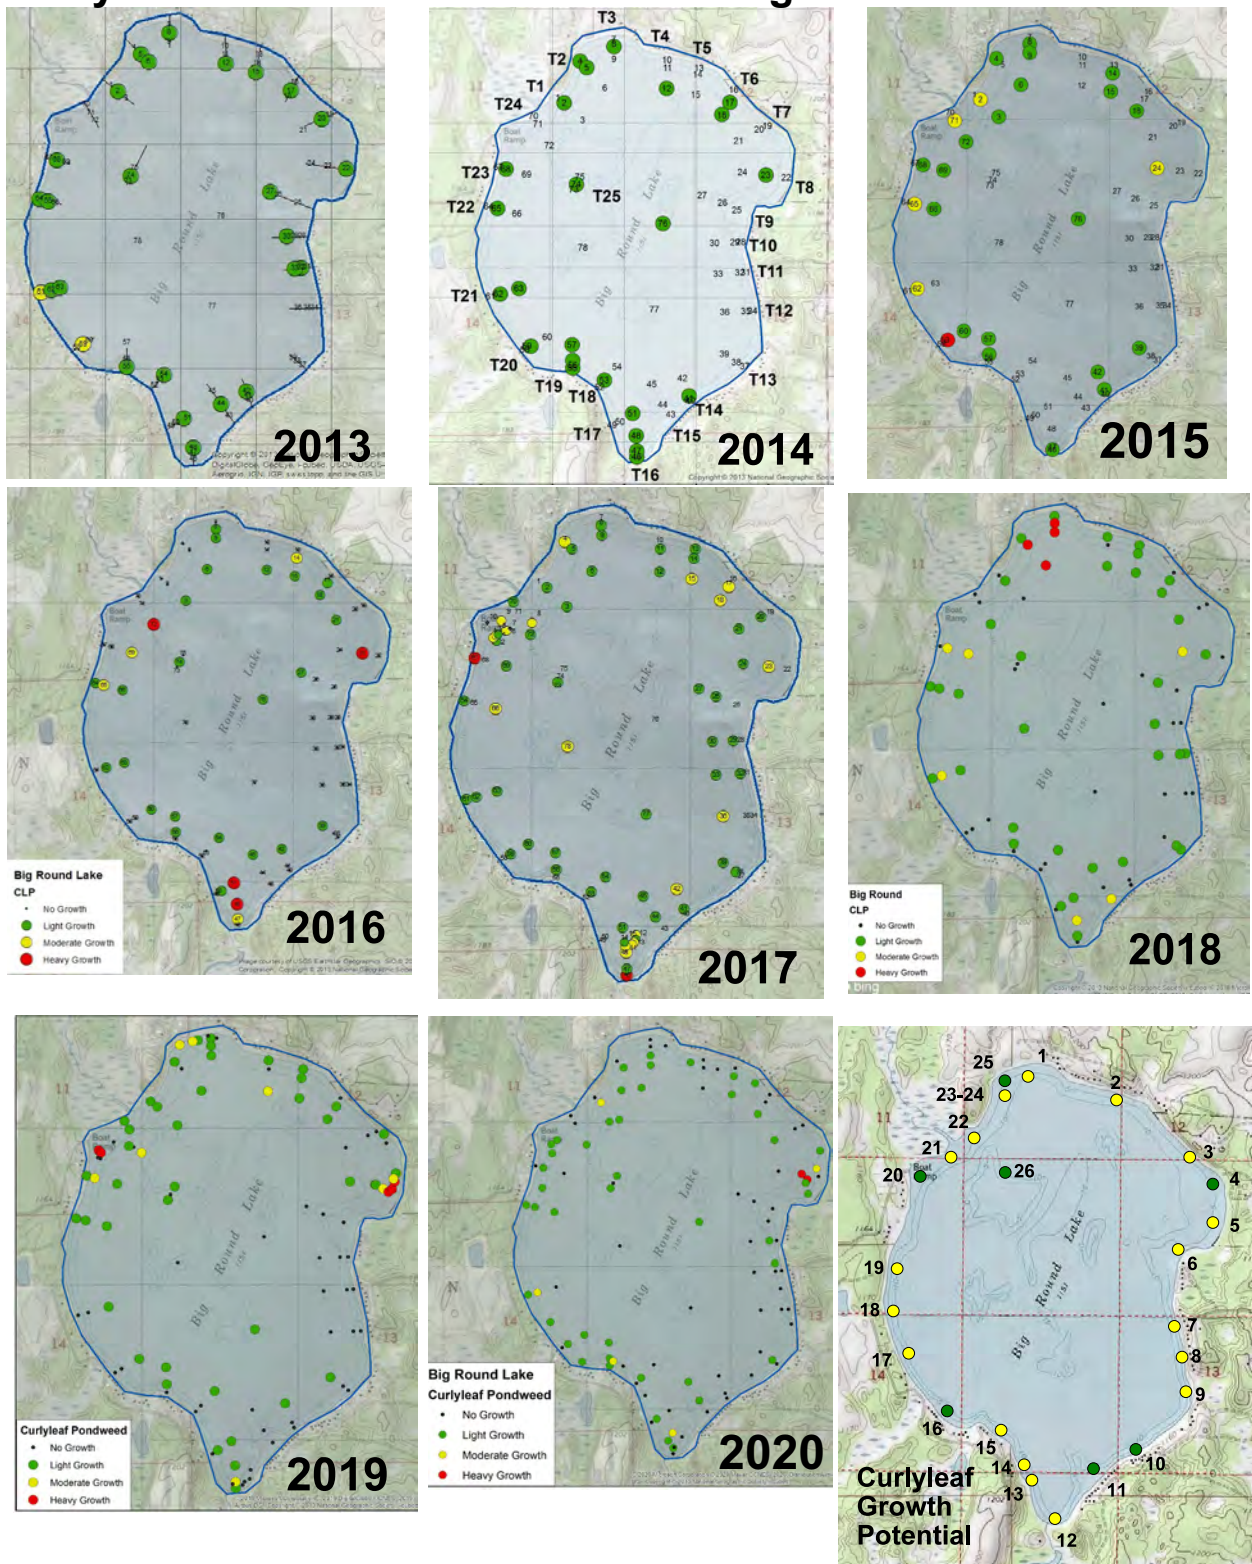
Curlyleaf Pondweed Distribution in Big Round Lake

Figure 4. Curlyleaf pondweed coverage on June 14, 2013 was estimated at 215 acres. Curlyleaf pondweed coverage on June 24, 2014 was estimated at 190 acres of light growth. Curlyleaf pondweed coverage on June 15, 2015 was estimated at 200 acres of mostly light growth. Curlyleaf pondweed coverage on June 3, 2016 was estimated at 225 acres. Curlyleaf pondweed coverage on June 12, 2017 was estimated at 250 acres. Curlyleaf pondweed coverage on June 8, 2018 was estimated at 250 acres. Curlyleaf pondweed coverage on June 21, 2019 was estimated at 240 acres. Curlyleaf pondweed coverage on May 27, 2020 was estimated at 215 acres. Curlyleaf growth potential is shown on the lower right map.

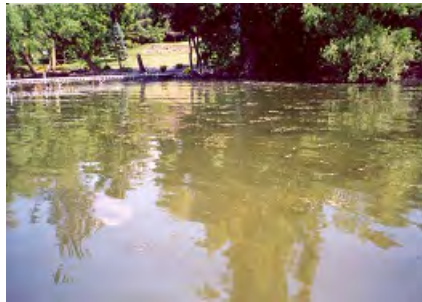
Light Growth Conditions

Plants rarely reach the surface.

Navigation and recreational activities are not generally hindered.

Stem density: 0 - 160 stems/m²

Biomass: 0 - 50 g-dry wt/m²

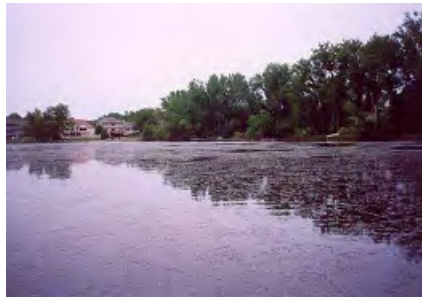
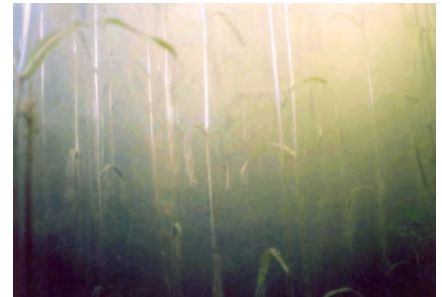
Moderate Growth Conditions

Broken surface canopy conditions.

Navigation and recreational activities may be hindered.

Lake users may opt for control.

Stem density: 100 - 280 stems/m²

Biomass: 50 - 85 g-dry wt/m²

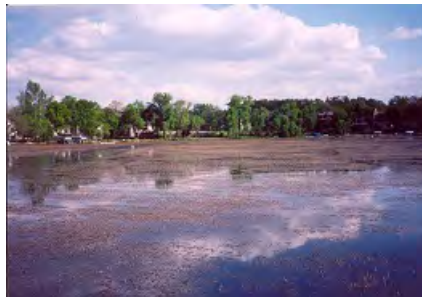
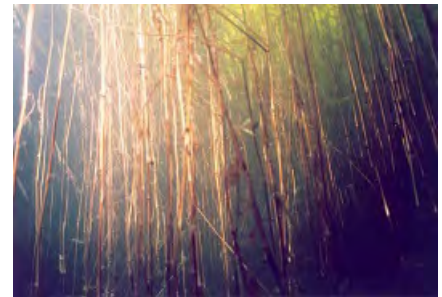
Heavy Growth Conditions

Solid or near solid surface canopy conditions.

Navigation and recreational activities are severely limited.

Control is necessary for navigation and/or recreation.

Stem density: 400+ stems/m²

Biomass: >300 g-dry wt/m²
