## **LPT71821 INTERIM REPORT December 2023**

### **Deer Lake Conservancy**

#### Best Management Practice Installation and Inspections

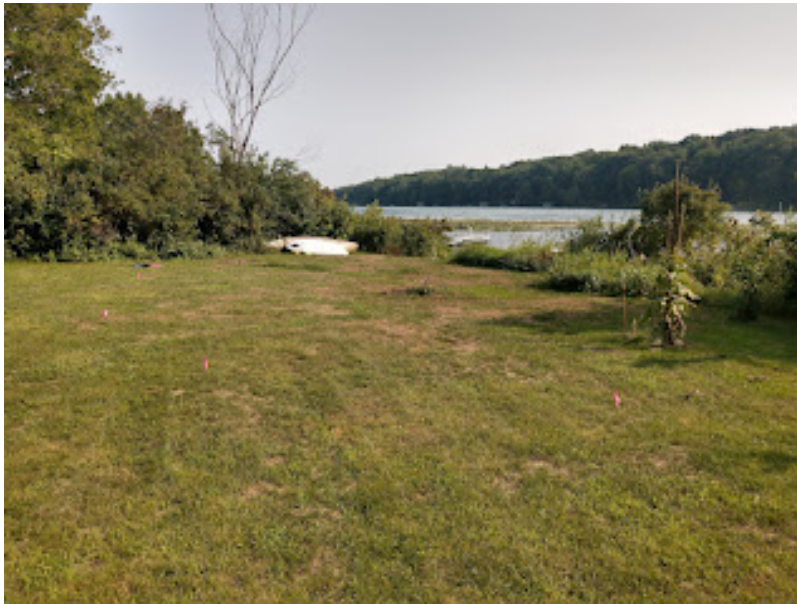
*Johnson*

**Johnson - Native Planting (3, 350ft<sup>2</sup> plantings - 1300 ft<sup>2</sup>, 45.5 ft of shoreline, prairie)**

*Before: August 2023*

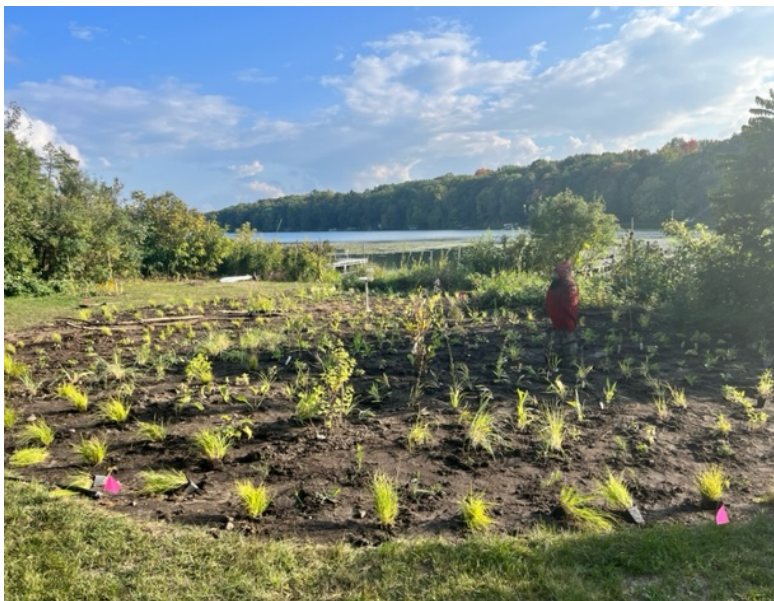
*Johnson*

*After: September 2023*

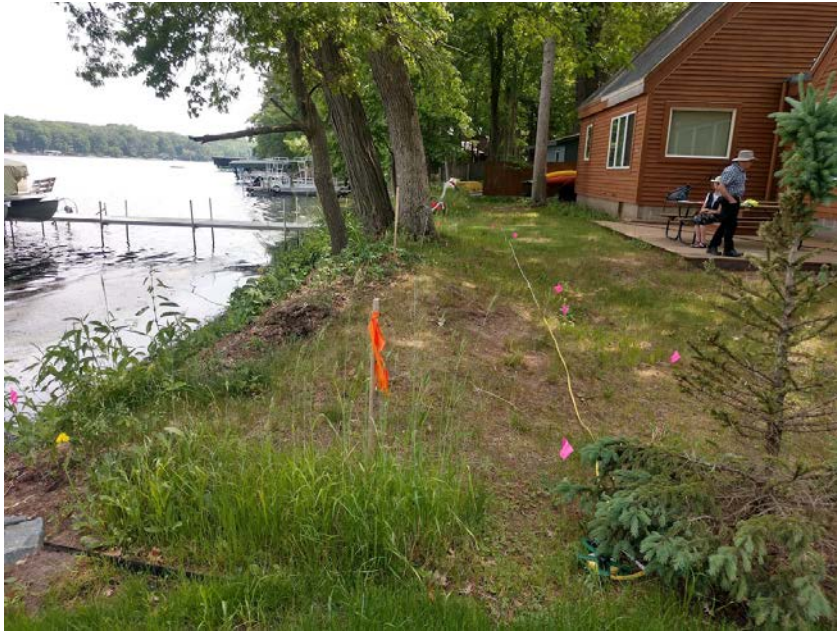
*Lagus*

**Lagus Native Planting (1, 375ft<sup>2</sup> planting, 36.5 ft shoreline, woodland planting)**

*Before: June 2023*

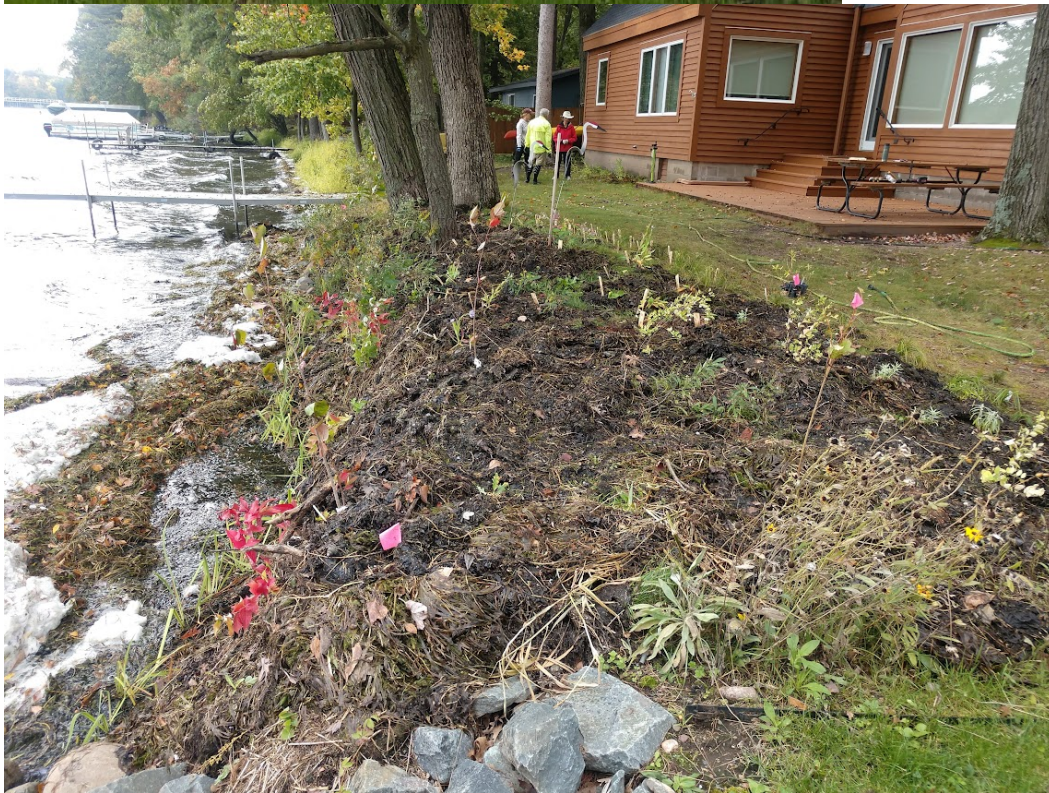
*Lagus*

*After:  
September*

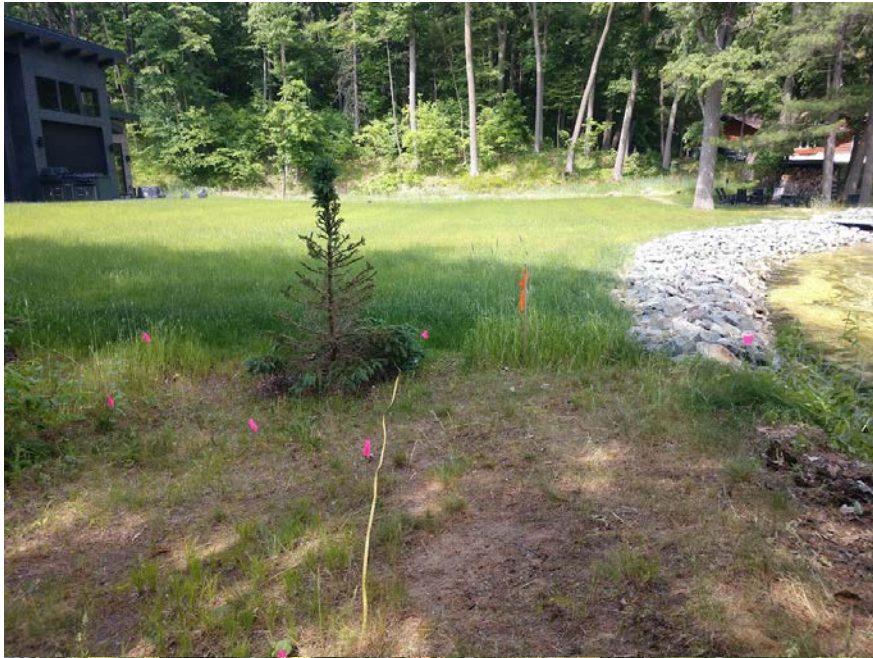
*Lagus*

*Before: June 2023*

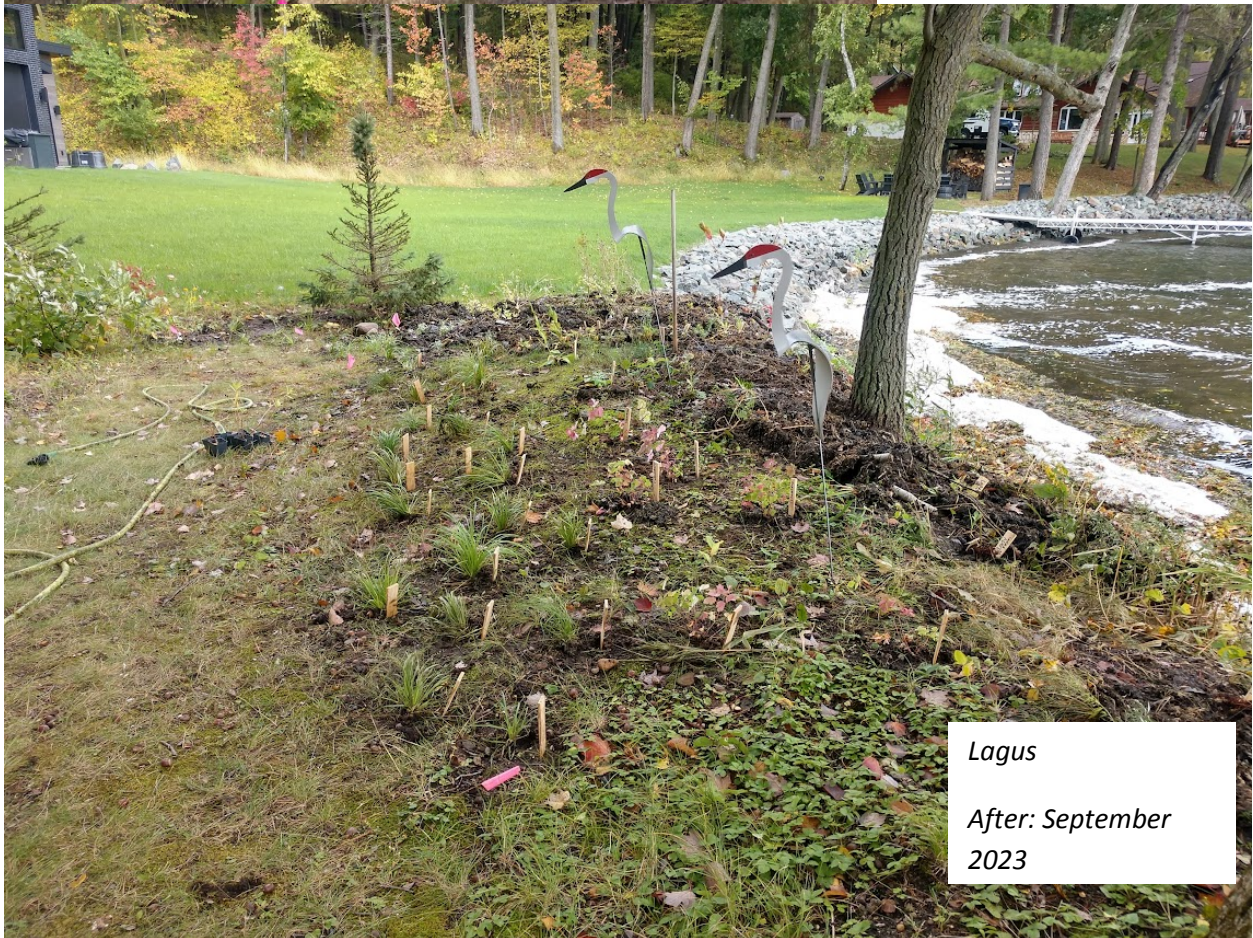
*Lagus*

*After: September  
2023*

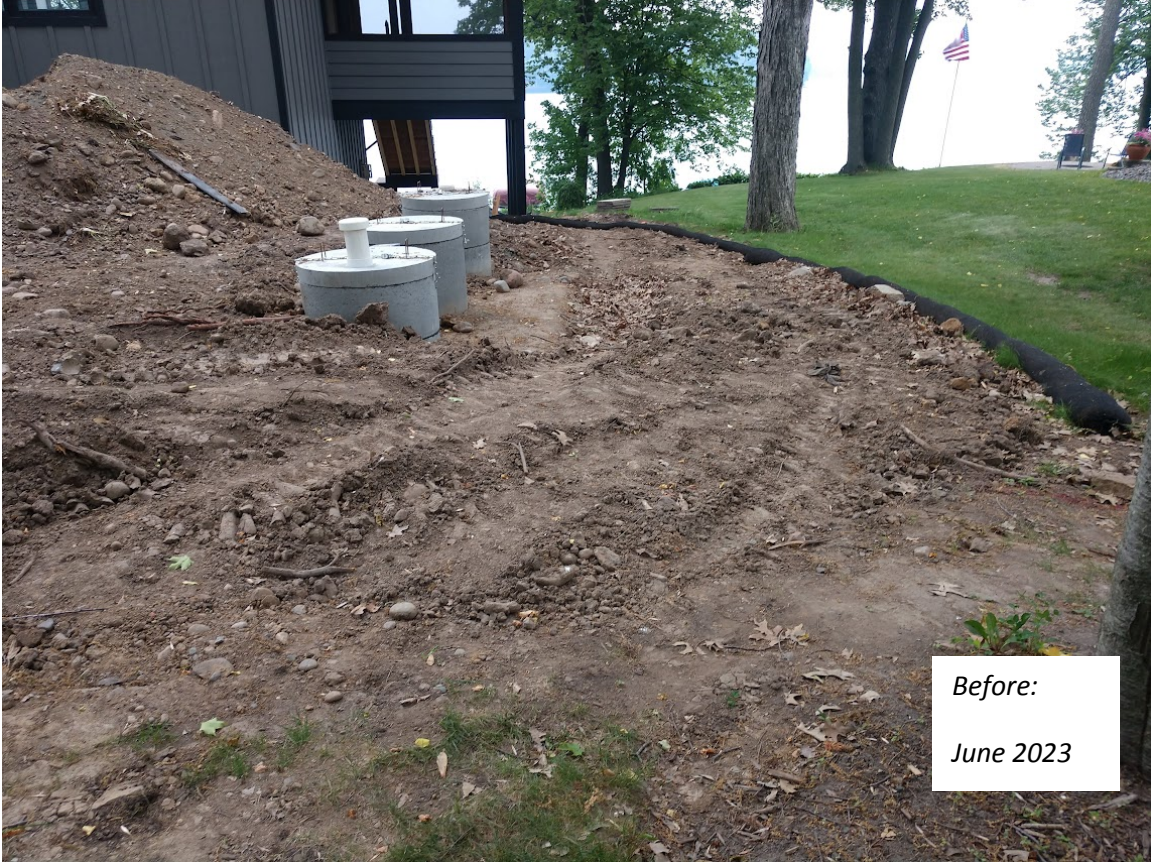
**Mortenson Runoff Reduction Project**

*Before:  
June 2023*

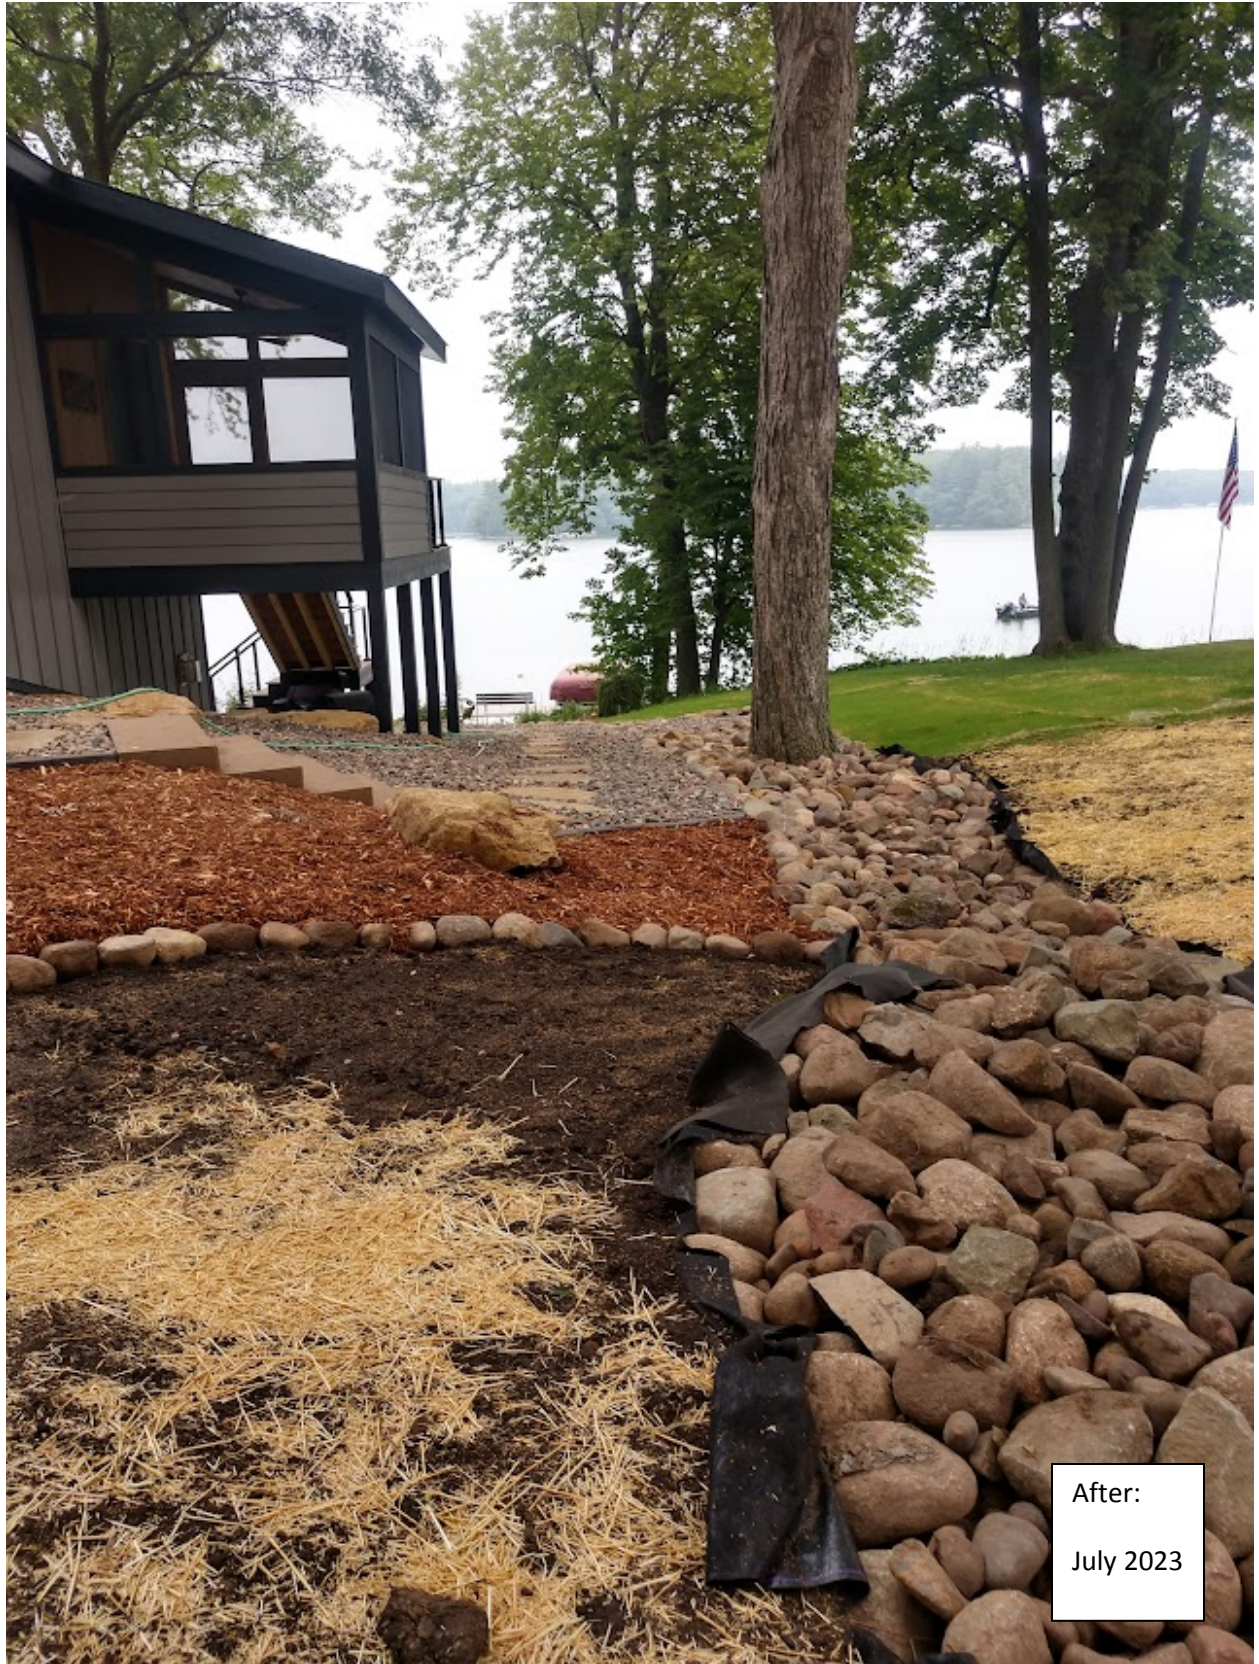
After:  
July 2023

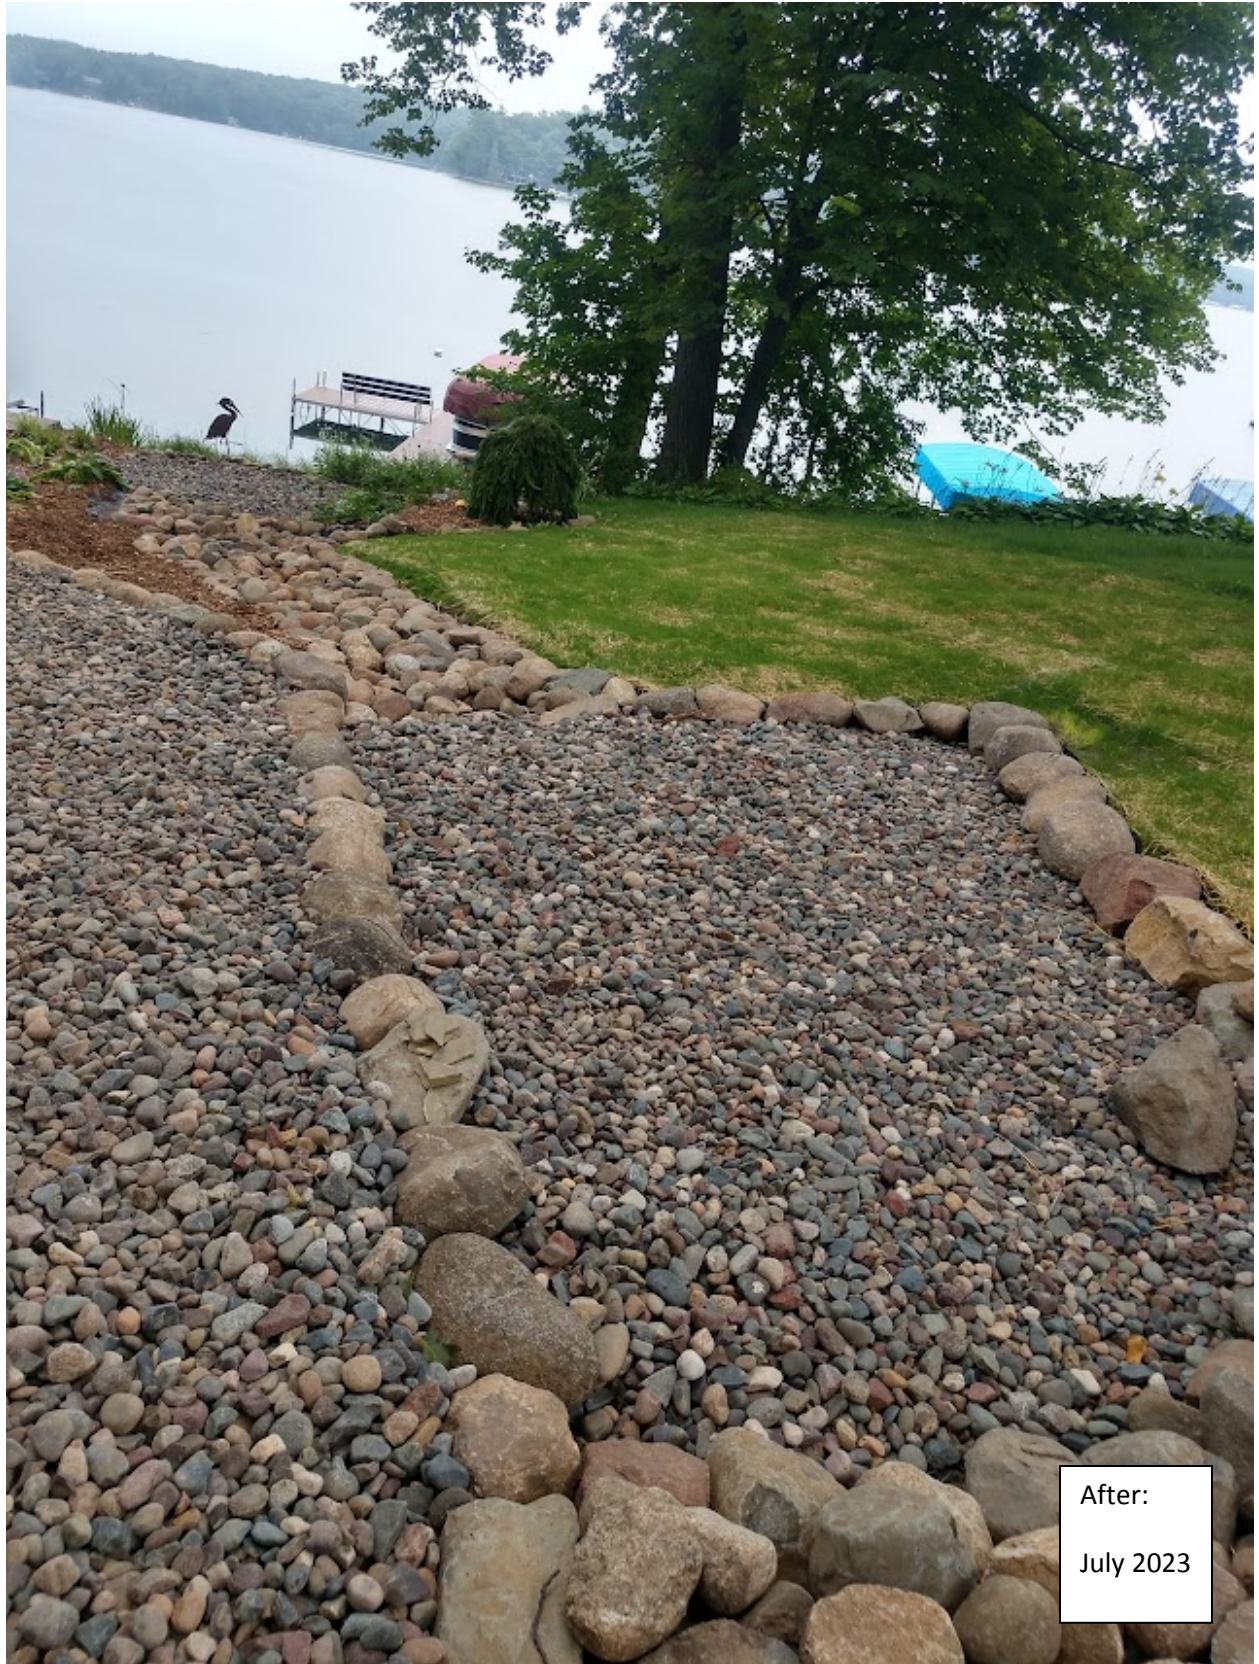
After:  
July 2023
