Summary of Monitoring at Boat Landings and Water Inlets for Eurasian Water-milfoil (*Myriophyllum spicatum*) and Other AIS on Wood (Big Wood) Lake (WBIC: 2649800) Burnett County, WI

Project Initiated by:
The Big Wood Lake Association

Landing Monitoring Conducted by and Report Prepared by:
Endangered Resource Services, LLC
Matthew S. Berg, Research Biologist
St. Croix Falls, Wisconsin
June-October, 2020

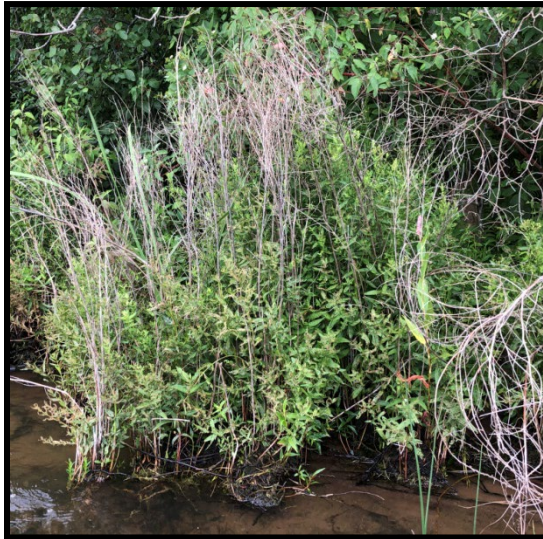
Beetle herbivory on central island Purple loosestrife 7/25/20

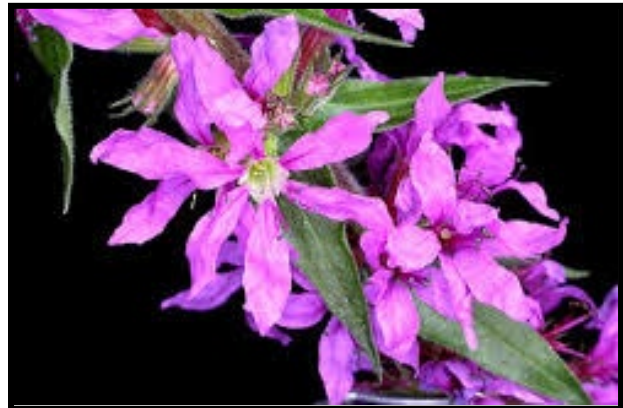
Close up of Purple Loosestrife flowers

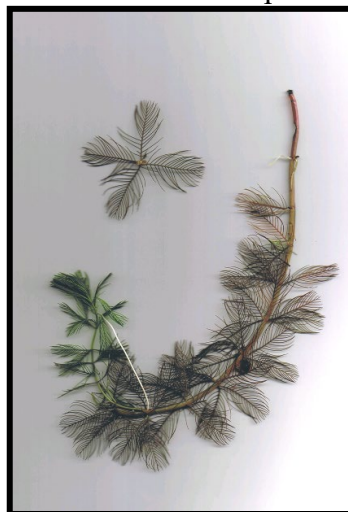
Figure 3: EWM and Northern Water-milfoil Identification (Berg 2007)

We completed landing transect surveys on June 1st, July 1st, July 25th, August 29th, and October 11th. We also did whole shoreline surveys on June 1st and October 11th. **We did NOT find Eurasian Water-milfoil anywhere in Big Wood Lake.** However, in 2020 the lake again supported a moderately high population of the similar looking native species Northern water-milfoil (*Myriophyllum sibiricum*). NWM is widely distributed throughout Big Wood in all habitats, but does best over sandy and organic muck. Despite its superficial resemblance to EWM, Northern water-milfoil can be told apart by its leaflets numbering <24 whereas EWM normally has >26 (Figure 3). EWM also tends to have a bright red growth tip on the top of the plant whereas NWM has a bright lime green growth tip. In the fall, NWM also forms winter buds on the tips of shoots whereas EWM has none (Figure 4). These were evident on all NWM plants during the October survey.

Eurasian water-milfoil

Northern water-milfoil

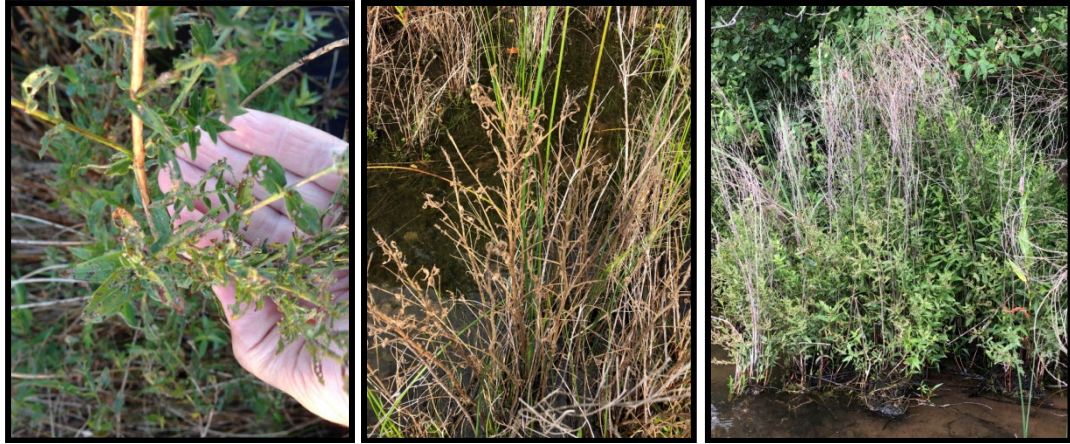
Purple loosestrife (*Lythrum salicaria*), another exotic invasive plant, was present in the wetlands adjacent to and along the immediate shoreline of the lake. Although this species prefers mucky soils and is most common among the Cattails (*Typha* spp.) and Northern wild rice (*Zizania palustris*) near the Spirit Creek Inlet and just south of the Wood River Outlet, we also encountered scattered plants along the western midlake shorelines. Both of the central islands also had significant number of plants including a dense monotypic stand on the south end of the north wooded island. In 2015, Galerucella beetles (in imported insect species that specializes in eating PL) were raised and released by Grantsburg High School students at this location. Although beetles were visible on plants throughout the summers of 2016 and 2017, until 2018, they showed little effect on the island's PL population. However, during both the September 2, 2018 and October 4, 2019 surveys, we found the beetles had eaten all the leaves and top-killing all the plants on the point. In 2020, they were also present but showed only moderate herbivory (Figure 5). Although the beetles won't kill the roots, they usually prevent the plants from flowering and spreading. Another positive development was the natural dispersal of these micro-herbivores as we again located at least some live beetles on all loosestrife plants growing on both the islands and scattered along the western lakeshore.

Figure 5: Plants on Central Island Showing Limited Herbivory on 10/6/16 (left), Extensive Damage on 9/2/18 (middle), and Moderate Herbivory on 7/25/20 (right)

Plans for GHS students to raise and release more beetles around the lakeshore in 2020 fell through due to the pandemic. Expectations are to try again in the future when public health conditions improve.
