Little Pickerel Lake Aeration Implementation Project – Final Report

WDNR Lake Protection Grant LPT53917

Attachment A: Little Pickerel Lake Aeration System Installation

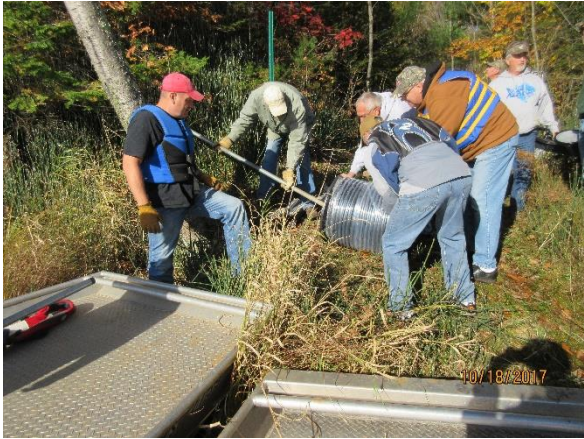
Loading Airline Reels onto WDNR Boats

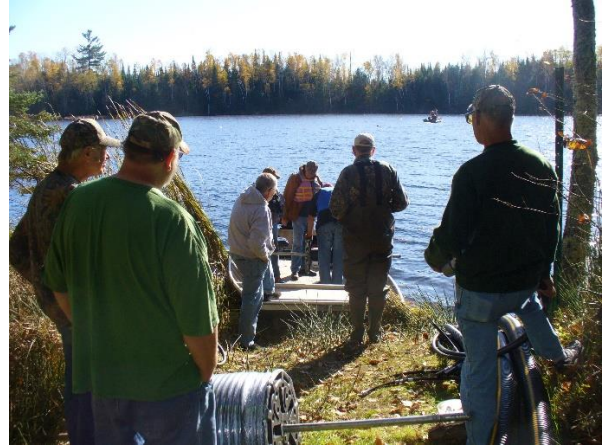
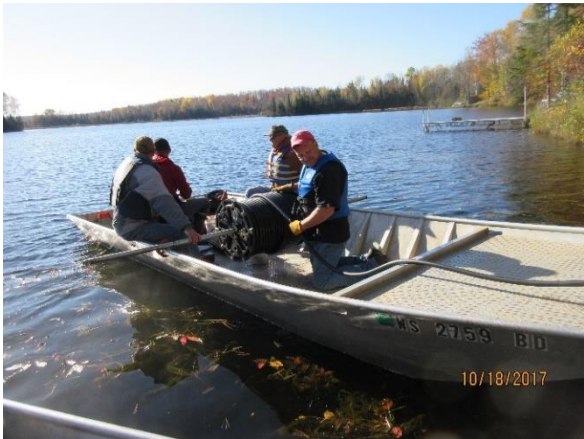
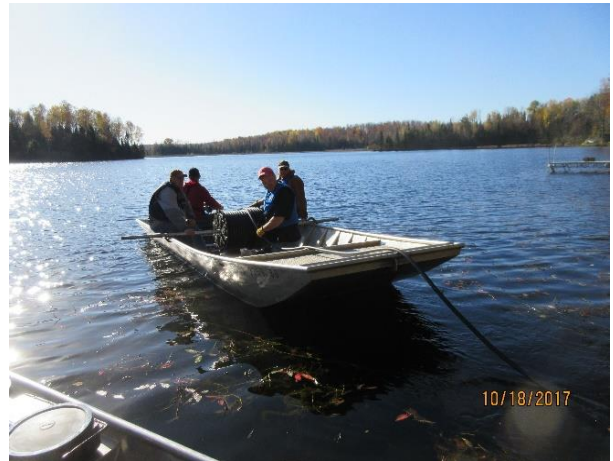
Placement of Airline into Lake

Four airline reels, each with 500 feet of 5/8-inch weighted airline, were used for the airline installation in the lake. The airlines were laid on the lake bottom between the shoreline and the diffuser locations, with a separate airline laid to each diffuser. For installation, the airline rolls were supported in flat bottom boats provided by the WDNR and the airline unrolled from the shoreline to the desired diffuser locations marked prior in the lake. The diffuser units were connected to the airlines at the desired locations, and the diffuser units were lowered with guide ropes to the lake bottom. The airlines sections placed in the lake include one length at 270 feet, two lengths at 290 feet, 2 lengths at 340 feet, and one length at 390 feet. Twelve PCLA members assisted the WDNR fisheries staff to complete the airline and diffuser placement.

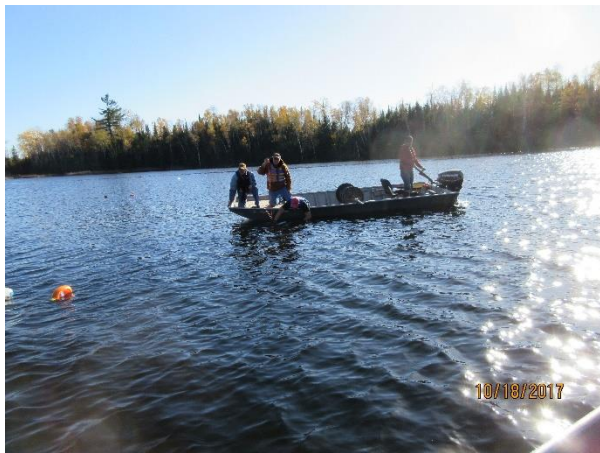
Lowering Diffuser into Position

The WDNR fisheries staff for Oconto County assisted the PCLA to install the airlines and diffuser units in Little Pickerel Lake on October 18, 2017. The locations for the six diffusers were marked in the lake by PCLA members prior to the installation using plastic bottles held in place with weights. The markers were set in place based on pre-determined GPS coordinates that would provide the desired spacing between the diffusers.

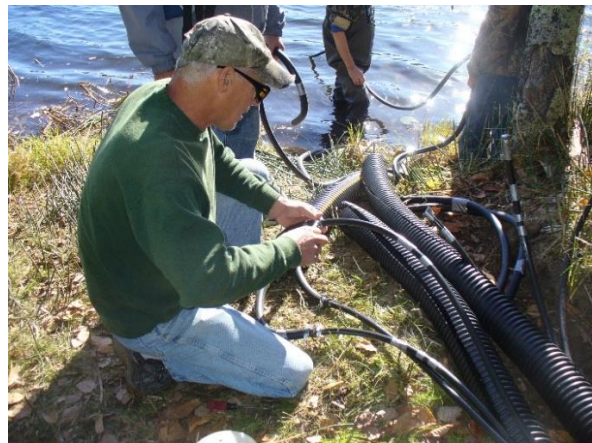
Connecting Weighted Airline in lake to Non-weighted Airline and 4-inch Tile on Shore

The compressor cabinet for the aeration system is located 65 feet from the shoreline of Little Pickerel Lake. This location was selected based on the ease of providing electric power to the compressor cabinet and to allow for the continued and unobstructed public use of the access to Little Pickerel Lake from the PCLA property. Six lengths of 5/8-inch non-weighted airline were used to connect the weighted airlines in the lake to the compressors. These airlines are laid along the ground surface and were placed inside of a pair of 4-inch corrugated tiles to help protect them from damage and rodents.

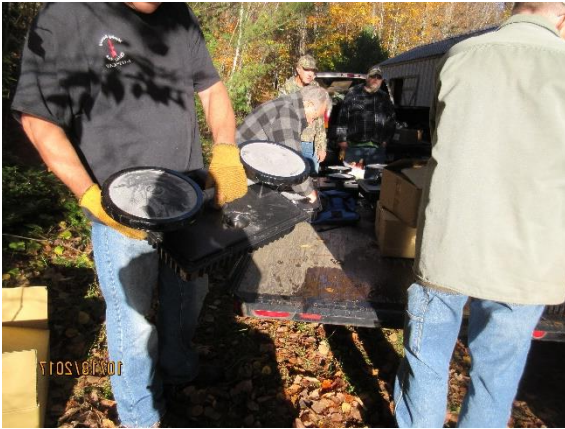
Dual-disk Diffuser unit

An aeration system using $\frac{3}{4}$ horsepower, 230 volt, rocking piston compressors, 5/8-inch weighted airline, and duel disk diffusers was selected for the Little Pickerel Lake system. These materials were selected because they would provide the air output desired, could be purchased at a reasonable cost, and because they were similar to the materials the PCLA installed and operates with good success on Pickerel Lake.

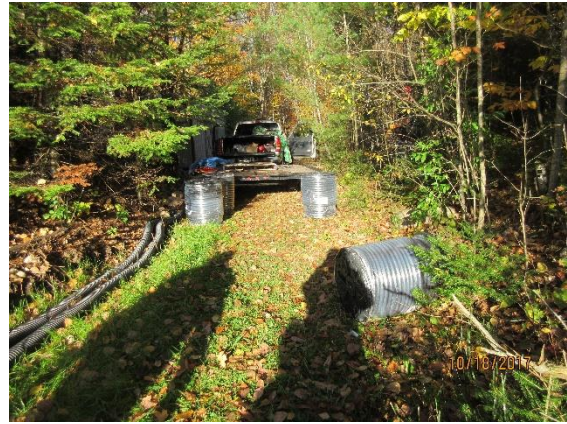
Reels of Weighted Airline

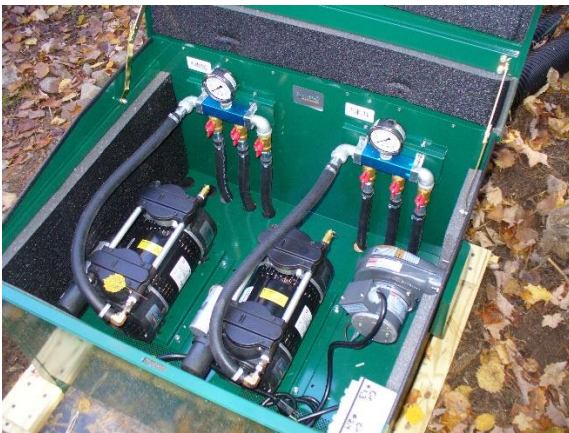
Cabinet with Rocking Piston Compressors

The rocking piston compressors were selected based on providing an acceptable noise level during operation, ability to provide operating pressures to perform with diffusers in up to 20 feet of water, and providing similarity with the PCLA's compressors on Pickerel Lake.

Both of the Little Pickerel Lake aeration system compressors are housed in a single compressor cabinet. The cabinet was set in place, electric wiring was trenched between the compressor cabinet and the meter pedestal/breaker panel, and final electric connections to power the compressors were completed by the PCLA in September of 2017.

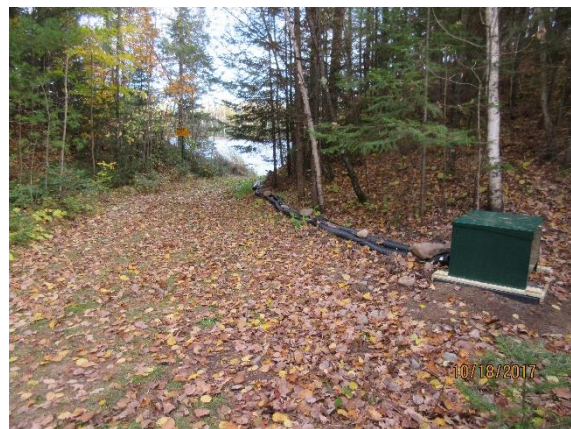
Compressor Cabinet and Airlines to lake

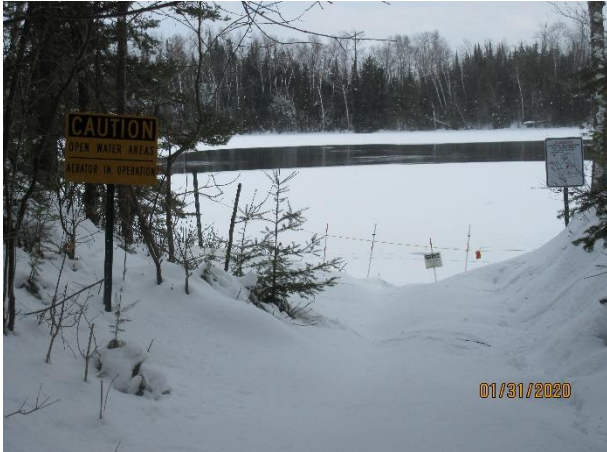
Open Water Caution Signing at Little Pickerel Access

Two signs are placed at five different locations, and these include a 24-inch wide by 18-inch high Caution /Open Water sign and an 18-inch wide by 24-inch high Location/Caution sign that shows a layout of the three lake chain and the general location of the aeration system in each lake. Photos showing the caution signing placed at the Little Pickerel Lake access location, at the Pickerel Lake boat landing access location, and at a Pickerel Lake snowmobile access location are shown in Attachment C in the Attachment Section of this report.

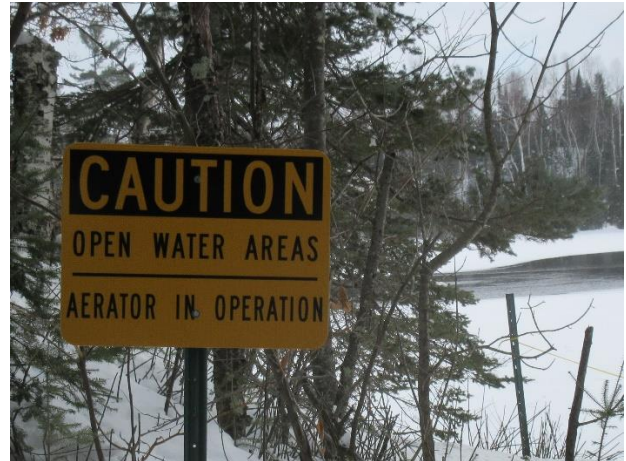
Open Water Caution Sign Wording

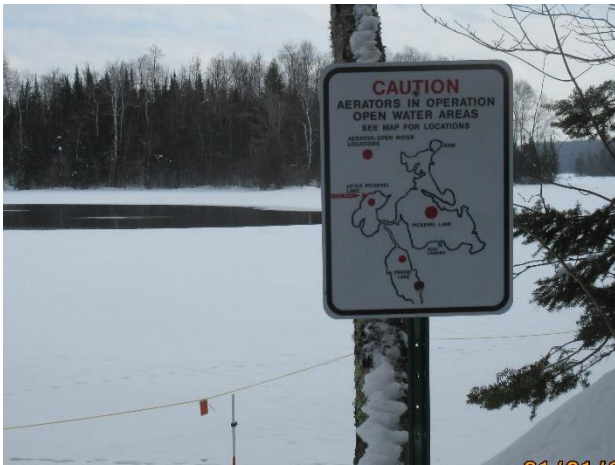
Open Water Caution and Location Sign Wording at Little Pickerel Lake Access

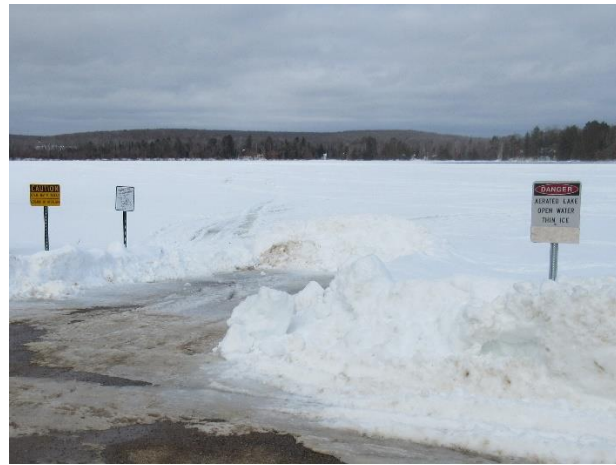
Open Water Caution Signing at Pickerel Lake Boat Landing

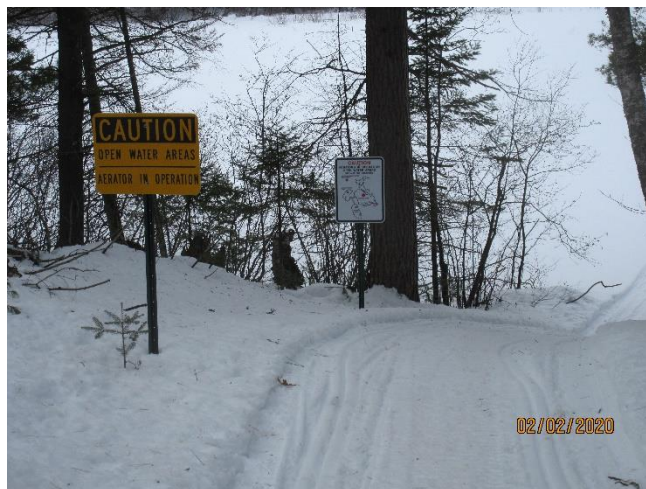
Open Water Caution Signing at Pickerel Lake Snowmobile Access

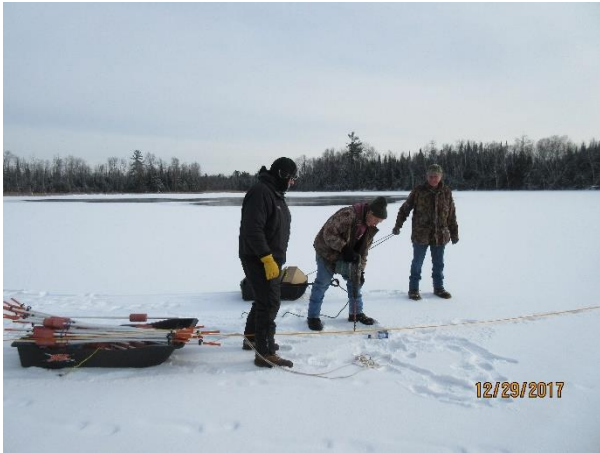
Drilling Holes for Open Water Warning Fence Posts

The open water post and rope warning system is installed each winter once safe ice thickness for foot travel is present on the lake. PCLA members install the post and rope warning system, typically using 4 to 5 members to complete the work, and completing the work when the ice is a minimum of 6-inches thick.

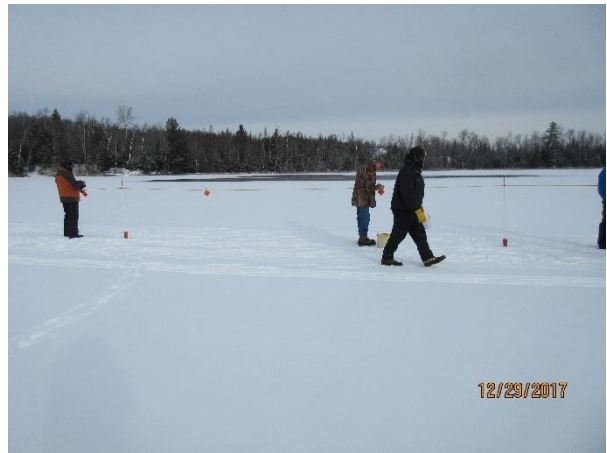
Hanging Open Water Fence Rope and Plates

The open water warning fencing system consists of 1 1/16-inch diameter by 5-foot long fiberglass posts placed at approximately a 25 foot spacing, and connected with a 3/8-inch diameter nylon rope. The posts are placed such that the warning fence system surrounds the open water area at a distance of approximately 150 feet from the open water edge. The rope is connected to each post with a clip at about 4 foot from the lakes ice surface. Two aluminum plates, measuring 4-inch square in size, are evenly spaced and hung on the rope between each set of posts. Two foam floats, each 3-inch diameter by 3-inch high, are placed on each post to provide a means for maintaining the post height above the ice surface and to provide floatation for the posts following ice out in the spring. The posts are set in the ice using a hammer drill and a 3/4 inch drill bit to provide a hole in the ice to set the posts. The lower of the two floats is set approximately 8-inches up from the bottom of the posts.

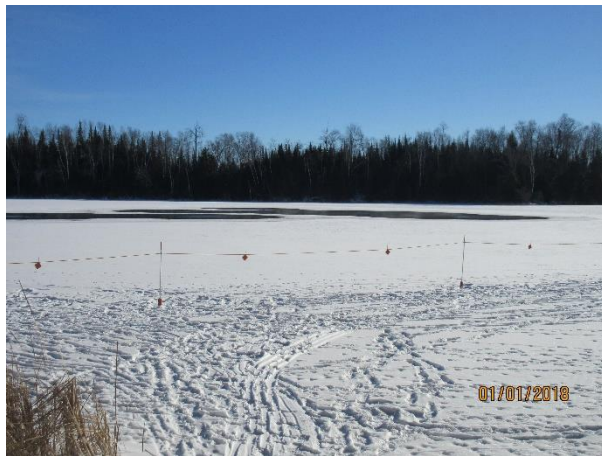
Open Water Fencing System – posts, plates, rope

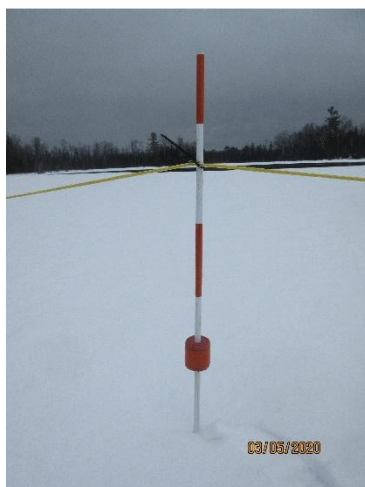
Open Water Fence Post with Reflective Tape on Post and top Float

Reflective tape is used on each post and on the aluminum plates to help provide both daytime and nighttime visibility of the warning fencing system. The PCLA has applied two 6-inch lengths of reflective tape to each post, one at the top of the post and another at mid-height of each post. An additional strip of reflective tape has also been applied on the higher of the two floats on each post. Photos of the open water warning fence system installation and materials are shown in Attachment D in the Attachment Section of this report

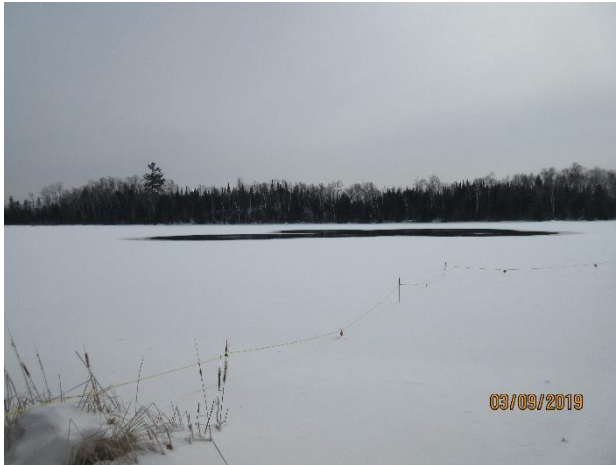
Open Water – March 2018

The Little Pickerel Lake aeration system operated continually throughout each of its first three seasons of operation with no problems. The diffuser placements provided the desired single large open water area in the lake. The open water area remained basically unchanged in size throughout each season. The system operated continuously each season until the system was shut down with the onset of spring temperatures and deteriorated ice conditions on the lake. The compressor pressures remained between 9 and 10 psi throughout each winter season, with these valves in the expected range for the system based on the length of the airlines and depth of the diffusers. Photos showing the open water area created by the Little Pickerel Lake aeration system are shown in Attachment E in the Attachment Section of this report.

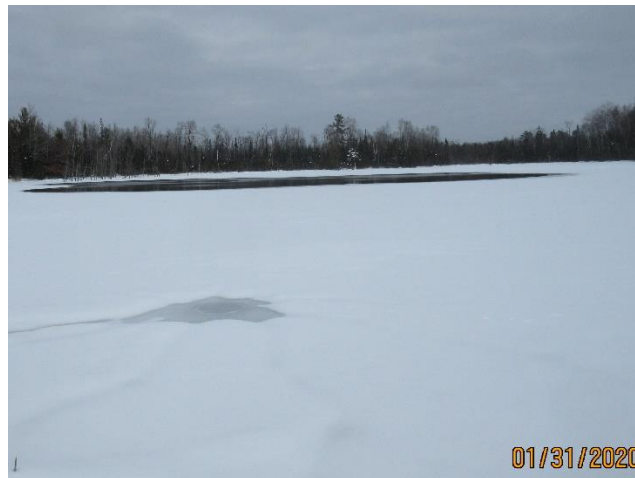
Open Water Area – January 2020
