Whitney Lake 2018 Lake Assessment Report

Prepared by
Vilas County Land & Water Conservation

September 30, 2019

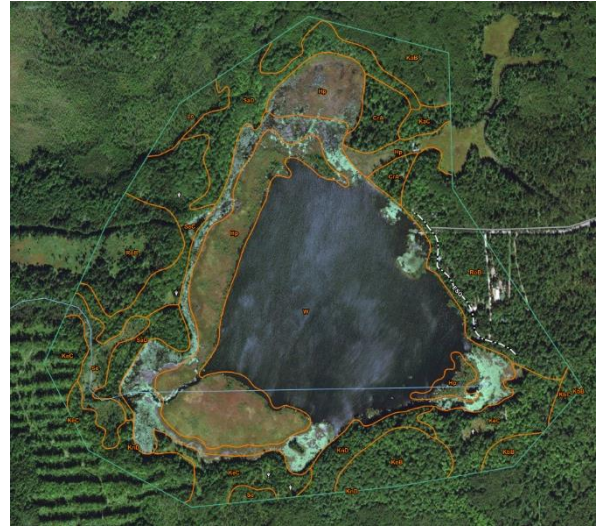
Figure 2. Soils of Whitney Lake. Pondered histosols (Hp), Rubicon sand (RoB), Keweenaw-Sayner-Vilas complex (KeC), and Sayner-Rubicon sand (SaD) predominate the riparian area. Courtesy Soil Web Survey, NRCS.

The adjacent riparian land is owned by the Northern Highland American Legion State Forest (about 87% of shoreline) and private landowners (about 13% of shoreline). The ground cover is primarily forests and bogs, however there is some development on the lake. Pondered histosols are largely present around lake and are indicative of wetlands. Other predominant surrounding soils are sandy soils (primarily Rubicon Sand, Sayner-Rubicon Sand, or Keweenaw-Sayner-Vilas complex) with slopes ranging from 0-35%. These soils are rates "well drained" or "excessively drained". (*Web Soil Survey*).

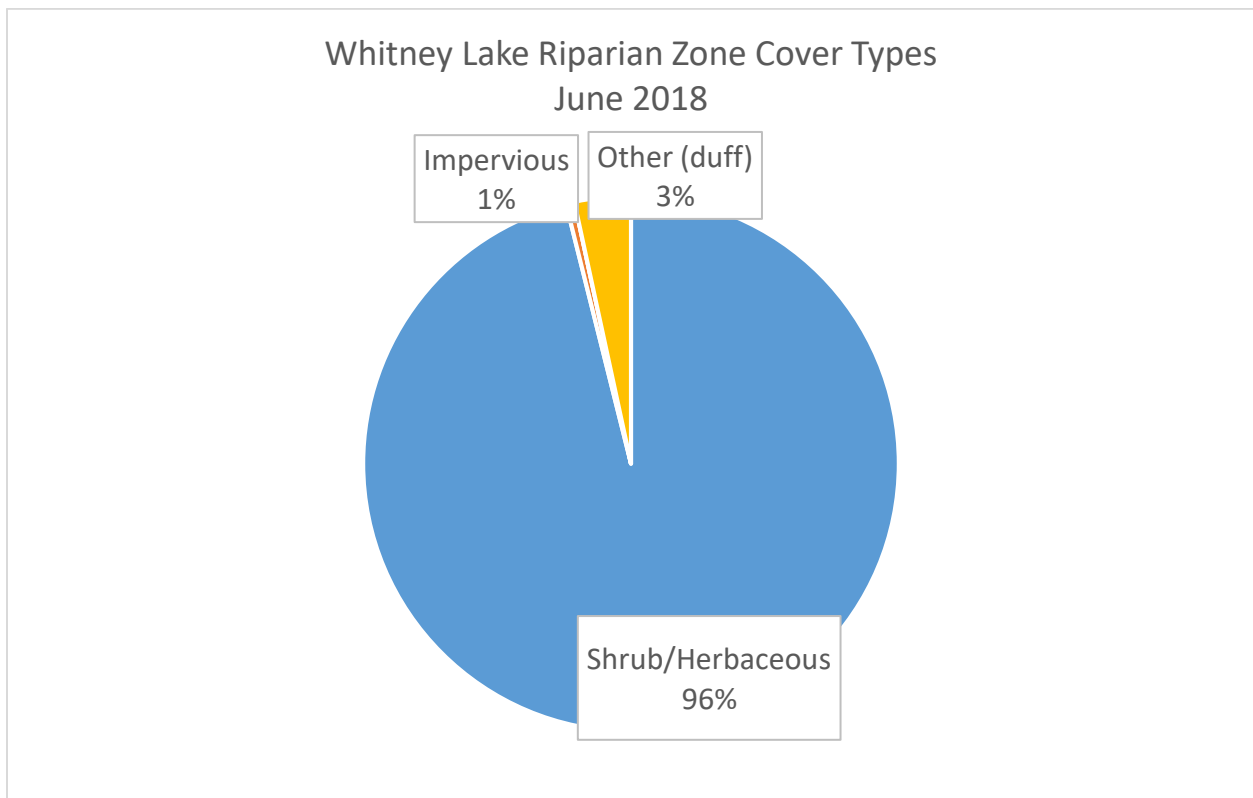
Figure 3. Ground cover type in Riparian Buffer Area (35 ft. inland from shore) on Whitney Lake, 2018.

Lake-wide, 96% of the riparian area (35 ft. inland from ordinary high water mark) was covered by a shrub/herbaceous layer. Lawn made up 0% of the riparian area, and Impervious surfaces made up 1%. See Appendix 5 for Riparian Buffer Zone Cover Types.

- **Maintain native vegetation to grow in the 35 ft. shoreland buffer areas:**
 - The shoreland owners of Whitney Lake have done an excellent job of creating minimal impact to their shorelines. Encourage this leaving native plants, shrubs, and trees within the 35 ft buffer zone. Roots of turf grasses are not as well equipped as the existing native shoreline plants at holding down soil and reducing runoff. Contact Cathy Higley from Vilas County Land & Water Conservation 715-479-3738 or cahigl@vilascountywi.gov for assistance or question in preserving native shorelines.

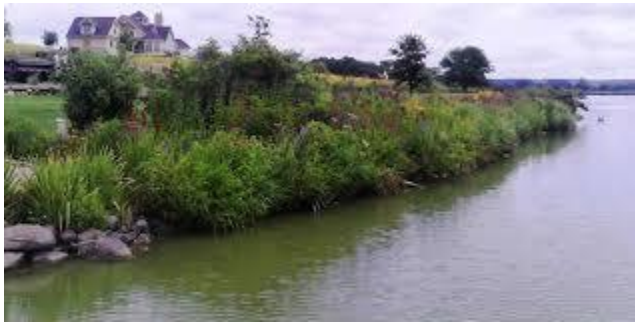
Figure 5. Landowners experiencing minor-moderate erosion issues may find that Healthy Lakes practices such as native plantings are enough to reduce runoff. Contact Land & Water Conservation for an assessment. Photo courtesy of Healthy lakes WI.

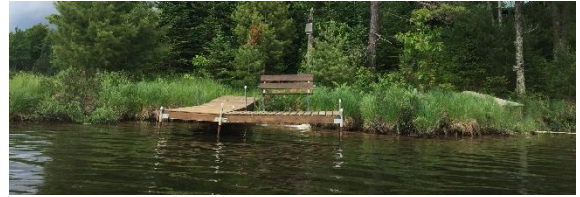
Ten docks or less per kilometer (16 docks/mile) of shoreline has been shown to be a threshold of maintaining high quality fish diversity in Minnesota (Jacobsen et. al). Whitney Lake is below this figure at 1.5 docks/mile. Additional littoral structures such as boat lifts, swim rafts, etc. would intuitively seem to add to this stress. Other major categories for structures were: boats on shore (46); buildings (38); boat lifts (32); and other riparian structures (20).

Figure 4. Dock density on Whitney Lake was low, and disturbance to riparian areas appeared minimal. Lake-wide, there were 1.5 docks/mile on Whitney Lake. Having a lake-wide dock density greater than 16 docks/mile has been shown to have negative effects on fish diversity (Jacobsen et.al).

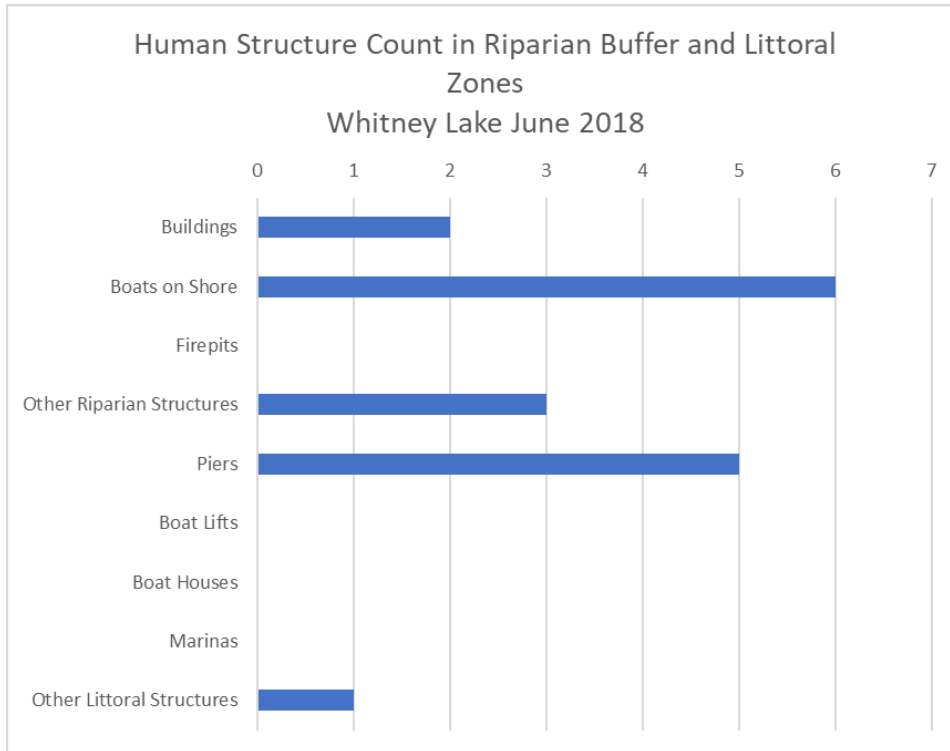
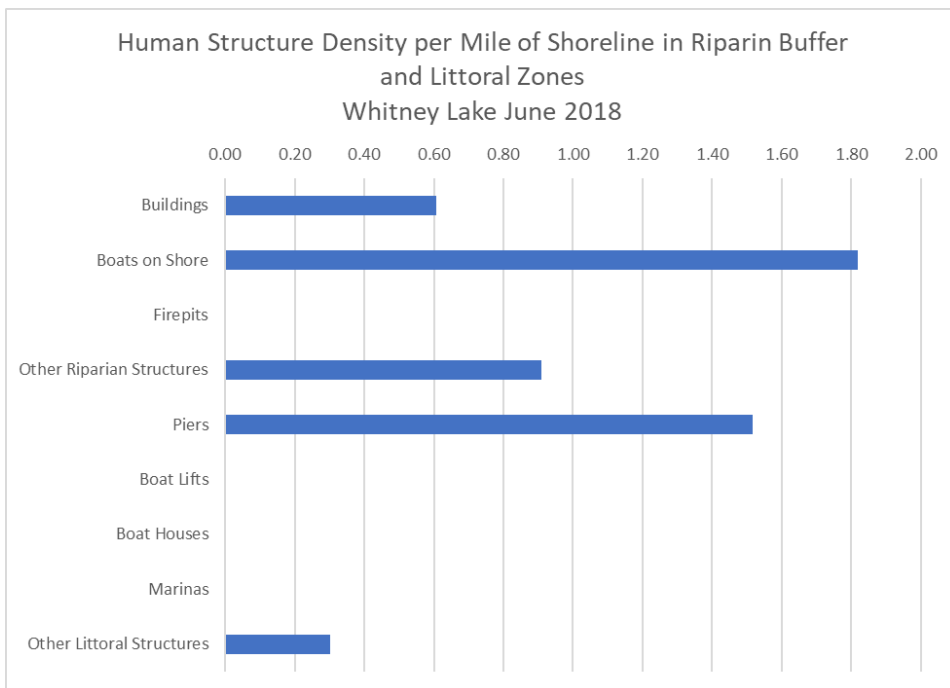
Some human structures or modifications were noted in the Riparian and Littoral Zones. See Figure 6 for Human Structures in Riparian Buffer and Littoral Zones Charts.

Because of their ecological importance, these areas are typically protected by County Zoning and DNR regulations and permits are often required to modify or place new structures in these areas. In Whitney Lake, boats on shore were the most common structure.

Figure 6. Number and density per mile of shoreline of human structures documented in the Riparian Buffer and Littoral Zones on Whitney Lake 2018.

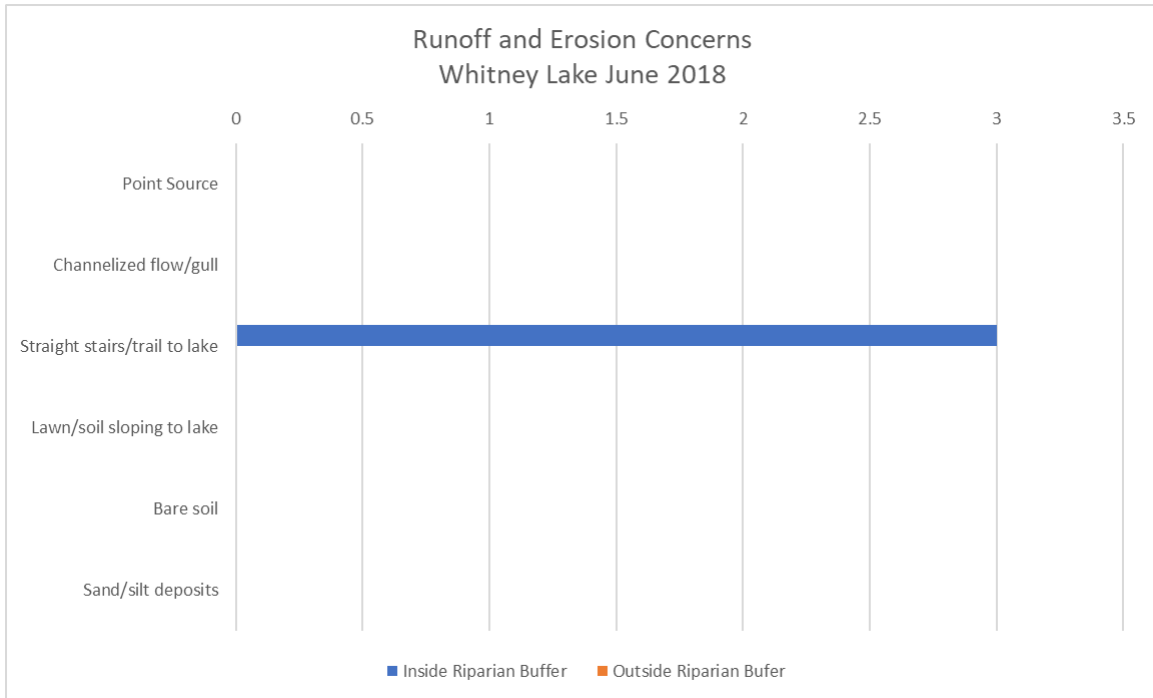
A few runoff and erosion concerns were documented within the riparian area: 3 parcels had a straight stairs/trail/road to the lake. See Figure 7 for Number of Parcels with Erosion or Runoff Concerns.

Figure 7. Number of parcels with runoff and erosion concerns in Riparian Zone and Outside Riparian Zone on Whitney Lake 2018. Of the 19 parcels, 3 had erosion or runoff concerns (16%).

- **Maintain awareness of stormwater management and resources for private landowners:**
 - The number of parcels with erosion concerns was low (3), but landowners should be encouraged to seek assistance as needed with stormwater concerns. Stormwater management (gutters, infiltrations, curved/vs. straight access paths, etc.) outside the 35 ft. buffer zone should also be addressed with willing landowners. Contact Cathy Higley from Vilas County Land & Water Conservation 715-479-3738 or cahigl@vilascountywi.gov for assistance.

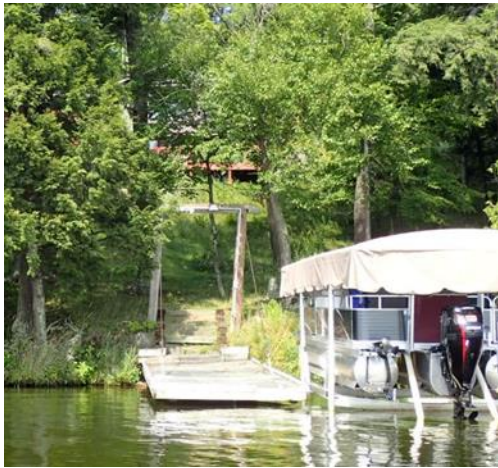
Figure 8. Minimizing impervious surfaces in and around lake access paths, maintaining vegetation, and curving the trail across the slope keeps shoreland erosion in check.

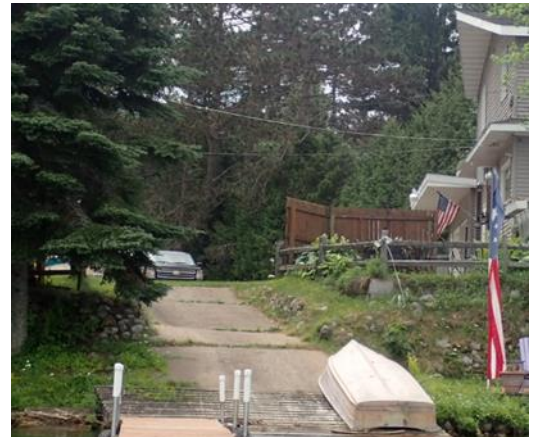
Figure 9. Impervious surfaces and straight trail access make a site even more prone to erosion. This site (not on Whitney Lake) was augmented with a water infiltration pit to minimize runoff into the lake.

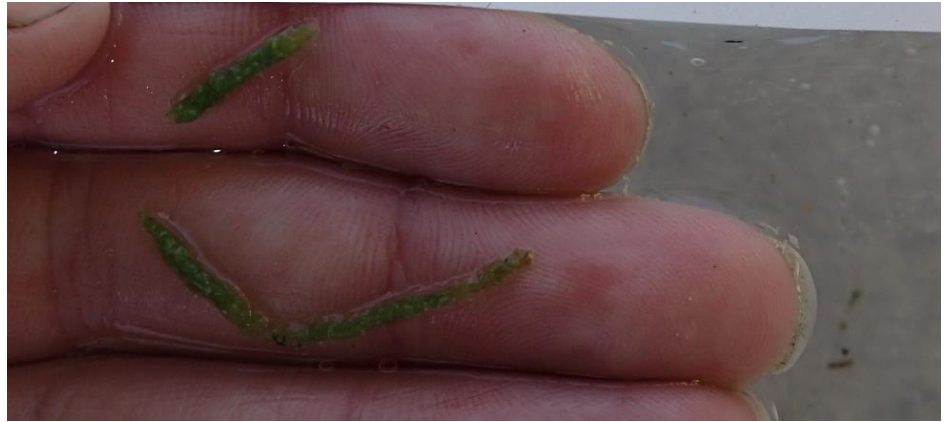
Freshwater sponges were found at 12% of littoral area points sampled in the aquatic plant point intercept survey.

Figure 10. Freshwater sponges were found at over 12% of littoral points surveyed.

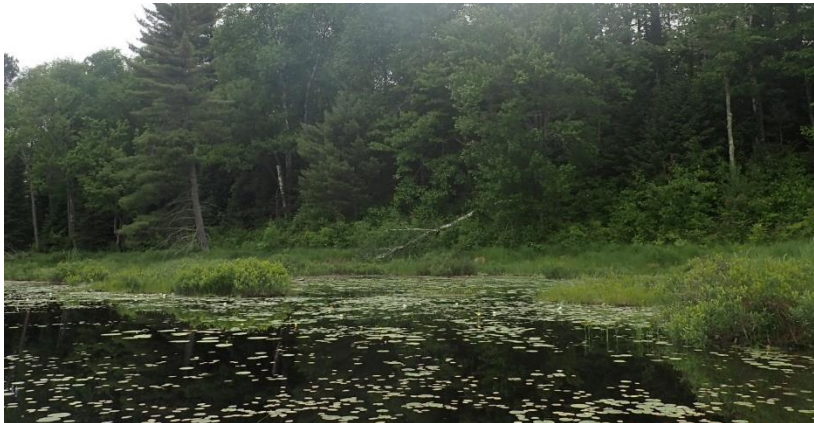
Trumpeter swans as well as much of the diversity of aquatic plants took refuge in the navigable waterway behind the bog mats on the lake.

Figure 11. Quiet areas of the lake were protected by bog mats.

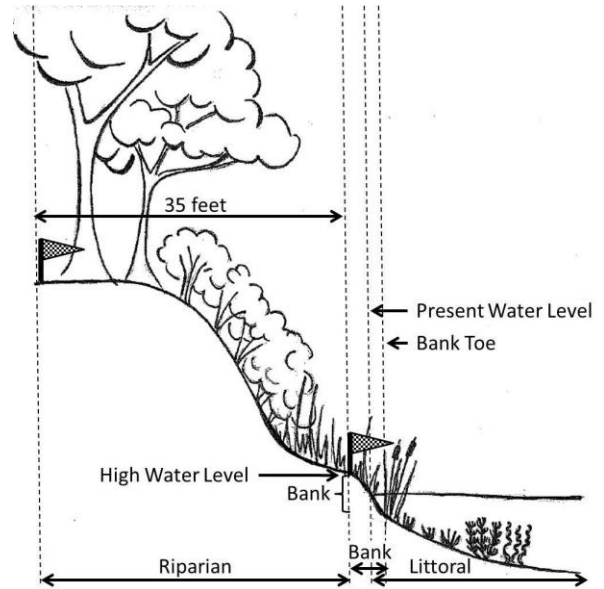
The Shoreland Assessment protocols call for documenting the condition of the Riparian Buffer Zone 35 ft. inland from shore, the bank zone, and the littoral zone – see Figure 12. If it was uncertain if structures were located within the 35 ft. riparian buffer zone, a rangefinder was used to measure distances.

Figure 12. Shoreland areas assessed included the Riparian Buffer Zone, Bank Zone, and Littoral Zone. Graphic courtesy of WI DNR.

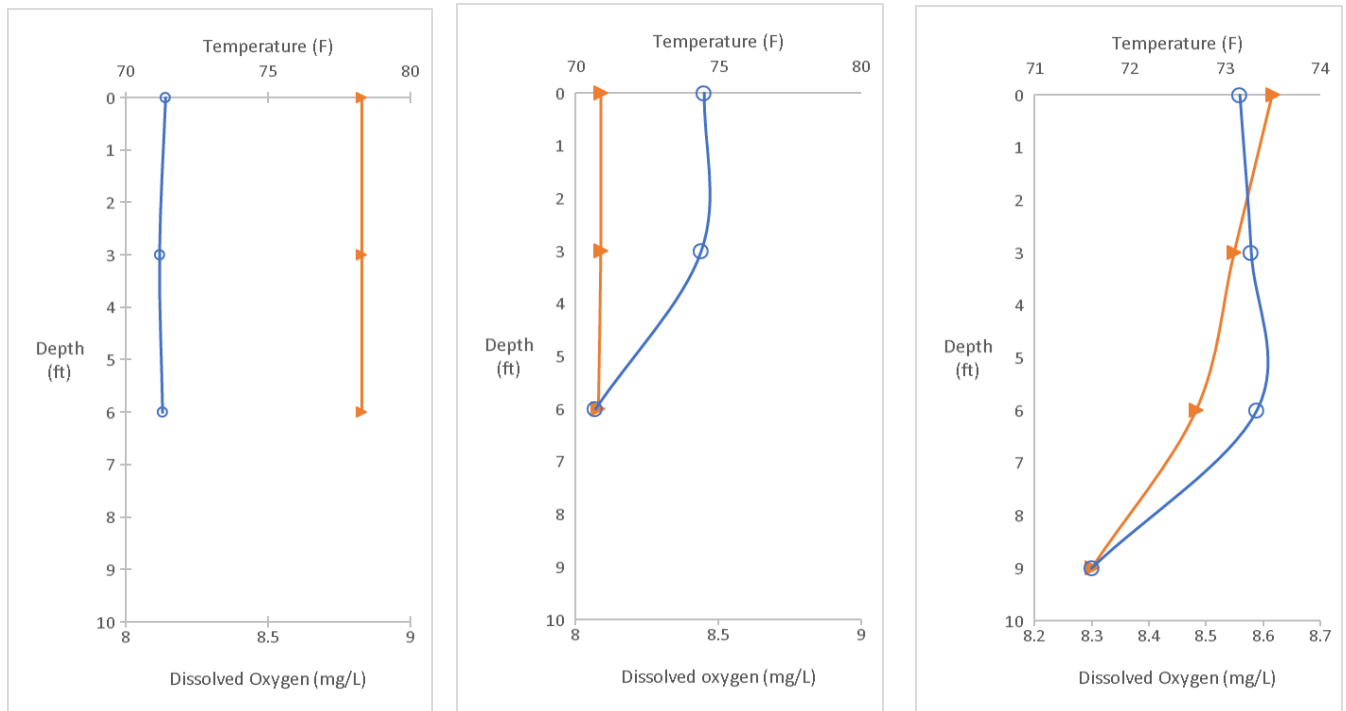
Temperature and dissolved oxygen monitoring showed that Whitney Lake was well mixed. “Warm water” fish need dissolved oxygen levels of at least 5 mg/L (Shaw et.al.). More than 5 mg/L dissolved oxygen was found on Whitney Lake down to the lake bottom. See Appendix 2 for water quality raw data and temperature and dissolved oxygen profiles.

The July, August, and September temperature and dissolved oxygen profiles show the lake was mixed and did not stratify.

Figure 13. July, Aug, and Sep 2018 dissolved and temperature profiles for Whitney Lake.

- **Monitor water quality regularly:**
 - While it seems apparent that Whitney Lake has good water quality, it may be helpful to have year-round dissolved oxygen information to correlate with any future winter fish kills. Contact Sandy Wickman from WI DNR 715-365-8951 or Sandra.wickman@wisconsin.gov for additional assistance.

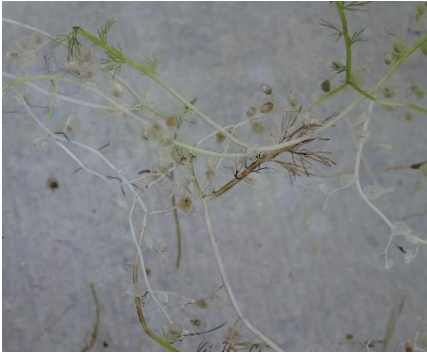
Figure 15. Flat-leaf bladderwort (*Utricularia intermedia*) found in Whitney Lake 2018 point-intercept survey. This plant occurred in over 10% of littoral sites surveyed.

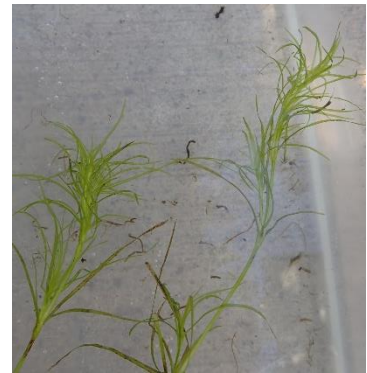
Figure 17. Slender naiad (*Najas flexilis*) found in Whitney Lake 2018 point-intercept survey. This plant occurred in over 30% of littoral sites surveyed.

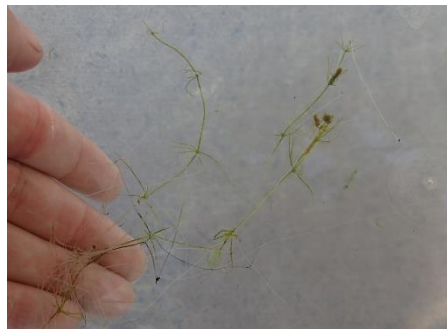
Figure 19. Muskgrass (*Chara contraria*) found in Whitney Lake 2018 point-intercept survey. This plant occurred in over 18% of littoral sites surveyed.

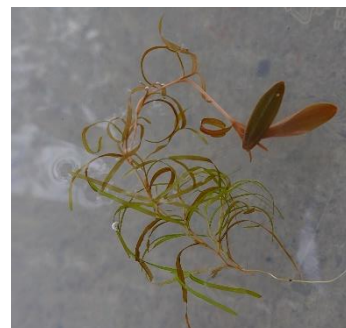
Figure 23. Spiral fruited pondweed (*Potamogeton spirillus*) found in Whitney Lake 2018 point-intercept survey.

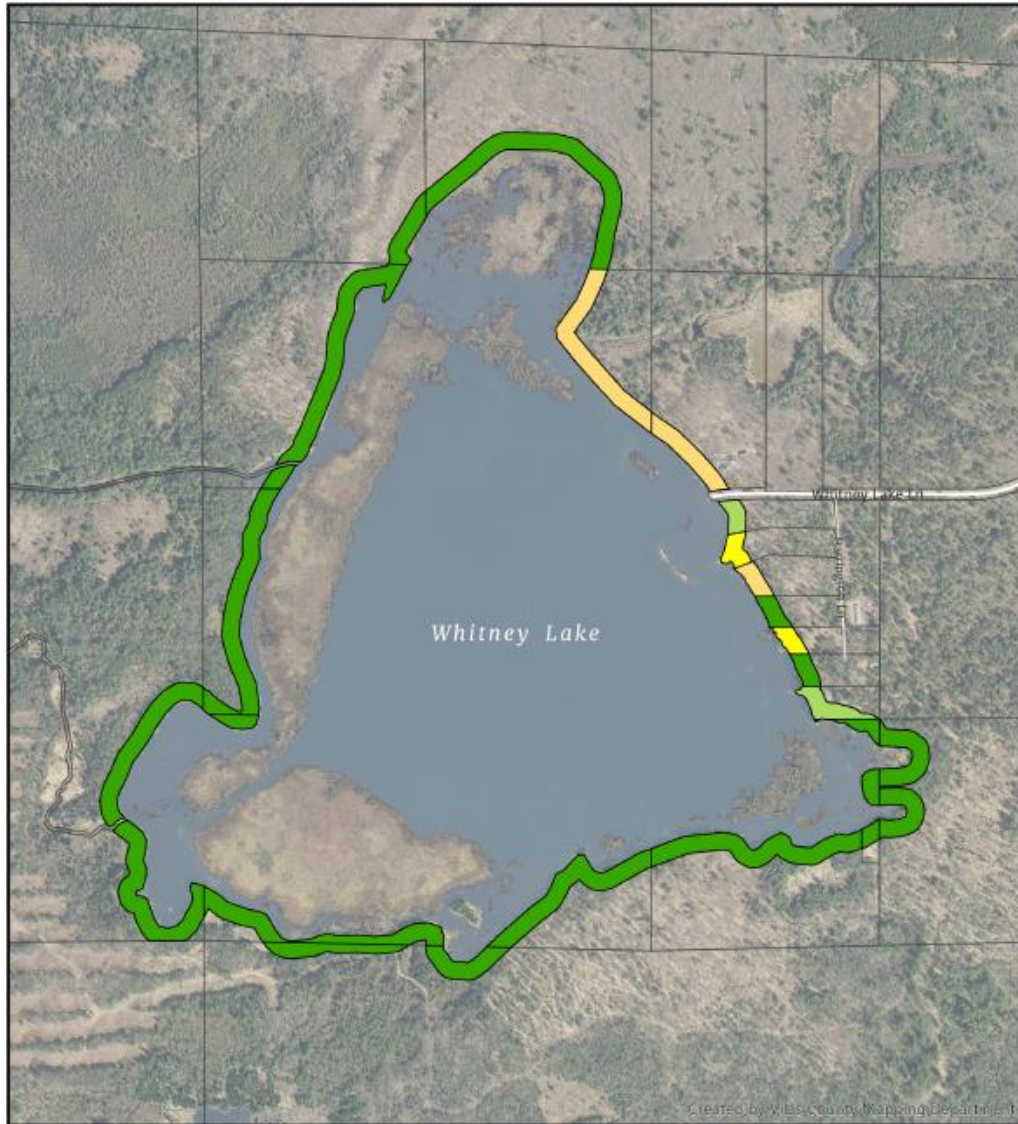
Shoreland Habitat Map 2018 - Whitney Lake (2338100)

Percent Canopy

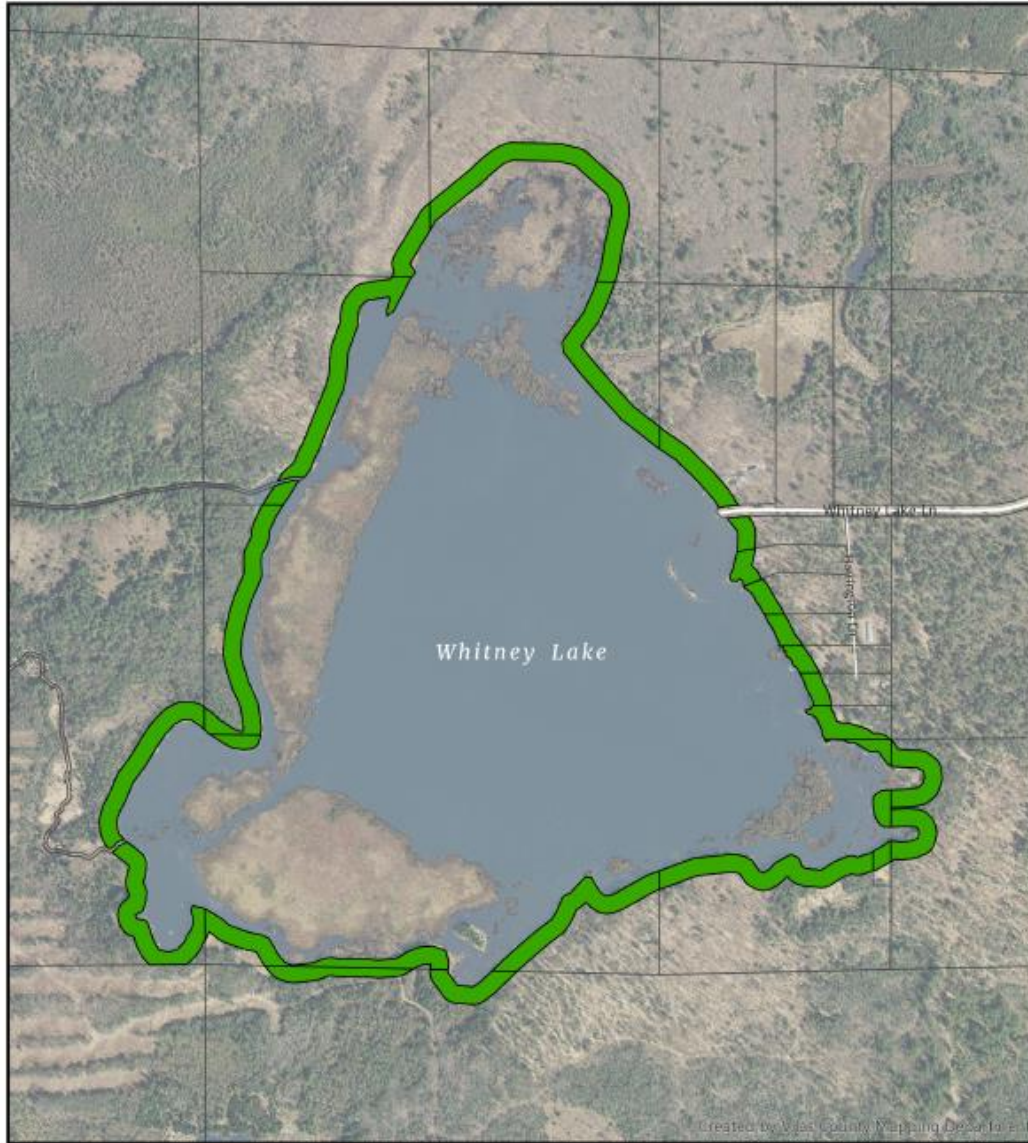
Shoreland Habitat Map 2018 - Whitney Lake (2338100)

Percent Shrub/Herbaceous

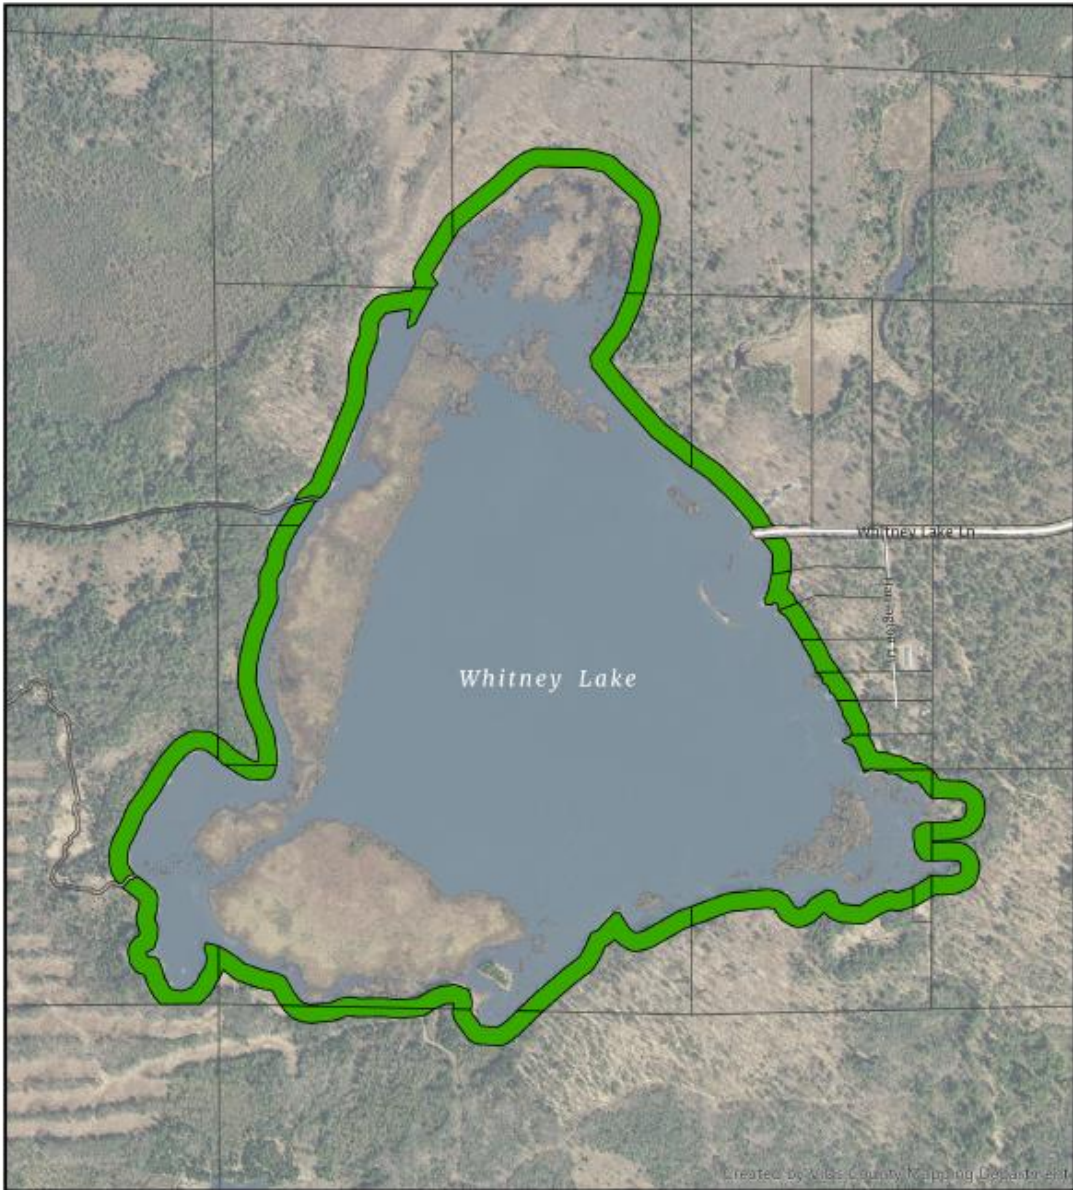
Shoreland Habitat Map 2018 - Whitney Lake (2338100)

Percent Lawn

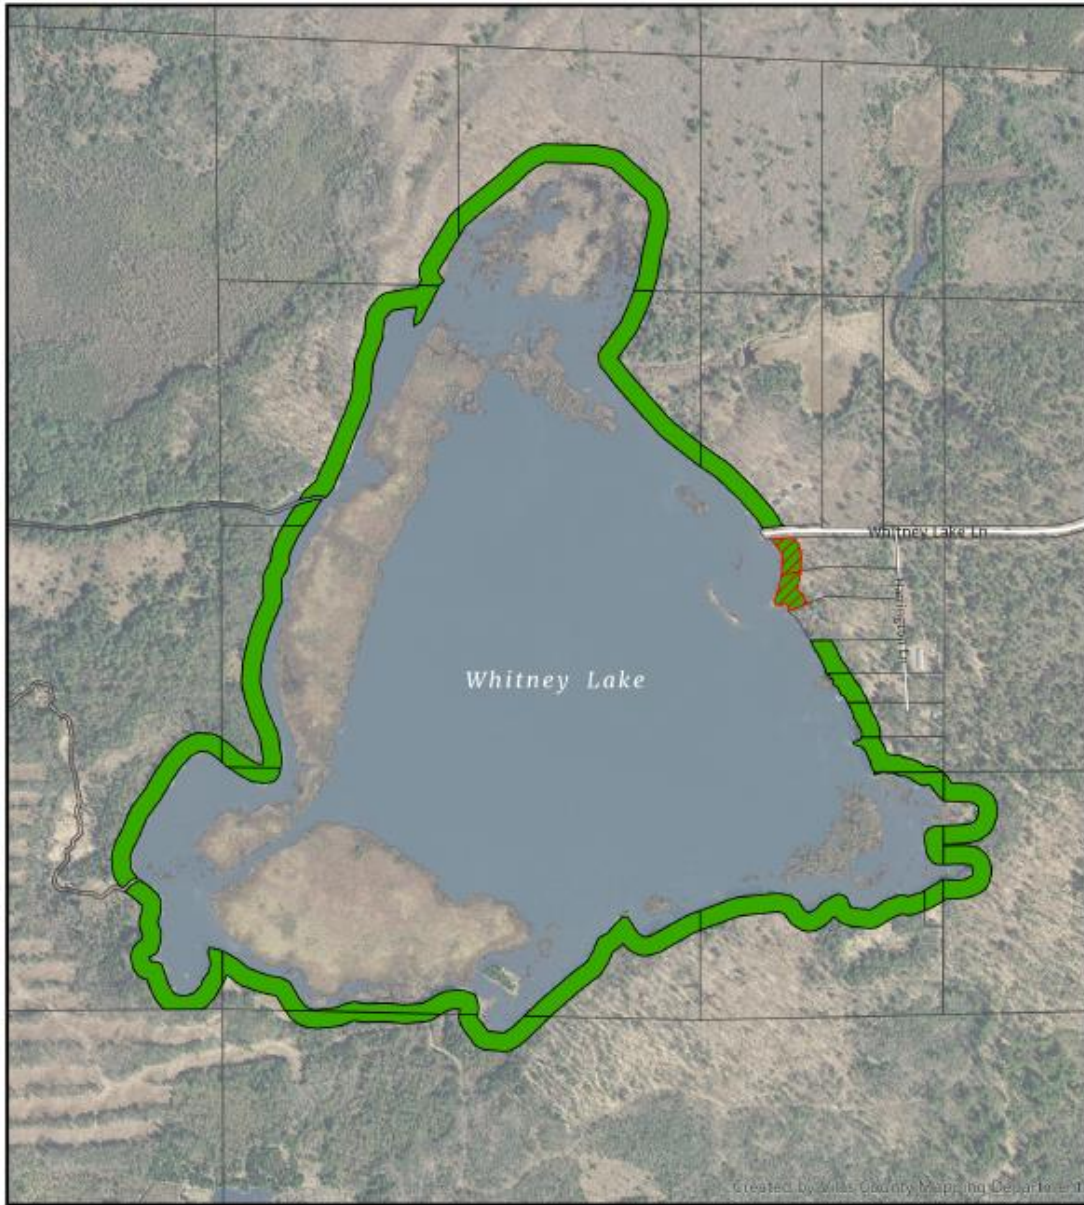
Shoreland Habitat Map 2018 - Whitney Lake (2338100)

Emergent and Floating Aquatic Plants
