**Eurasian water-milfoil (*Myriophyllum spicatum*)
Pre/Posttreatment and Bed Mapping Surveys
Sand Lake (WBIC: 2661100)
Barron County, Wisconsin**

Project Initiated by:

The Sand Lake Management District, Lake Education and Planning Services, LLC, and the Wisconsin Department of Natural Resources

Endangered Resource Services, LLC
Matthew S. Berg, Research Biologist
St. Croix Falls, Wisconsin
May 15, July 8, and September 26, 2021

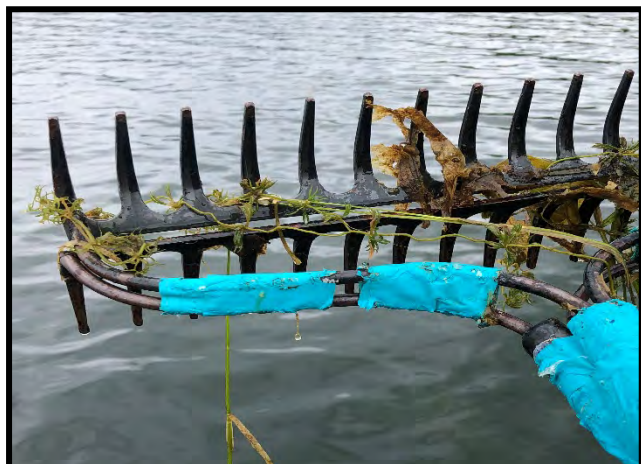
Dead EWM in control area 7/8/21

Herbicide burned but not killed Coontail in the control area 7/8/21
