Lake Protection Grant LPT 45715

Bone Lake Management District

2019 Report

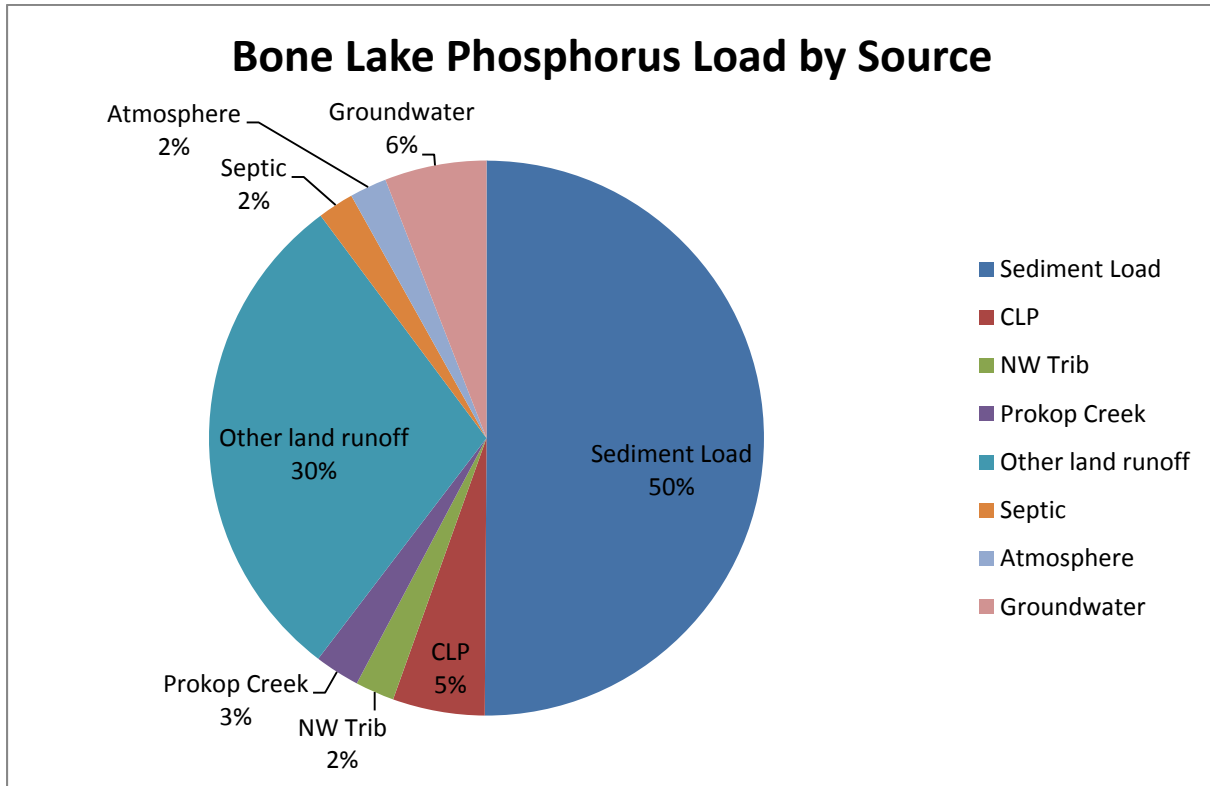
The phosphorus load was estimated by using the groundwater flow multiplied by the average concentration of phosphorus in groundwater samples to determine a mass of phosphorus flowing into the lake via groundwater. Groundwater flow was estimated in winter months by measuring tributary inflow and outflow and volume from lake level measurements. Well samples were taken and data analyzed to estimate groundwater contributions to Bone Lake's phosphorus budget.

Updated Phosphorus Budget including groundwater study results:

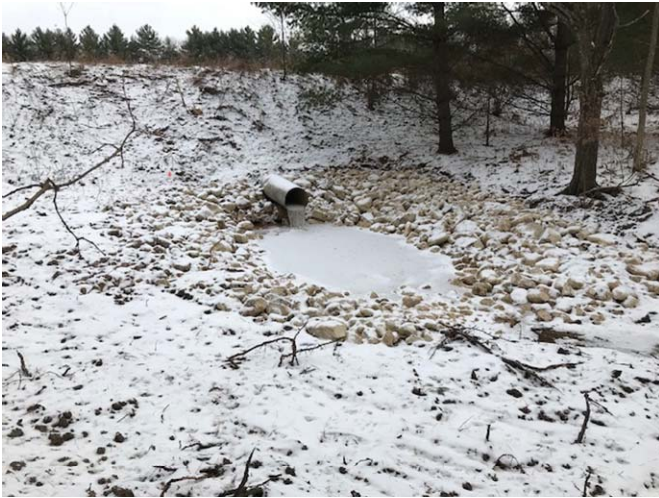
A rock plunge pool was installed at the outlet of a pond tributary to Bone Lake on the Musial property. Scott Geddes, Polk County LWRD, designed this project.

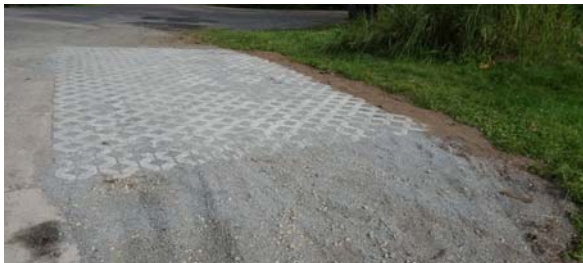
Plastic porous pavers were replaced with a concrete geogrid at the Bone Lake North Landing. The plastic pavers did not stand up to regular boat and trailer traffic and snowmobiles in the winter.
