Comprehensive Lake Management Plan

for Chute Pond, Oconto County, Wisconsin

April 2014

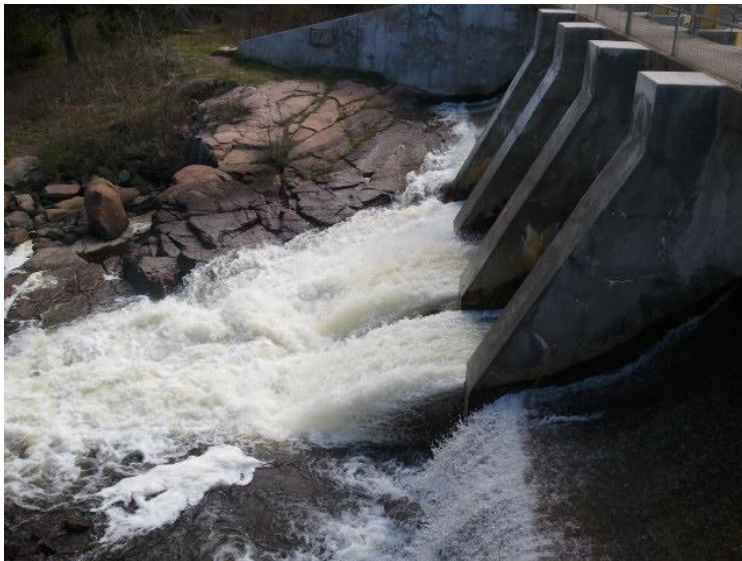
Figure 1. Area surrounding Chute Pond, Oconto County, Wisconsin.

Chute Pond is a flowage located in northwest Oconto County within the Chequamegon-Nicolet National Forest near the Town of Mountain (**Figure 1**). It has a surface area of 433 acres, maximum depth of 18 feet and is fed by the North Branch of the Oconto River (**Figure 2**). It contains approximately 2,759 ac-ft of water. An Oconto County park with a swimming beach, campground, public fishing pier and boat landing are located on the northeast shore of the lake. There is an additional boat launch on the south shore and two additional public access sites. Chute Pond has approximately 10 miles of shoreline. Approximately 70% of this shoreline is developed. The remaining 30% is in public ownership by the National Forest and Oconto County. The dam on Chute Pond was installed in 1937 and maintains a 13-foot head during the summer months. In the winter, the water is routinely lowered one foot. The Flowage receives heavy recreational use in the summer by anglers, skiers and boaters.

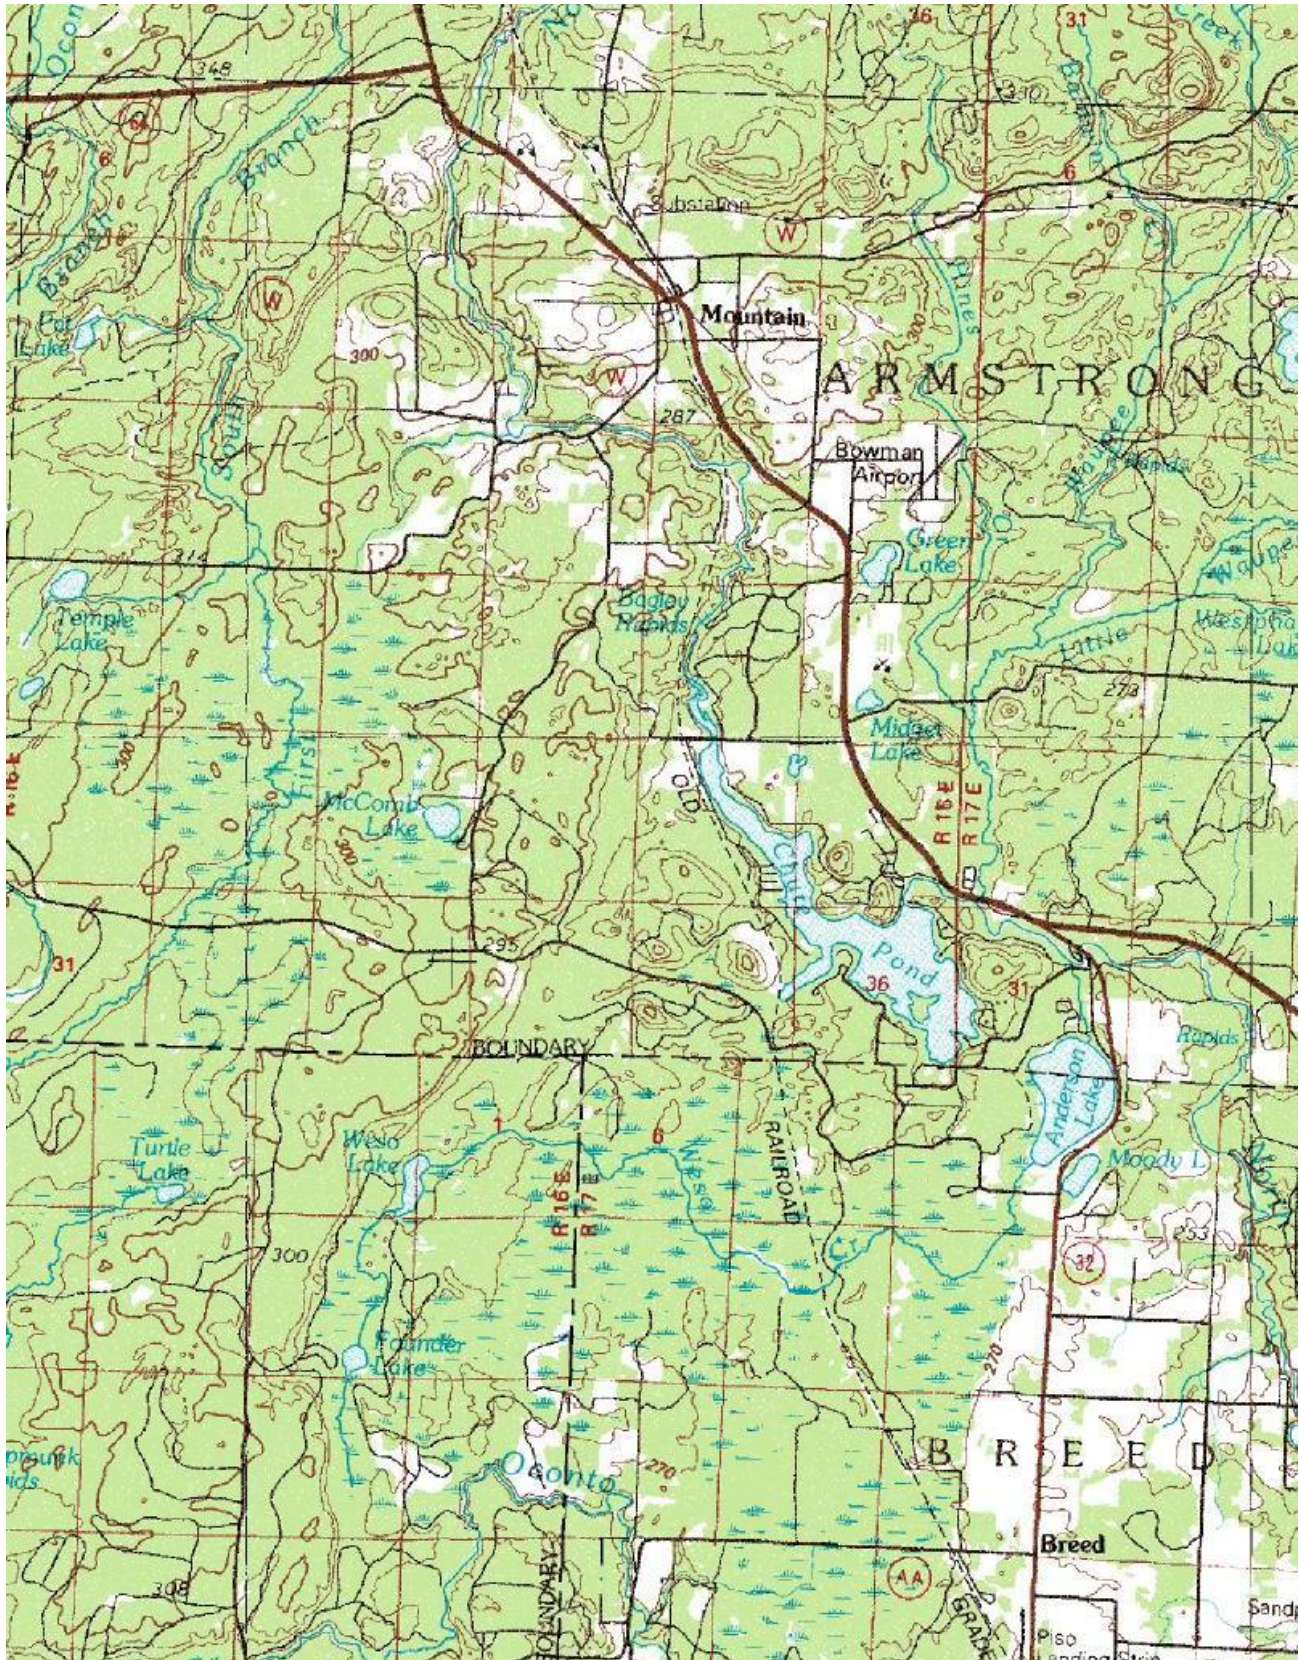
Figure 2. Bathymetric map of Chute Pond, Oconto County, Wisconsin (1975).

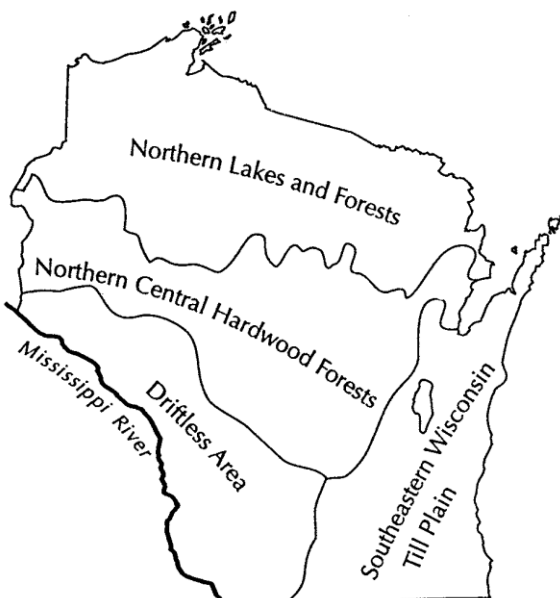
Figure 5. Ecoregions of Wisconsin (after Omernick and Gallant, 1988)

A total of 34 submergent, emergent and floating-leafed aquatic plant species were found during the 2012 survey (**Table 1**). This is above the state-wide average of 13 species. Chute Pond is in the Northern Lakes and Forests regions of Wisconsin (**Figure 5**). The average number of species found in flowages in these regions is 23.5 species (Nichols, 1999). The most abundant plant species encountered in Chute Pond were coontail, common waterweed, forked duckweed and wild celery. These species were found at 53.8%, 43.5% and 42.5% of the sites within vegetated areas, respectively. **Figures 6-8** show the distribution and density of these species across Chute Pond at the time of the survey.

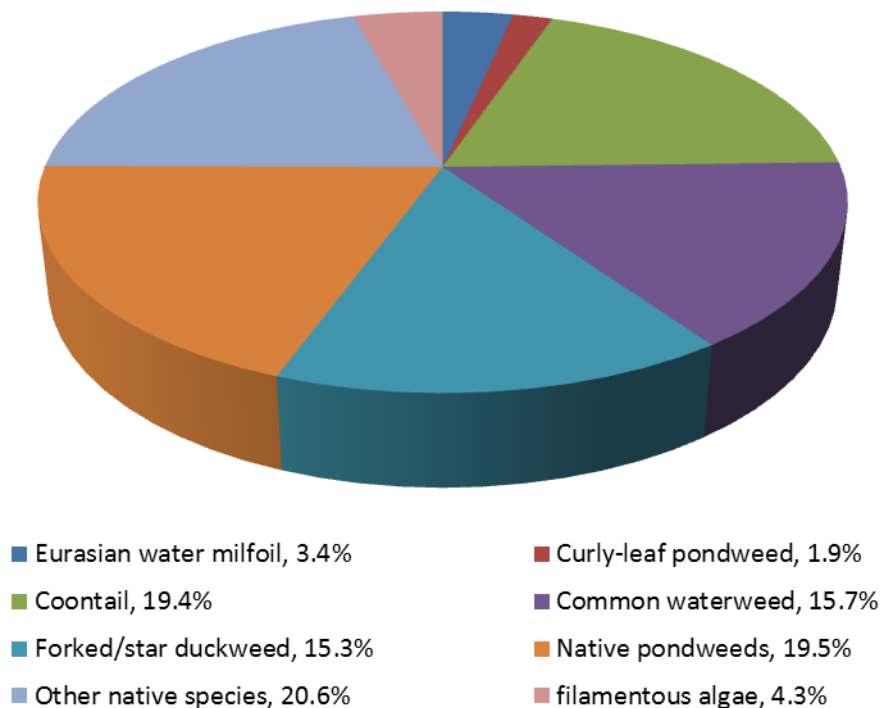
Figure 9. Submergent aquatic plant community composition from July 2 - 3, 2012 in Chute Pond, Oconto County, WI.

Figure 9 presents the relative abundance of submergent aquatic plant species found in Chute Pond at the time of the 2012 survey.

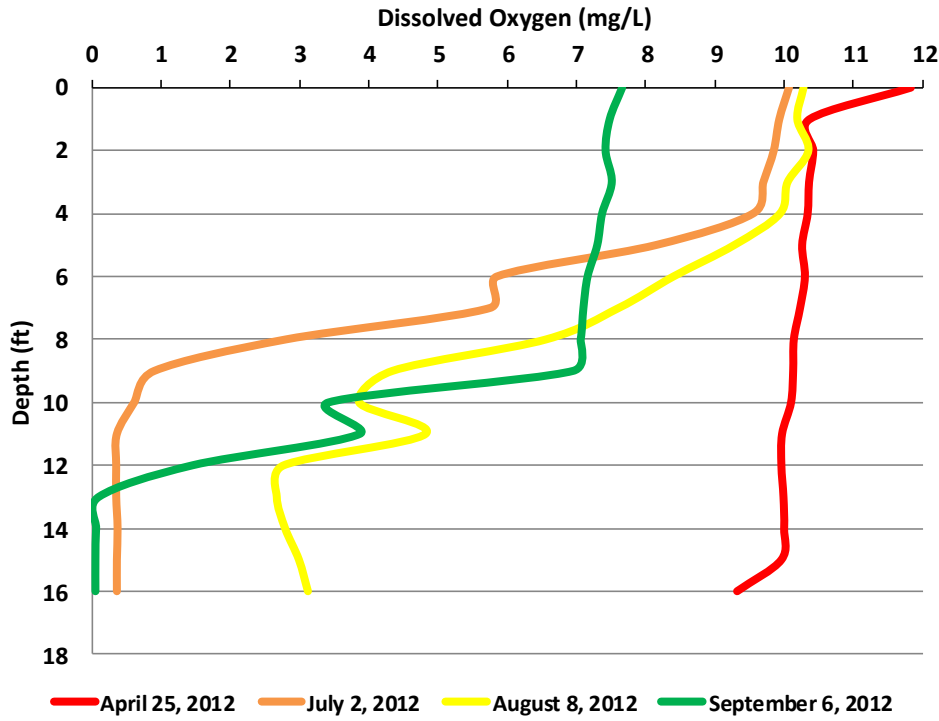
Figure 12. Dissolved oxygen data from 2012 for Chute Pond, Oconto County, WI.

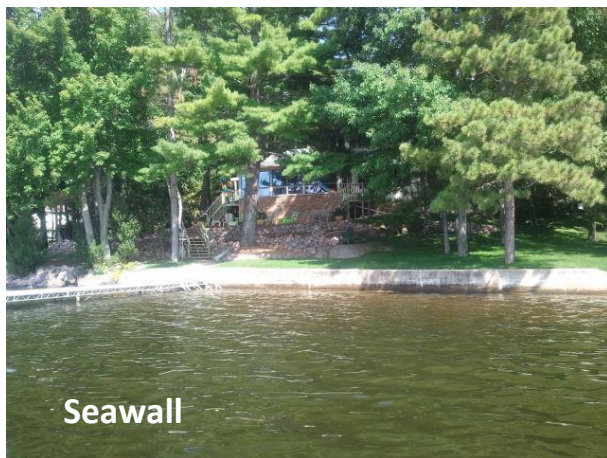
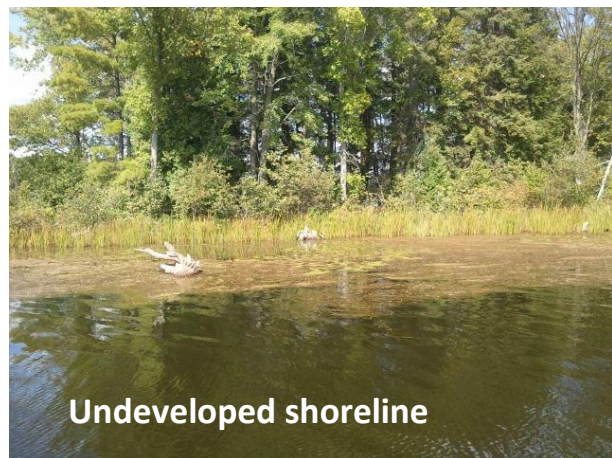
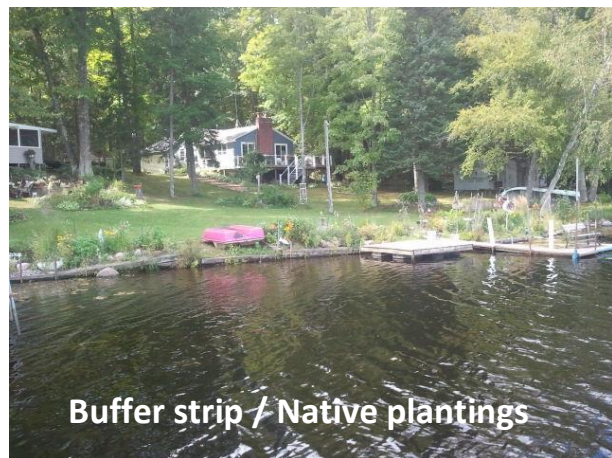
Figure 16. Shoreline images from Chute Pond, Oconto County, Wisconsin.

During the watershed assessment, no signs of significant runoff or erosion were found in the outlying areas. While approximately 200 homes can be found on the shore of Chute Pond, areas of significant erosion were not evident near shore either. The shoreline of the flowage contains a mix of homes with rip rap, sea walls, or undeveloped/unaltered waterfronts with native shoreline vegetation (**Figures 16 and 17**). In addition, the steepness of shorelines varies throughout the system. Human activity can contribute to shoreline erosion. An increase in development translates to increases in the number of lawns, driveways and other hard surfaces which are known to contribute nutrients and sediments to a lake. Often it is those areas closest to the lakes which have the greatest influence on water quality.
