### **CORRESPONDENCE/MEMORANDUM**

DATE:	9-5-2023	FILE REF: North Shore Healthcare
TO:	Mike Polkinghorn, Limits Calculator; Roy Van Gheem,	Compliance Engineer
FROM:	Andrew Hudak, Stream Biologist; Kristi Minahan, Wate Limit Calculator Coordinator	r Quality Standards; Diane Figiel,
SUBJECT:	Schoenick Creek (WBIC 321000) and Wetland Tributary waters for North Shore Health Care, Shawano Co.	y (WBIC 5014152), receiving

# Schoenick Creek and Tributaries to Long Lake

## Schoenick Creek and Long Lake Tributary Report

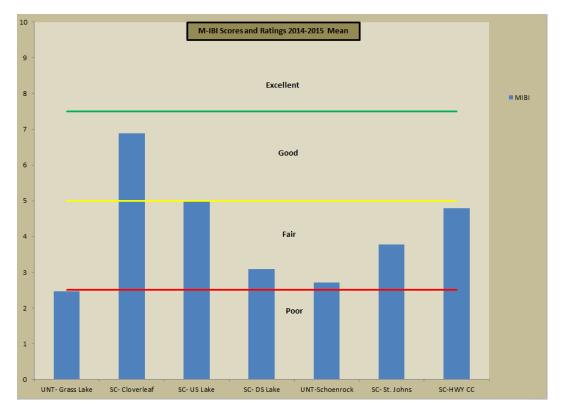
Figure 4- Average M-IBI for Schoenick Creek and Long Lake Tributaries- 2014 and 2015.

Macroinvertabrate samples were collected at all sites in 2014 and selected follow-up sites in 2015 and evaluated with the Hilsenhoff Biotic indices (HBI, Hilsenhoff, 1987) and the Macroinvertebrate index of biotic integrity (MIBI, Weigel, 2003). The Hilsenhoff Biotic Index (HBI) provides a relative measure of organic loading to a stream and as the score increases so does the environmental degradation. The macroinvertebrate IBI (MIBI) was developed for streams within specific eco-regions of Wisconsin and uses metrics related to assemblage composition, structure and function and assesses a wide range of environmental degradation increases and scores below 2.5 are generally considered degraded and impaired. M-IBI results were consistently fair with the exception of Schoenick Creek at Cloverleaf Lake Road achieving a good score and the unnamed tributaries to Schoenick at Grass Lake Road and Schoenrock Lake Road Creek having a poor score. (See Figures 4 and 5 and Tables 4 and 5)

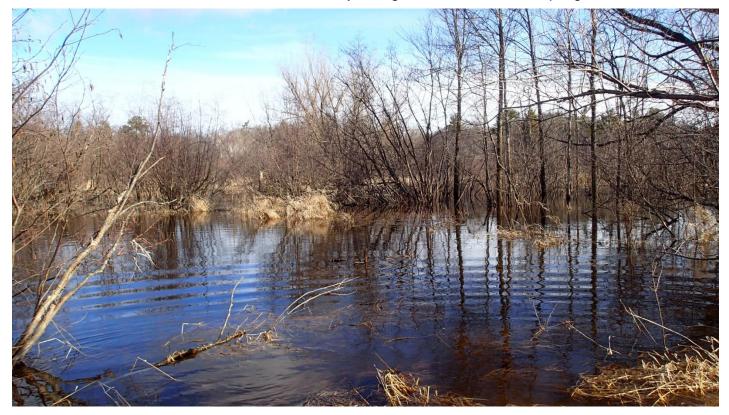
Figure 6. Picture looking north from flooded wetland near inlet/outlet of Long Lake.

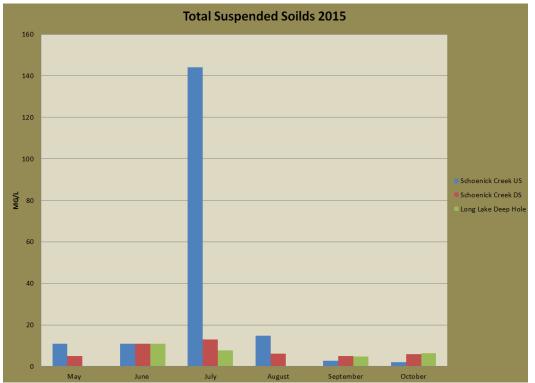
Figure 15. Total Suspended Solids results from growing season samples 2015.

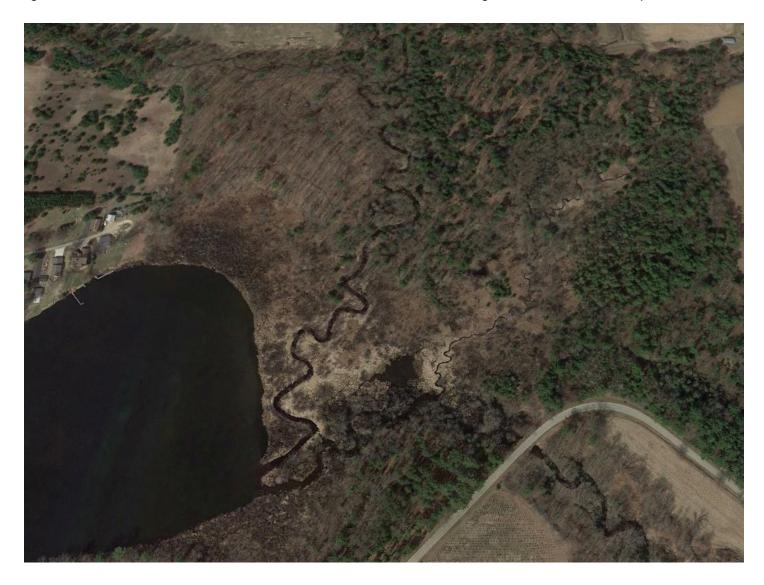
Figure 19. Leaf off Air Photo of Schoenick Creek inlet and outlet of Long Lake and wetland complex.

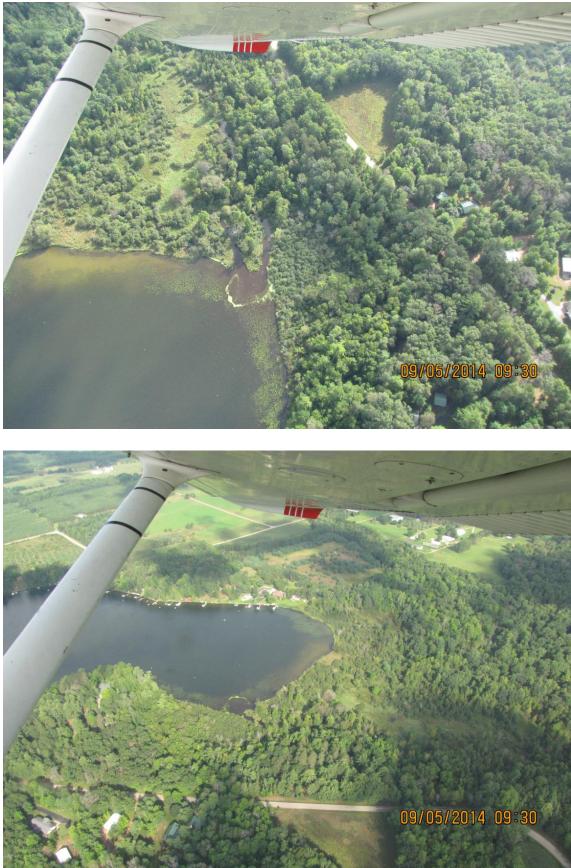
# Figure 20. Flyover storm event photo(s) 9/5/2014

Aerial flyovers were conducted twice following large summer rainfall events to determine watershed influences on lake and stream interactions at the confluence location. Direct observation was desired to discern if noticeable sedimentation plums enter the lake following large rainfall events and how these plums may spread throughout the lake. 
 Table 1. Schoenick Creek and Long Lake Tributary Sampling Sites- 2014, 2015.
