# Little Butternut Lake

## Lake Management Plan, 2022-2032

Polk County Land and Water Resources Department

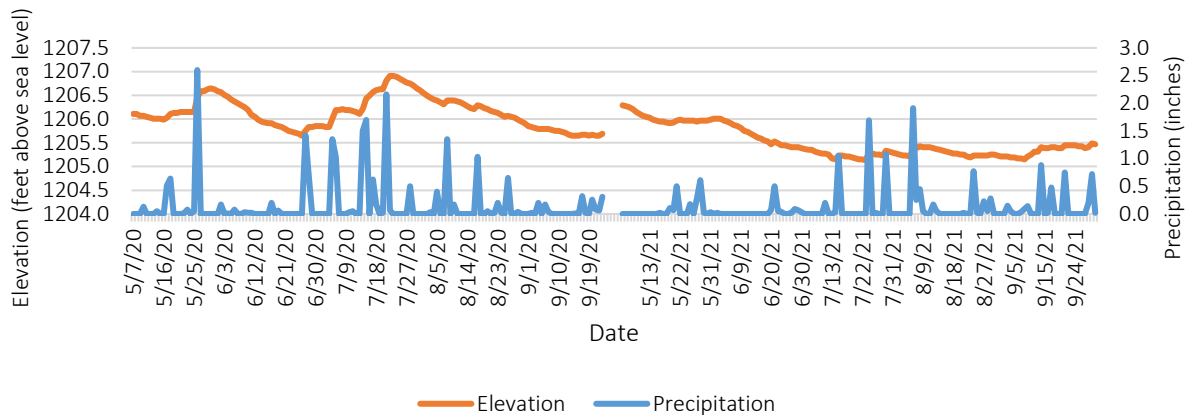
Little Butternut Lake Level and Precipitation, 2020 and 2021

Wisconsin State Climatology Office data indicate that 2020 began as a period of very moist and unusually moist conditions and ended as near normal. As 2021 progressed, conditions moved from near normal to moderate and severe drought.

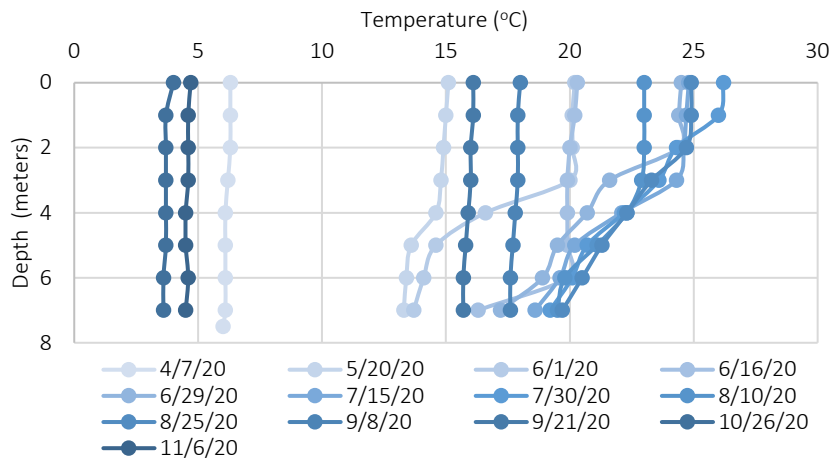
Little Butternut Lake Temperature, 2020

Surface Temperature on Little Butternut Lake (°C)	
4/7/20	6.3
5/20/20	15.1
6/1/20	20.2
6/16/20	20.3
6/29/20	24.5
7/15/20	24.8
7/30/20	26.2
8/10/20	23.0
8/25/20	24.9
9/8/20	18.0
9/21/20	16.1
10/26/20	4.0
11/6/20	4.7
4/5/21	8.4
5/3/21	12.7
5/17/21	17.3
6/1/21	18.5
6/21/21	22.1
7/7/21	23.7
7/19/21	26.5
8/2/21	24.8
8/16/21	23.3
8/30/21	23.4
9/13/21	20.2
10/27/21	9.3

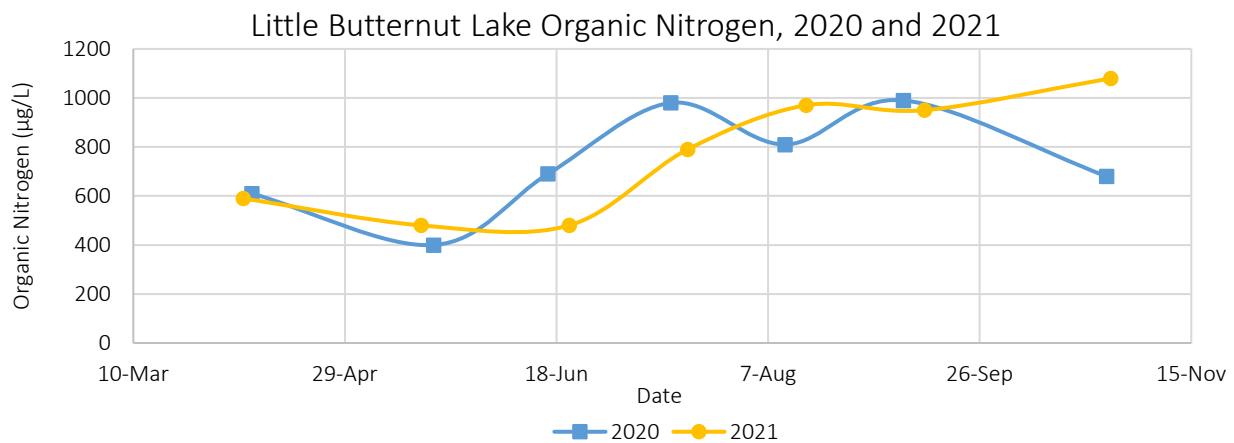
Organic nitrogen was greatest in September in 2020 and greatest in October in 2021.

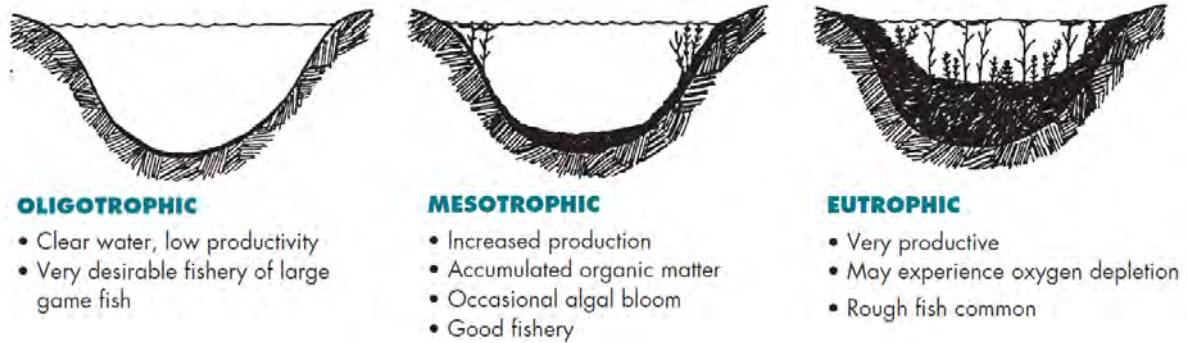
9

A common method of determining a lake's trophic state is to compare total phosphorus (important for algae growth), chlorophyll a (an indicator of the amount of algae present), and secchi disk readings (an indicator of water clarity). Although many factors influence these relationships, the link between total phosphorus, chlorophyll a, and secchi disk readings is the basis of comparison for the trophic state index (TSI).

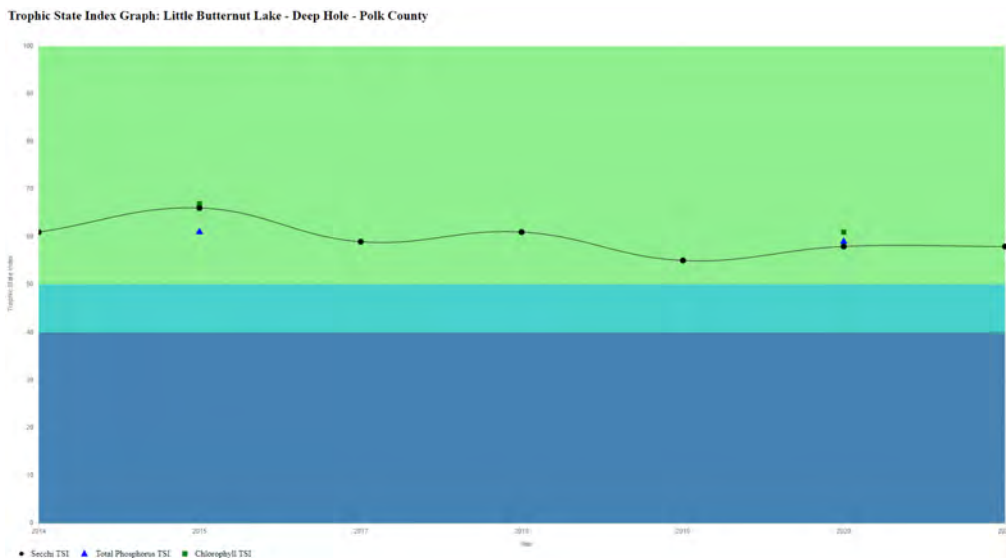
Monitoring the trophic state index of a lake gives stakeholders a method to gauge lake productivity over time. TSI data exists for Little Butternut Lake for secchi depth for 2014-2015, 2017-2021 and for total phosphorus and chlorophyll for 2015, 2020, and 2021. The historic data indicates that Little Butternut Lake is eutrophic.

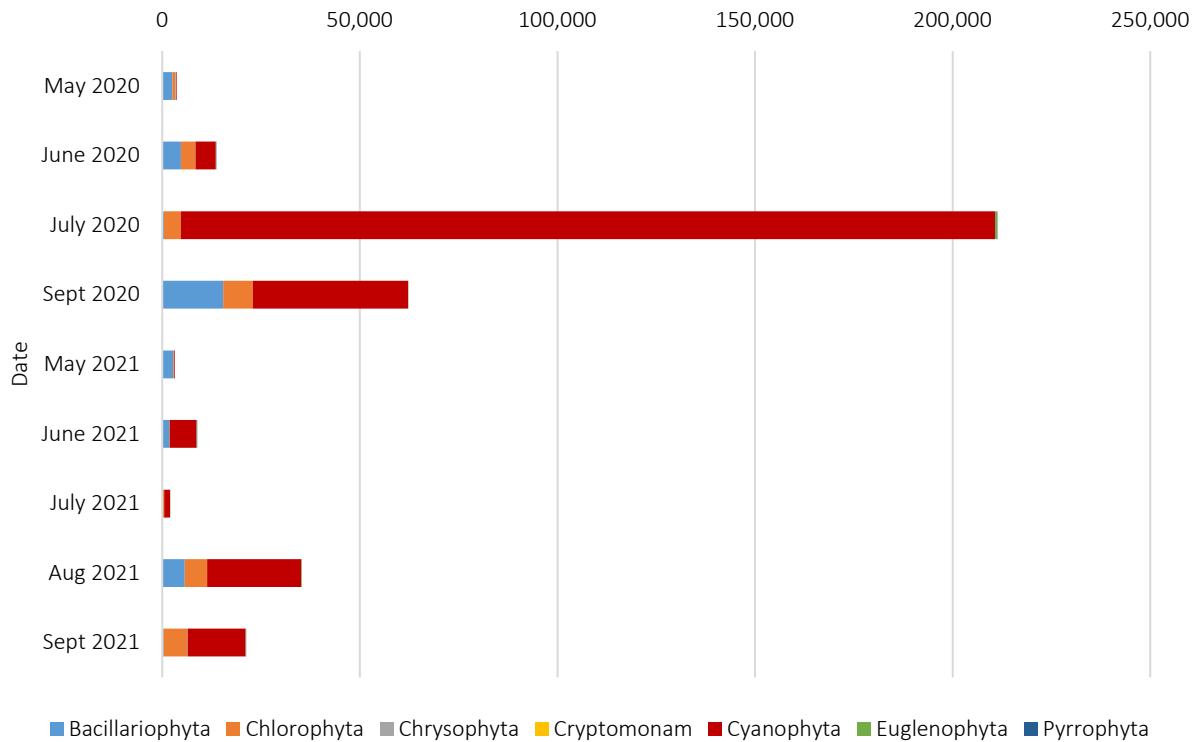
### Little Butternut Lake Algae, 2020 and 2021

The algae data for Little Butternut Lake suggests that the lake is mesotrophic but that it may not take much to change the character of the lake to a less desirable eutrophic state or, through careful management of nutrients, to a lake that experiences fewer algal blooms.

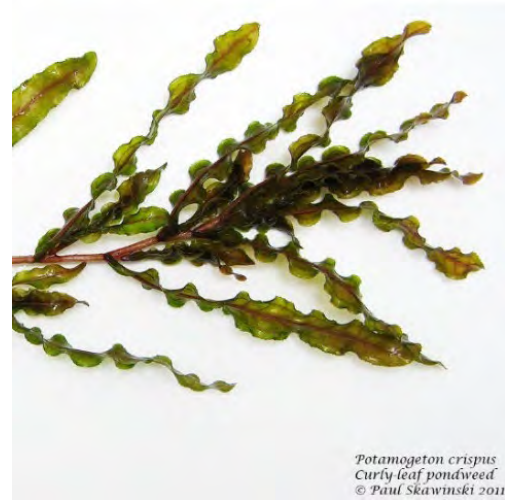
**Curly Leaf Pondweed** is a submerged aquatic invasive plant. The leaves of curly leaf pondweed are easily distinguished by their rounded tip, prominent mid-vein, and finely toothed edges. In most growing conditions, the leaves appear wavy.

Curly leaf pondweed is found in a wide variety of habitats, although it prefers alkaline and high nutrient waterbodies and typically grows in less than 3 meters of water.

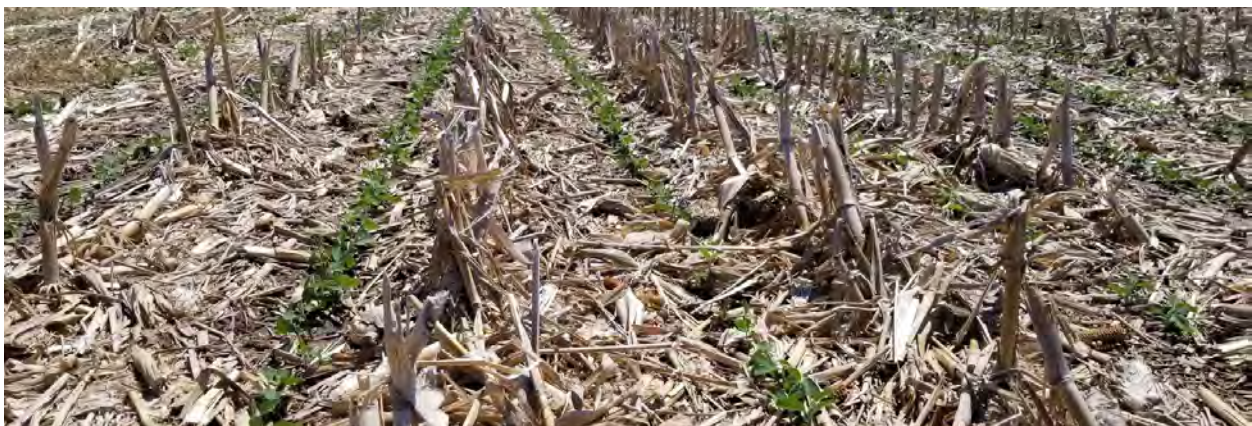
No-till planting is a conservation practice where crops are grown without the use of tillage. Soil tillage is a common agricultural practice used to loosen soil, incorporate crop residue and plant nutrients (fertilizer and manure), and prepare a suitable seed bed for planting the crop. Tillage also increases the potential of soil erosion and nutrient runoff. Tillage breaks soil structure, inhibits the process of soil aggregation, and reduces surface crop residue. Soil is left exposed and more susceptible to the erosive forces of wind and water. Soil erosion from agricultural landscapes can be a major source of sediment and nutrients in lakes and rivers causing decreased water quality. The adoption of no-till planting reduces the potential for soil erosion and nutrient loss, thus minimizing agriculture's impact on water quality.

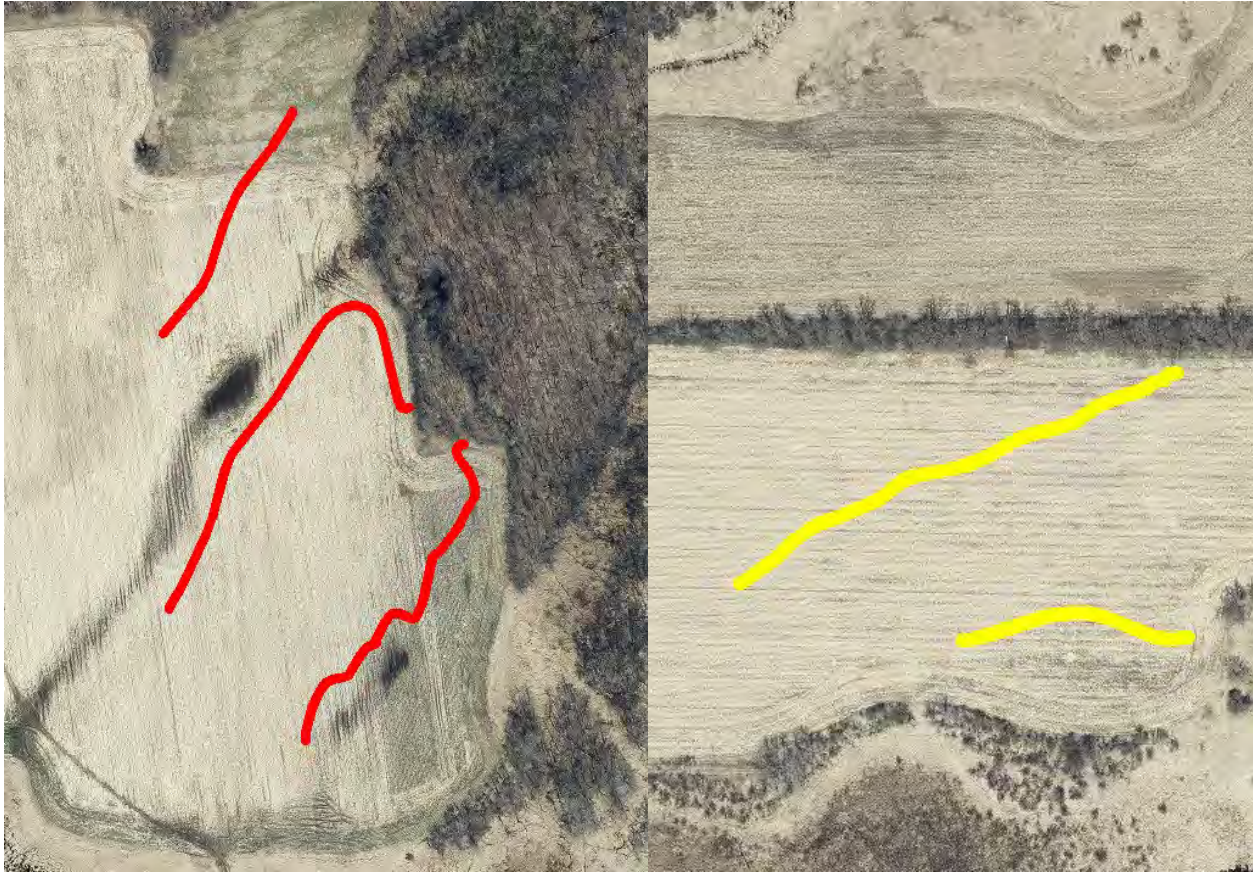
In the Little Butternut Lake Watershed 38 contour buffer strips were identified and categorized based on runoff risk potential: 3 high priority (red), 8 moderate priority (yellow), and 27 low priority (green). In the examples below, some fields have multiple

contour buffer strip locations identified. Although each buffer might be identified as low priority, if all the buffers were installed, runoff would be greatly reduced in a single field.
