SUBJECT: Grand Geneva Resort & Spa, Wetland channel (SWIMS Station 10058272) to Como Creek (WBIC 757600), Walworth County

Overview of issue

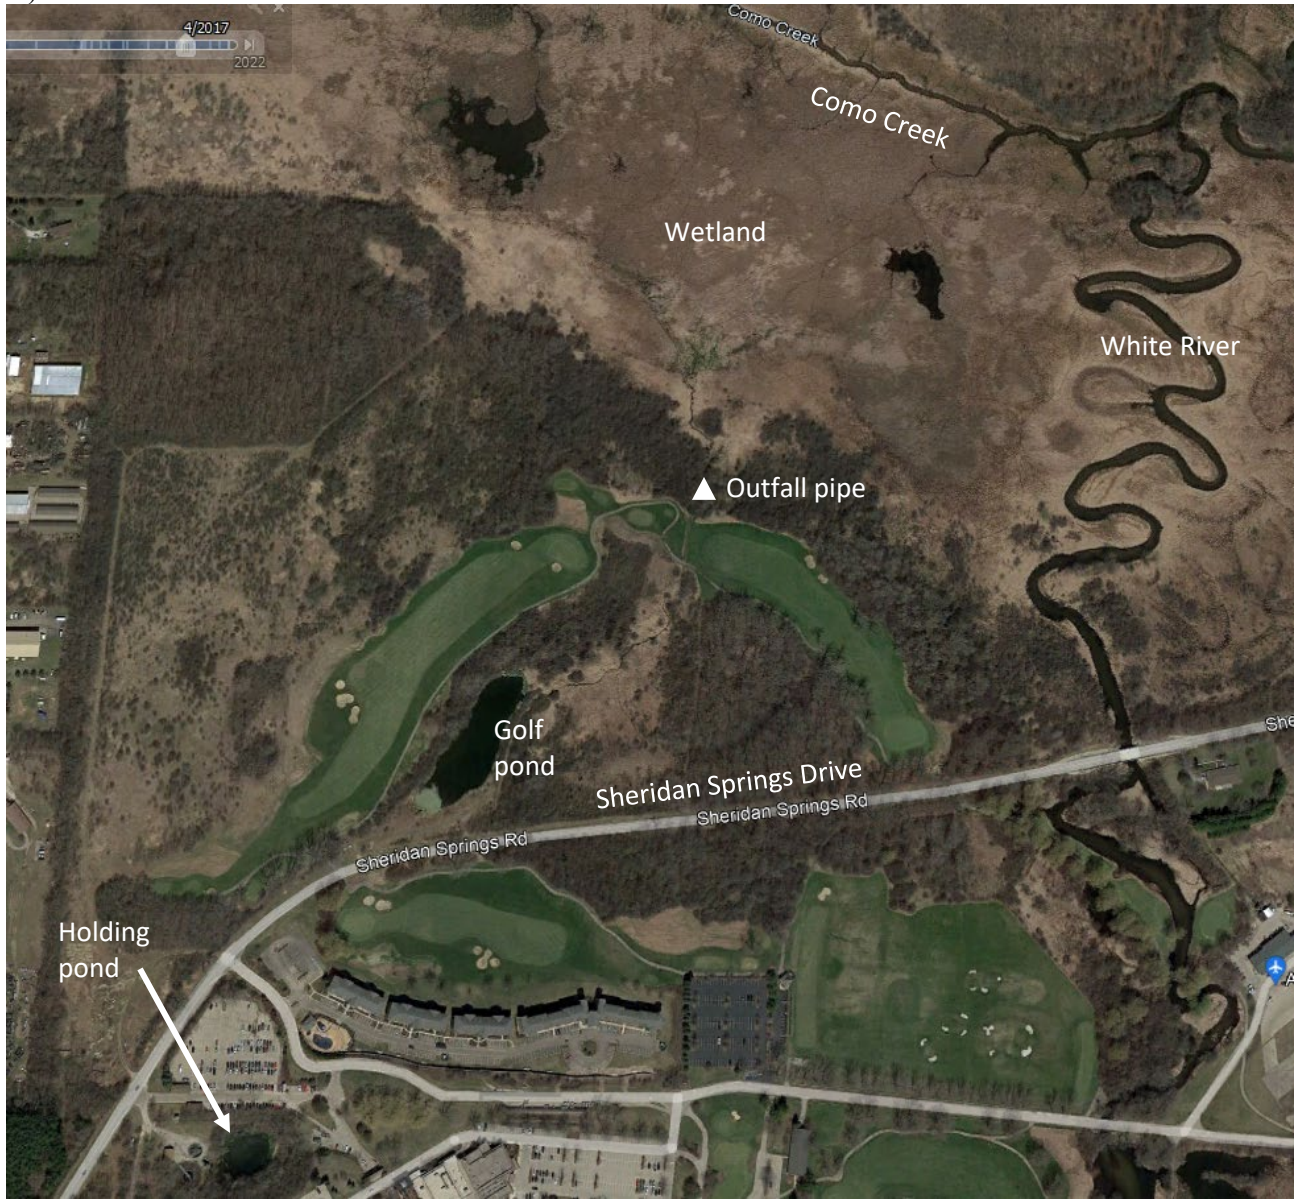
Map 1. Aerial photo (Google Earth) showing overview of area and receiving waters. (Closer view in Map 2.)

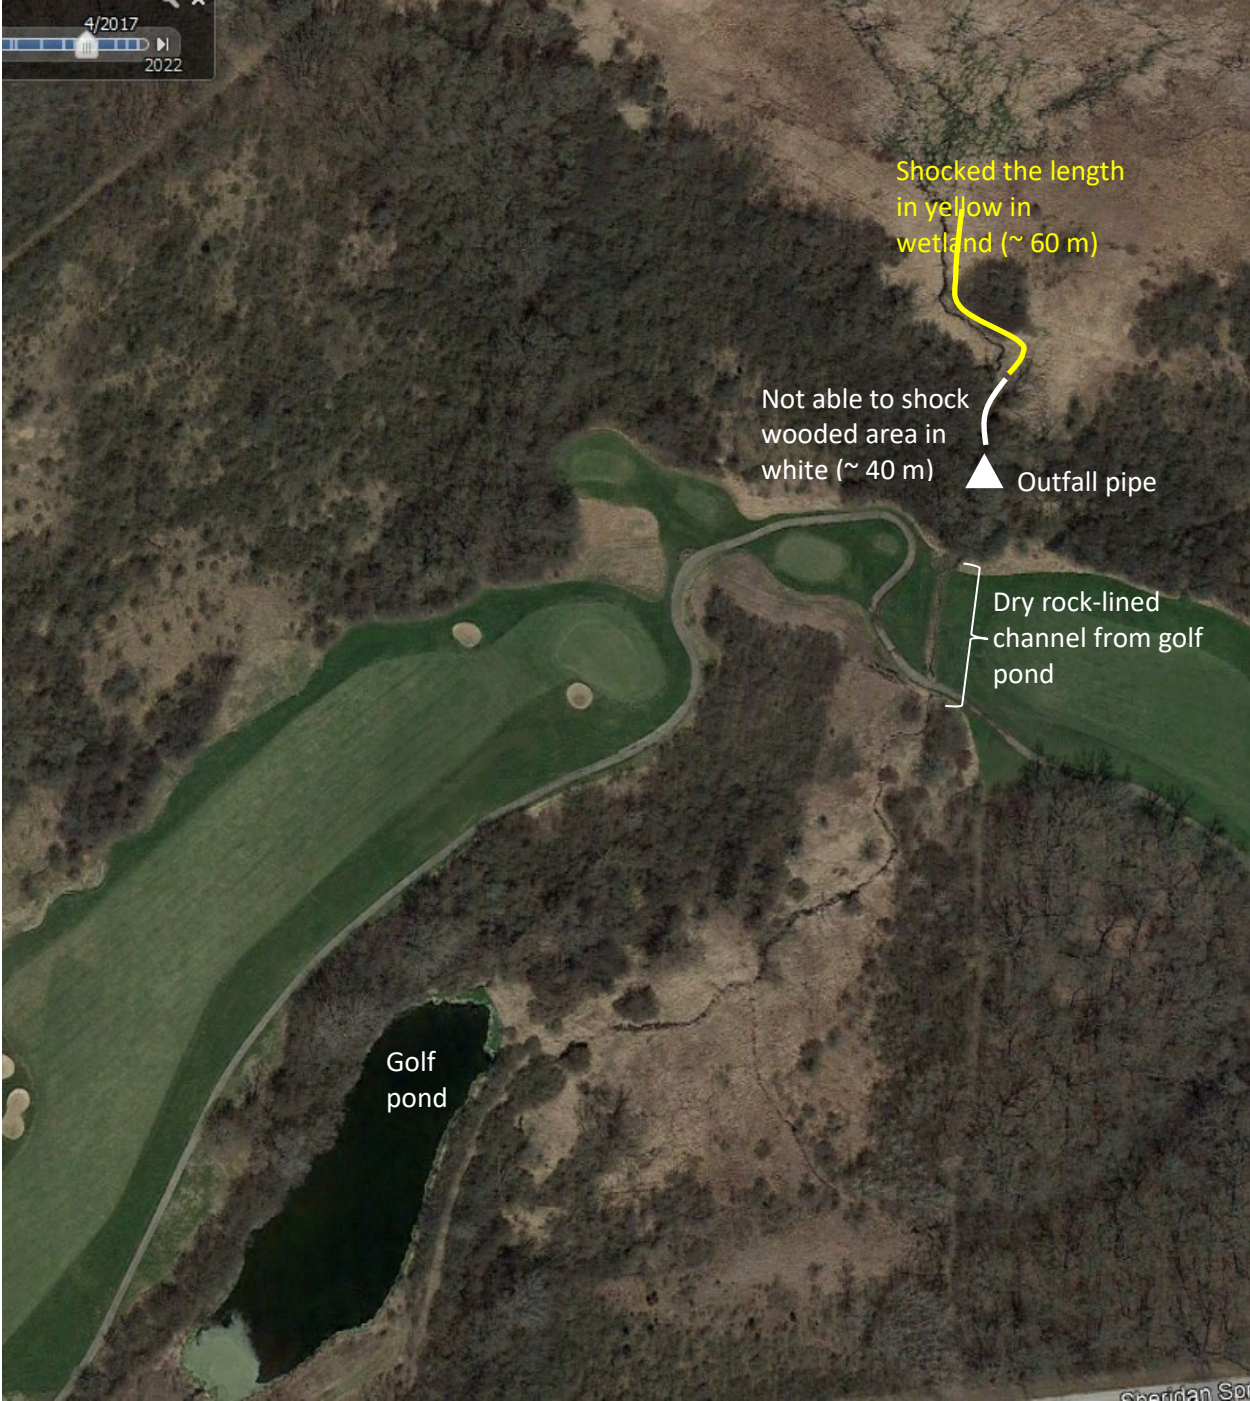
Map 2. Aerial photo (Google Earth) showing closer view of flow path and which stretch was shocked for fish.

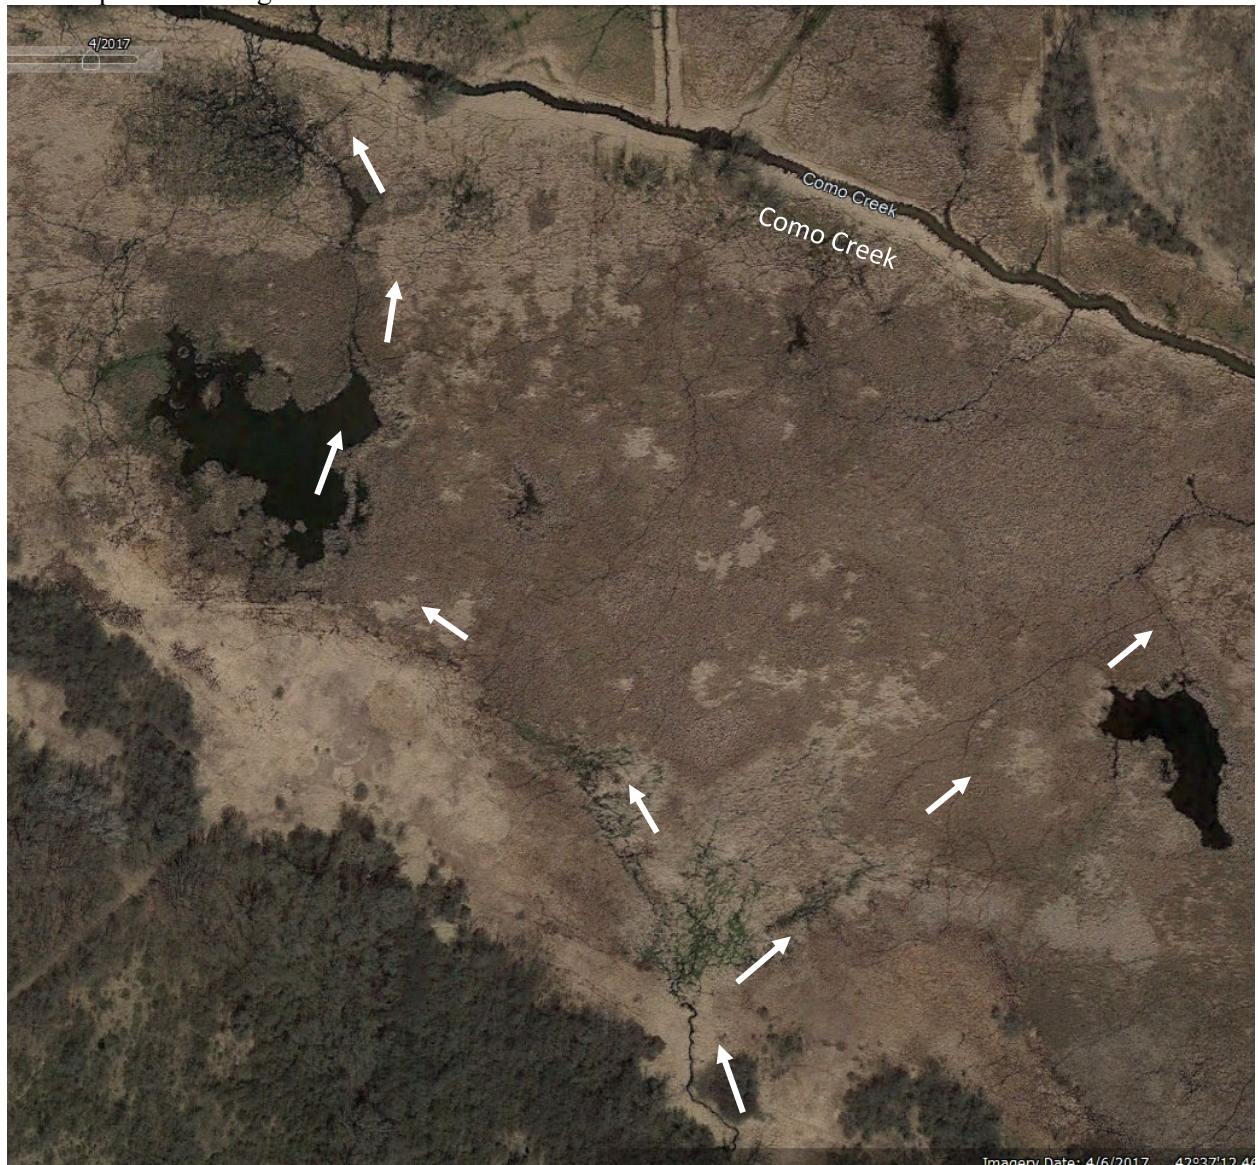
Map 3. Two possible flow paths to Como Creek. Channels through the wetland are evident in aerial photos, indicating connectivity of flow. Path to the left is ~.4 mi; path to the right is ~.25 mi. Google Earth April 2017 image.

- Channels through the wetland are evident on the aerial maps, and although they may become diffuse through portions of the wetland corridor, the effluent most likely reaches Como Creek due to the short distance to Como Creek. Therefore, permit limits based on downstream protection are recommended.

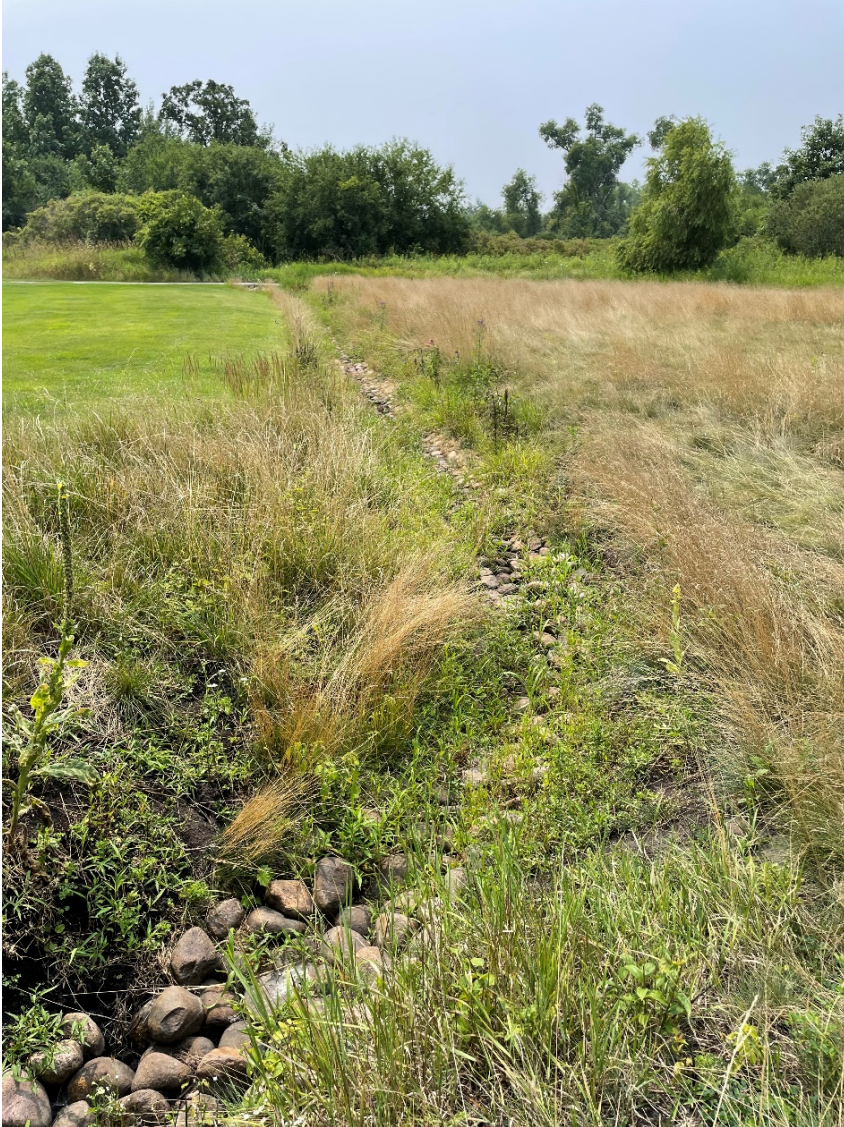
Photo 1. Upstream of the outfall (looking south) is a dry, rock-lined overflow channel from a golf pond across the golf course, to the area where the outfall is located.

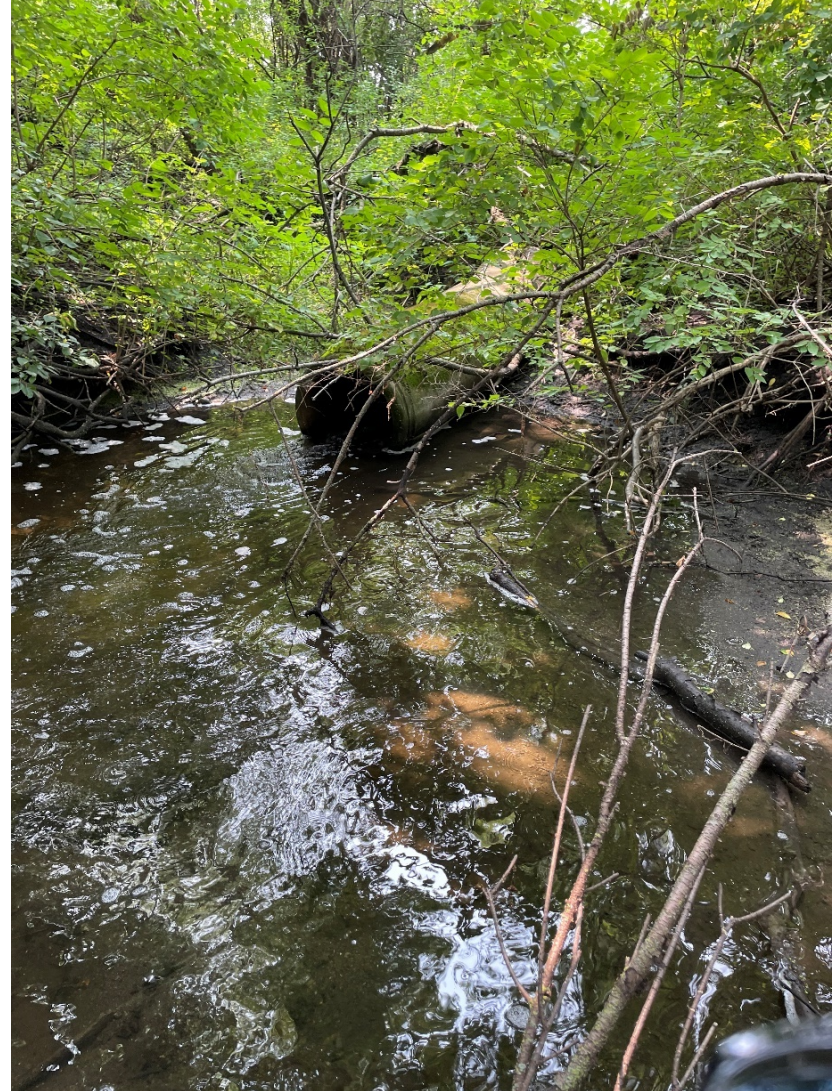
Photo 2. The outfall pipe is in a small wooded area adjacent to the golf course area shown in Photo 1. Stream was widest here (10 ft wide, 1 ft deep) and a few fish were observed by the outfall but we were not able to shock this area due to equipment failure.

- **Segment 1: Channel from outfall to larger wetland**
 - Segment 1 originates at the outfall and travels north through a short wooded stretch (~40 meters). The outfall has created a small plunge pool approximately 10 foot at it widest and approximately 1 foot in depth. Three small fish (did not identify species) were seen in this pool area. The water flows north through the wooded area meandering in an approximately 4-foot-wide channel with an average 3-4 inches of water depth. Substrate in the channel consisted of mostly soft sediments and sand.
 - Downstream of the outfall approximately 40 meters, the channel enters into a wetland area that the channel meanders through. The channel transitions quickly from sand and small gravel substrate at the beginning of the wetland area to being dominated by soft sediments.

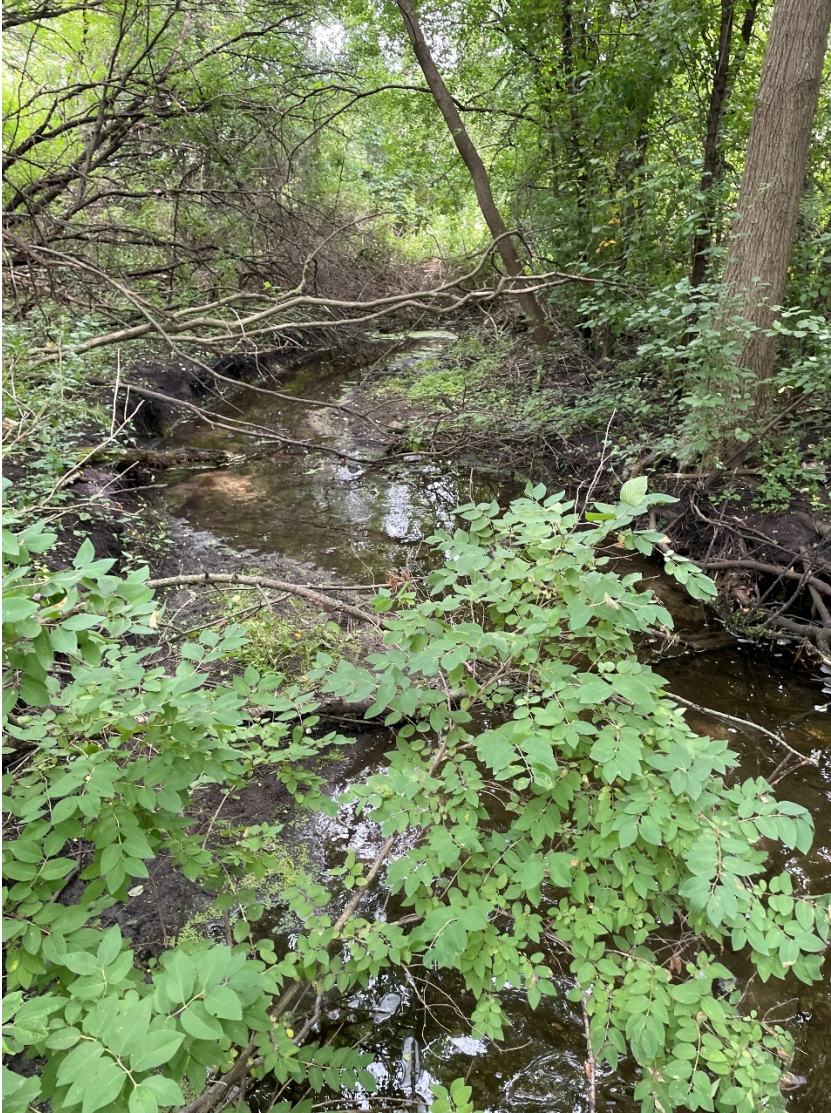
Photo 3. Runs through a wooded thicket for a short distance (~40 meters).

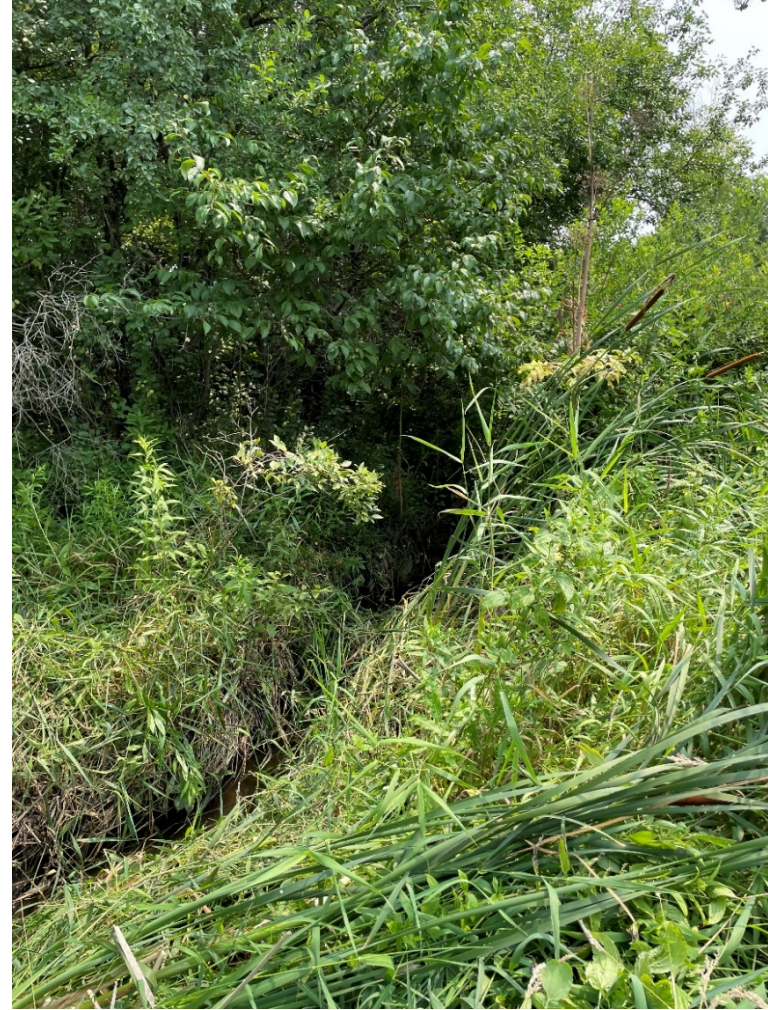
Photo 4. Channel emerges from wooded area into open wetland area with tall vegetation. Channel becomes very narrow (on average channel was 2.5 ft wide by 1 foot deep with approx. 5 inches of soft sediment on bottom of the channel). No fish found in wetland area.

The channel ranges from 1.5 foot to 2.5 foot wide in the wetland area for the 60 additional meters of channel accessed during the survey. On average the water was 1 foot in depth with an average of 5 inches of soft sediment on the bottom. The channel was overgrown with vegetation (reed canary, cattails, nettles, sedges and other wetland plant species) that had to be swept to the side to complete the fish survey. One snapping turtle was found at the start of the survey station in the wetland; it was buried in the soft sediments of the channel. Angelica was also observed which is typically found in areas of groundwater discharge.

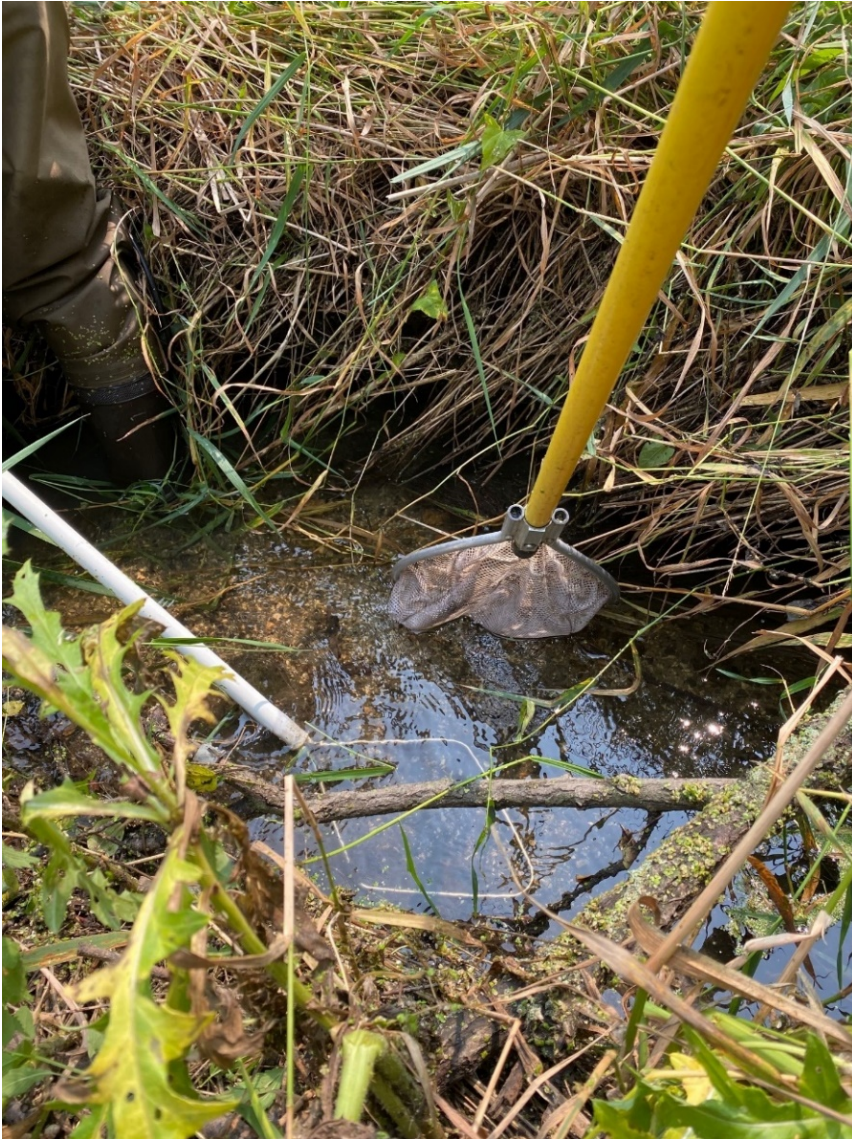
Photo5. Channel just after entering the wetland area, has some sand/gravel bottom here for a short stretch. Large amounts of duckweed encountered here as well.

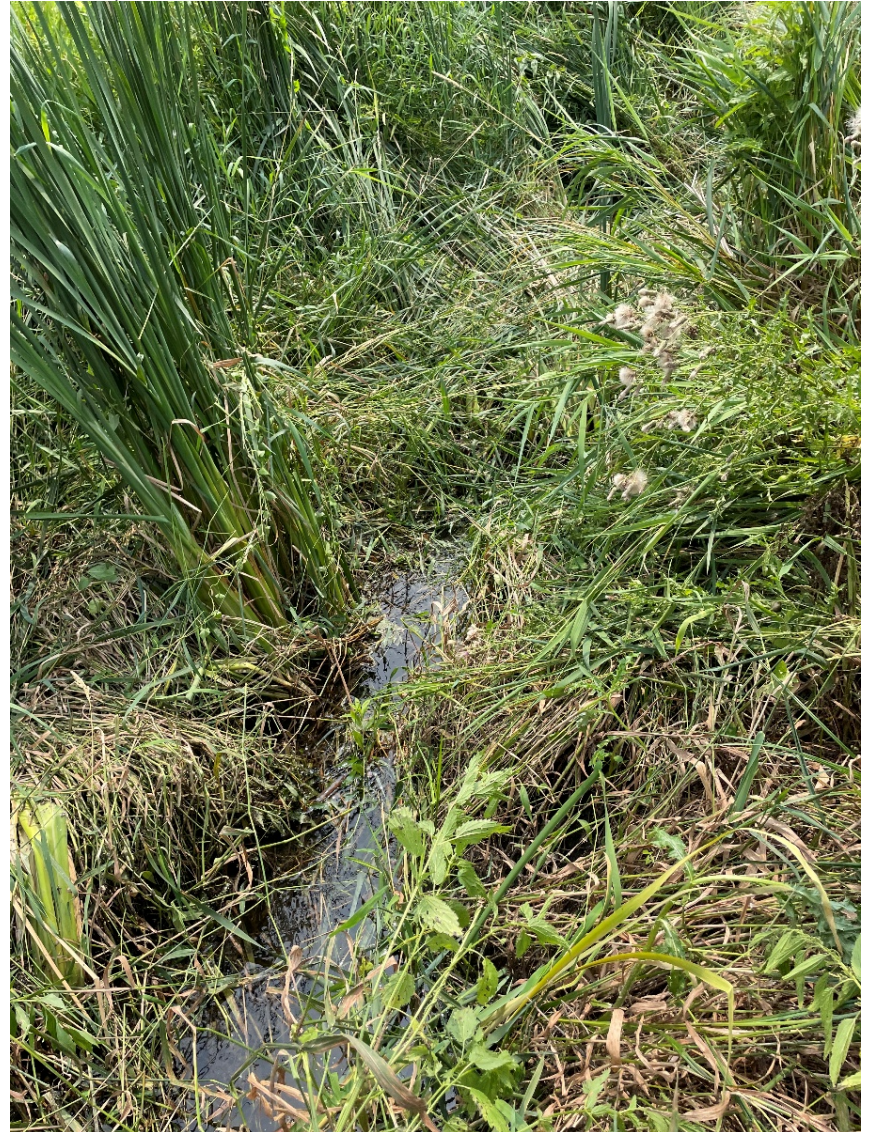
Photo 6. Channel through the wetland was covered by vegetation and difficult to find. Mucky bottom. (Here, vegetation has been trampled down to access it.)

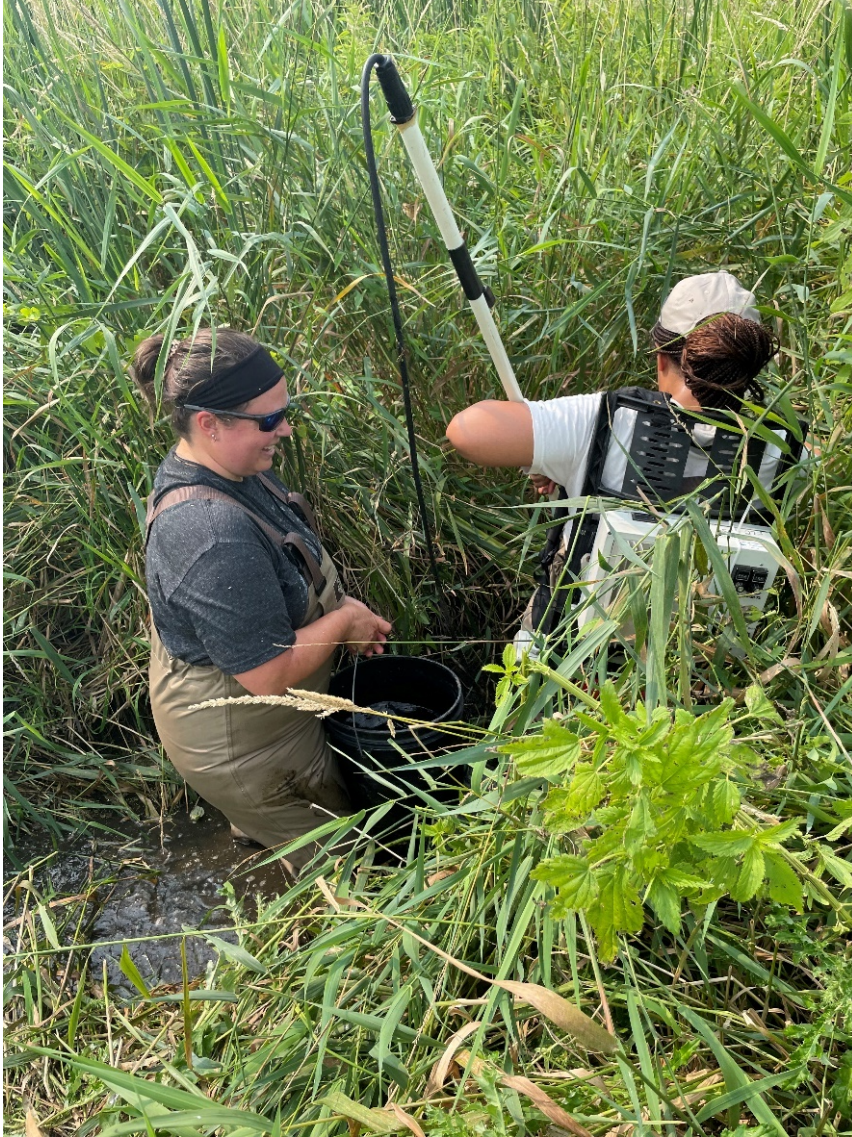
Photo 7. Channel in wetland was about 1-1.5 ft deep. One snapping turtle was encountered.

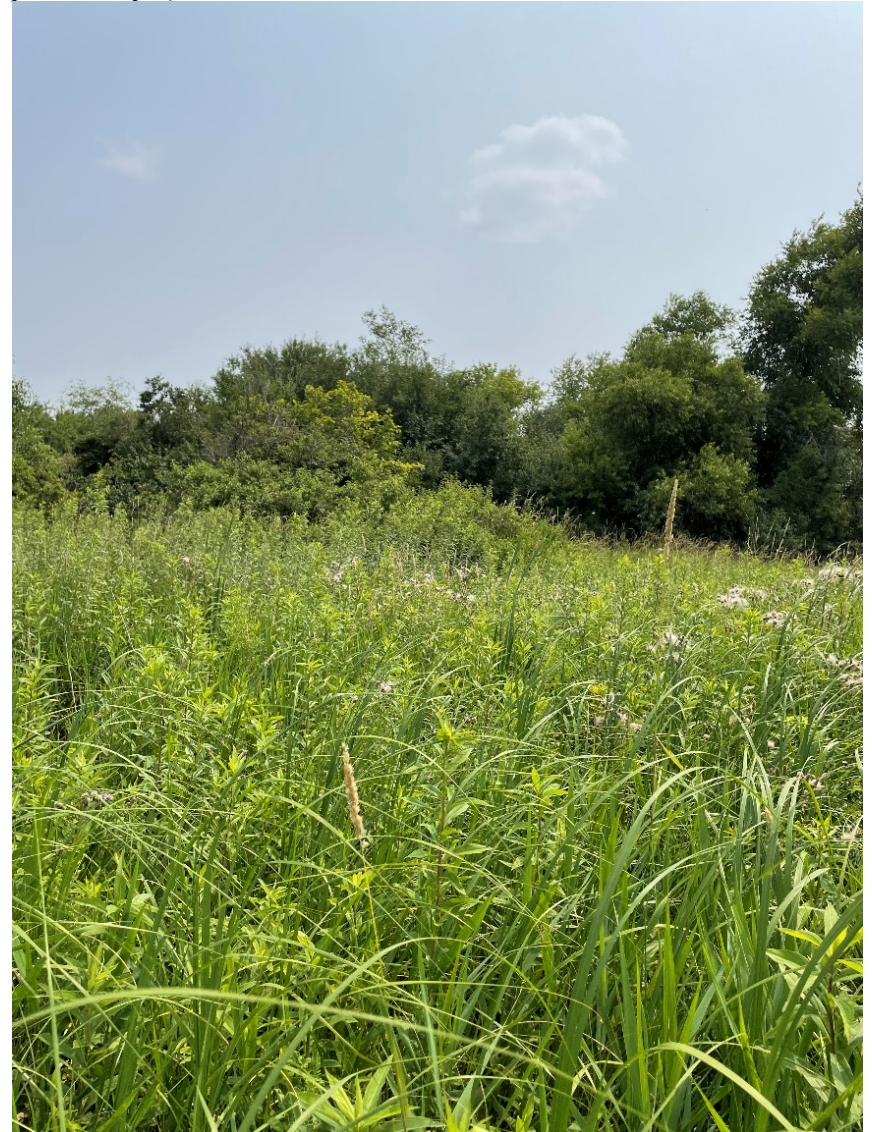
Photo 8. View of wetland, which is very large and continues beyond the stand of trees. Don't know whether/how far channel extends (but see aerial photo, Map 3).
