SUBJECT: Village of Gilman, Wetland Tributary (no WBIC) to Yellow River, Taylor County

### Overview of issue

**Site overview maps**

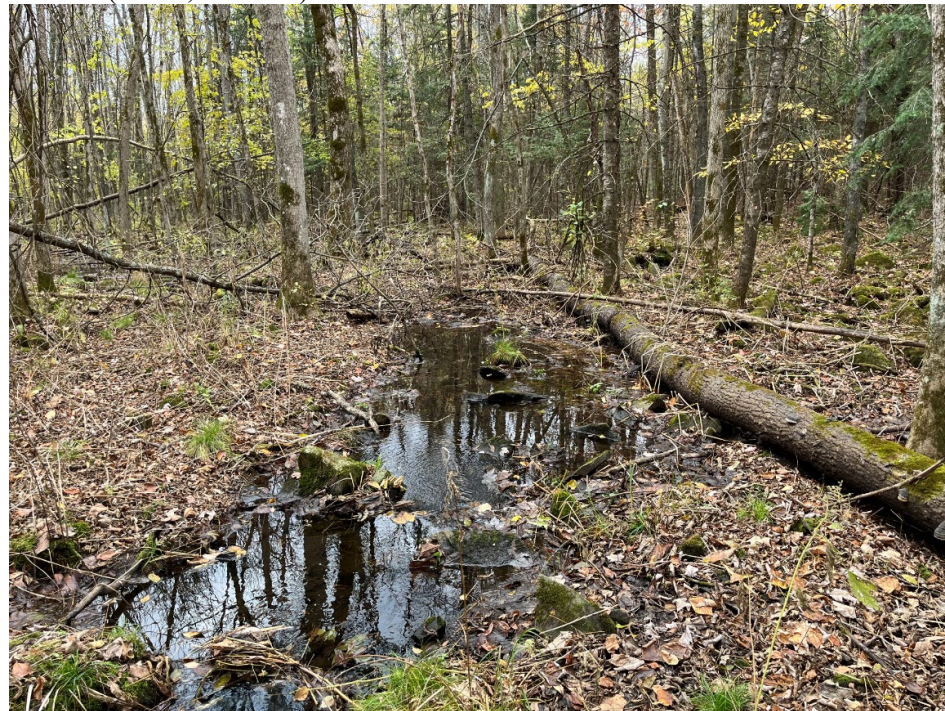
Photo 4 (Kleist, 10-2023). Stream in the forested wetland.

- The channel was not ditched; it meandered gently through the wetland. It was approximately 3 to 4 feet wide and had depths up to 1 foot. Channel bottom was soft and mucky, typical of a wetland stream. Woody cover was the main habitat type for aquatic life.

- A standard backpack shocker was used to look for fish through the entire reach from the outfall channel to the Yellow River. The stream was shocked from upstream to downstream due to limited access, which is not a typical survey method (normally surveys proceed downstream to upstream), and the date of the site visit, October 18, 2023, was outside of the index period for an IBI or natural community evaluation. The intent of the site visit was to determine if fish were present in the channel. No fish were observed in the channel. It seemed unusual to have such a large and defined channel without fish being present (Photo 4).

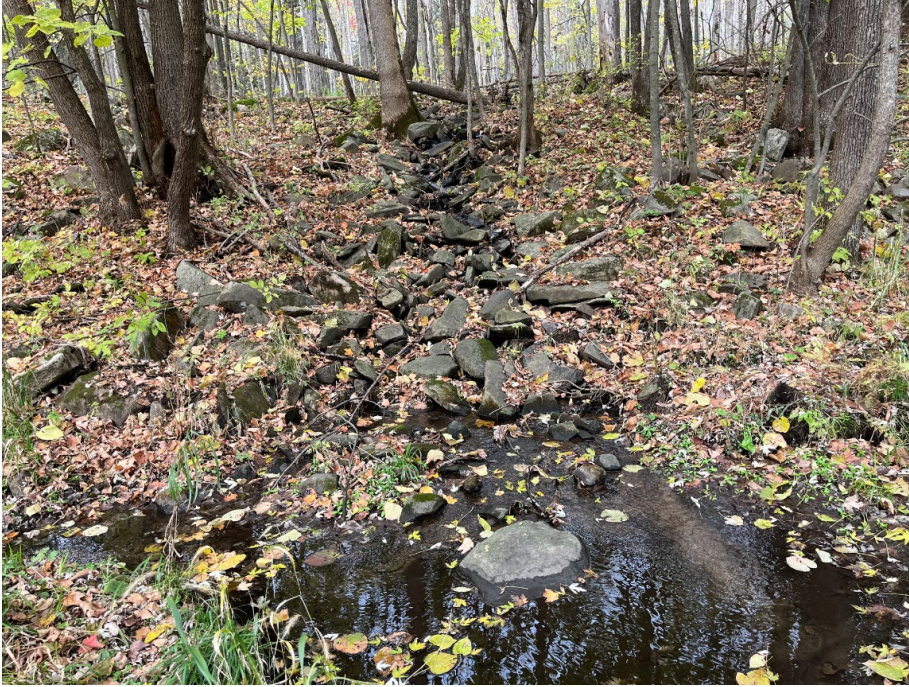
Photo 5 (Kleist, 10-2023). View from the bottom of the rocky channel looking upstream at the plunge pool and rocks. Plunge pool in foreground.

- Approaching the Yellow River, the channel disappeared from the surface and flowed through a cobble/boulder channel down a steep bank (Photo 5) before re-emerging to the surface into a plunge pool-like feature where it then continued about 20 or 30 feet to its confluence with the Yellow River (Photos 6-8). The current channel condition must prohibit fish from navigating the steep rocky channel on the bank lip and colonizing the stream channel. A review of the floodplain maps shows the area is outside the 100-year floodplain. While it's difficult to interpret from the map panels it's likely the floodplain ends near the contour line at the top of the stream bank (see inset USGS Topo map in Figure 2). A flood event greater than the 100 year event may overtop the stream bank and fish could then navigate upstream into the channel. However, they have not been able to establish or maintain a population or one would have been observed during the October site visit.

The entire distance from the point of the WWTP discharge to the Yellow River was surveyed and no fish were observed in the stream channel upstream of the plunge pool near the Yellow River, as previously described (Photo 5). Fish were observed in the short segment of stream between the plunge pool and the Yellow River. The topography prohibits fish from entering the stream (above the steep rocky slope) except during large flood events, and this portion of the stream does not currently support a fish population. The infrequent ability for fish to access the stream from the Yellow River and low flows or low oxygen levels typical of wetland stream likely keeps a fish population from being established. Currently the stream should be classed as a macroinvertebrate stream and LAL. If the channel dimensions were to change and the rocky channel eliminated to allow fish passage from the Yellow River, a new assessment should be conducted, and the reach should be reevaluated.

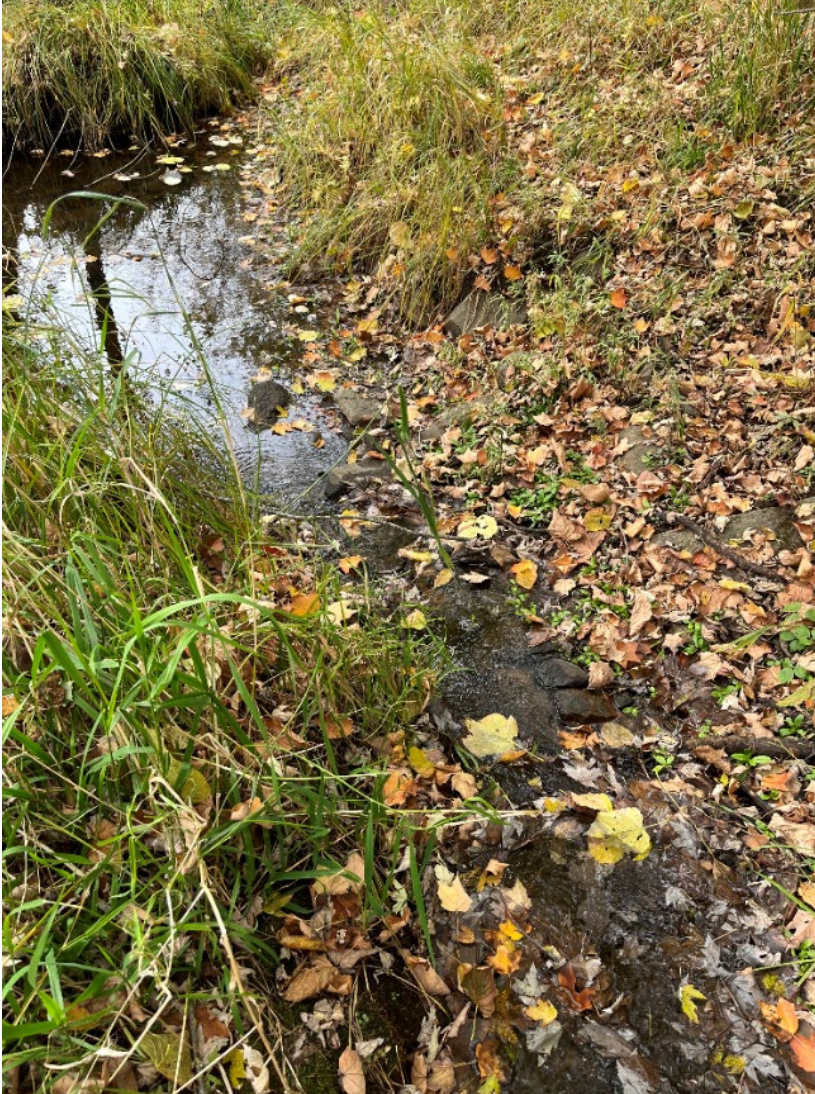
Photo 7. Looking downstream mid-channel toward Yellow River.

- The 20 or 30 foot segment of channel from the base of the steep rocky channel to the Yellow River did have a minnow population present in October of 2023. A couple creek chubs were observed in that segment of channel. Any fish species present in the Yellow River could potentially navigate that small reach of channel.

Photos 7-8 (Kleist, 10-2023). Confluence with Yellow River. The connection with the Yellow River at this point allows fish to move upstream to use this small stretch of stream (~20-30 ft) to plunge pool in photos 5 and 6.
