Long Lake Shoreland & Shallows Habitat Survey Report

Supported by:
Wisconsin Department of Natural Resources
Surface Water Planning Grant #LPL184223

Introduction

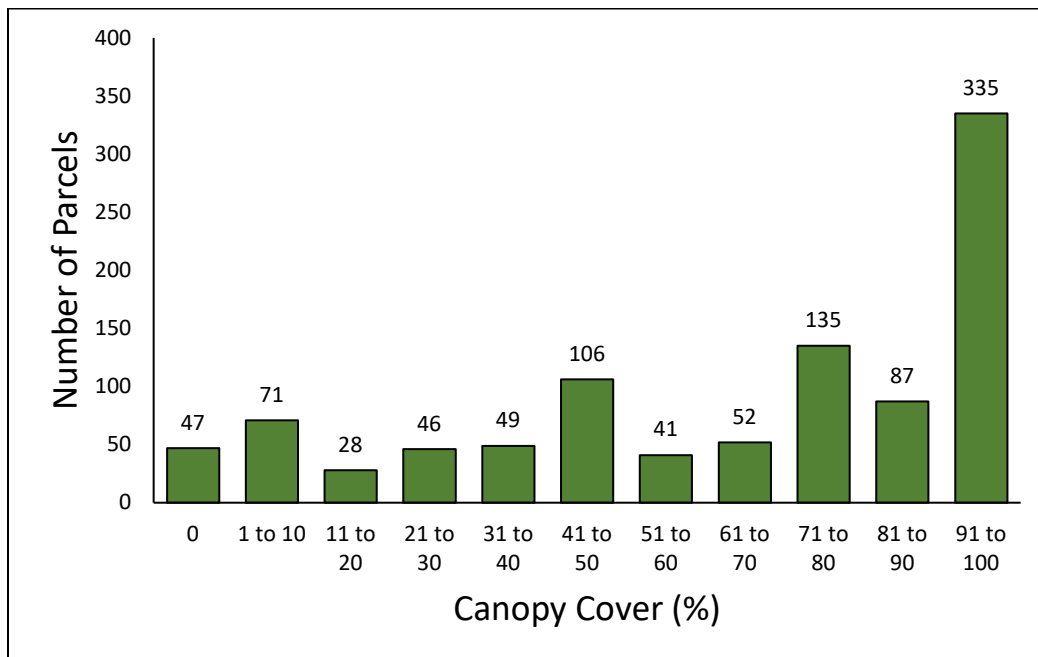
Figure 1. Long Lake Riparian Canopy Cover

The average percent canopy cover was 67.1%, and the median percent canopy cover was 75.0%. Approximately 236 parcels were ‘natural’ with 100% canopy cover, 100% shrub and herbaceous cover, and no human structures. There were 335 parcels with over 90% canopy coverage (Figure 1). There were 650 parcels with greater than 50% canopy coverage and 347 with less than 50% canopy coverage (Figure 1). It is important to note that some parcels are only 50 feet of shoreline, and others may be 1,600 feet (Figure 2). The Tomahawk Scout Camp provides the majority of uninterrupted canopy coverage, as this property is largely undeveloped.

The current state of Long Lake’s riparian canopy coverage is good but could be improved, as there are some areas where canopy coverage is sparse. Restoring canopy coverage can take many years while vegetation grows. Thus, it is important to preserve the current canopy coverage as well as encouraging landowners to restore native vegetation growth.

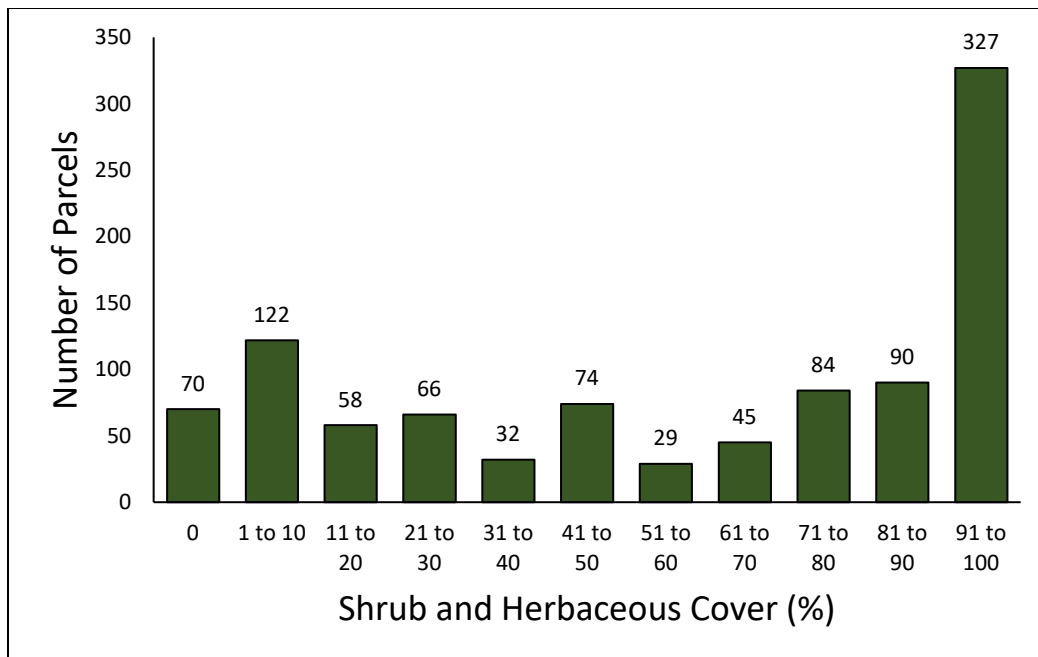
Figure 3. Long Lake Riparian Shrub and Herbaceous Cover

The average shrub and herbaceous cover for parcels was 60.9%, and the median percent canopy cover was 75.0%. There were 327 parcels with over 90% shrub and herbaceous coverage (Figure 3). There were 575 parcels with greater than 50% shrub and herbaceous coverage and 422 with less than 50% shrub and herbaceous coverage (Figure 3). There are areas where shrub and herbaceous coverage is naturally sparse under a dense canopy (Figure 4). However, even these areas may benefit from native plant restoration efforts.

The current state of Long Lake’s riparian shrub and herbaceous coverage is good but could be improved, as there are some areas where coverage is sparse or has been replaced with manicured lawn. Preserving the current shrub and herbaceous coverage as well as encouraging landowners to restore native vegetation growth should be a priority. There may be opportunities using the Healthy Lakes² grant program to facilitate native plantings.

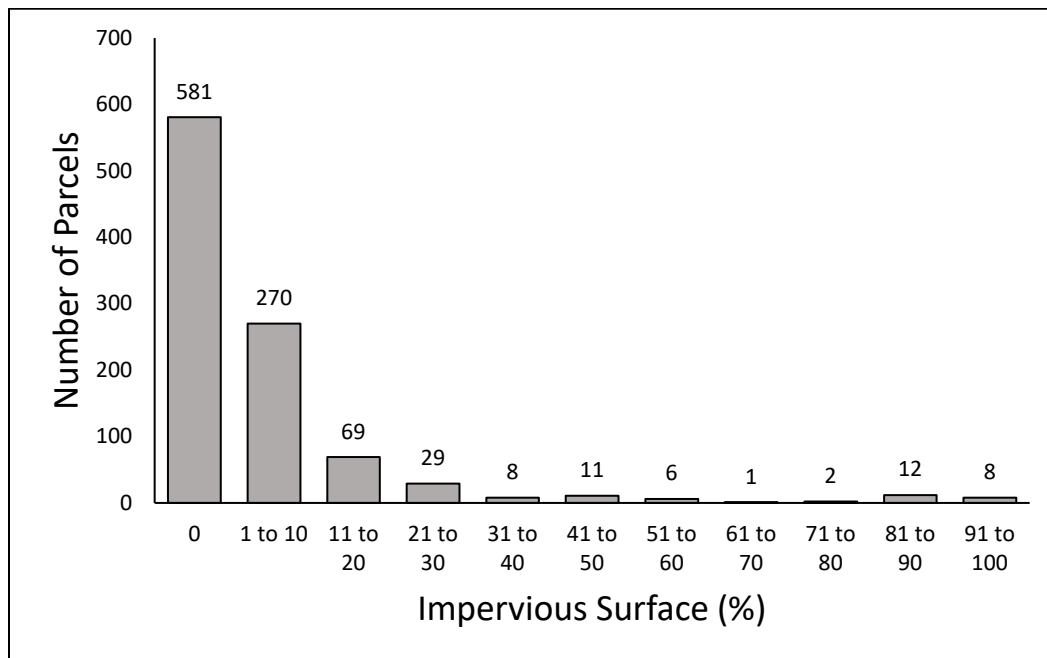
Figure 5. Long Lake Riparian Impervious Surface Cover

The average impervious surface cover for parcels was 7.4%, and the median percent canopy cover was 0.0%. There were 851 parcels with less than 10% impervious surface coverage and 146 parcels with more than 10% impervious surface cover (Figure 5).

While impervious surface cover in Long Lake's riparian area is relatively low, the cumulative impact over time may be detrimental to Long Lake's water quality, habitat, ecological integrity, and potentially property values³. There may be opportunities using the Healthy Lakes grant program to facilitate native plantings, rock infiltration systems, runoff diversions, and rain gardens to replace impervious surfaces.

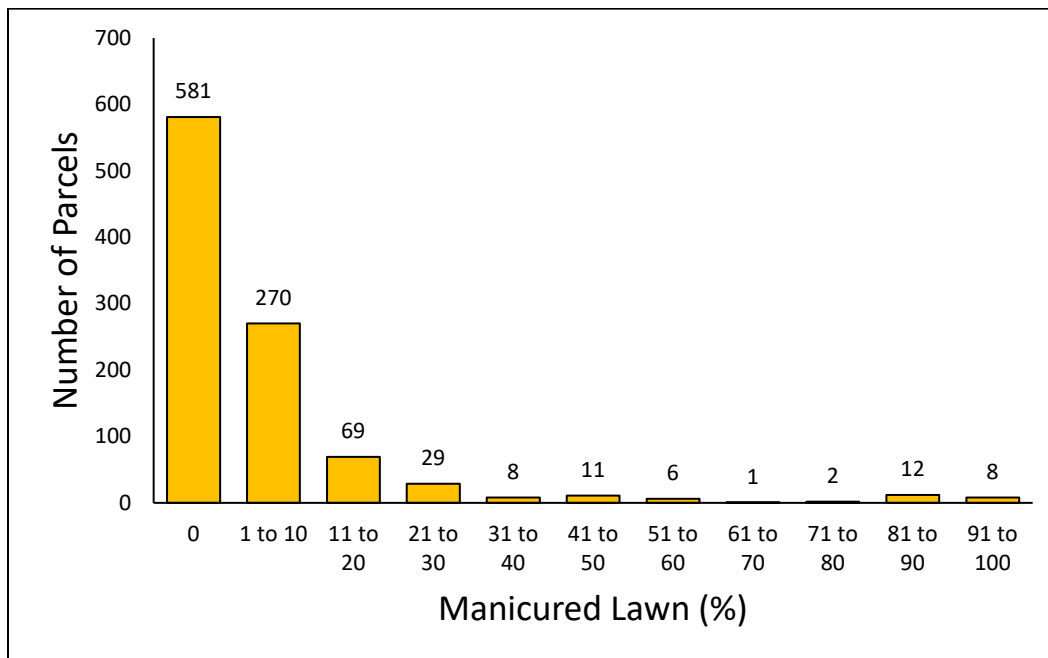
Figure 7. Long Lake Riparian Manicured Lawn Cover

The average impervious surface cover for parcels was 28.4%, and the median percent canopy cover was 0.0%. There were 554 parcels with less than 10% manicured lawn coverage and 442 parcels with more than 10% manicured lawn cover (Figure 7). Manicured lawn and shrub and herbaceous cover are inversely related – where there is more lawn, there is less native vegetation (Figure 8).

Manicured lawns around Long Lake are a great example of where the LLPA could leverage educational opportunities and the Healthy Lakes program to develop and foster a culture of stewardship-focused shoreline property owners. There may be opportunities using the Healthy Lakes grant program to facilitate native plantings, rock infiltration systems, runoff diversions, and rain gardens to replace the expanses of manicured lawn.

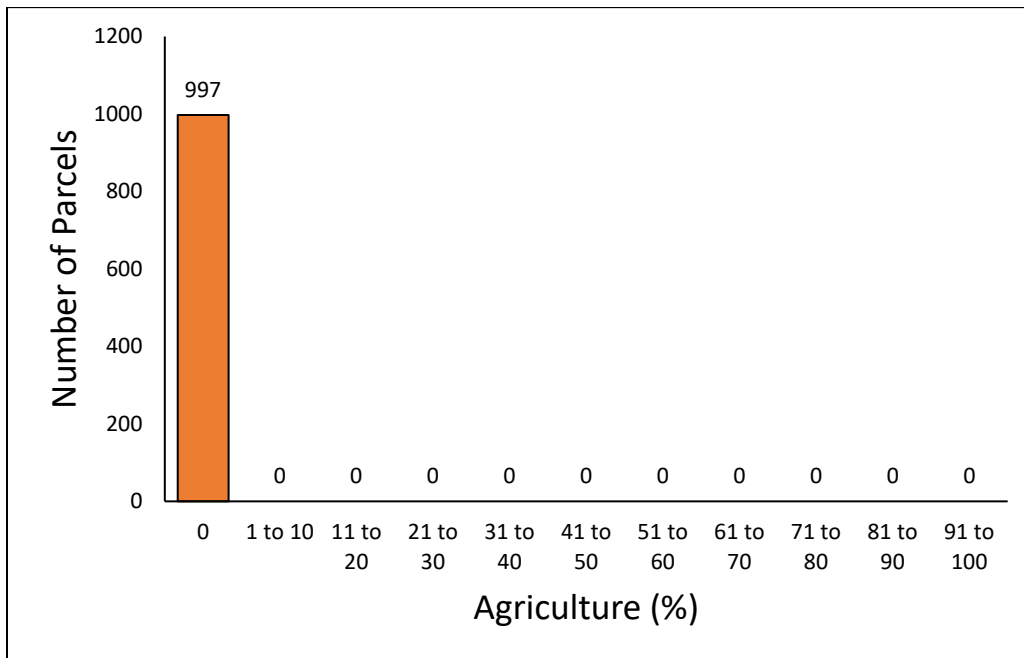
Figure 10. Long Lake Riparian Agriculture Cover

There were no parcels recorded with agriculture (Figure 10).

Protecting Long Lake's riparian area from agricultural use should continue to occur. There are approximately 5,100 acres of agriculture throughout the watershed (9.43%) that likely contribute up to 14.3% of Long Lake's total phosphorus load (phosphorus is often the nutrient responsible for algal blooms)⁵. As such, the LLPA should work to develop relationships with area farmers to foster a relationship that prioritizes protecting Long Lake.

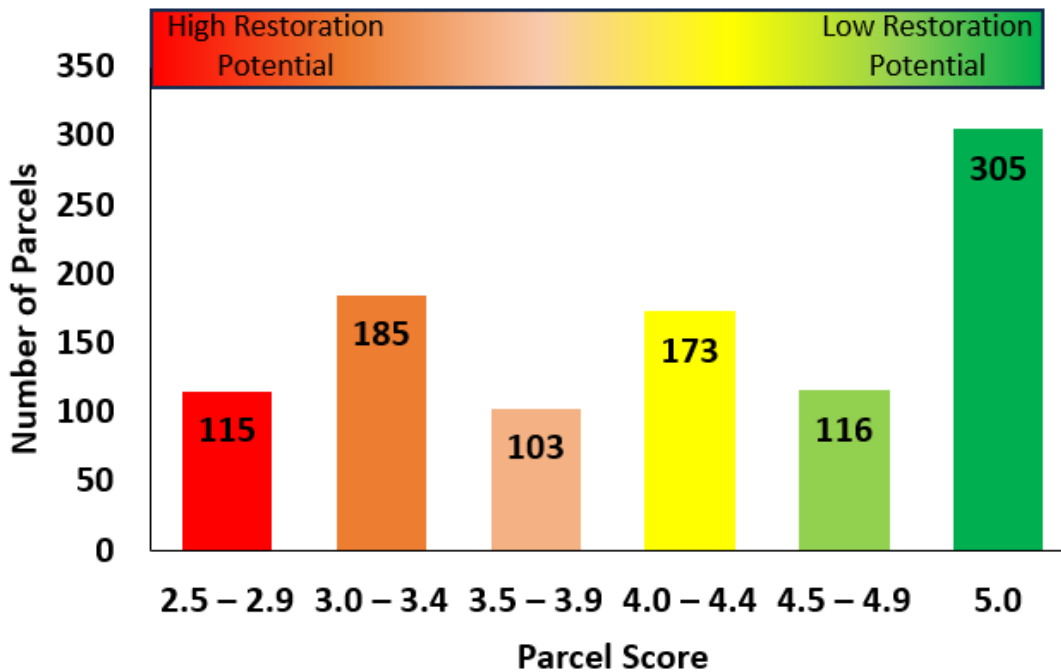
Figure 12. Long Lake Parcel Restoration Potential

Using riparian canopy cover and the percentages of herbaceous/shrub cover, impervious surfaces, manicured lawn, and agriculture as indicators of development, scores were assigned to parcels on a scale of 0-5 with 5 representing totally undeveloped shorelines and 0 representing worst case developed shorelines (Figure 12). No parcels scored below 2.5 based on these parameters. The survey showed that there are condensed areas where improvements could be made and areas where the shoreline should continue to be protected (Figure 13). These results should be combined with the results of the 2023 social survey to offer opportunities for shoreline restoration in high priority areas.

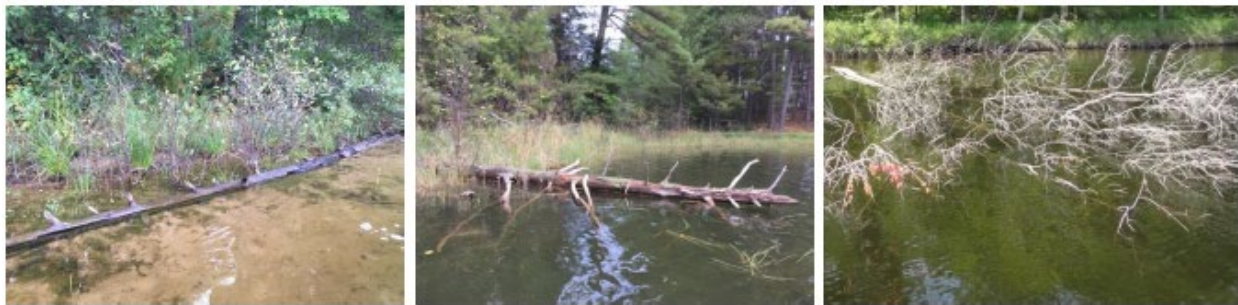
The LLPA solicited the assistance of the Mary Griggs Burke Center for Freshwater Innovation and the Tomahawk Boy Scout Camp to conduct the coarse woody habitat survey. The presence and characteristics of coarse woody habitat was documented around the shoreline of Long Lake following the Shoreland Habitat Monitoring Field Protocol. This protocol only enumerates “large wood,” defined as greater than 4 inches in diameter somewhere along its length and at least 5 feet long. Wood is counted that is between the high water level (HWL) and the 2 foot depth contour. Tree branches hanging over the water and live/dead wood standing vertically in the water and tree stumps with roots should be counted if they met the size criteria. Each piece of wood was marked using a GPS and given a series of scores. The wood was scored based on branchiness, whether or not it touches shore, and whether or not the wood was underwater.

On a lake with no development, there is an average of about 895 logs per mile of shoreline (about 1 log every 7 feet). On developed lakes, there is an average of about 92 logs per mile of shoreline (about 1 log every 63 feet). On Long Lake, there were 1,470 pieces of wood documented along the shoreline, for an average of about 138 logs per mile of shoreline (about 1 log every 38 feet). However, this distribution was not even around the lake. The Boy Scout Camp shoreline, bays, and natural areas contained the majority of the CWH, and some areas where there was likely additional CWH were difficult to access (Figure 14). Some areas of Boy Scout Camp shoreline did not have much CWH habitat, this is likely because the shoreline is high energy with lots of wind and wave action as well as a steeply sloping lake bottom (Figure 14).
