## Lower Nemahbin Starry Stonewort Dash Removal- 2024

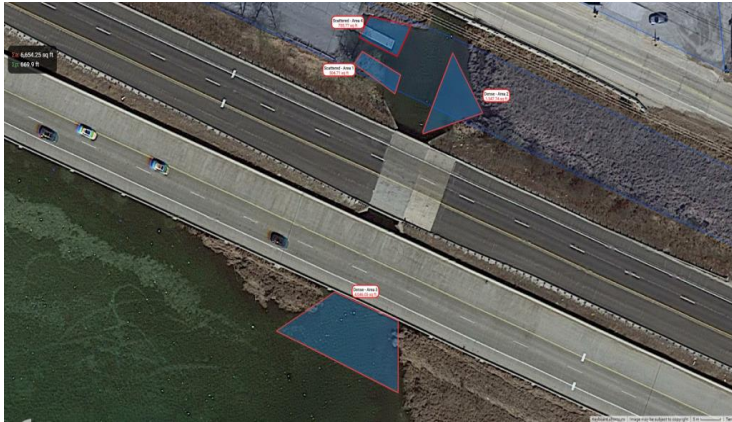
7/8/24 Treatment- Eco targeted all four zones on the map, spending more time in zones 2 & 3. Areas 2 & 3 were more heavily covered with SS, where areas 1 & 4 had a heavier growth of Chara. Ongoing manual efforts are managing sporadic plant outbreaks with focus on the SS saturated areas specifically. Starry Stonewort remains the prevalent species, with some intermingled Chara. Eco's focus remains on selectively eliminating starry stonewort, even in areas where it coexists with Chara. Areas 1 & 4 were not heavily covered with SS, but had more chara, so they were lightly filtered through to allow the Chara to hopefully to overpower the area, reducing SS for the next season.

Area 1: 10 bags    Area 2: 40 bags    Area 3: 32 bags    Area 4: 7 bags

8/12/2024- The 2<sup>nd</sup> treatment for 2024 will go back over these same areas to remove any missed or new growth of the Starry Stonewort plants. Upon completion of 2<sup>nd</sup> treatment, significantly less amounts of SS were collected.

Area 1: 3 bags    Area 2: 27 bags    Area 3: 12 bags    Area 4: 5 bags

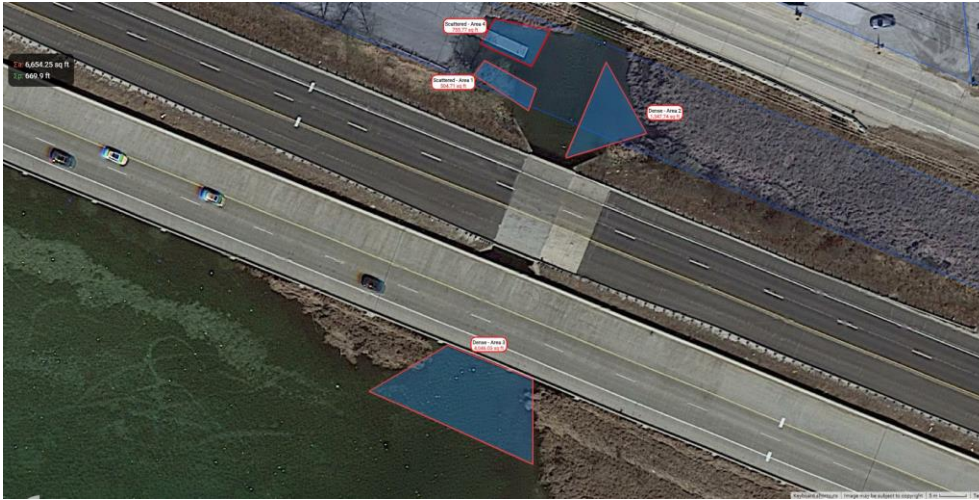
7/13/2023 Treatment – Eco targeted all four designated zones on the map, covering the docking area and its surroundings, including the south side, the boat launch area's eastern side, and south of the bridge. Ongoing manual efforts are managing sporadic plant outbreaks in these zones. Divers focused on the deeper side of each area working towards land, in order to create navigation paths in hopes of limiting the amount of starry touched by watercrafts at the launch. Starry Stonewort remains the prevalent species, with some intermingled Chara. Eco's focus remains on selectively eliminating starry stonewort, even in areas where it coexists with Chara. Eco left Chara beds that did not have a presence of Starry in hopes they will be able to overpower the area to help reduce the Starry Stonewort return next season. This year Eco collected the following number bags in each area on the first visit.

Area 1: 13 bags    Area 2: 35 bags    Area 3: 21 bags    Area 4: 8 bags

8/21/2023 Treatment – A follow up treatment was completed. We found significantly less SS around the boat launch area treated in July. Most of the time was spent in Area 3, south of the bridge and covering any missed plants or regrowth in the remaining areas. We collected a total of 31 bags of material.

Area 1: 4 bags    Area 2: 9 bags    Area 3: 16 bags    Area 4: 2 bags

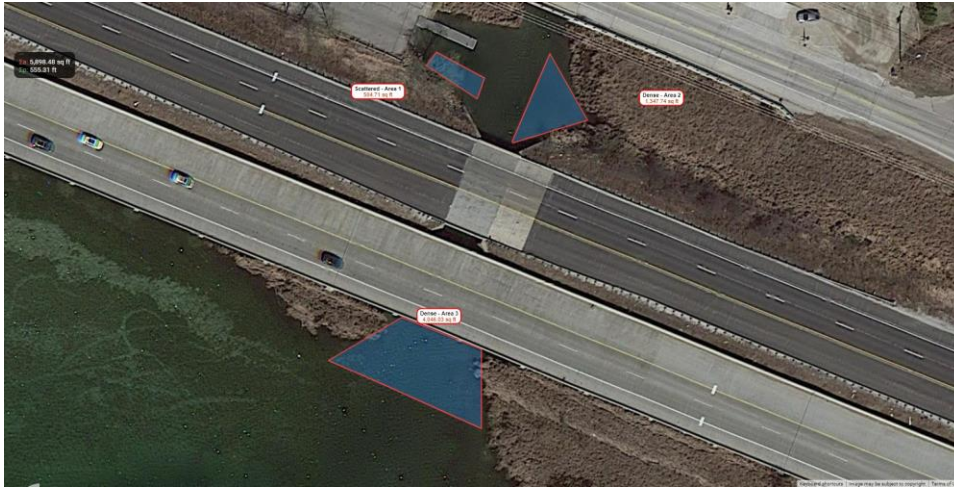
7/18/2022 Treatment – Eco targeted the boat launch areas 1 and 2 shown on the map above. This includes directly in and under the docking area, the south side of the docking area, and along the east side of the boat launch area. There consistently seems to be small outbreaks of scattered plants which are being controlled by hand pulling. This year ECO collected 37 bags north of the bridge in Areas 1 and 2. The 2<sup>nd</sup> treatment for 2022 will concentrate on the south side of the bridge, looking for sporadic outbreaks. Other Native plants of chara and water celery were present around harvesting areas.

8/8/2022 Treatment – A follow up treatment was completed. We found significantly less SS around the boat launch area treated in July. Harvesting was focused south of the bridge in Area 3. We collected 53 bags of plant material.

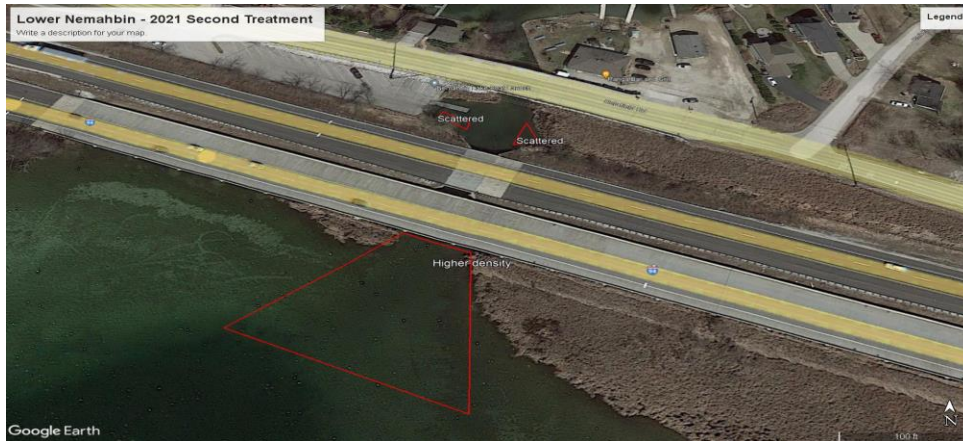
7/12/21 Treatment – A review of the area shows that areas harvested in 2019 when we used geo textile bags and collected some sediment along with plant material was still relatively clear of SS. This includes directly in and under the docking area and the south side of the docking area, and along the middle channel. There consistently seems to be small outbreaks of scattered plants which are being controlled by hand pulling. The areas where we did not remove much sediment in 2019 but have been hand pulling along the east side of the boat launch and on the south side of the bridge leading into Lower Nemahbin had dense patches of SS. Both in 2019 and 2020, we limited the harvesting on the east side of the boat launch due to it being considered a non-traffic area. This is the area which now is abundant with SS and moving into the main channel area. Eco spent the majority of time in this area. The area on the south side of the bridge also had a higher density of SS then in 2020. Eco collected 62 bags of SS on 7/12/21. Last year at the first treatment Eco collected 32 bags. The 2<sup>nd</sup> treatment for 2021 will concentrate first on the East side of the boat launch again and harvesting further out on the south side of the bridge, looking for sporadic outbreaks. Other Native plants of chara and water celery were present around harvesting areas.

8/25/21 Treatment – A follow up treatment was completed. We found significantly less SS around the boat launch area treated in July. Most of the SS was near the Lily Pads and against the wall of the I94 bridge on the south of the boat launch area. We collected 9 bags of plant material. Last year during the second treatment Eco collected 5 bags.

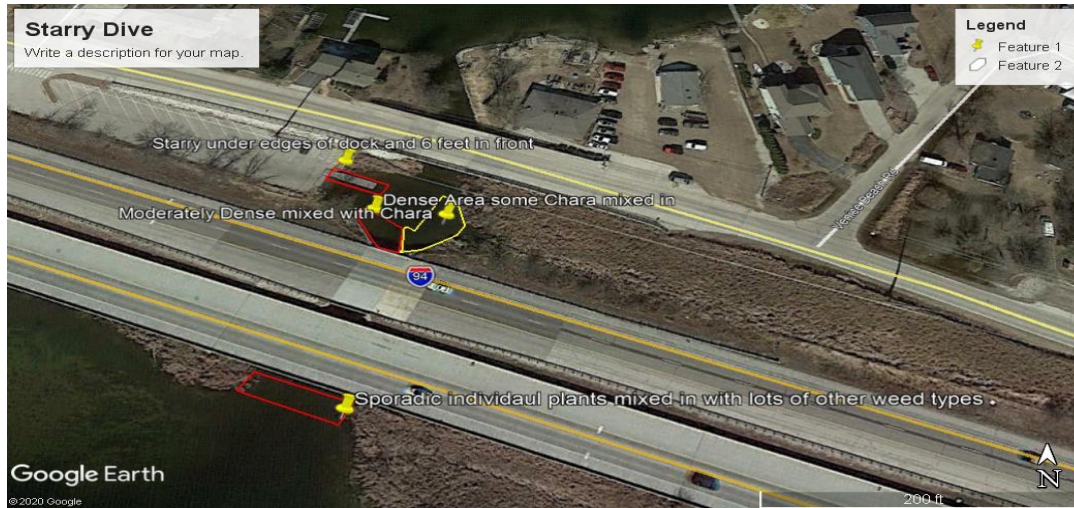
7/27/20 Treatment – While the amount of SS was significantly decreased in certain areas from the outbreak in 2019, there were still some moderately dense areas within the boat launch area and on the outside of the South I94 overpass bridge. Most of the outbreak was in specific patches and not in an overall area. A map is attached of the service from this hand harvesting treatment. We collected 32 bags or 1120lbs of plant material. 75% of the material was SS and 25% native plants of primarily Chara. Based on DNR direction and in consideration of allowed treatment time and budget, some SS was left on the East side of the boat launch. This area was considered a non-traffic area with less exposure for migration.

8/31/20 Treatment – A follow up hand harvesting treatment was completed. There was little to no SS plant material in the areas treated in July. There were a few small patches that were found within the boat launch area and removed. Divers concentrated more on Lower Nemahbin, South of the I94 overpass bridge. New outbreak areas were found where there was prop rutting. SS was growing within the bare areas of the prop ruts. Divers removed these plants and determined the entire original treatment area, except the previously excluded area on the East side of the boat launch was clean. There were some sporadic SS plants intermingled with other native plants, primarily CHARA. The native plant environment seemed to be overtaking the SS growth areas. The primary plant was CHARA. Amy Kruetlow, DNR, was present at treatment time and observed the results of treatments. We collected 5 bags or 175lbs of plant material. 90% of the material was SS and 10% native Chara. A map is attached of the service from this hand harvesting treatment.
