Hybrid Eurasian water-milfoil
(*Myriophyllum spicatum* X *sibiricum*)
Bed Mapping Survey
Jackson Lake – WBIC: 2734200 - Bayfield County, Wisconsin

Endangered Resource Services, LLC
Matthew S. Berg, Research Biologist
Saint Croix Falls, Wisconsin
August 20, 2024

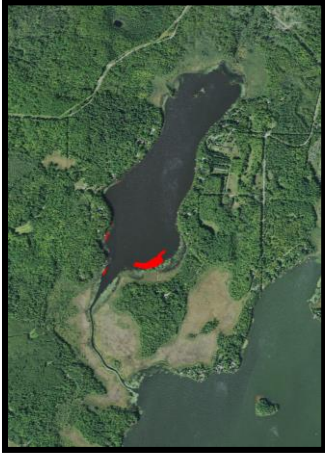
HWM beds (red) in Jackson Lake 8/20/24

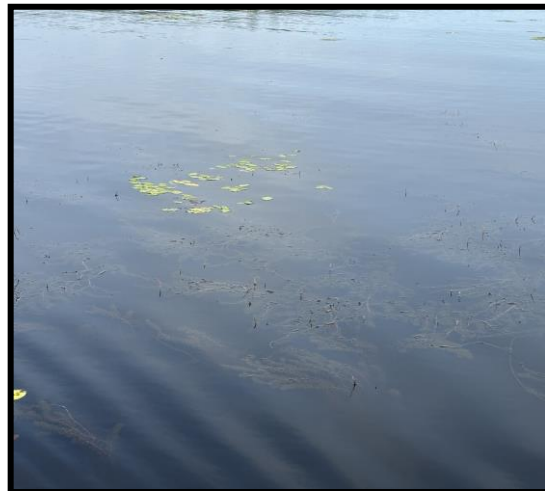
Canopied HWM in Jackson Lake's southeast bay (8/20/24)

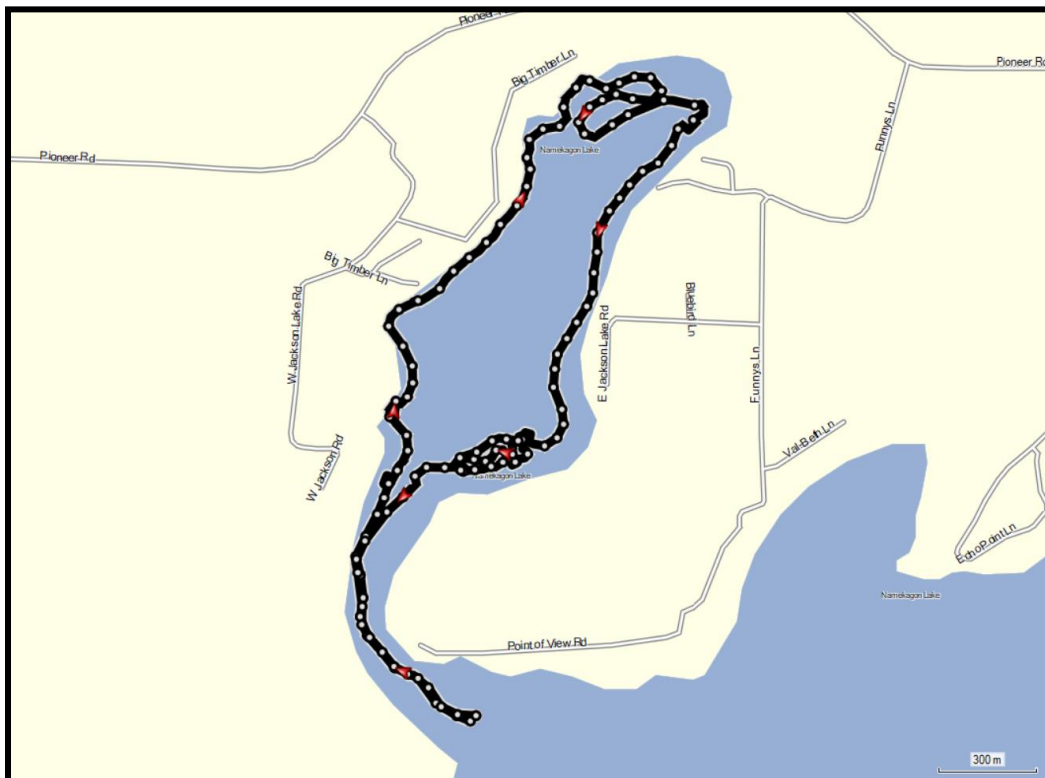
Figure 3: August 20, 2024 Littoral Zone HWM Survey Transects

On August 20, 2024, we surveyed transects covering 6.8km (4.2 miles) (Figure 3). At the time of the survey, we had sunny skies and mostly calm winds which made for excellent search conditions and allowed us to see down in the water column approximately 3ft. After seeing nothing in the access channel from Namekagon Lake or along the western shoreline during our 2022 survey, we found and rake removed four individual Hybrid water-milfoil plants in the southwest end of Jackson Lake in 2023. In 2024, this area supported two microbeds of HWM, and we located an additional small bed further north along the shoreline (Figure 4) (Appendix I). In the northeast bay where we found and rake removed a single HWM plant in 2022, we were again pleased to find no evidence of HWM. Similarly, we found nothing in the area where we rake removed a single HWM plant on the eastern shoreline in 2023.

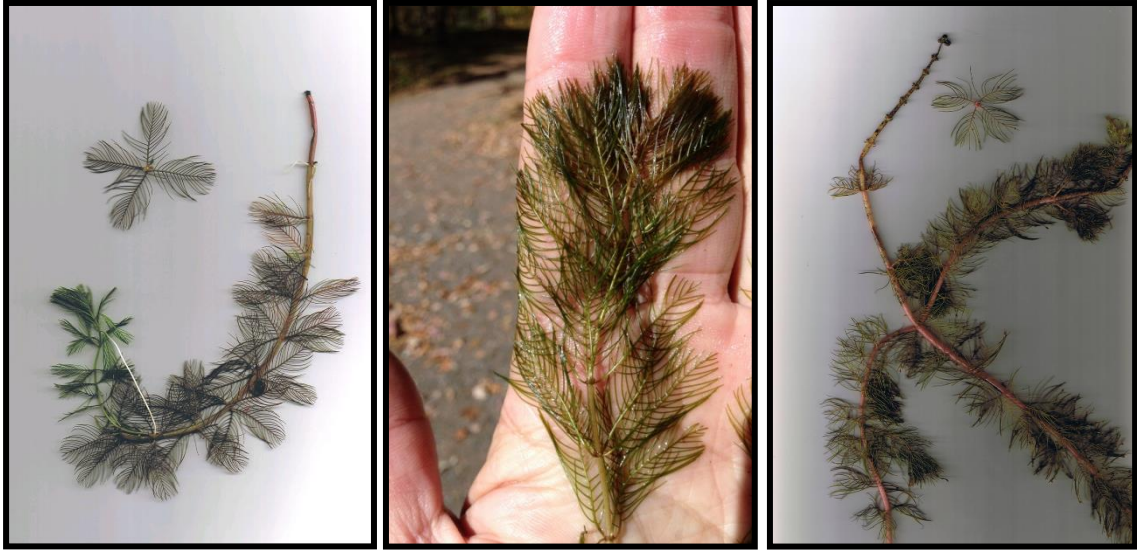
Figure 5: Eurasian, Hybrid, and Northern Water-milfoil Identification

Eurasian Water-milfoil

Hybrid Water-milfoil

Northern Water-milfoil

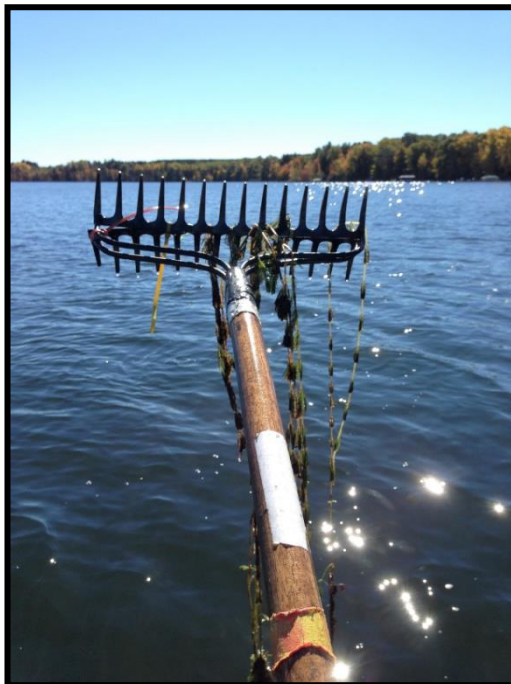
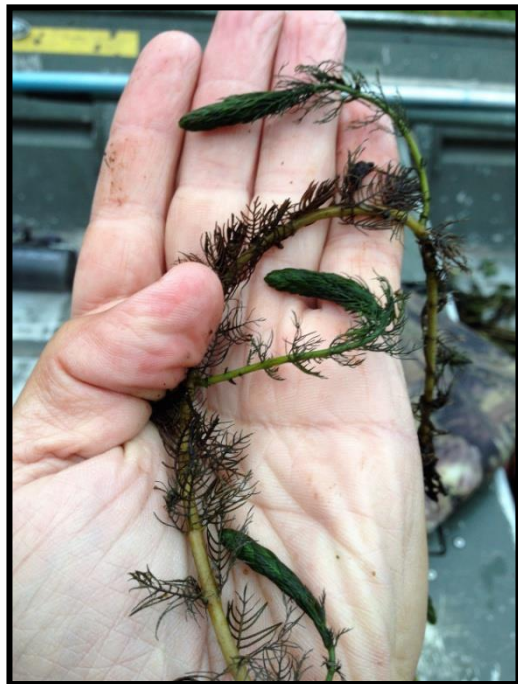
Figure 6: Limp Nature of EWM/HWM Leaflets along Stem – Stiff Nature of NWM Leaflets along Stem and Overwintering Turions

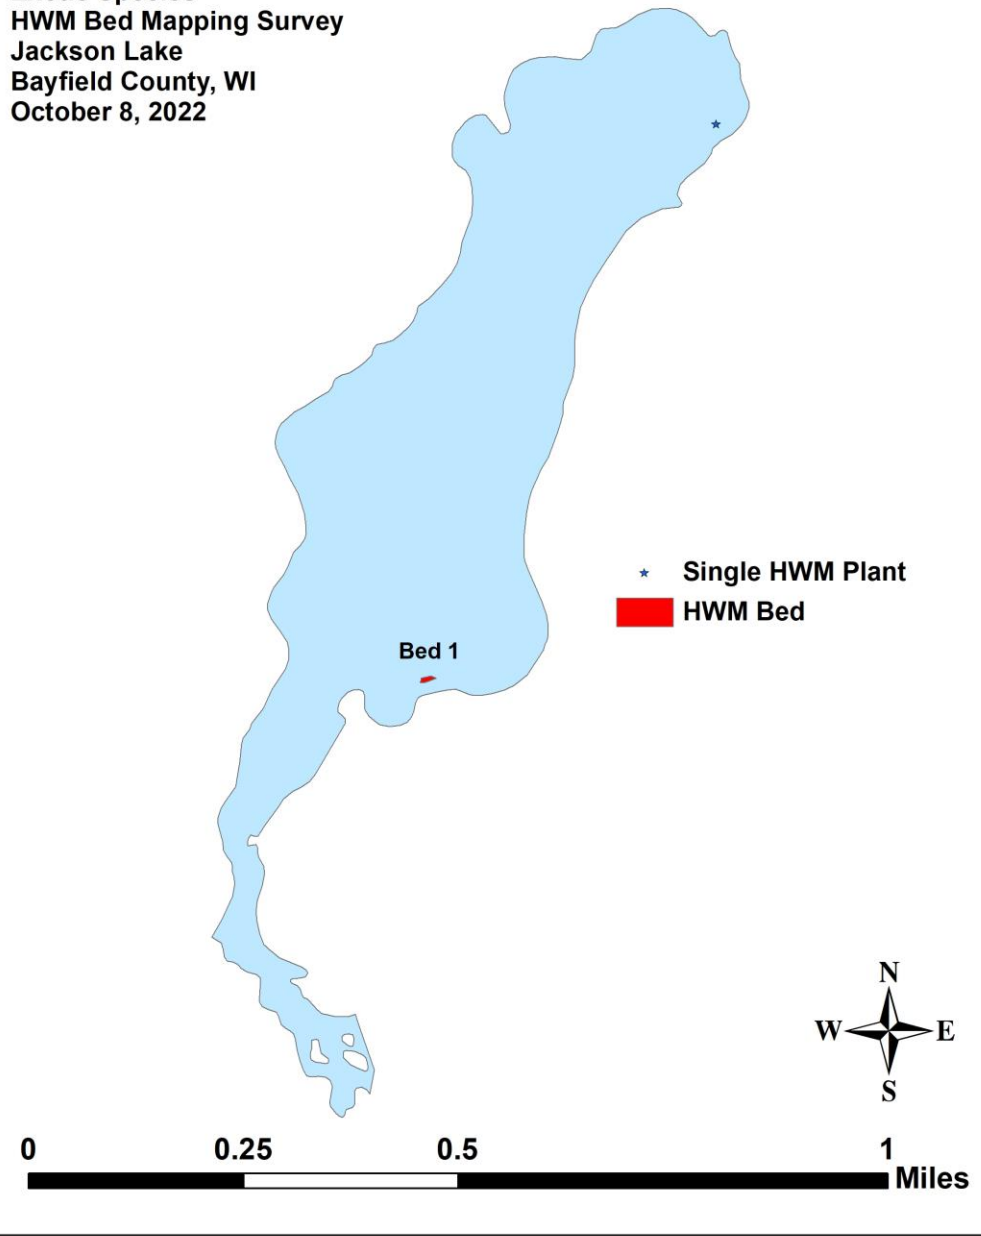
Exotic Species
HWM Bed Mapping Survey
Jackson Lake
Bayfield County, WI
October 8, 2022

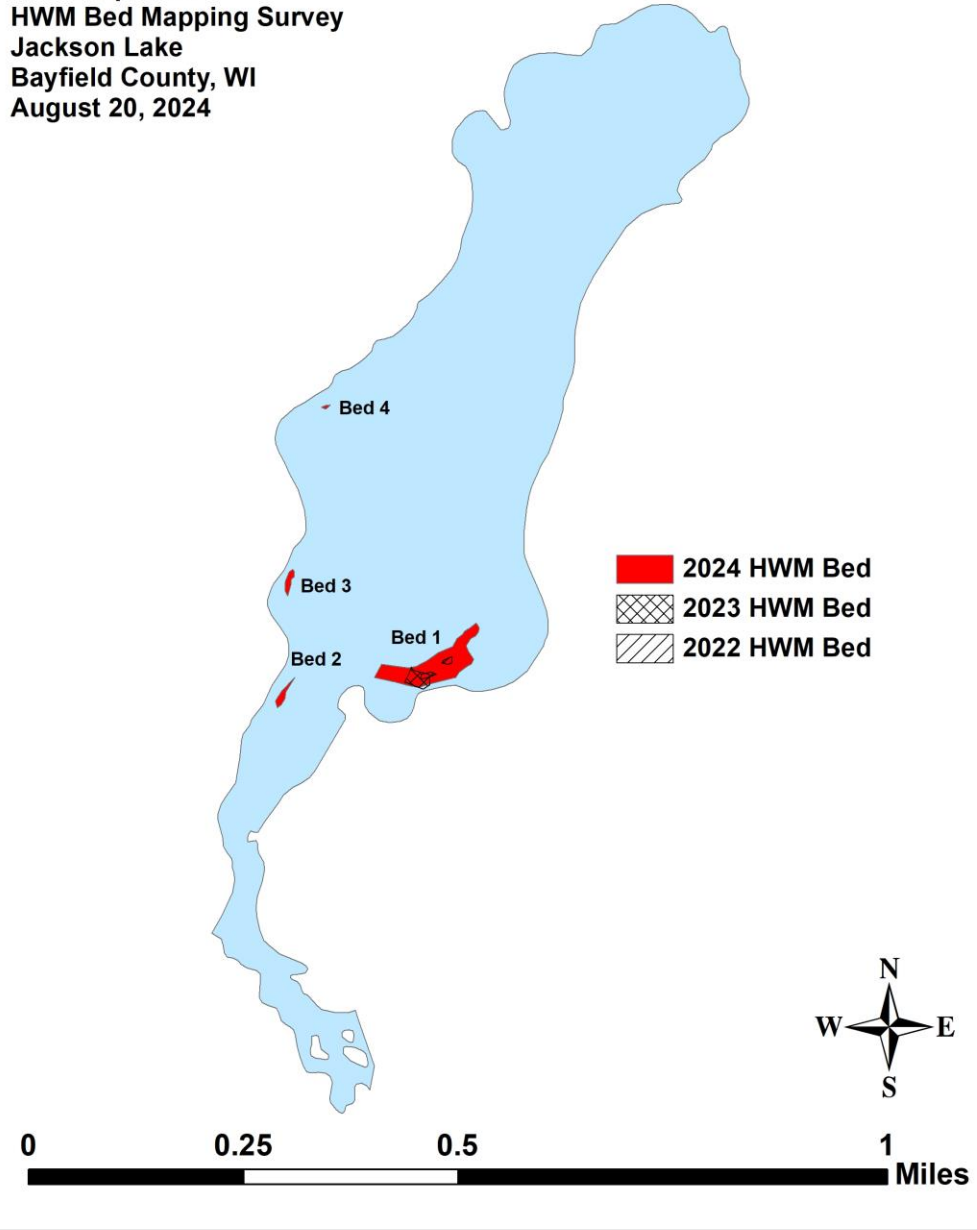
Exotic Species
HWM Bed Mapping Survey
Jackson Lake
Bayfield County, WI
August 20, 2024
