PRETTY LAKE AQUATIC MANAGEMENT PLAN

PRETTY LAKE PROTECTION & REHABILITATION DISTRICT
CREATED AUGUST 2024

Prepared by:
Pretty Lake Protection & Rehabilitation District

Aquatic Plant Point-Intercept Survey Pretty Lake, Waukesha
County Wisconsin July 2024

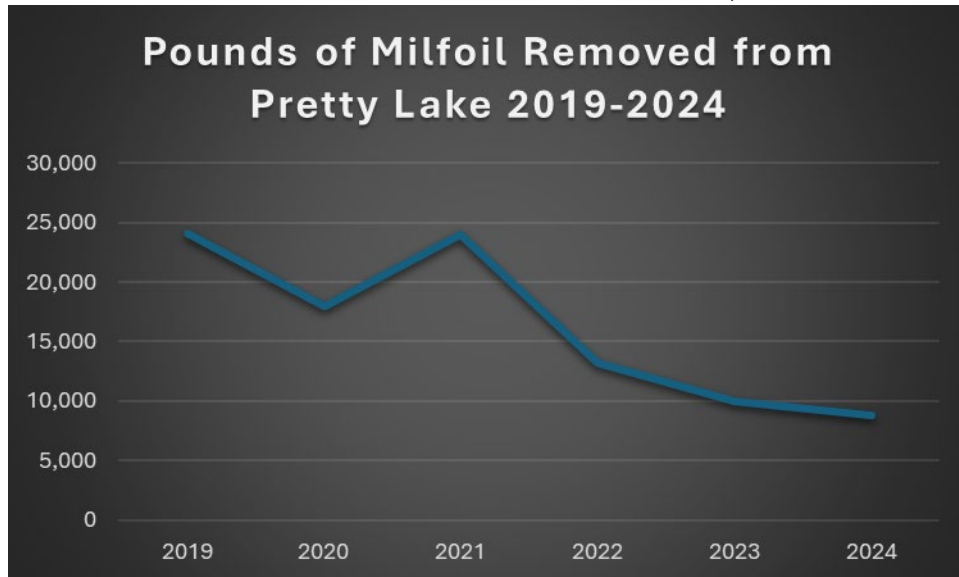
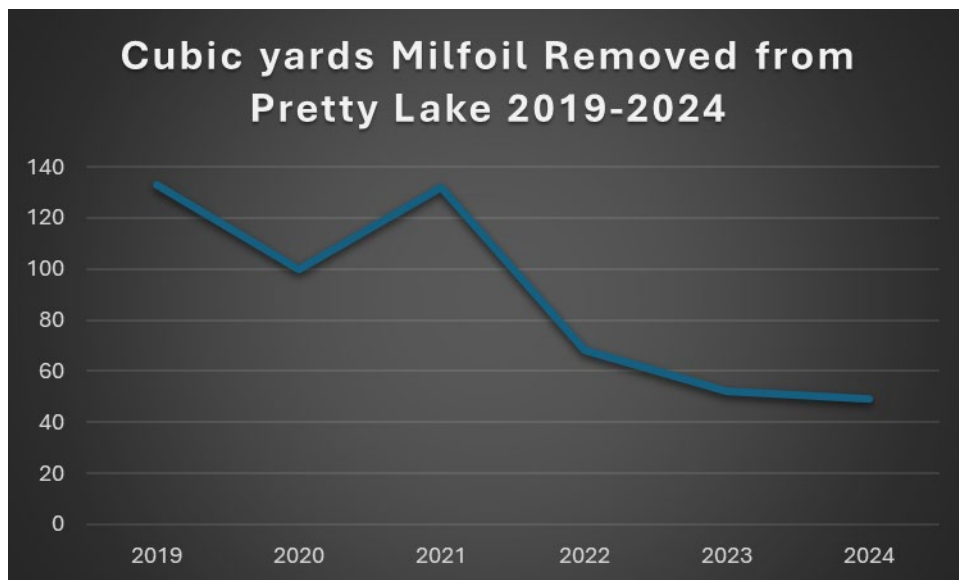
Our long term goal is to remove milfoil from stubborn areas and then seek and destroy small random pockets of the weed. As you can see from the charts the amounts we have harvested have decreased as we, have removed most of the dense areas.

The Pretty Lake DASH Boat was put into service in 2018. The boat crew average 17-18 pulls per year, removing tons of EWM. Areas of high density that had the EWM removed reverted to native vegetation. In comparing the 2018 Point Intercept Survey (PIS) to the 2024 PIS, there was a marked decrease in the number of locations and frequency of EWM. Locations went from 40 to 14, and the frequency went from .20 to .07.

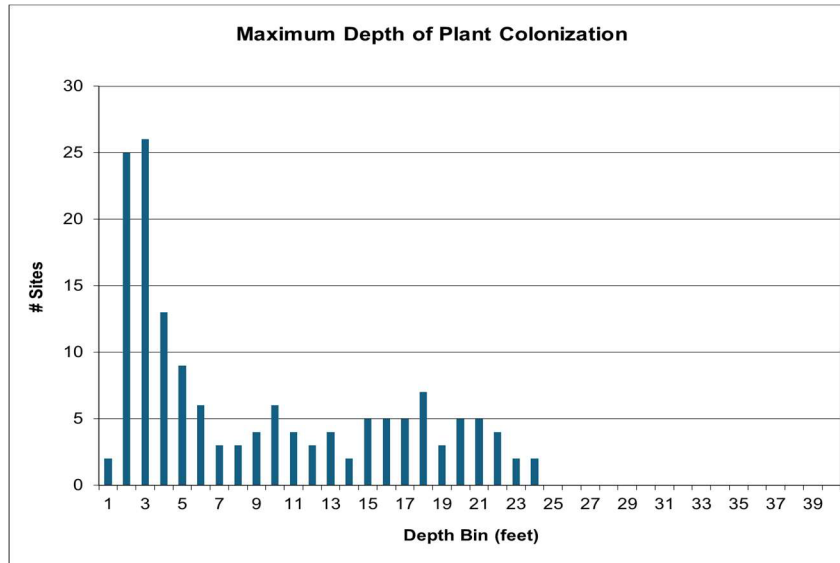
Figure 9: Distribution of plant occurrences versus water column depth

Figure 10 shows the maximum depth of colonization. This is the depth of the deepest site sampled at which vegetation was present. The maximum depth of colonization is an important metric as it can be indicator of water clarity and water quality.
