# Nancy Lake Critical Habitat Designation Report

*Washburn County, WI*

April 2013

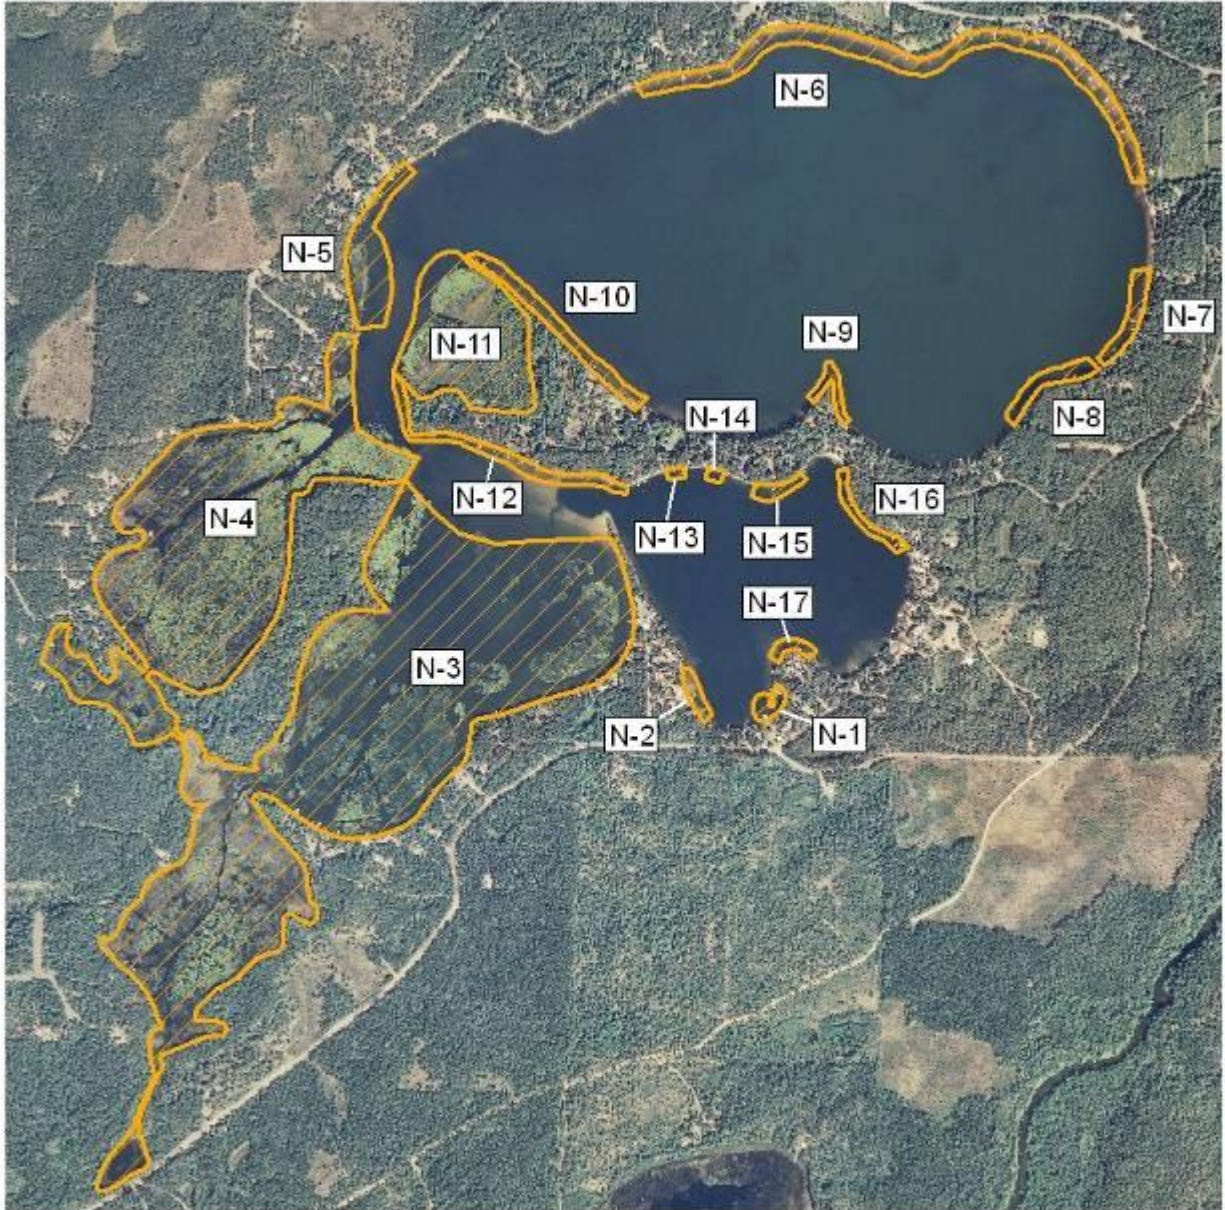
# Nancy Lake Critical Habitat Areas

Seventeen areas are designated as Critical Habitat on Nancy Lake for a total of 337.3 acres. Twelve areas are classified as Sensitive Areas for rushes, emergent and floating leaf aquatic plants, and/or submergent aquatic plants. Five areas are classified as Public Rights Features for spawning substrate and woody habitat.

Critical Habitat Polygon ID	Acreage	Justification	Justification	Justification	Classification
N-1	1.18	3	2	0	Sensitive Area
N-2	1.15	3	2	4	Sensitive Area
N-3	174.24	3	2	4	Sensitive Area
N-4	90.25	3	2	4	Sensitive Area
N-5	8.27	3	2	4	Sensitive Area
N-6	16.52	3	2	4	Sensitive Area
N-7	2.49	4	3	2	Sensitive Area
N-8	2.50	8	7	0	Public Rights Feature
N-9	1.26	8	0	0	Public Rights Feature
N-10	4.67	4	3	2	Sensitive Area
N-11	25.87	3	6	2	Sensitive Area
N-12	4.77	3	4	0	Sensitive Area
N-13	0.27	4	3	2	Sensitive Area
N-14	0.33	3	0	0	Sensitive Area
N-15	1.06	8	0	0	Public Rights Feature
N-16	1.56	8	7	0	Public Rights Feature
N-17	0.94	8	0	0	Public Rights Feature

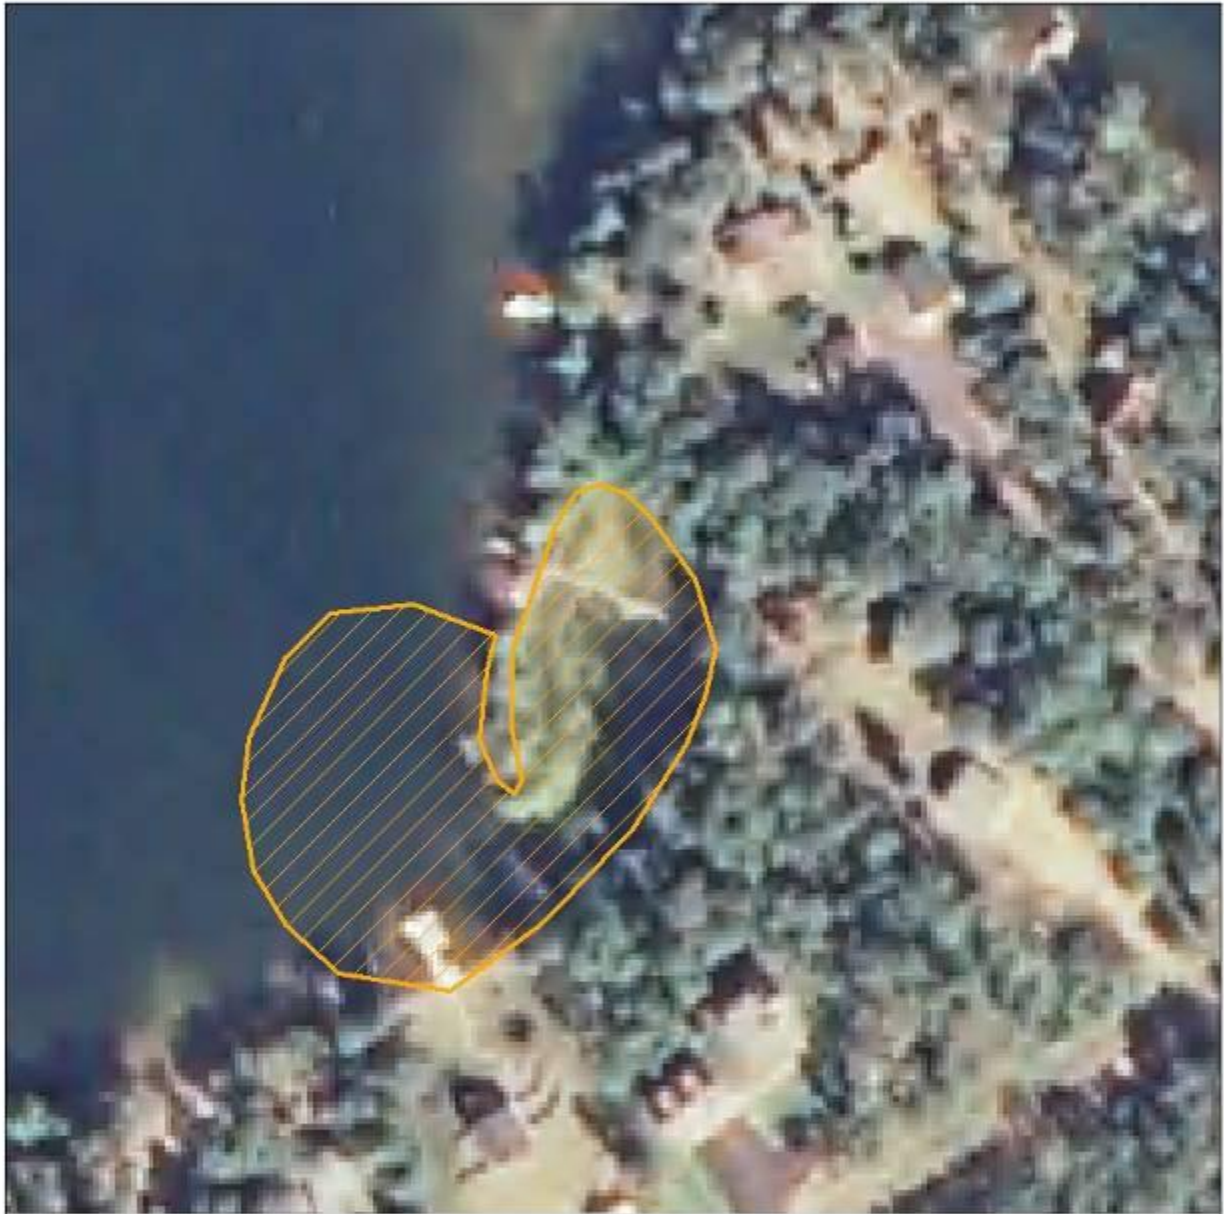
# N1 Critical Habitat Area

Critical Habitat Site N1 is designated a Sensitive Area because of its Emergent and Floating Leaf Vegetation and Submerged Aquatic Vegetation Important to Fish and Wildlife Habitat. It is 1.18 acres in size and is located in the little bay on the South end of Deep Lake.

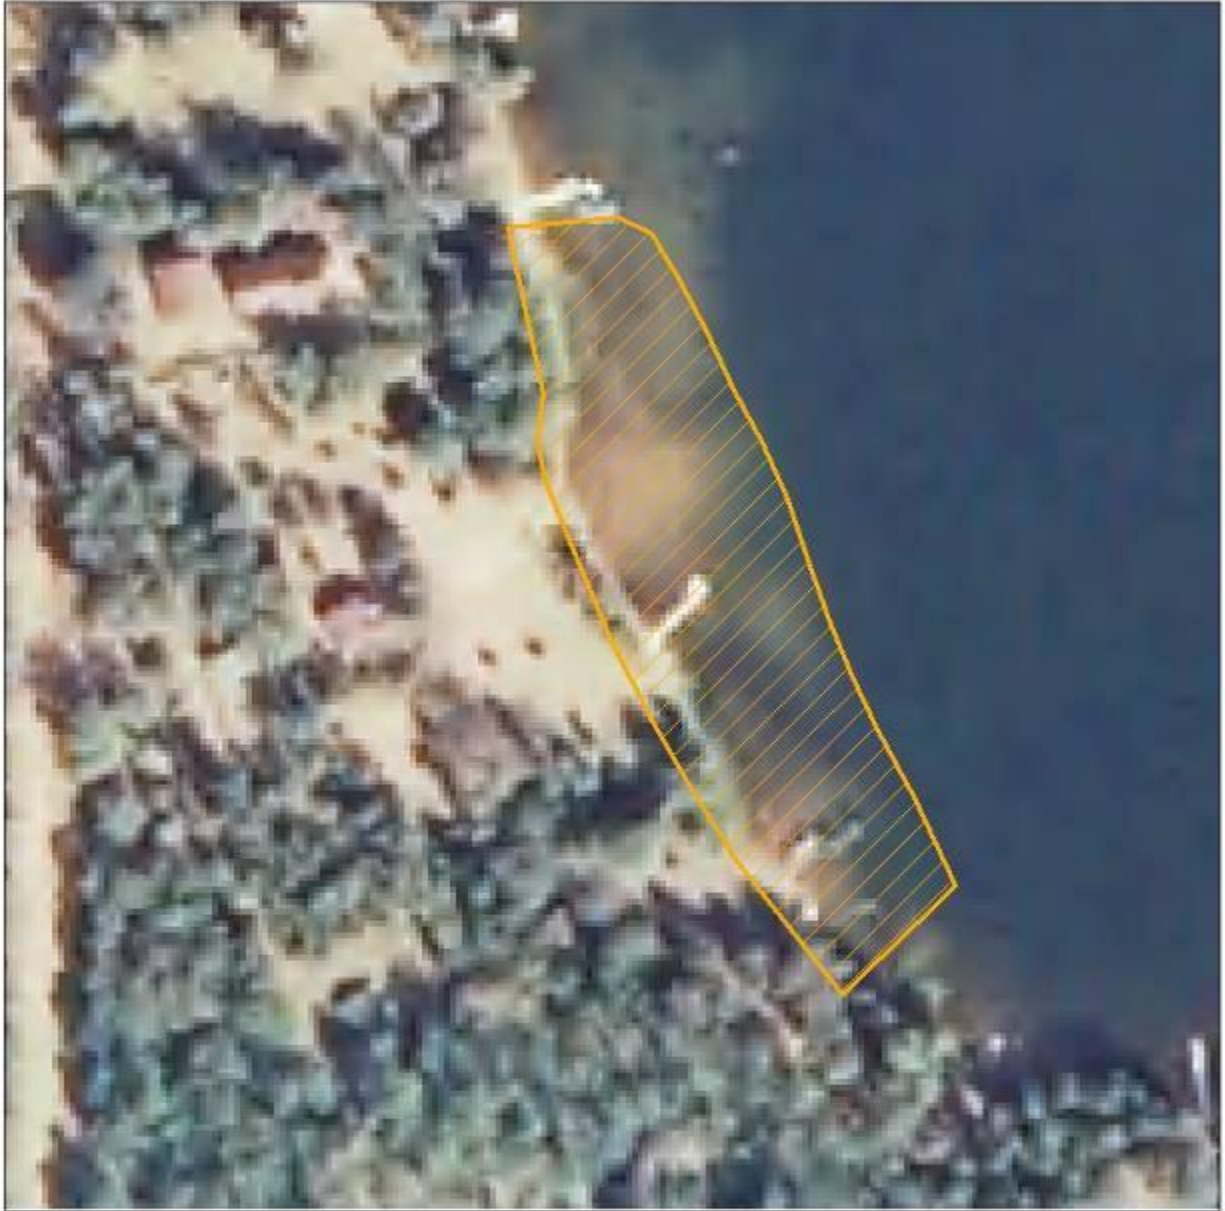
# N2 Critical Habitat Area

Critical Habitat Site N2 is designated a Sensitive Area because of its Emergent and Floating Leaf Vegetation, Submerged Aquatic Vegetation Important to Fish and Wildlife Habitat, and Bulrush Beds. It is 1.15 acres in size and is located along the southwest shore of Deep Lake.

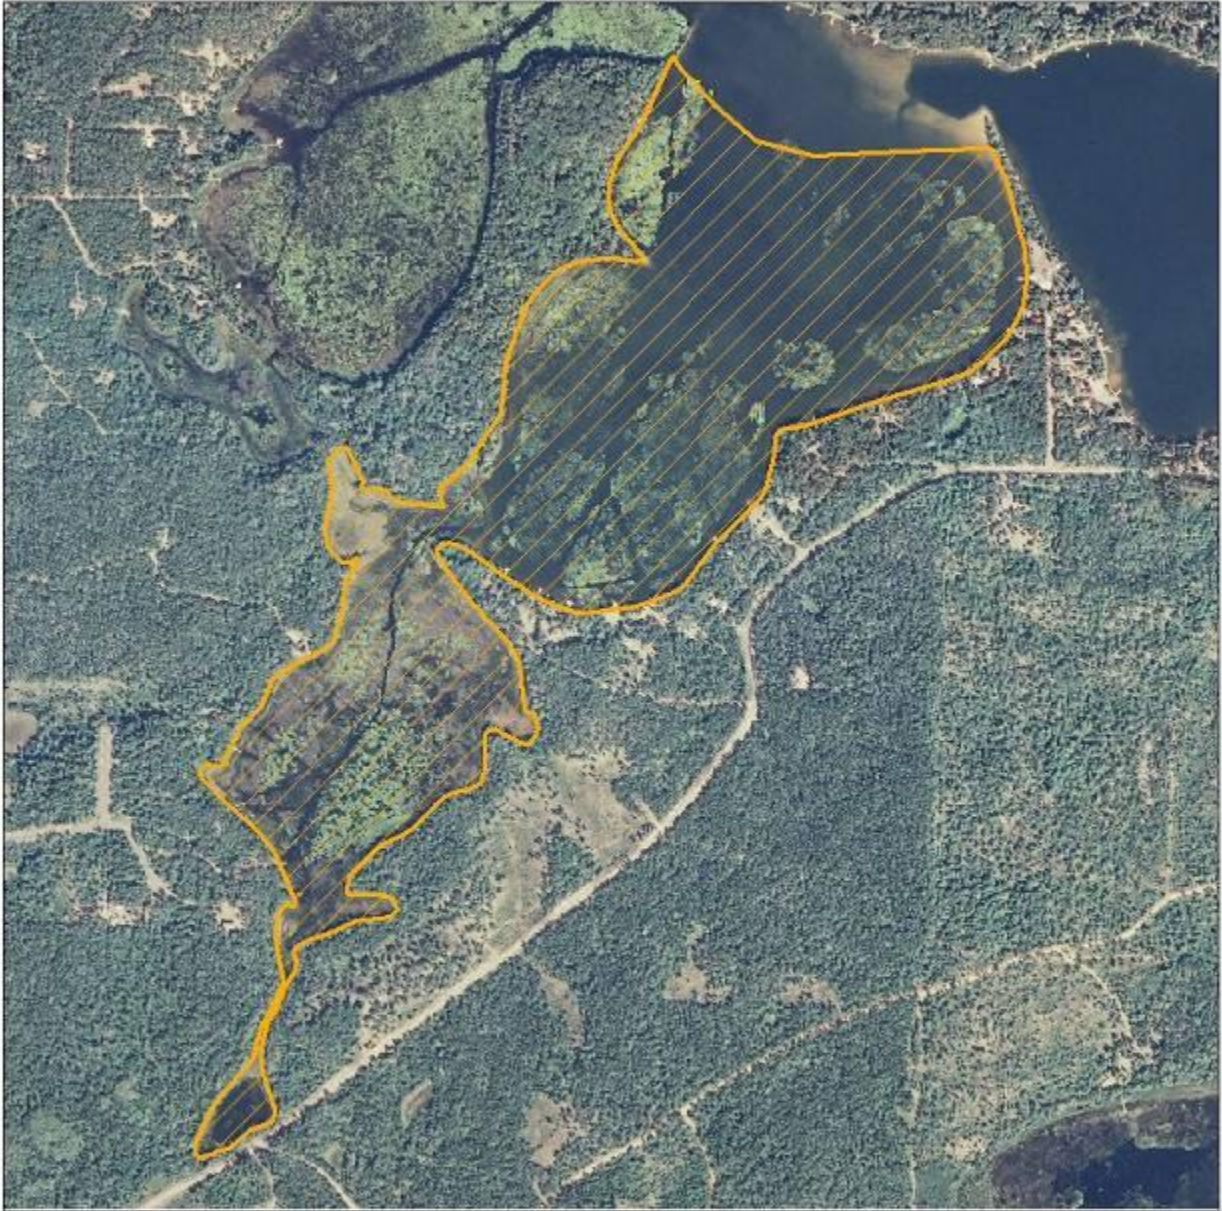
# N3 Critical Habitat Area

Critical Habitat Site N3 is designated a Sensitive Area because of its Emergent and Floating Leaf Vegetation, Submerged Aquatic Vegetation Important to Fish and Wildlife Habitat, and Bulrush Beds. It is 174.24 acres in size and encompasses the big shallow bay east of the state owned island.

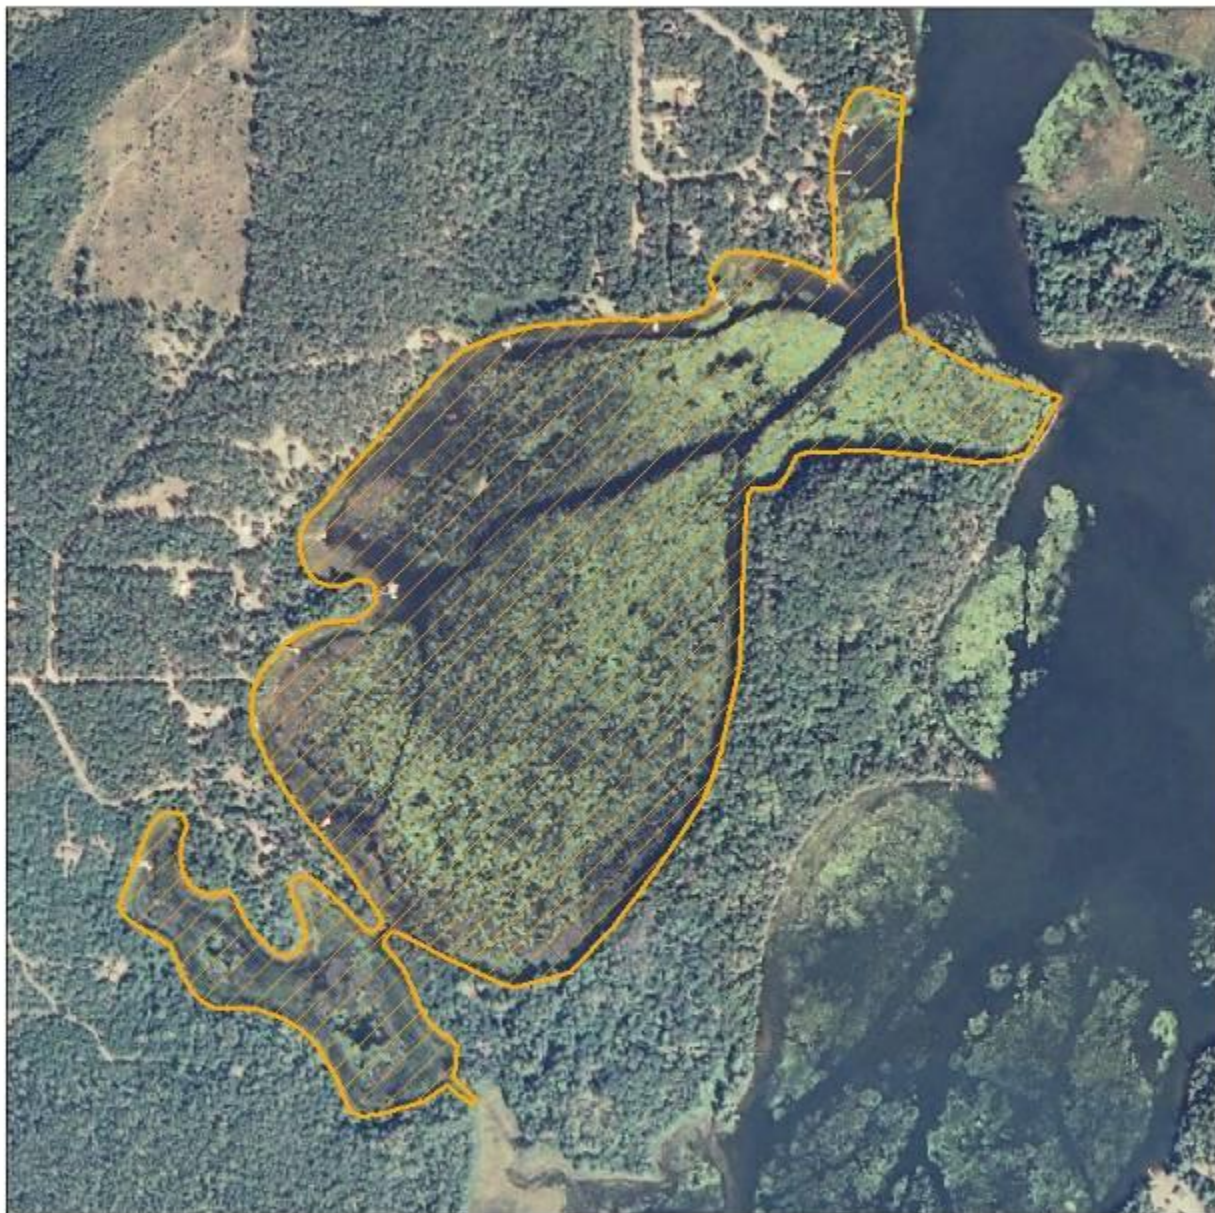
# N4 Critical Habitat Area

Critical Habitat Site N4 is designated a Sensitive Area because of its Emergent and Floating Leaf Vegetation, Submerged Aquatic Vegetation Important to Fish and Wildlife Habitat, and Bulrush Beds. It is 90.25 acres in size and encompasses the shallow bay west of the state owned island.

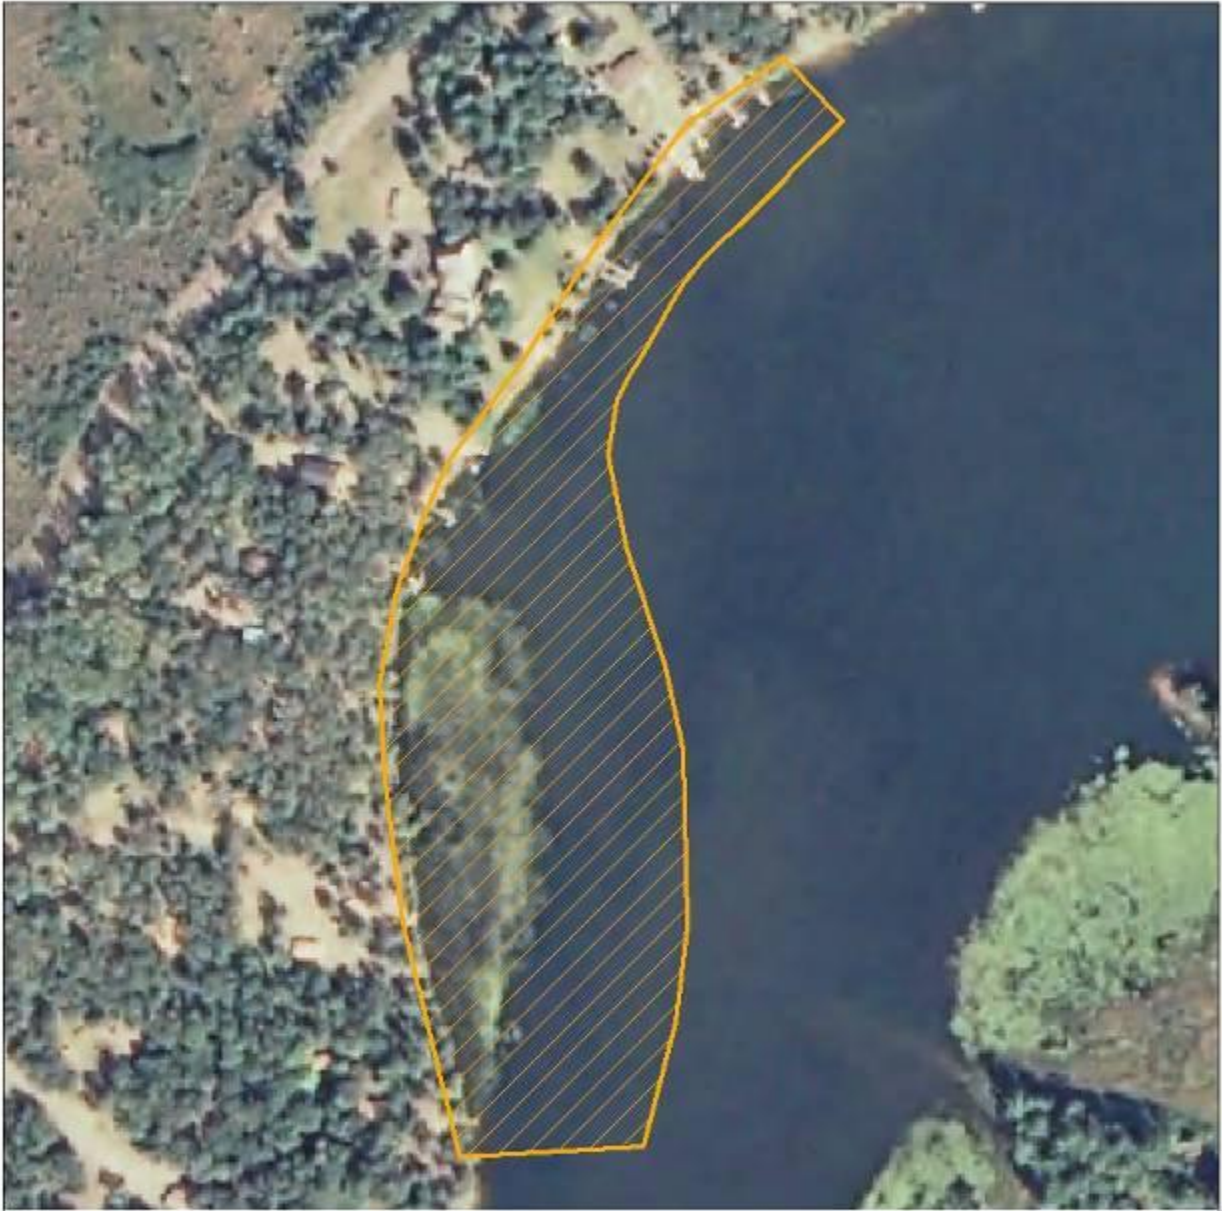
# N5 Critical Habitat Area

Critical Habitat Site N5 is designated a Sensitive Area because of its Emergent and Floating Leaf Vegetation, Submerged Aquatic Vegetation Important to Fish and Wildlife Habitat, and Bulrush Beds. It is 8.27 acres in size and is located along the west shore of the lake.

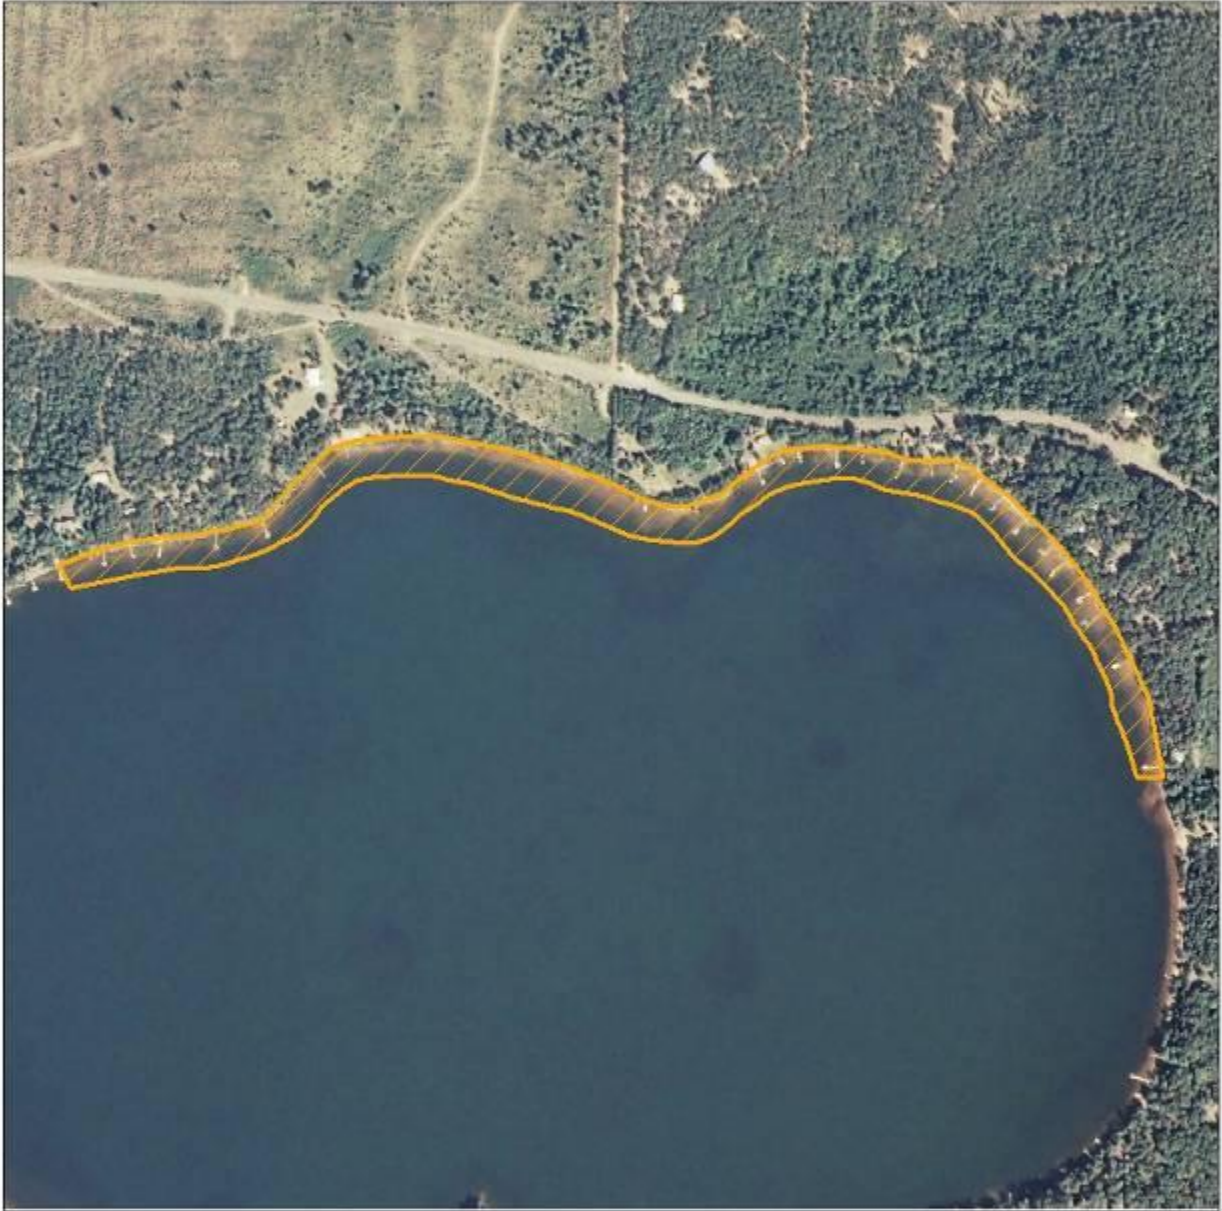
# N6 Critical Habitat Area

Critical Habitat Site N6 is designated a Sensitive Area because of its Emergent and Floating Leaf Vegetation, Submerged Aquatic Vegetation Important to Fish and Wildlife Habitat, and Bulrush Beds. It is 16.52 acres in size and is located along the north shore of the lake.

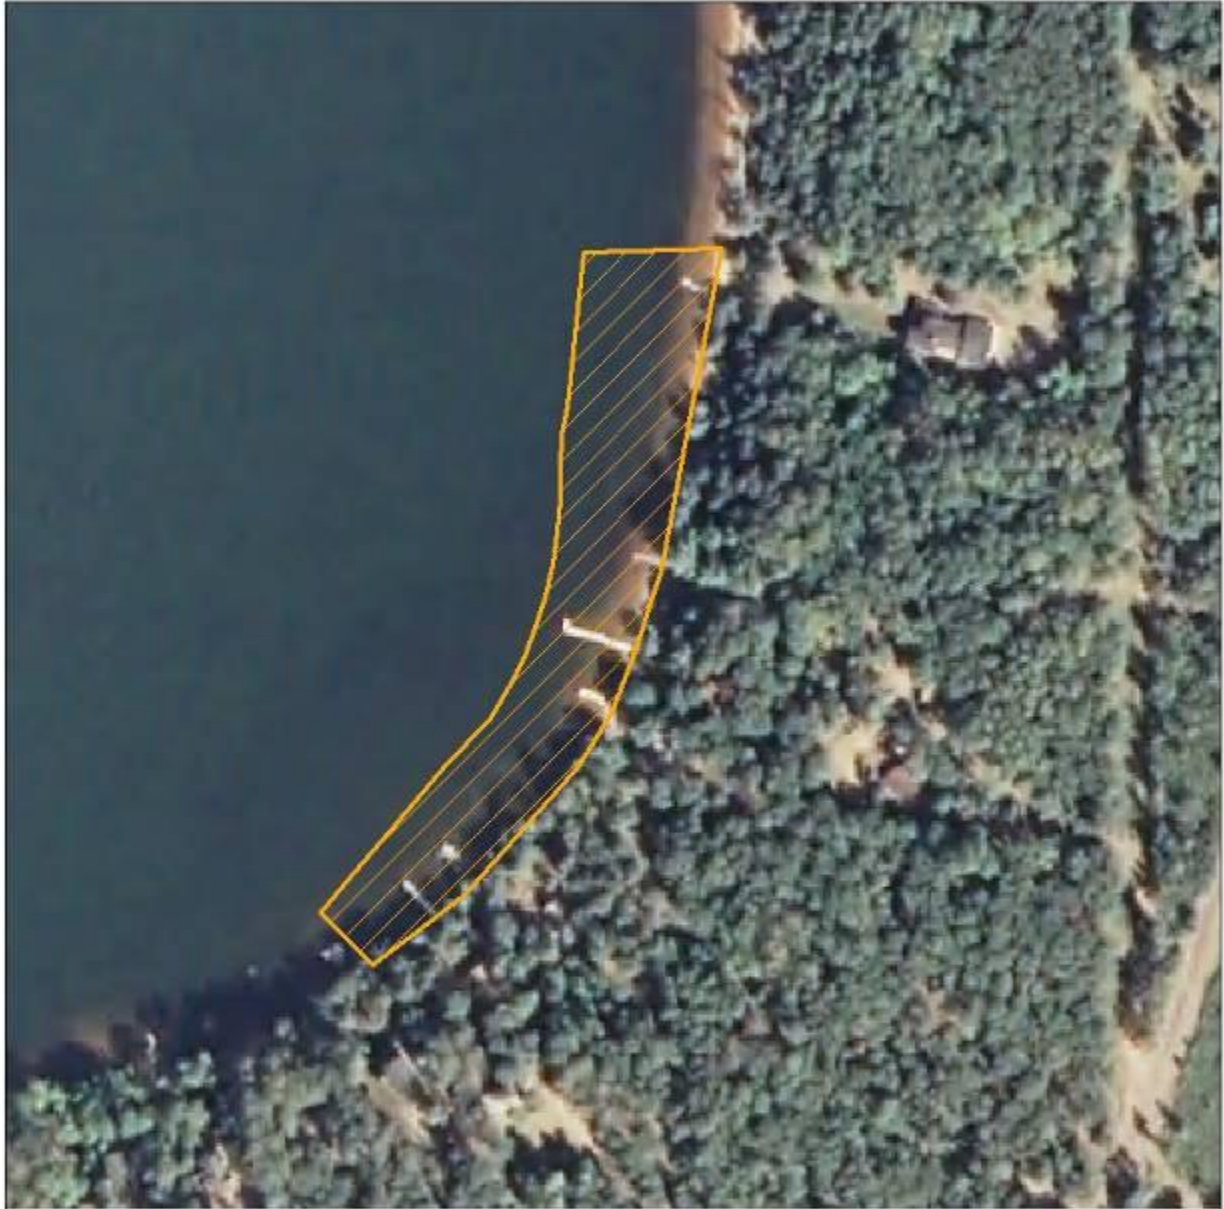
# N7 Critical Habitat Area

Critical Habitat Site N7 is designated a Sensitive Area because of its Bulrush Beds, Emergent Vegetation, and Submerged Aquatic Vegetation Important to Fish and Wildlife Habitat. It is 2.49 acres in size and is located along the east shore of the lake.

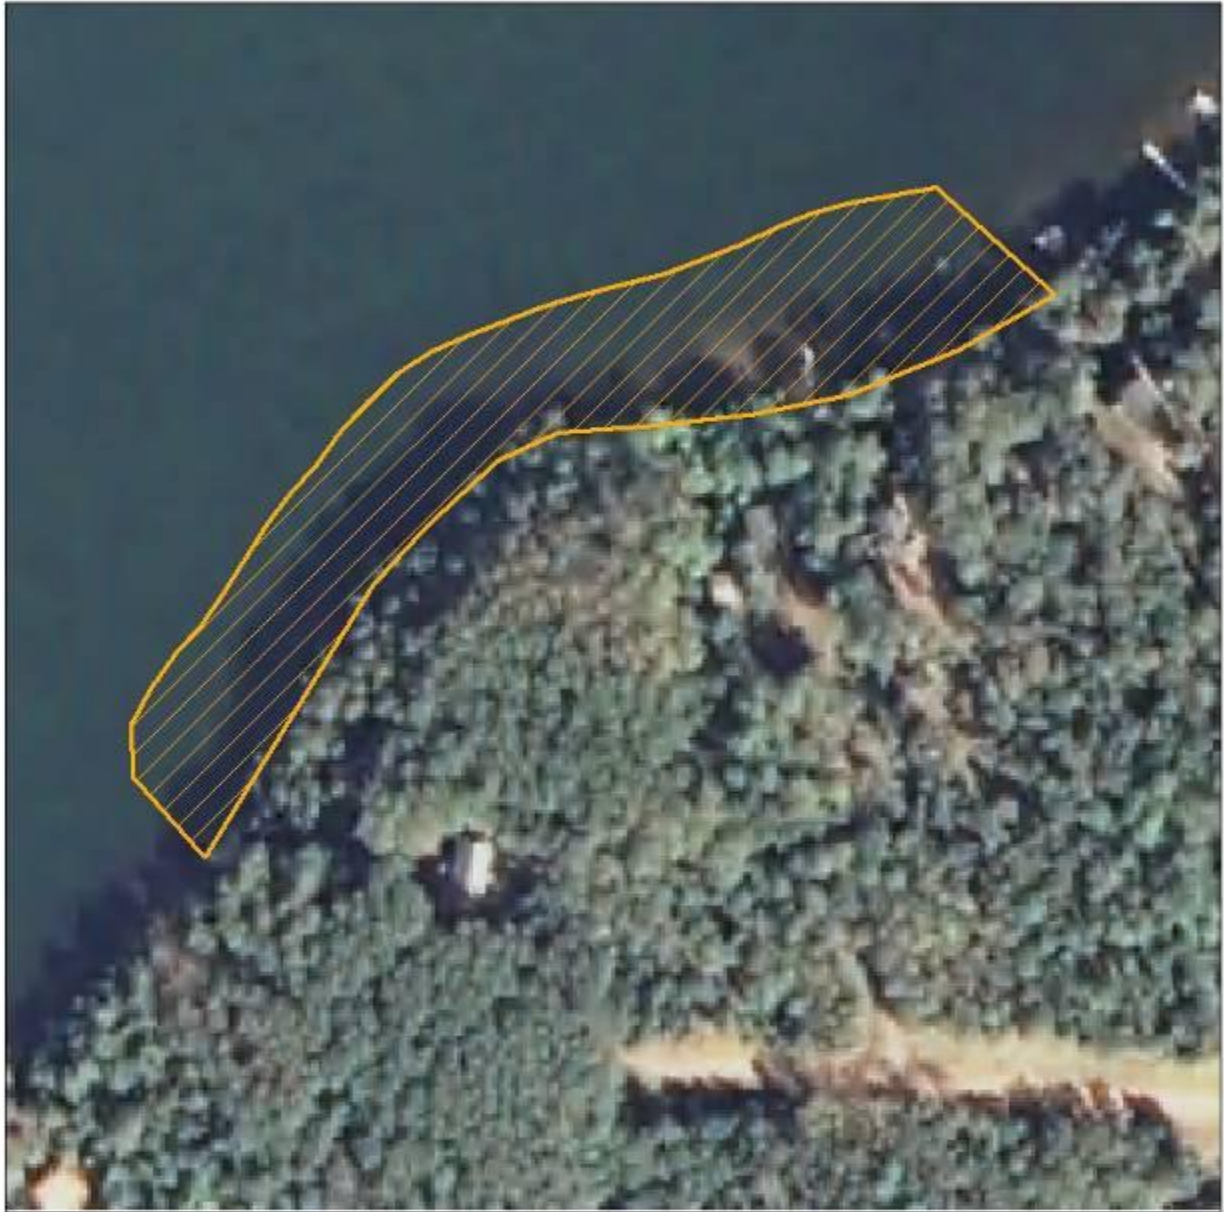
# N8 Critical Habitat Area

Critical Habitat Site N8 is designated a Public Rights Feature because of its Spawning Substrate and Woody Habitat. It is 2.50 acres in size and is located along the southeast shore of the lake. This area is one of the principle spawning areas for Walleyes and Suckers.
