## 2010 Water Quality Management Plan Update

Southeast Basin, Wisconsin

August, 2010

# Pike River Watershed

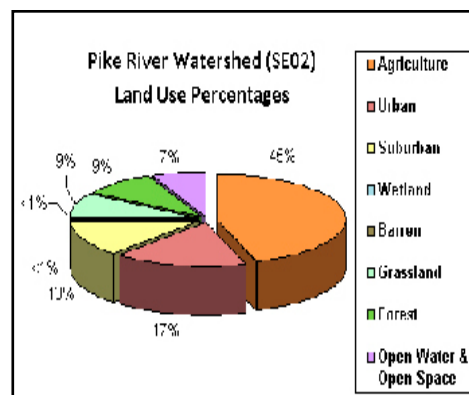
Figure 1: Land Use (2001)

Land use refers to the primary ways people develop and manage the landscape. Today, the watershed contains a mix of land use types (Figure 1 and Appendix), but 170 years ago the Pike River Basin was essentially undeveloped. Native people lived in a landscape that was rich with upland forests of oak, hickory, walnut and box elder trees. The first European settlement in the Pike River watershed, the Village of Pike River, was developed in 1835 near the mouth of the Pike River one mile north of the present City of Kenosha Harbor. Pike River once had dwellings, stores, mechanics' shops, and warehouses. But during 1842 and the following year, many of the buildings were moved to Southport (present day City of Kenosha), and the Village ceased to exist. In addition to Southport, settlements near the Pike River watershed also included Root River, (Present day City of Racine). Settlement of these areas began in 1835 and 1834, respectively. It was not until the 1950s that significant urbanization began to occur within the rest of the watershed. (SEWRPC 1983)

Although the towns and villages within the Pike River Watershed have experienced high rates of residential growth during the last two decades, agriculture remains the dominant land use. Urban and suburban land uses represent the next two largest land use types but even combined do not cover as much landscape as farmland does. Next to agriculture, grasslands and forests respectively represent the two next most common rural land uses. Wetlands and barren land covers make up less than two percent of the land area in the basin.

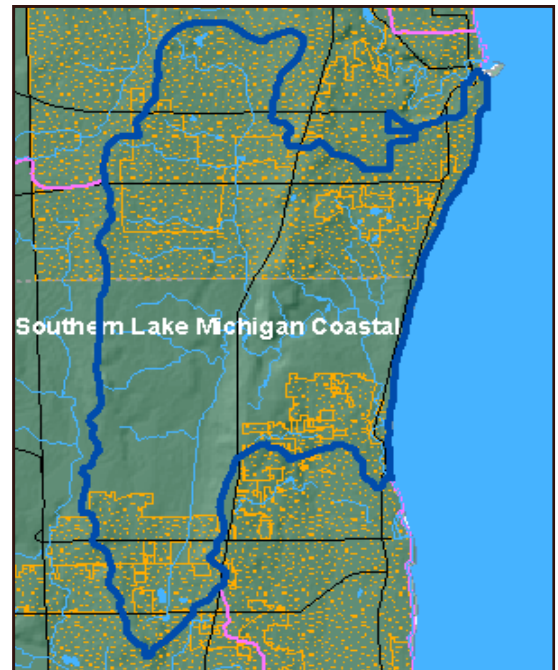
Map 3: Ecological Landscapes

This watershed is located in the middle of the Southern Lake Michigan Coastal Ecological Landscape (Map 3), which is characterized by ridge and swale topography, clay bluffs, and lake plain along Lake Michigan. Silt-loam soils overlying loamy and clayey tills are typical.

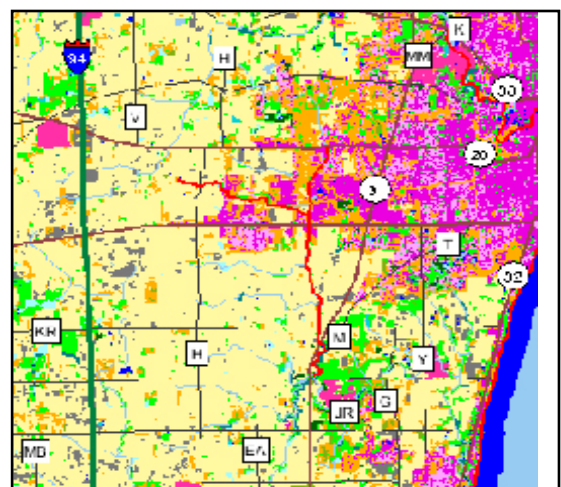
Map 4. Land Use (WisLAND) and impaired waters

Just over eight miles of streams in the Pike River Watershed are considered impaired and not meeting water quality standards. These streams are the North Branch of the Pike River from its junction with the South Branch up river 5.23 miles to State Highway 20, and the entire 2.91 mile length of Waxdale Creek in the Town of Sturtevant.

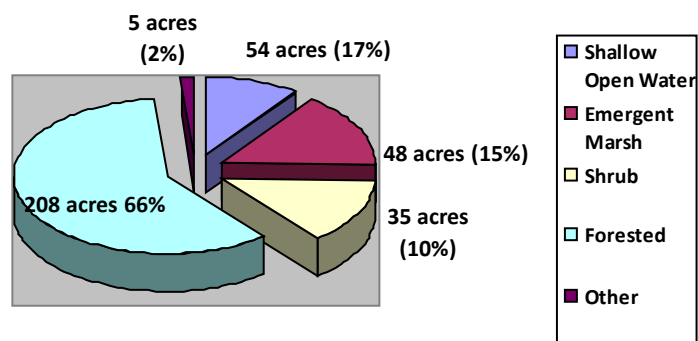
Figure 2. Wetland Types in the Pike River Watershed

lands in the watershed currently exist. Of these wetlands, forested wetlands (66% ) and emergent wetlands (15%), which include marshes and wet meadows, dominate the landscape (Figure 2 (previous page)).

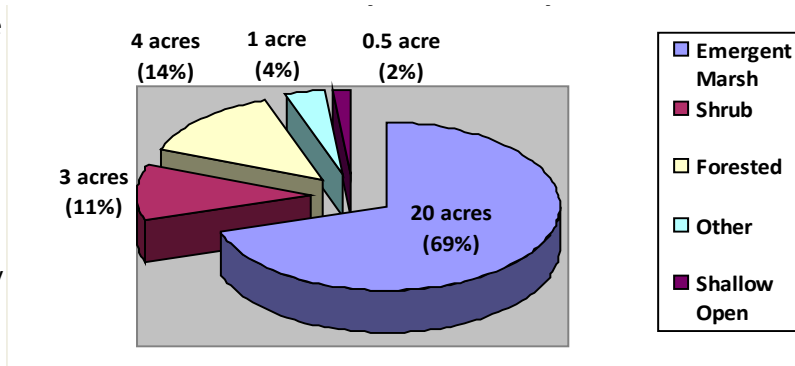
Figure 3: Portion of wetlands affected by Reed Canary Grass.

Little is known about the condition of the remaining wetlands but estimates of reed canary grass infestations, an opportunistic aquatic invasive wetland plant, into different wetland types has been estimated based on satellite imagery. This information shows that reed canary grass dominates 70% of the existing emergent wetlands, which includes wet meadows and marshes, and 15% of the remaining forested wetlands (Figure 3). Reed Canary Grass domination inhibits successful establishment of native wetland species.

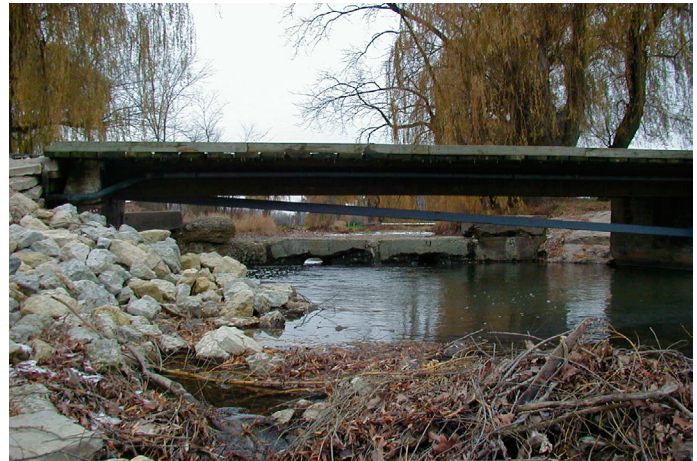
Before Restoration, Kenosha County Club Dam

In 2005, the US Fish and Wildlife Service working with WDNR and several other public and private partners removed a 1950s era dam from the Pike River approximately four miles upstream from the river's Lake Michigan outlet. A four foot high concrete dam was replaced with a series of deep pools and shallow riffles and approximately 800 lineal feet of eroding streambank was stabilized. (USFWS 2009) Salmon and steelhead can now be found above the old dam site during their annual runs from Lake Michigan. The dam had provided a source of irrigation water for a golf course and this function was preserved with the new river pools.

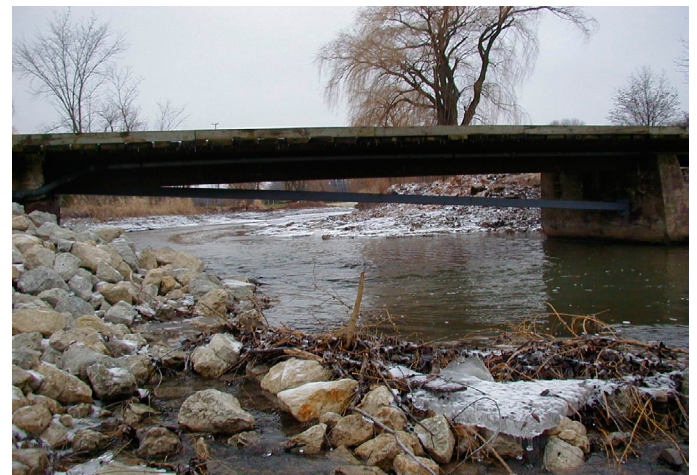
After Restoration, Kenosha County Club Dam
