Eurasian water-milfoil (*Myriophyllum spicatum*)

Pre/Posttreatment Surveys

Sand Lake (WBIC: 2661100)

Barron County, Wisconsin

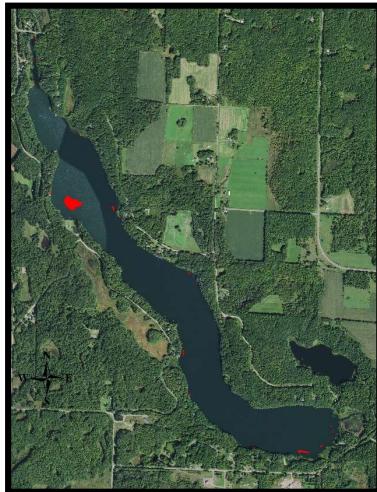
Sand Lake Eurasian water-milfoil beds 9/4/23

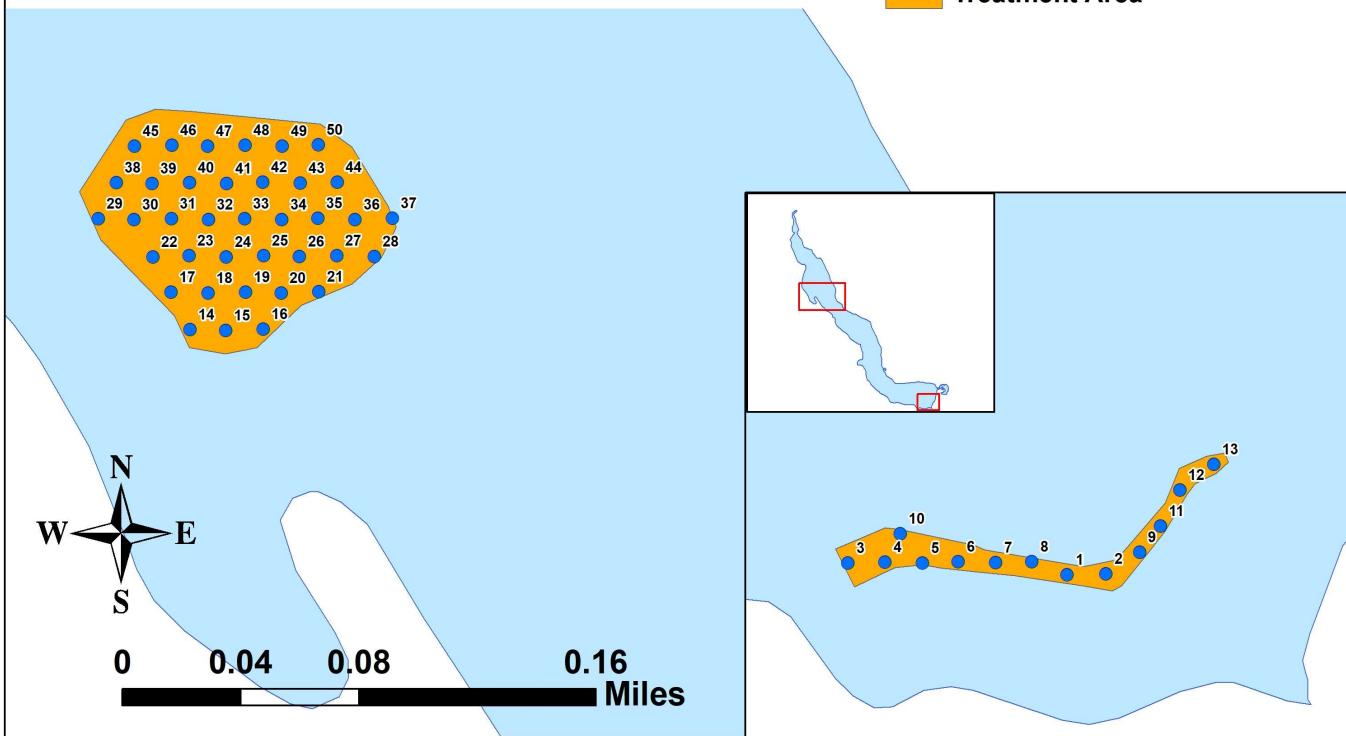
EWM Treatment Areas

Final Treatment Area - 4.63 Acres

The two management areas totaling 4.63 acres (1.44% of the lake's total surface area) were selected after analyzing the late-summer 2023 bed mapping survey which showed they had the highest levels of EWM anywhere on the lake (Figure 3) (Appendix I). After the pretreatment survey again found high levels of Eurasian water-milfoil throughout both areas, the SLMD decided to continue with treatment as initially proposed. Treatment occurred on June 10th with Northern Aquatic Services (Dale Dressel - Dresser, WI) applying ProcellaCor at a rate of 4-6 pdu/acre ft. (160.8 total pdus – at 3.17 fl. oz./pdu) (Table 1). At the time of treatment, the reported water temperature was 65°F and the air temperature was 63°F. Variable winds were clocked at 1-3mph.
