SUBJECT: Roxbury Sanitary District #1, Roxbury Creek (WBIC 1259900), Dane County

### Overview of issue

In preparation for reissuance of the Roxbury Sanitary District #1 permit, staff were requested to do a site visit to determine the appropriate stream classifications for the receiving waters. Roxbury is a continuous discharger, with an annual average design flow of 0.025 MGD (0.039 cfs).

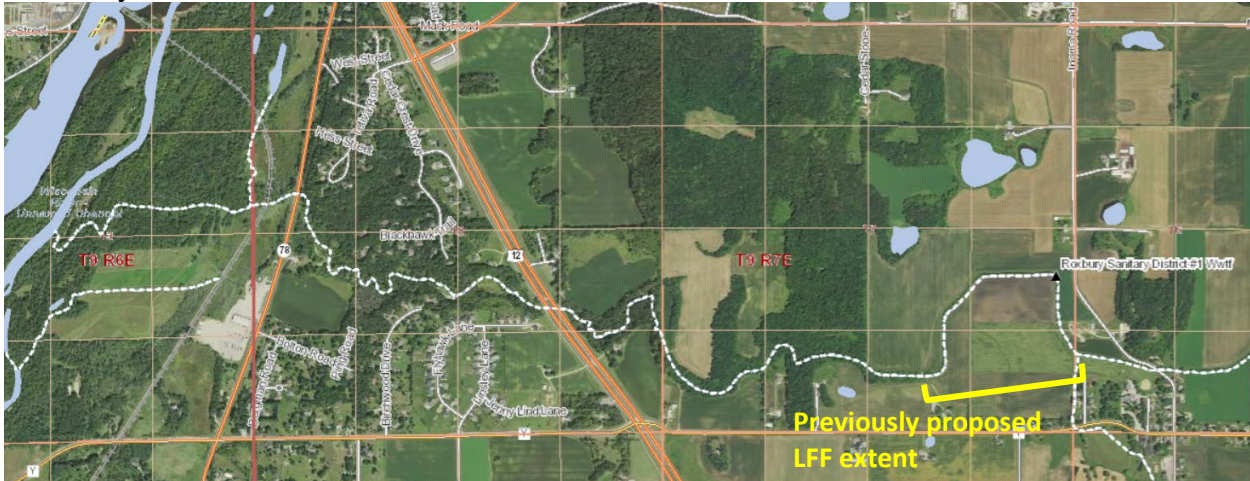
Map 2. Aerial photo (2022) from Water Condition Viewer. The short segment proposed as LFF in 2003 is shown in yellow.

- **1991 LFF recommendation:** Although the 1991 report from Schlessler recommends Limited Forage Fish (LFF) from the outfall approximately 560 meters (0.35 miles) downstream to the north line of the SW ¼ of the SE ¼, Section 17, T9N, R7E, this no longer appears to be appropriate. Stream flows have increased, more fish were caught in the 6 surveys conducted throughout the system for this evaluation, and qualitative and quantitative habitat surveys resulted in Fair to Good scores using the current techniques.

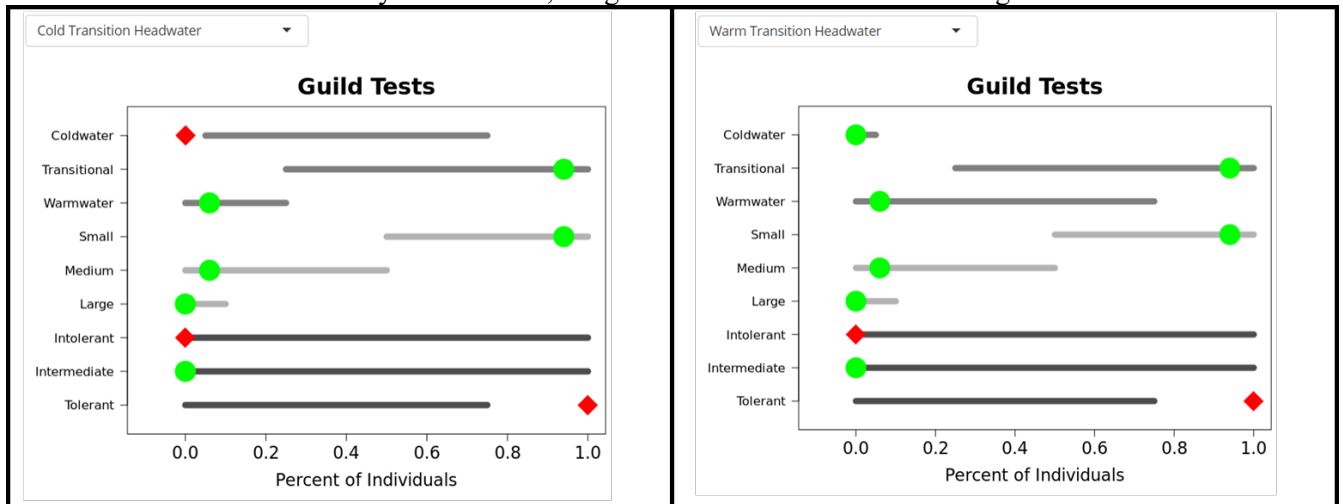
Figure 3. Guild tests for the survey conducted on Roxbury Creek at County Highway KP. The guild test for the modeled Natural Community is on the left, the guild test that fits best is on the right.

- **Segment 2: Roxbury Creek (WBIC 1259900) above Roxbury Sanitary District Outfall**
  - A fish survey was conducted using backpack electrofishing gear on Roxbury Creek upstream of County Highway KP (Map 3, dot 3). This survey was 120 meters long and captured six species. Brook Stickleback and Creek Chub were the most common species at this site. A majority of the fish captured fall within the small stream and transitional species guilds (Table 12). The stream is modeled as a cool-cold headwater, but no coldwater species were captured. The fish assemblage fits best as a warm-transitional headwater; however, both tolerance tests failed because all fish captured are tolerant species (Figure 3). The small stream IBI was applied to the data and received a score of 40, rating Fair (Table 13).

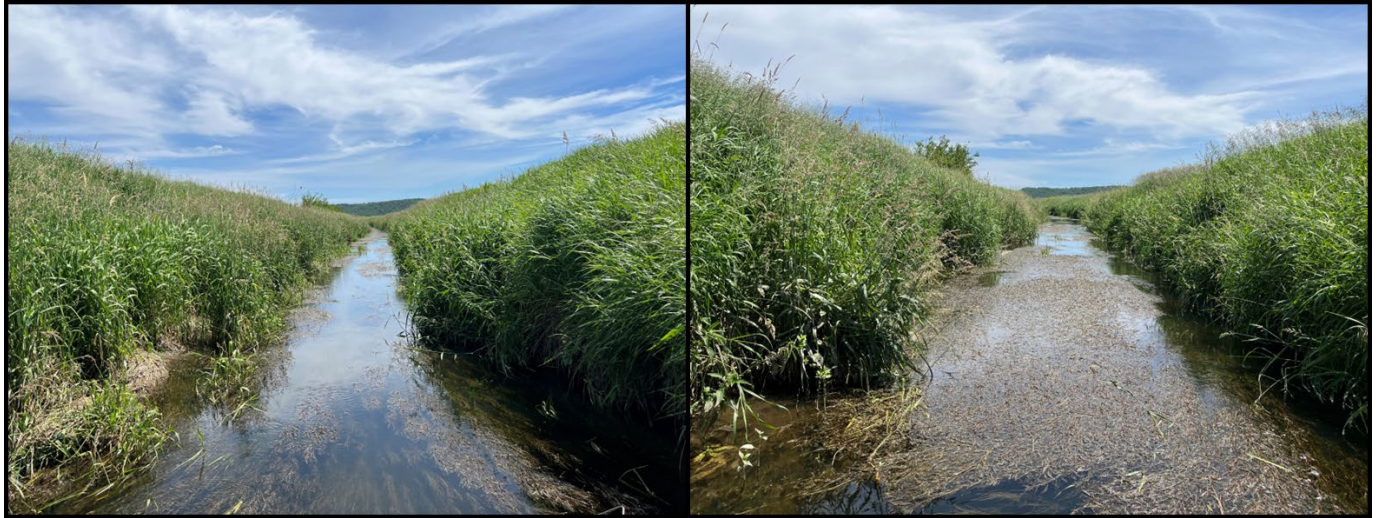
- A qualitative habitat survey was completed on Unnamed tributary (WBIC 1260000) to Roxbury Creek at County Highway Y and received a score of 45, rating Fair (Map 3, dot 1; Table 2; Photo 1). This stream reach consisted exclusively of run habitat with no bends or riffles, leading to Poor ratings for the riffle:riffle or bend:bend ratio and percent pool area metrics. Bottom substrate was primarily sand and silt, with some gravel patches, and received a Poor score. The stream was incised at this location; however, banks were well vegetated, and erosion was limited. There was a narrow buffer between the stream and the surrounding crop fields. The qualitative habitat score was boosted by Excellent ratings for width:depth ratio and fish cover, both of which are reflective of the agricultural influences of this site, where the creek is forced into a modified channel that is narrow and deep and excess nutrients are likely fueling the plant growth. The silty substrate observed at this site is also conducive for plant growth. Flow was not measured due to the dense aquatic vegetation found throughout this reach.

Photo 1. Beginning (left photo) and end (right photo) of fish and qualitative habitat survey on Unnamed tributary (WBIC 1260000) to Roxbury Creek at County Highway Y (Map 3, dot 1).

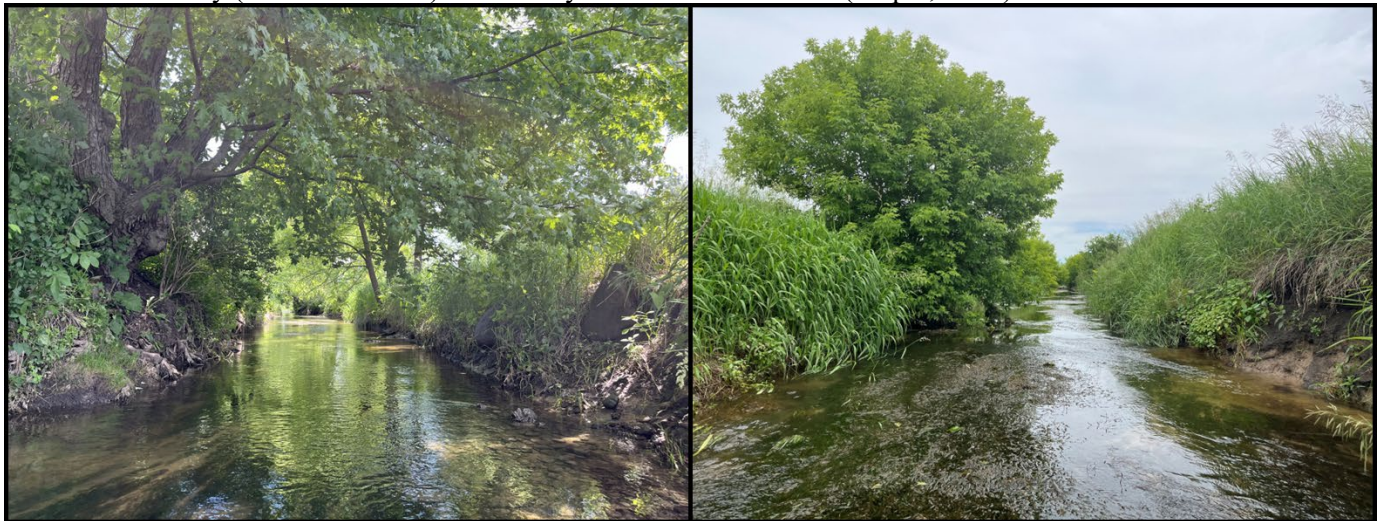
- An additional survey was conducted on Unnamed tributary (WBIC 1260000) to Roxbury Creek at Inama Road, approximately 350 meters (0.22 miles) upstream of the confluence with mainstem Roxbury Creek (Map 3, dot 2; Photo 2). A qualitative habitat survey was conducted and received a score of 48, rating Fair (Table 3). This downstream site was slightly more diverse than the upstream survey reach, with a few riffles and an area with a plunge pool where water from a tile drain enters the stream. The riparian corridor had a narrow buffer and primarily flowed through agricultural fields and through a small residential area near Inama Road. Bottom substrate consisted mostly of sand and silt. Gravel, rubble/cobble, and boulders were also present, but limited. Banks were relatively steep and eroded, leading to a Fair rating for the bank erosion metric. Similar to the upstream reach, this portion of the Unnamed tributary received Excellent ratings for width:depth ratio and fish cover, due to the channelized condition of the stream and the abundance of instream vegetation. Despite being an “Unnamed tributary” to Roxbury, this stream appears to make up a majority of the flow once it meets Roxbury Creek (Table 1).

Photo 2. Beginning (left photo) and end (right photo) of fish and qualitative habitat survey conducted on Unnamed tributary (WBIC 1260000) to Roxbury Creek at Inama Road (Map 3, dot 2).

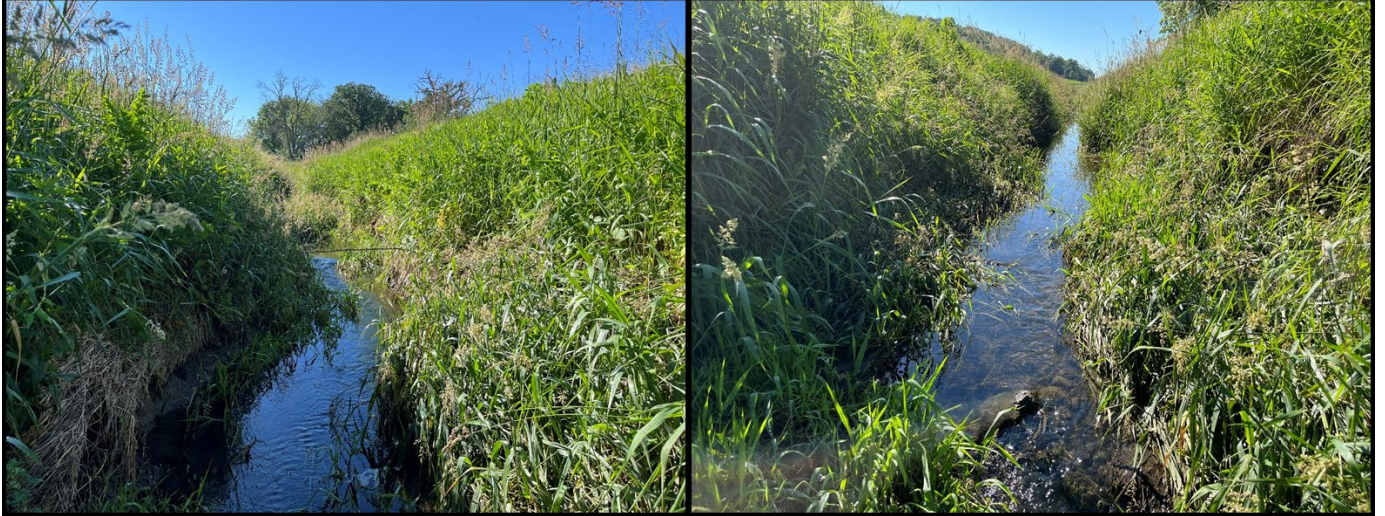
- A qualitative habitat survey was completed on Roxbury Creek upstream of County Highway KP (Map 3, dot 3; Photo 3). This stream reach received a score of 53, rating Good (Table 4). The riparian corridor had a narrow buffer and adjacent land use was pasture and row crops. Bank erosion was moderate, with a mix of steep, raw banks and some areas that were grassed and stable, rating Fair. The bottom substrate was mostly gravel, with sand and silt. Habitat diversity was low and pools were limited. This channelized reach received an Excellent width:depth ratio score, which is common for ditched systems. Fish cover also rated Excellent and included a substantial amount of overhanging vegetation and a few undercut banks.

Photo 3. Beginning (left photo) and end (right photo) of fish and qualitative habitat surveys on Roxbury Creek at CTH KP (Map 3, dot 3).

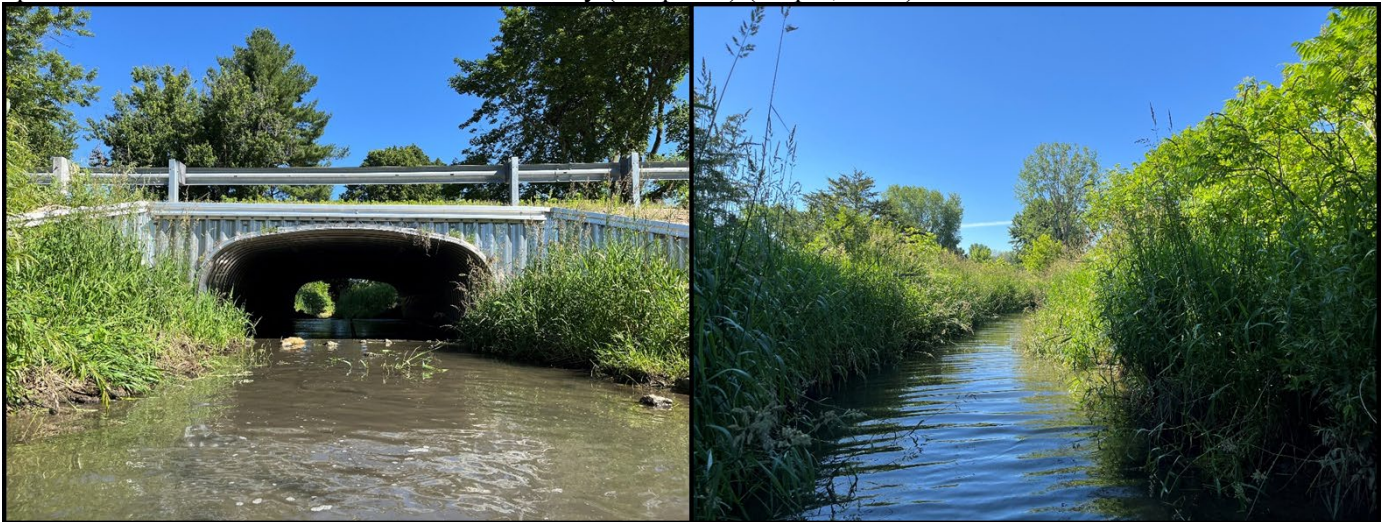
- An additional qualitative habitat survey was conducted on Roxbury Creek upstream of County Highway Y (Map 3, dot 4; Photo 4). This survey was heavily impacted by an improperly set culvert at the County Highway Y road crossing, which is impounding water and also contributing to sedimentation upstream (Photo 4, left image). This stream reach received a qualitative habitat score of 50, rating Good (Table 5). The stream flows primarily through an agricultural area, with a moderate buffer width and limited bank erosion. This stream reach is channelized, and the monotonous habitat lacks riffles, pools, or bends. The bottom substrate was primarily silt. Clay and gravel were also present but were completely covered by a thick layer of silt. Fish cover rated Excellent and included some woody debris and abundant overhanging vegetation. The flow measurement (1.74 cfs) was lower than expected and may have been impacted by the improperly set culvert. Efforts were made to select a site to measure flow upstream of its influence; however, a suitable site was difficult to find. There are obvious differences in stream characteristics upstream and downstream of the culvert; where the stream is wider and more stagnant upstream, and narrower and swifter downstream (Photo 5).

Photo 4. Improperly set culvert upstream of County Highway Y road crossing on Roxbury Creek. Right photo taken near the beginning of the fish survey on Roxbury Creek upstream of CTH Y. Roxbury Creek upstream of CTH Y near the end of the fish survey (left photo) (Map 3, dot 4).

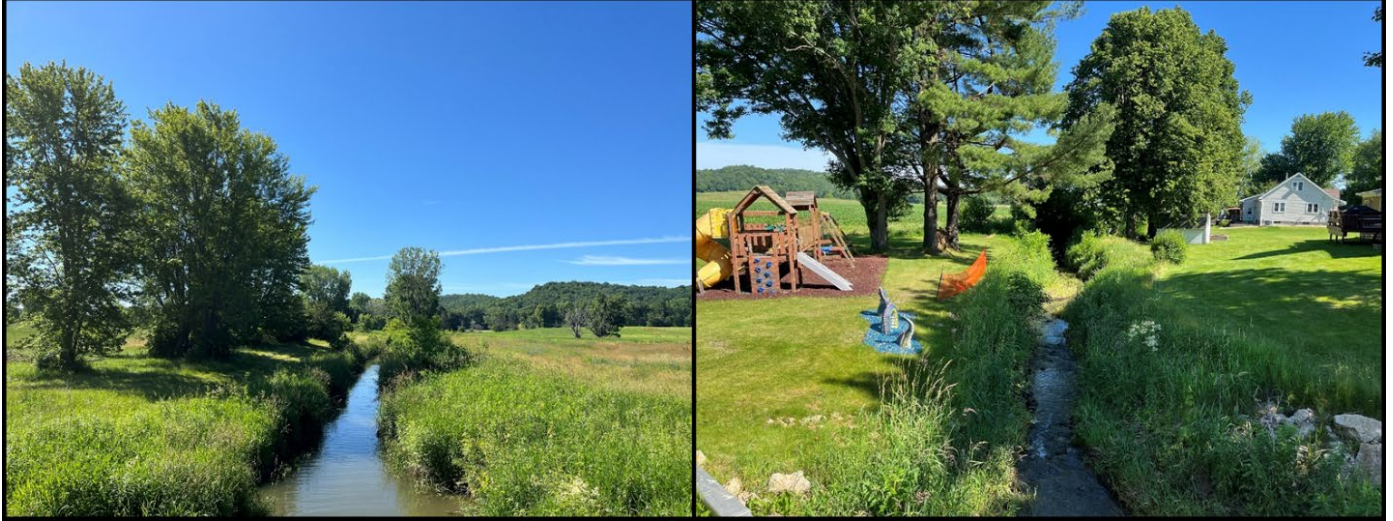
Photo 5. Roxbury Creek upstream of County Highway Y (left photo) and downstream of CTH Y (right photo). Note the difference in stream width and characteristics upstream versus downstream of CTH Y.

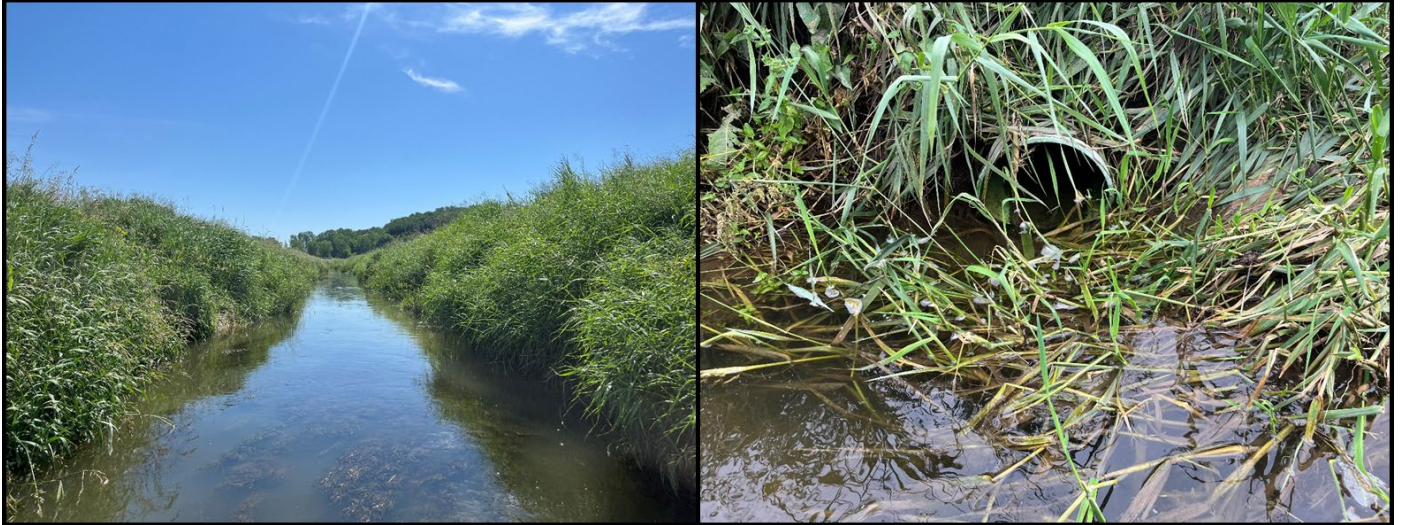
- A quantitative habitat survey was conducted and began approximately 180 meters downstream of the Roxbury Sanitary District Outfall, and ended at the outfall (Map 3, dot 5; Photos 6 and 7). This survey received a score of 40, rating Fair (Table 6). Bottom substrate consisted mostly of sand and silt, but also included clay and detritus to a lesser degree and sparse gravel that was completely embedded in the fine substrates. Fish cover was common throughout the reach, primarily in the form of submerged macrophytes, but overhanging vegetation was also common. The stream was heavily vegetated. The plant community was dominated by non-native Curly-leaf pondweed, but other native aquatic plants including Waterweed and Sago pondweed were present in low abundances. The stream corridor had a narrow buffer with a mowed path around the field edge, and was surrounded by agricultural fields. Habitat was monotonous and consisted of a run with no riffles or pools present.

Photo 6. Beginning of fish and quantitative habitat survey (left photo) on Roxbury Creek below the Roxbury Sanitary district outfall and the outfall pipe at upstream end of fish and quantitative habitat survey (right photo) (Map 3, dot 5).

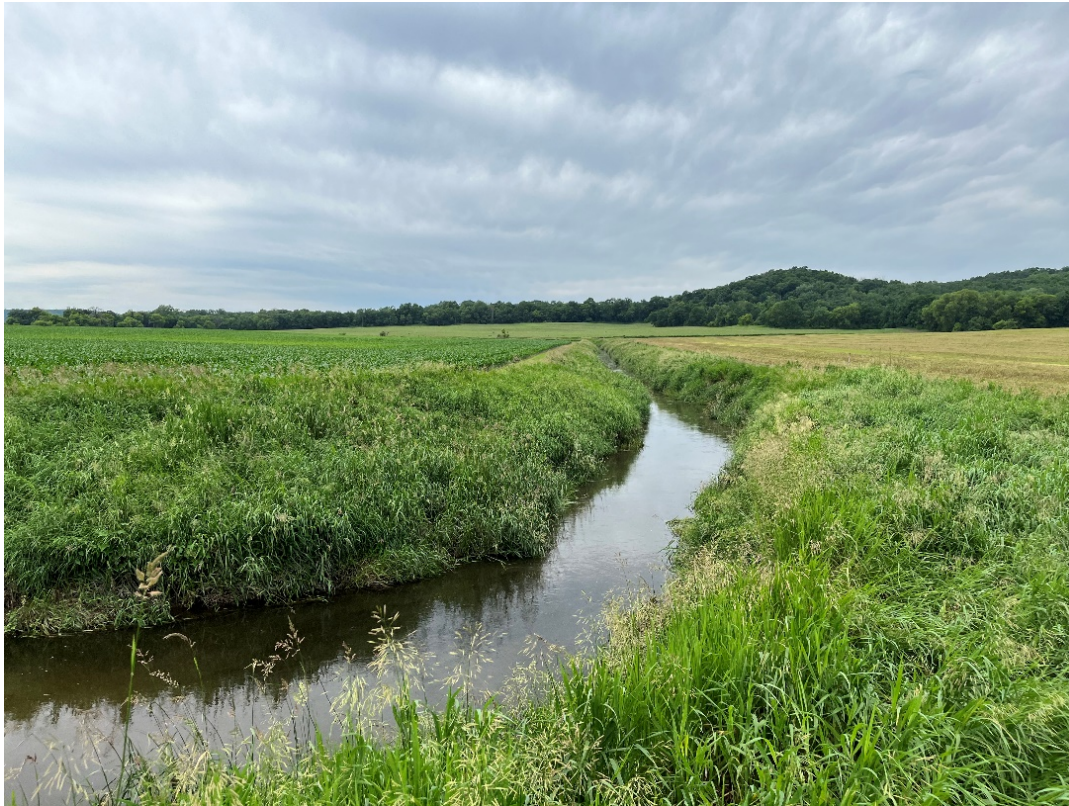
Photo 7. Roxbury Creek from wastewater treatment plant outfall and downstream. Overall view of survey reach.

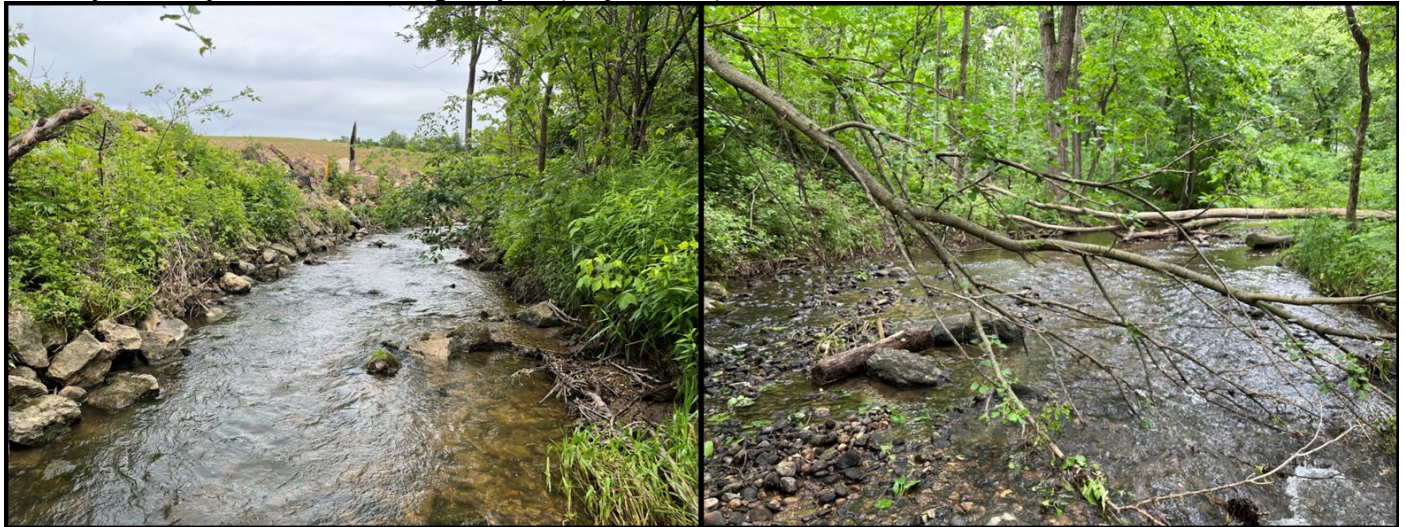
- A qualitative habitat survey was conducted on Roxbury Creek upstream of where it crosses STH 12, approximately 1.6 miles downstream from the Roxbury Sanitary District outfall (Map 3, dot 6; Photo 8). This qualitative habitat survey scored 78, rating Excellent (Table 7). At this location, the stream had a steeper gradient than the other sites and it flowed through a well-protected, forested riparian corridor with limited bank erosion. The stream exhibits a more natural, meandering channel and the bottom substrate was primarily gravel and rubble cobble with limited fine sediments. There were diverse habitats in this stream segment; riffles were common, some pools were present, and there was a good amount of fish habitat including woody debris, log jams, and root wads.

Photo 8. Beginning (left photo) and end (right photo) of fish and qualitative habitat surveys conducted on Roxbury Creek upstream of State Highway 12 (Map 3, dot 6).
