**CORRESPONDENCE/MEMORANDUM**

DATE: 1-22-2025 FILE REF: Briess Industries, Inc. Chilton

SUBJECT: Briess Industries-Irish Road, Unnamed Tributary (No WBIC) to South Branch Manitowoc River, (WBIC 77900), Chilton, Calumet County

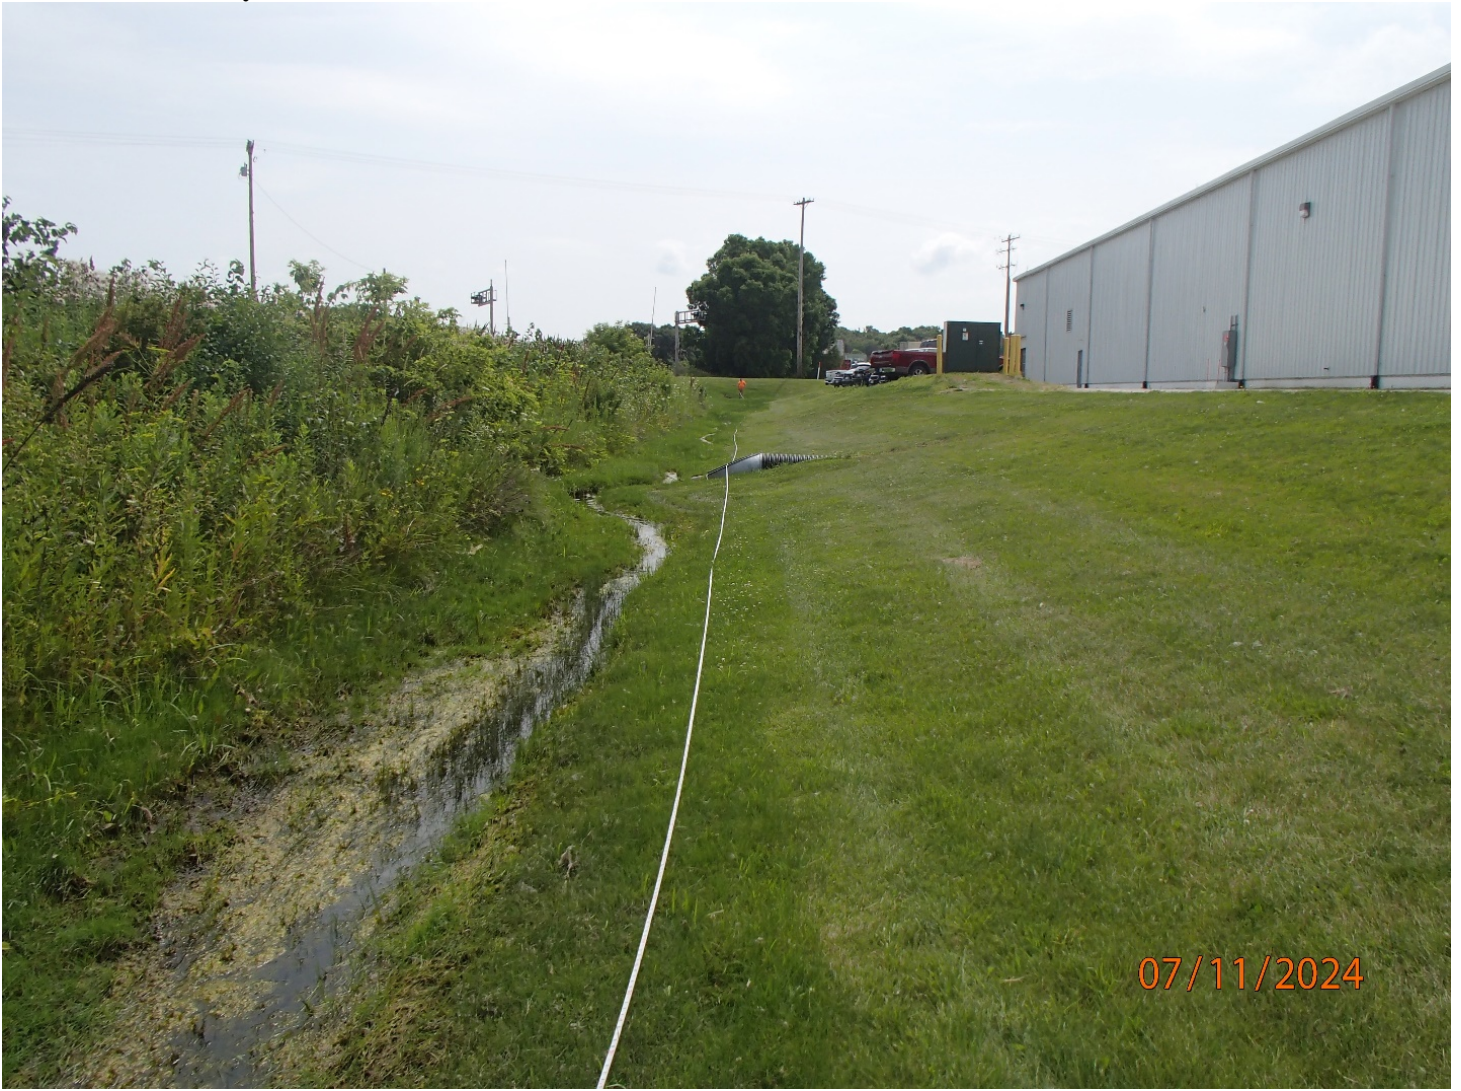
- Fish and habitat surveys were conducted in the Unnamed Tributary beginning 100 meters downstream (north-west) of Irish Road (starting at Photo 1 location). No fish were captured during the survey. The average stream width was 0.3 meters. The Dissolved Oxygen concentration in the tributary was 2.61 mg/L, with 31.3%

Saturation. Flow was measured at 0.00 cubic meters per second at the Irish Road culvert. The Qualitative Habitat survey scored 35 or Fair. Scanned data sheets are attached below.

**Photo 1: Unnamed Tributary to South Branch Manitowoc River facing East toward Irish Road. Photo taken by David Bolha on July 11<sup>th</sup>, 2024.**

- **Segment 1:** The Unnamed Tributary that flows out of the two detention ponds had little to no measurable flow, no fish present, fair qualitative habitat, and was disconnected from the South Branch Manitowoc River via the Chilton storm sewer system. The appropriate Natural Community is a Macroinvertebrate stream with a Limited Aquatic Life Designated Use.

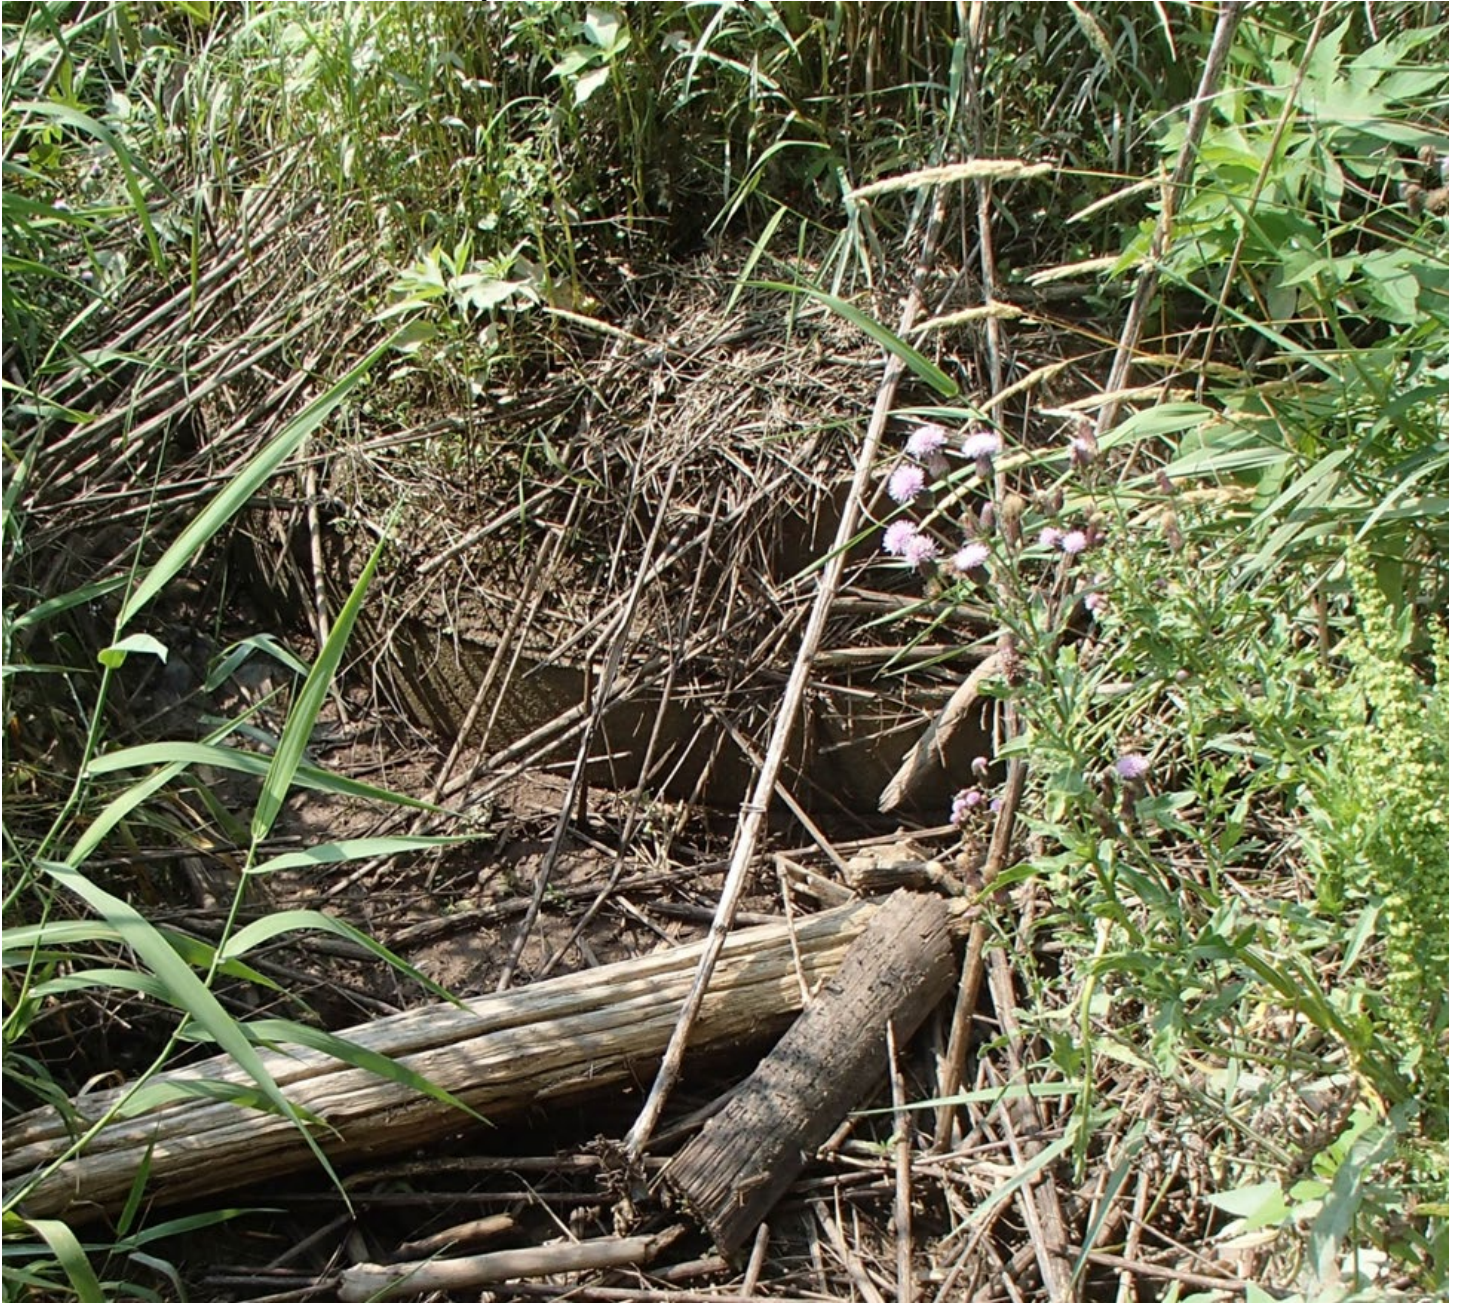
**Photo 2: Manhole 7110. Photo taken by David Bolha on July 11<sup>th</sup>, 2024.**

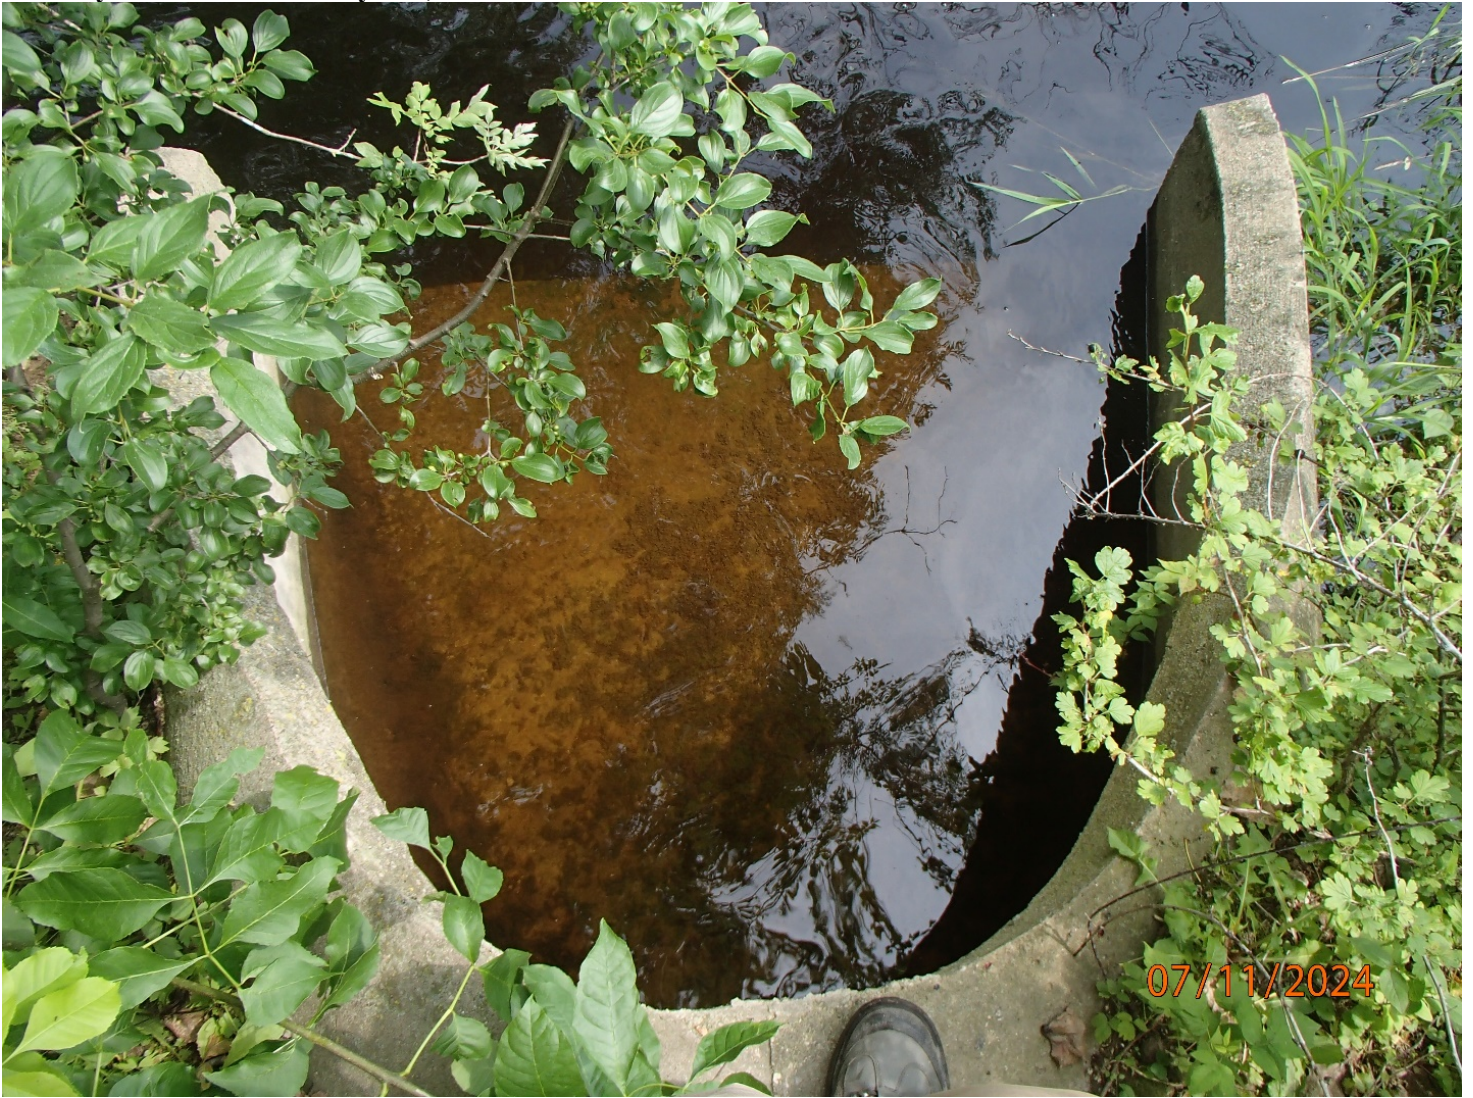
**Photo 3: Chilton Storm Sewer/Unnamed Tributary outlet to the South Branch of the Manitowoc River. Photo taken by David Bolha on July 11<sup>th</sup>, 2024.**

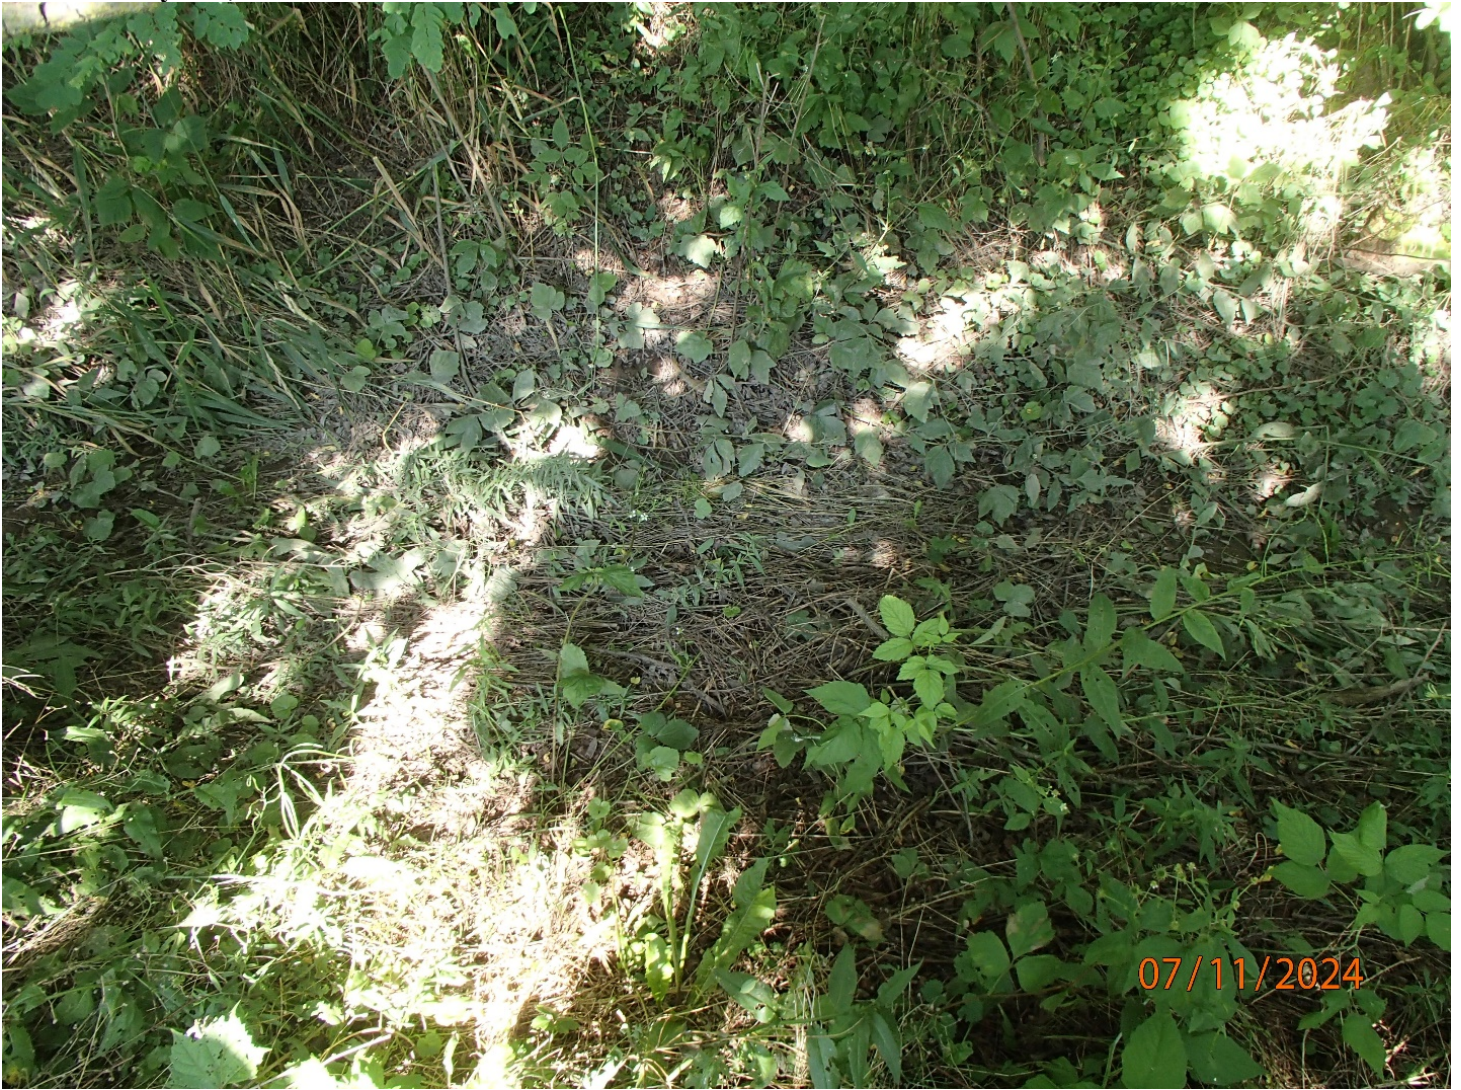
**Photo 4: Surface ditch above storm sewer with indications of overflow, sediment deposits. Photo taken by David Bolha on July 11<sup>th</sup>, 2024.**

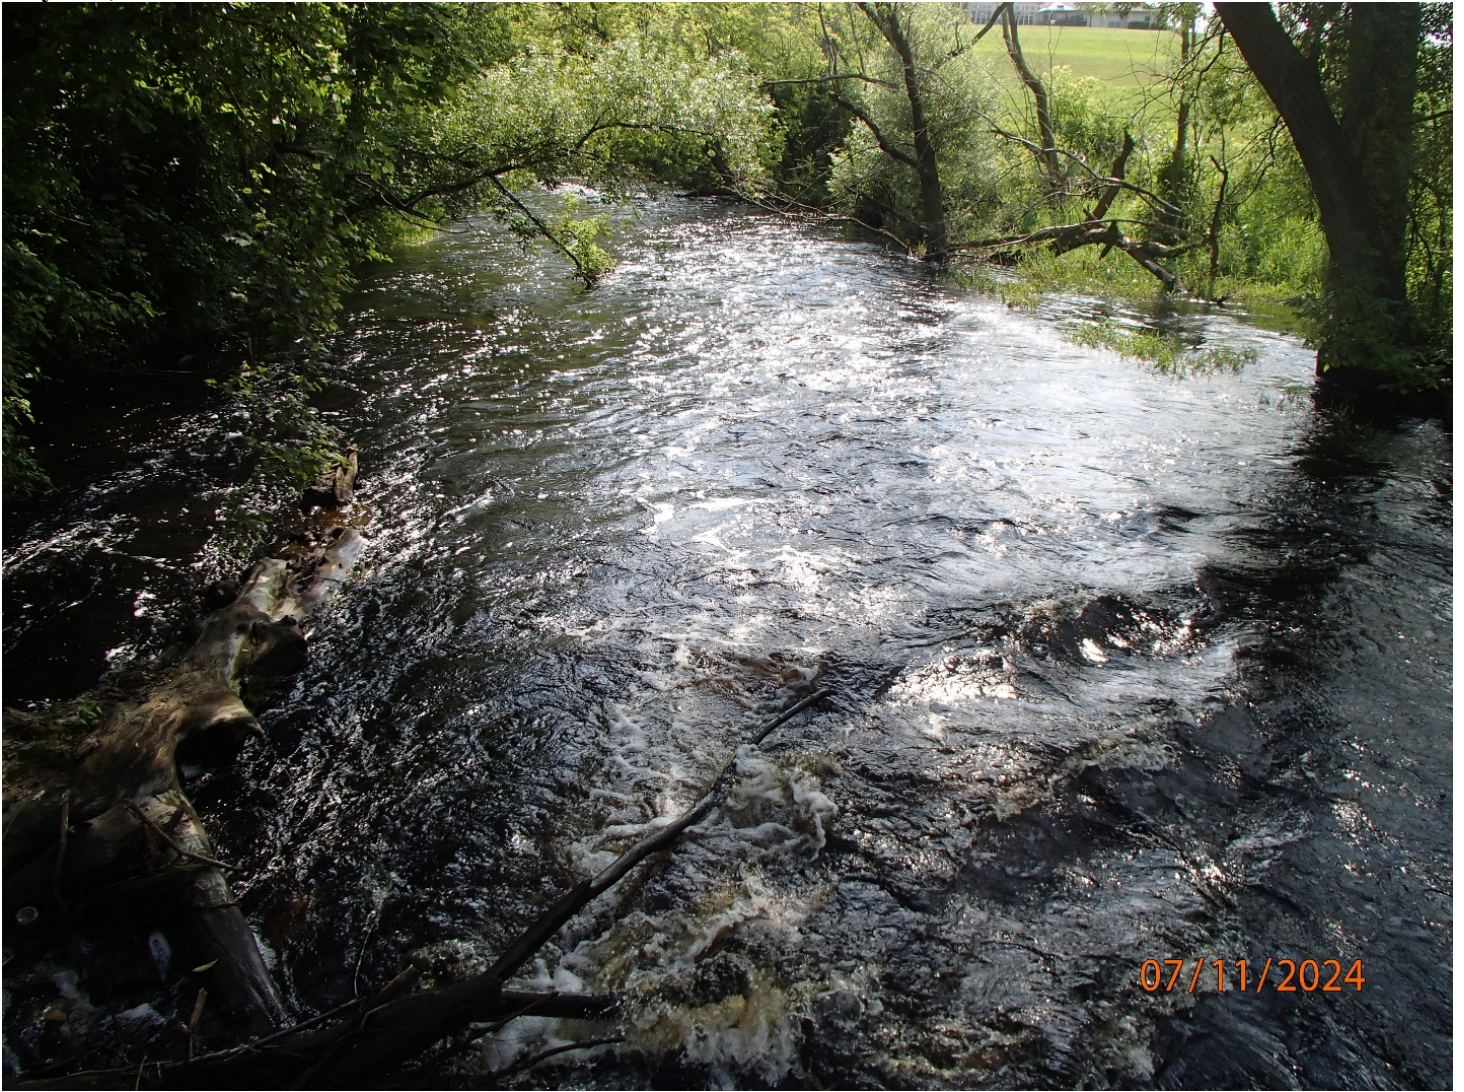
- Segment 2: South Branch Manitowoc River (WBIC 77900) (Photo 5)
  - No fish or habitat surveys were conducted on the South Branch Manitowoc River during this evaluation.

**Photo 5: South Branch Manitowoc River at Confluence with Unnamed Tributary. Photo taken by David Bolha on July 11<sup>th</sup>, 2024.**

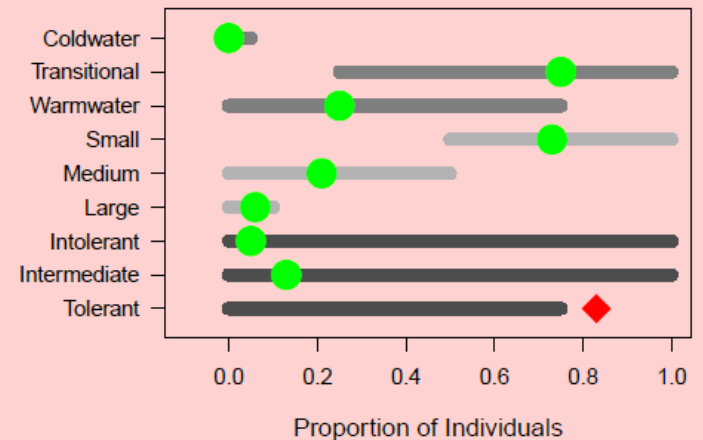
The NC shown below was considered but NOT selected Warm Transition Headwater
