**VILLAGE OF OREGON**

**URBAN SERVICE AREA AMENDMENT REQUEST: FEATHERWOOD TRAIL**

JULY 13, 2026

VANDEWALLE & ASSOCIATES

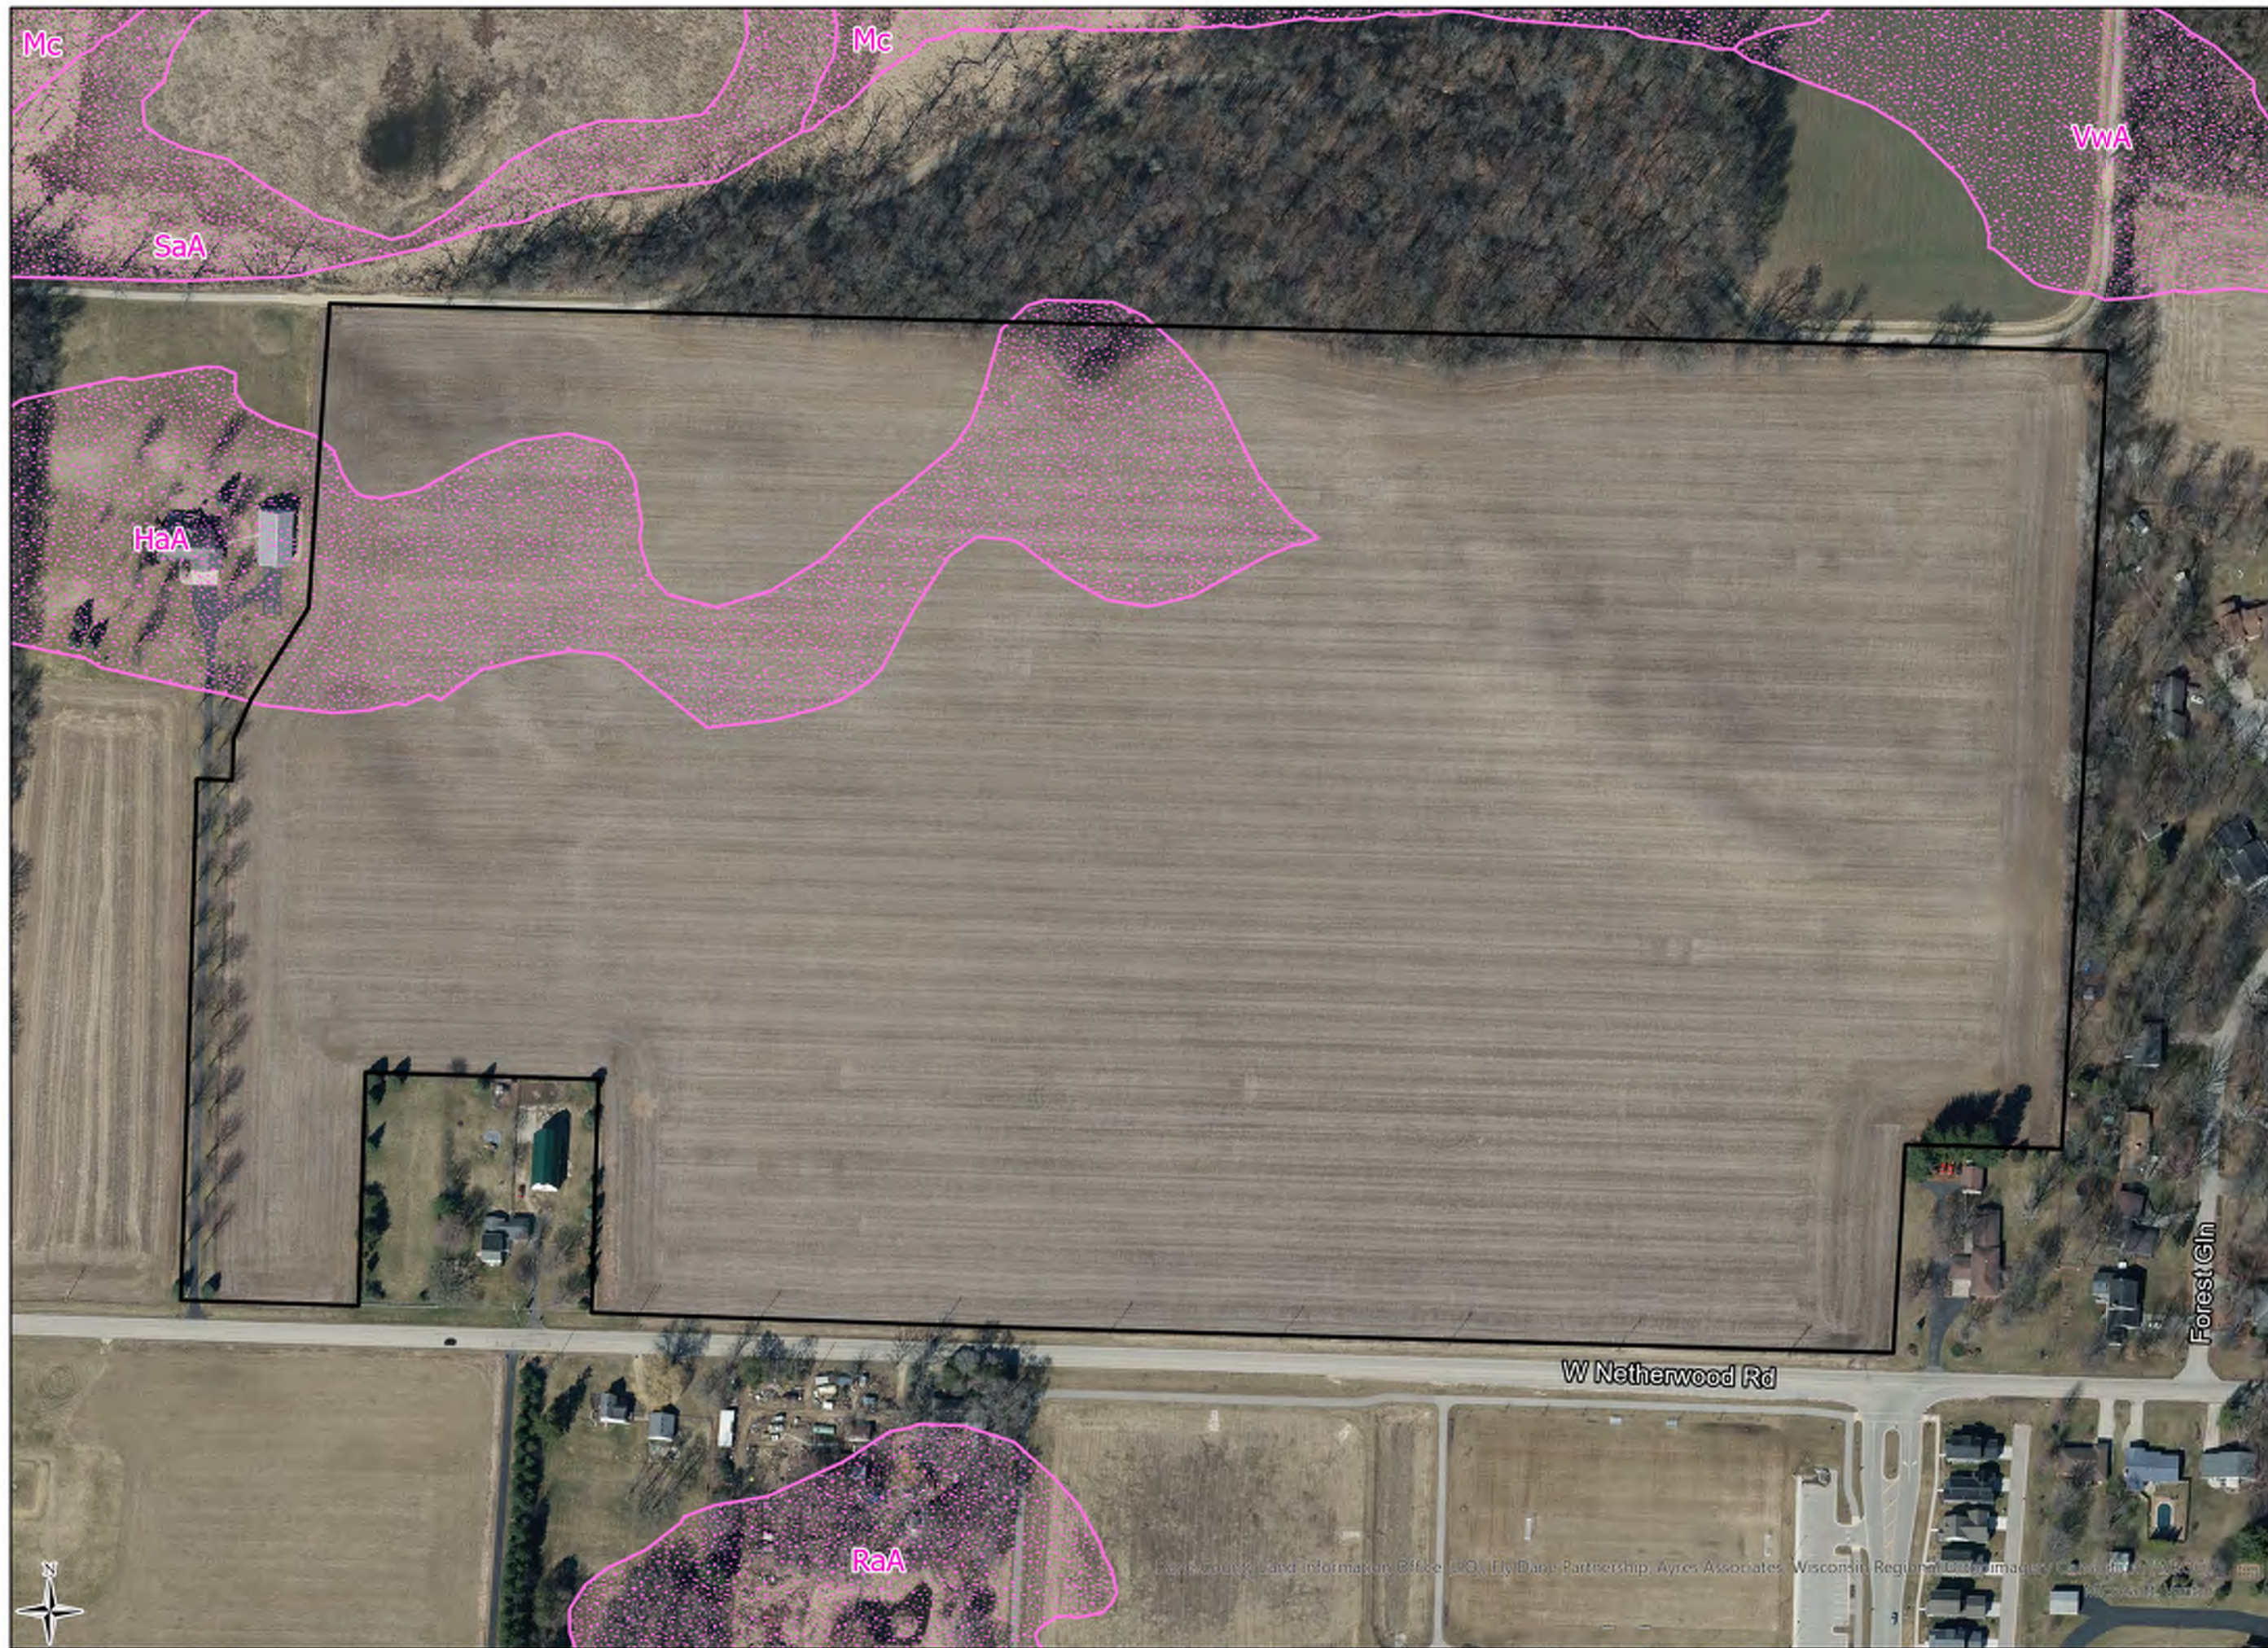
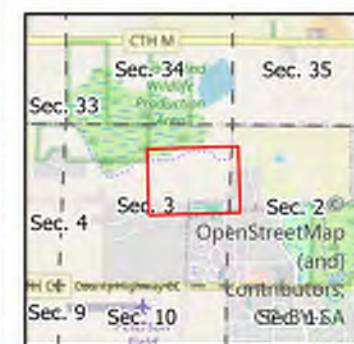
Figure 3. NRCS  
Hydric Soils  
Featherwood Trails  
Project # 20261736  
T5N, R9E, S3  
T Oregon, Dane Co

Soils mapped by the NRCS Soil Survey within the Study Area and their hydric status are summarized in Table 1. Wetlands identified during the field investigation are located within mapped non-hydric soils (Figures 3 and 4, Appendix A).

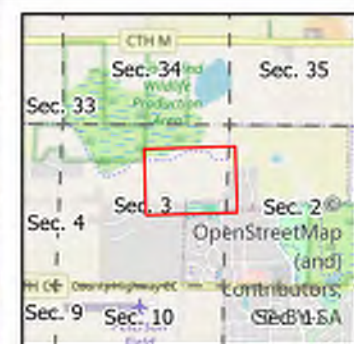
Figure 5. Wisconsin  
Wetland Inventory  
Featherwood Trails  
Project # 20261736  
T5N, R9E, S3  
T Oregon, Dane Co

The Wisconsin Wetlands Inventory (WWI) mapping (Figure 5, Appendix A) does not depict any wetlands within the Study Area.

No waterways, watercourses, or waterbodies are mapped within the Study Area (Figure 5, Appendix A).

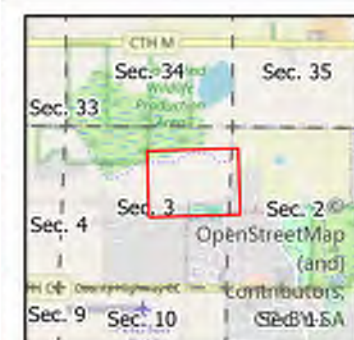
Figure 6. Color-Stretch  
 Digital Elevation Model  
 Featherwood Trails  
 Project # 20261736  
 T5N, R9E, S3  
 T Oregon, Dane Co

The topography within the Study Area is rolling. A linear ridge and hills/knolls are present in the northeastern and northcentral portions, respectively. A topographic high of approximately 991 feet above mean sea level is present on a ridge in the northeastern portion of the Study Area, and a topographic low of approximately 952 feet above mean sea level is present in the northeast corner (Figures 2, 6, and 7, Appendix A). Land use within

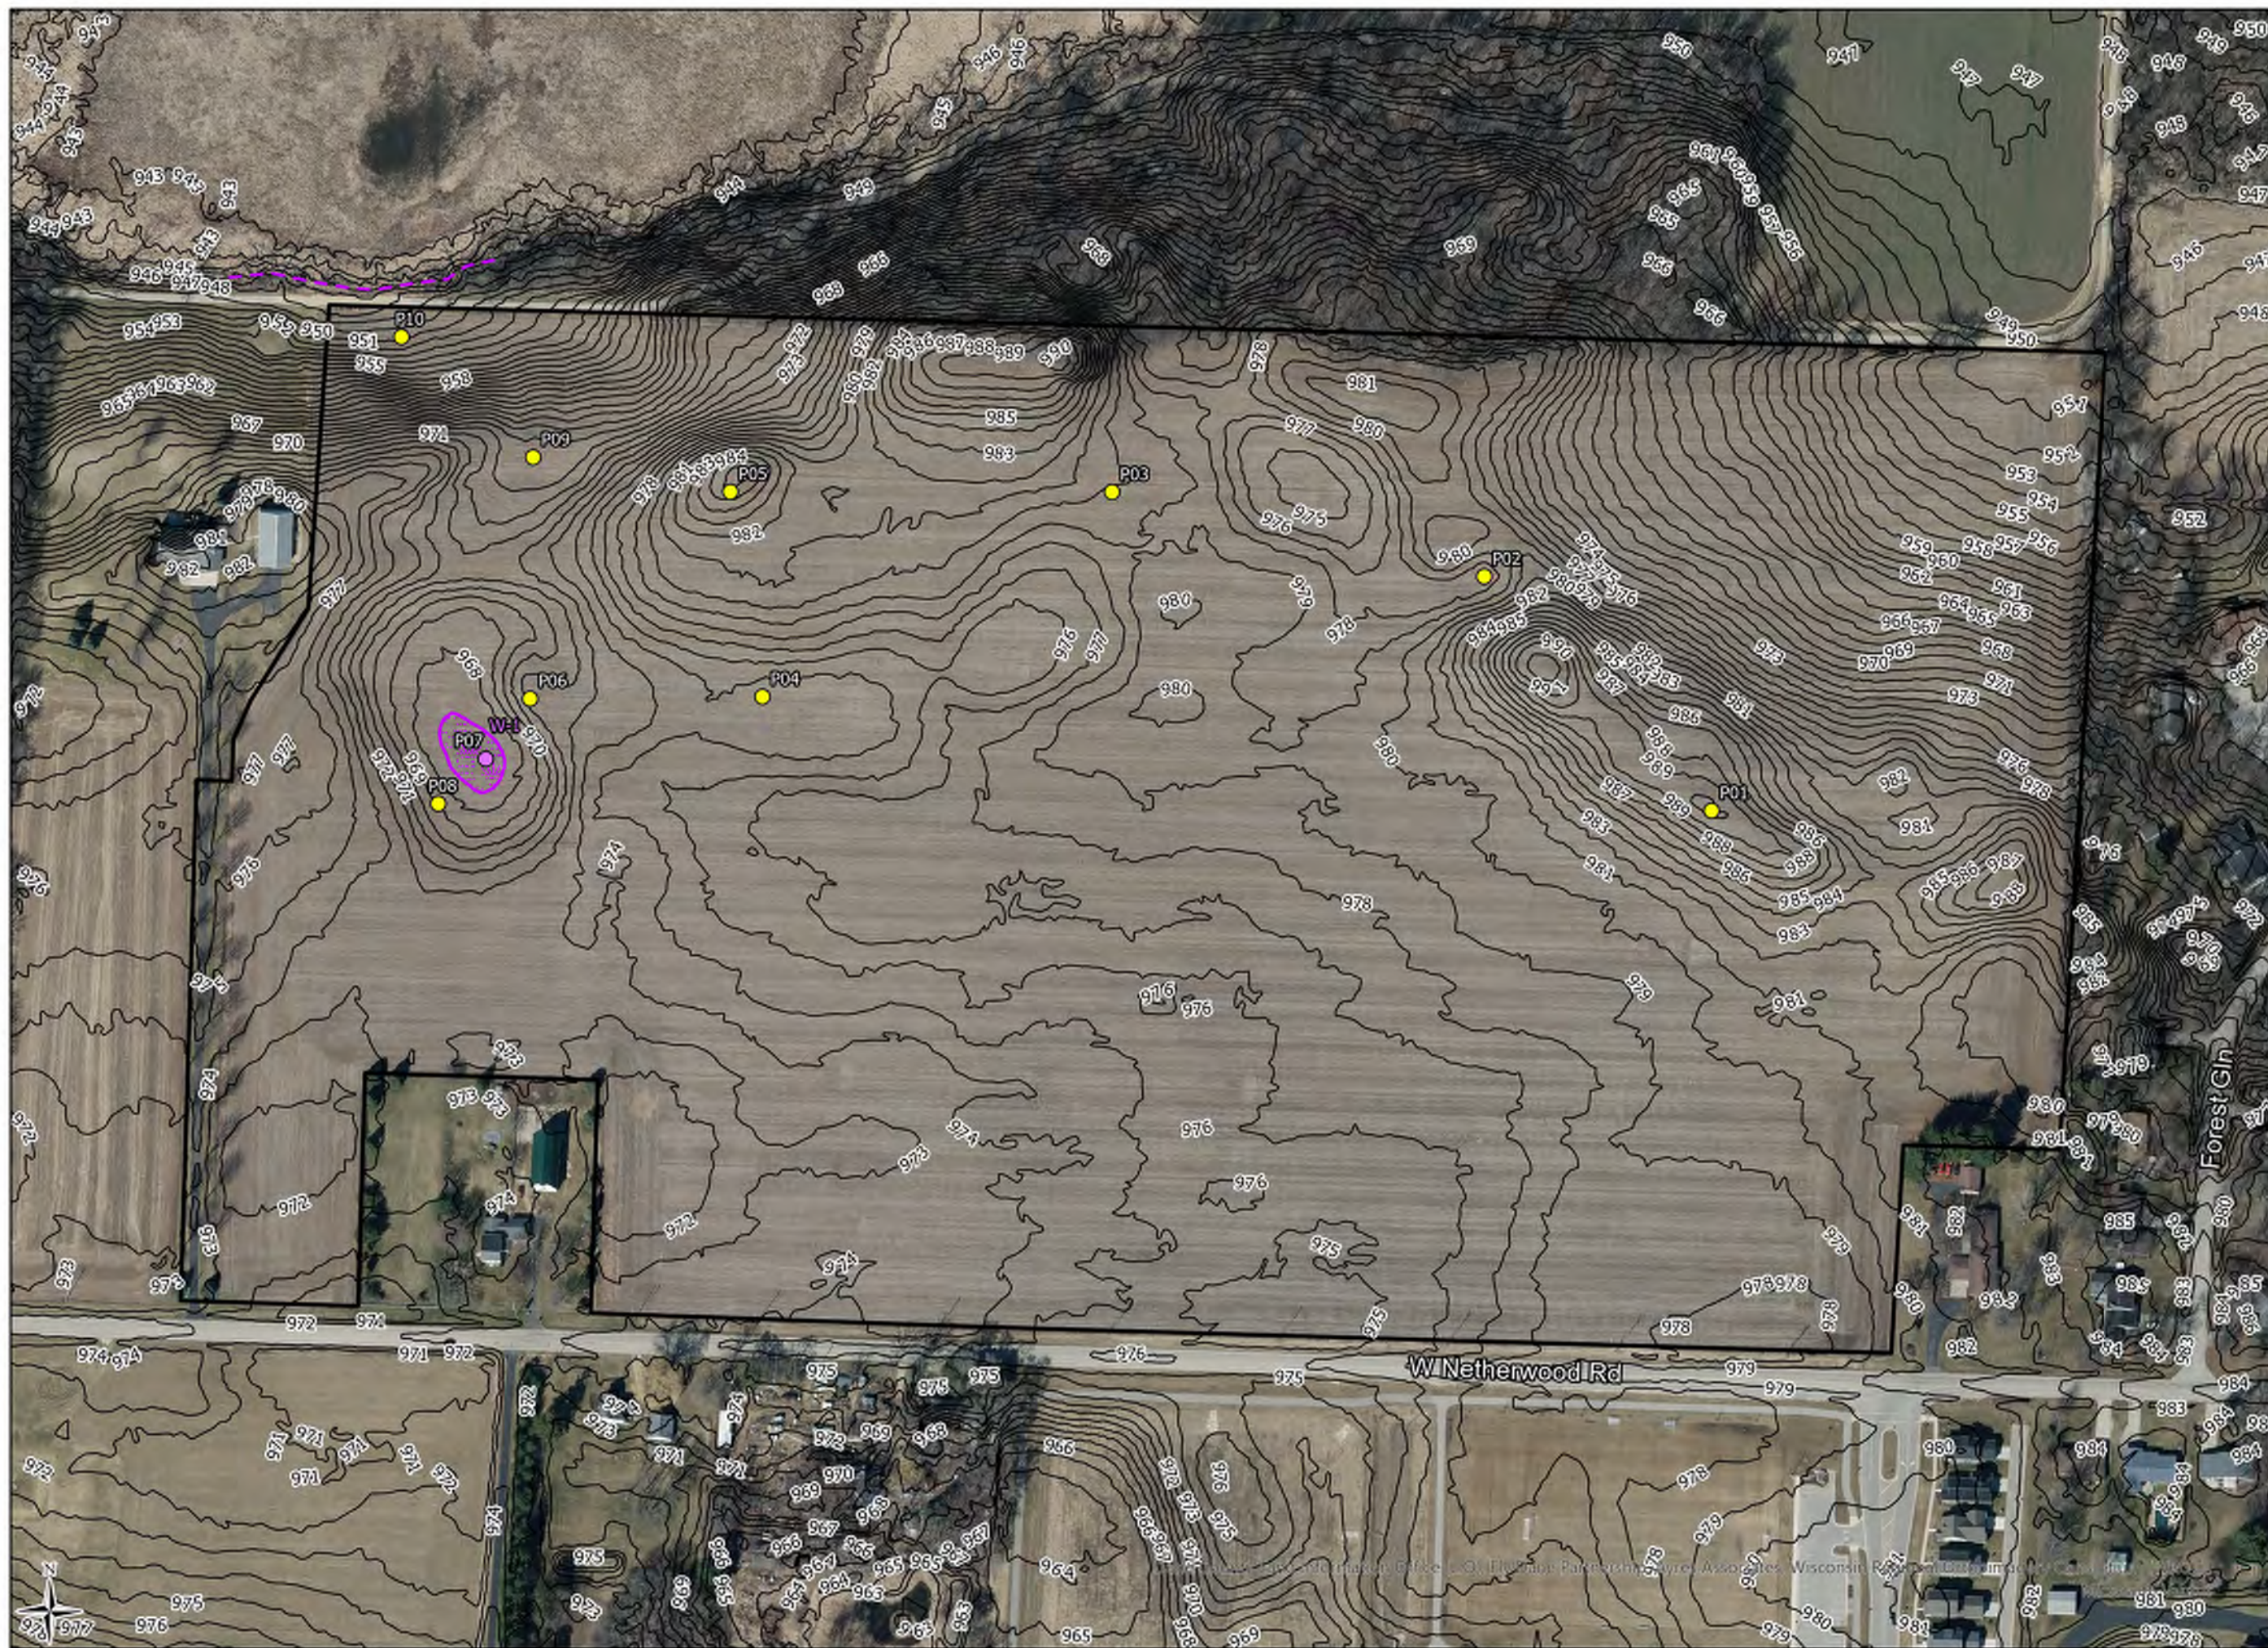
- Study Area (66.12 ac)
- Dane Co 1' Contours
- Field Delineated Wetlands (0.13 ac)
- Approx. Offsite Wetland Boundaries

One (1) wetland was identified and delineated within the Study Area. Wetland determination data sheets (Appendix C) were completed at ten (10) sample points that were representative of the wetland and upland conditions near the boundary and where potential wetlands may be present based on the desktop review and field reconnaissance. Appendix D provides photographs, typically at the sample point locations of the wetlands and adjacent uplands. Photographs providing evidence of growing season are also included. The wetland boundary and sample point locations are shown on Figure 7 (Appendix A) and the wetland is summarized in Table 2 and detailed in the following sections.

The Depleted Matrix (F3) hydric soil indicator was observed at the sample point completed within W-1 (sample point P07). Thus, the hydric soil parameter was met.

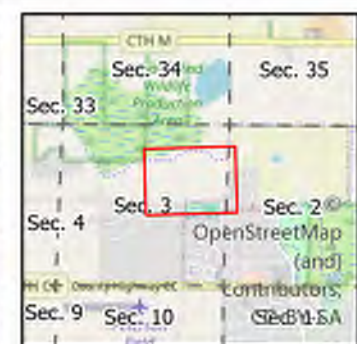
#### Figure 7. Field Delineated Wetlands

One (1) wetland area measuring approximately 0.13 acre was delineated and mapped within the Study Area (Figure 7, Appendix A).

One (1) wetland area was delineated and mapped within the 66.12-acre Study Area (Figure 7, Appendix A). The wetland, which may be classified as a farmed wet meadow, measures approximately 0.13 acre within the Study Area. No waterways, watercourses, or waterbodies were observed.

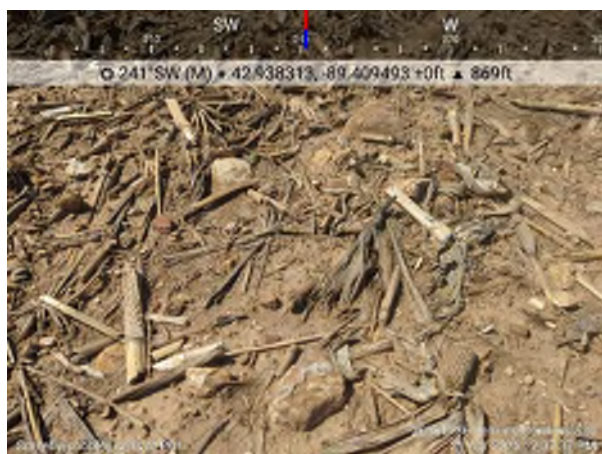
**Photo #41** Gravelly/cobbley soils at P01

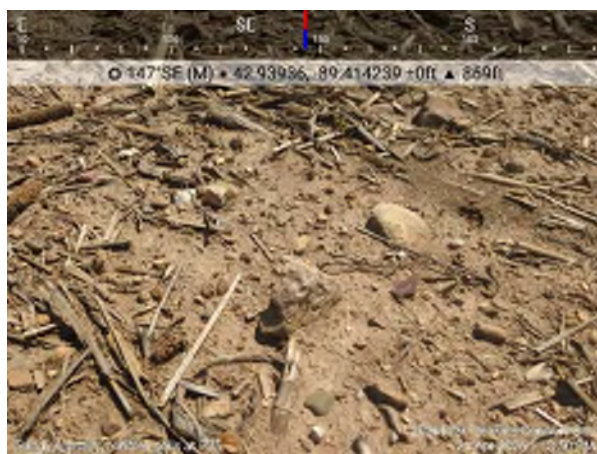
**Photo #42** Gravelly/cobbley soils at P05

No hydric soil indicators observed. Poorer gravelly/sandy/cobbly soils present upslope to the south.

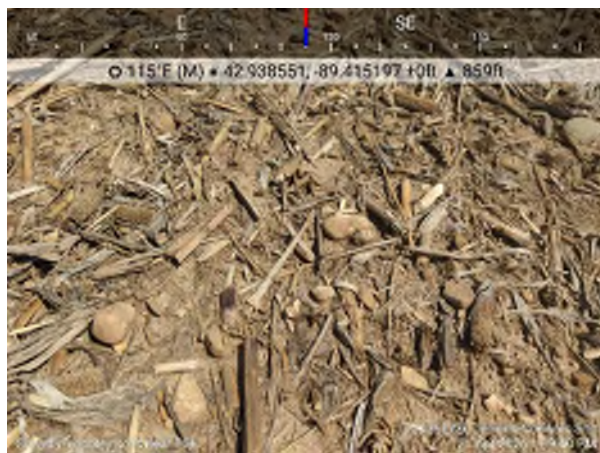
**Photo #43** Gravelly/cobblely soils at P06

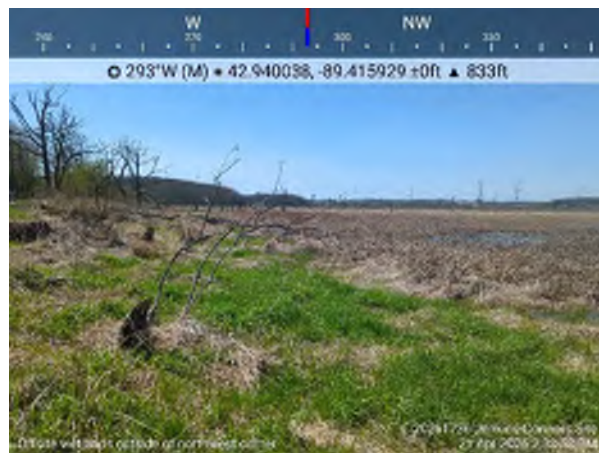
**Photo #44** Offsite wetlands northwest of site

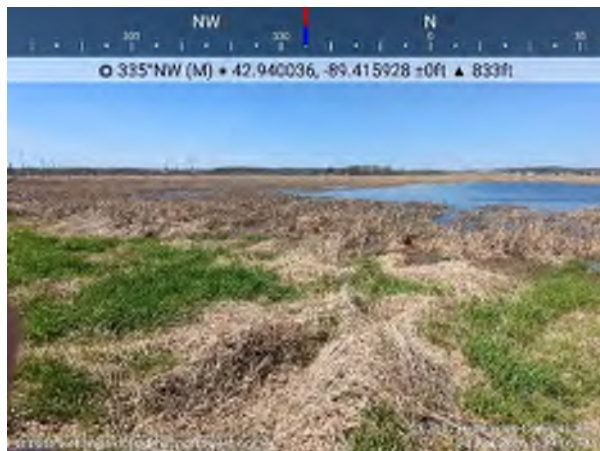
**Photo #45** Offsite wetlands northwest of site

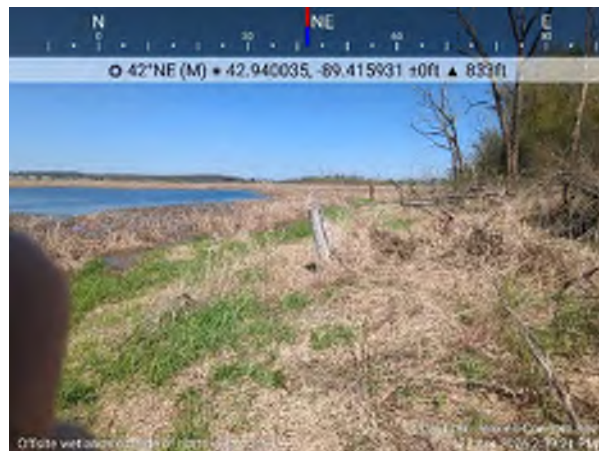
**Photo #46** Offsite wetlands northwest of site

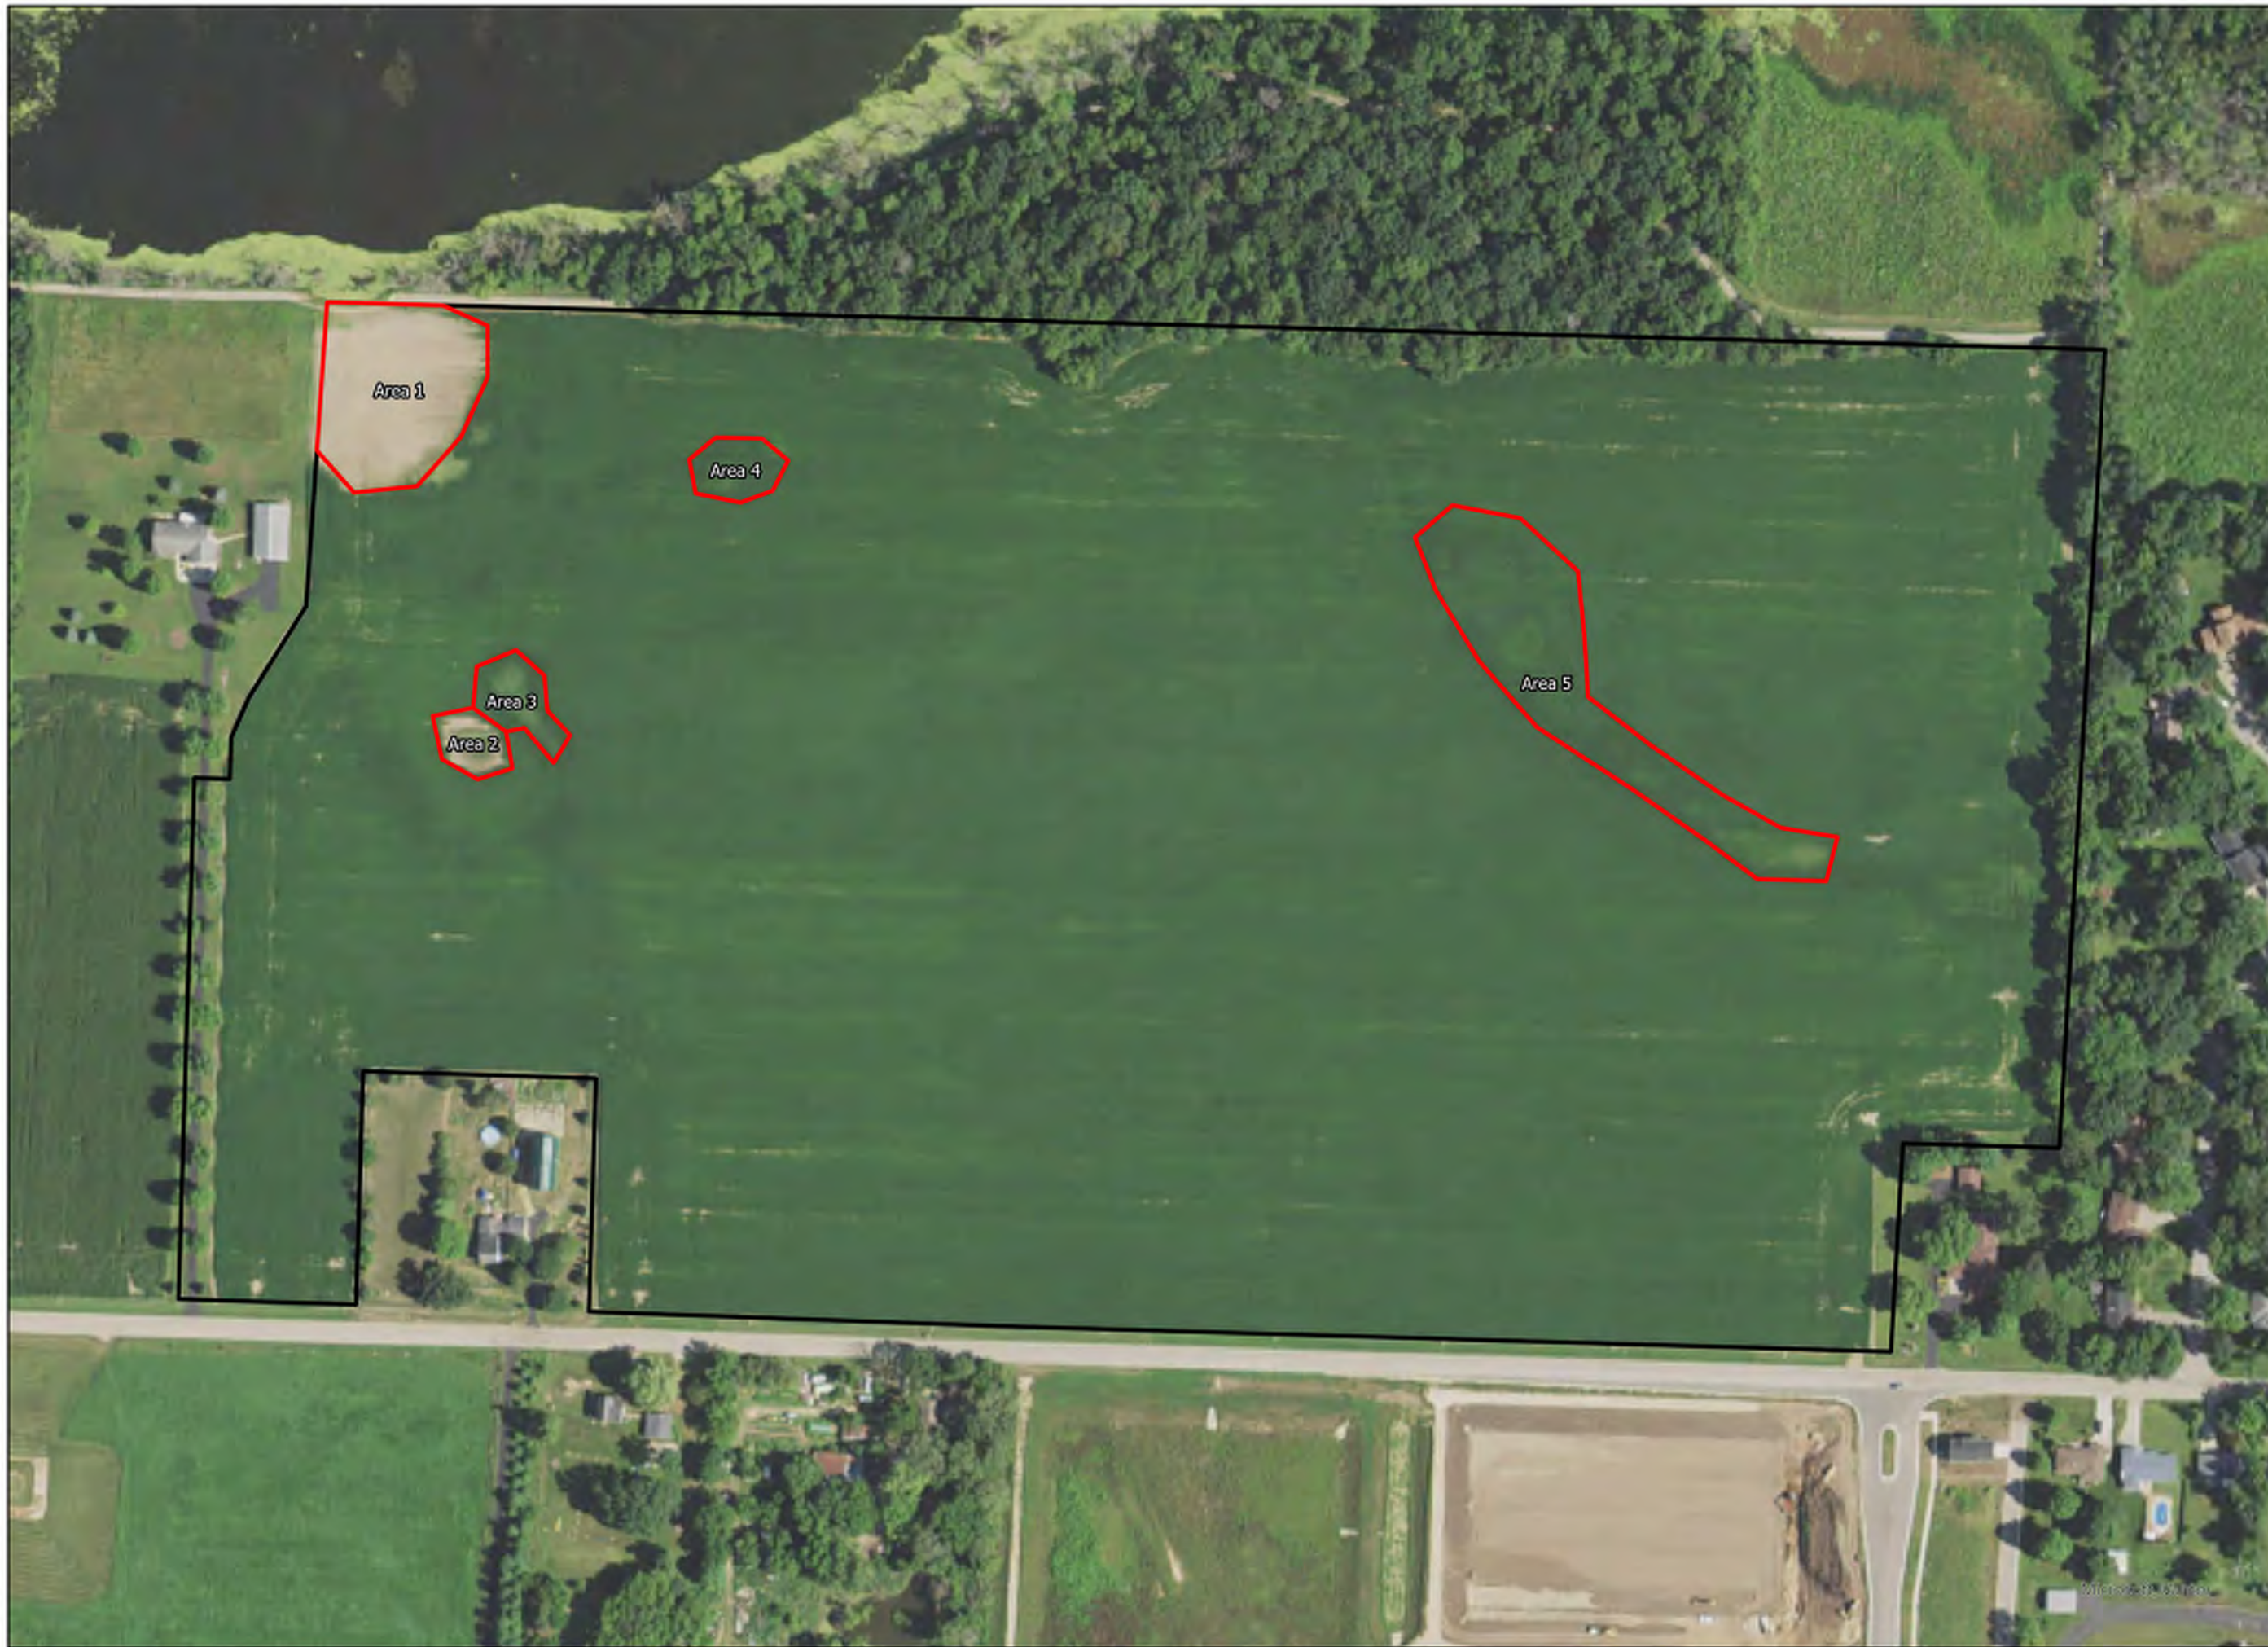
| Wetland Hydrology Indicators: | | Secondary Indicators (minimum of two required) |
|---|---|---|
| Describe Recorded Data (stream gauge, monitoring well, aerial photos, previous inspections), if available:<br>Potential wetland hydrology signatures observed in 38% of normal antecedent precipitation years. | | |

Agricultural fields within the Study Area were the focus of the Off-Site Analysis (OSA) (Appendix F). During the OSA, the secondary wetland hydrology indicator of "Stunted or Stressed Plants" (D1) was noted in five (5) areas.

A total of 21 aerial images were selected and reviewed based on the availability and quality of the imagery. Of these images, 13 were taken under normal antecedent precipitation conditions. Signatures were noted in five (5) areas within the Study Area, which were the focus of the OSA. At least one (1) of the seven (7) described wetland signatures per the July 2016 Guidance were noted in all five (5) of these areas on imagery taken under normal antecedent precipitation conditions. However, four (4) of the five (5) signature areas were on ridges or knolls and featured poor, sandy, gravelly, and/or cobbly soils during the field investigation. During the field investigation only one (1) signature area met wetland criteria.

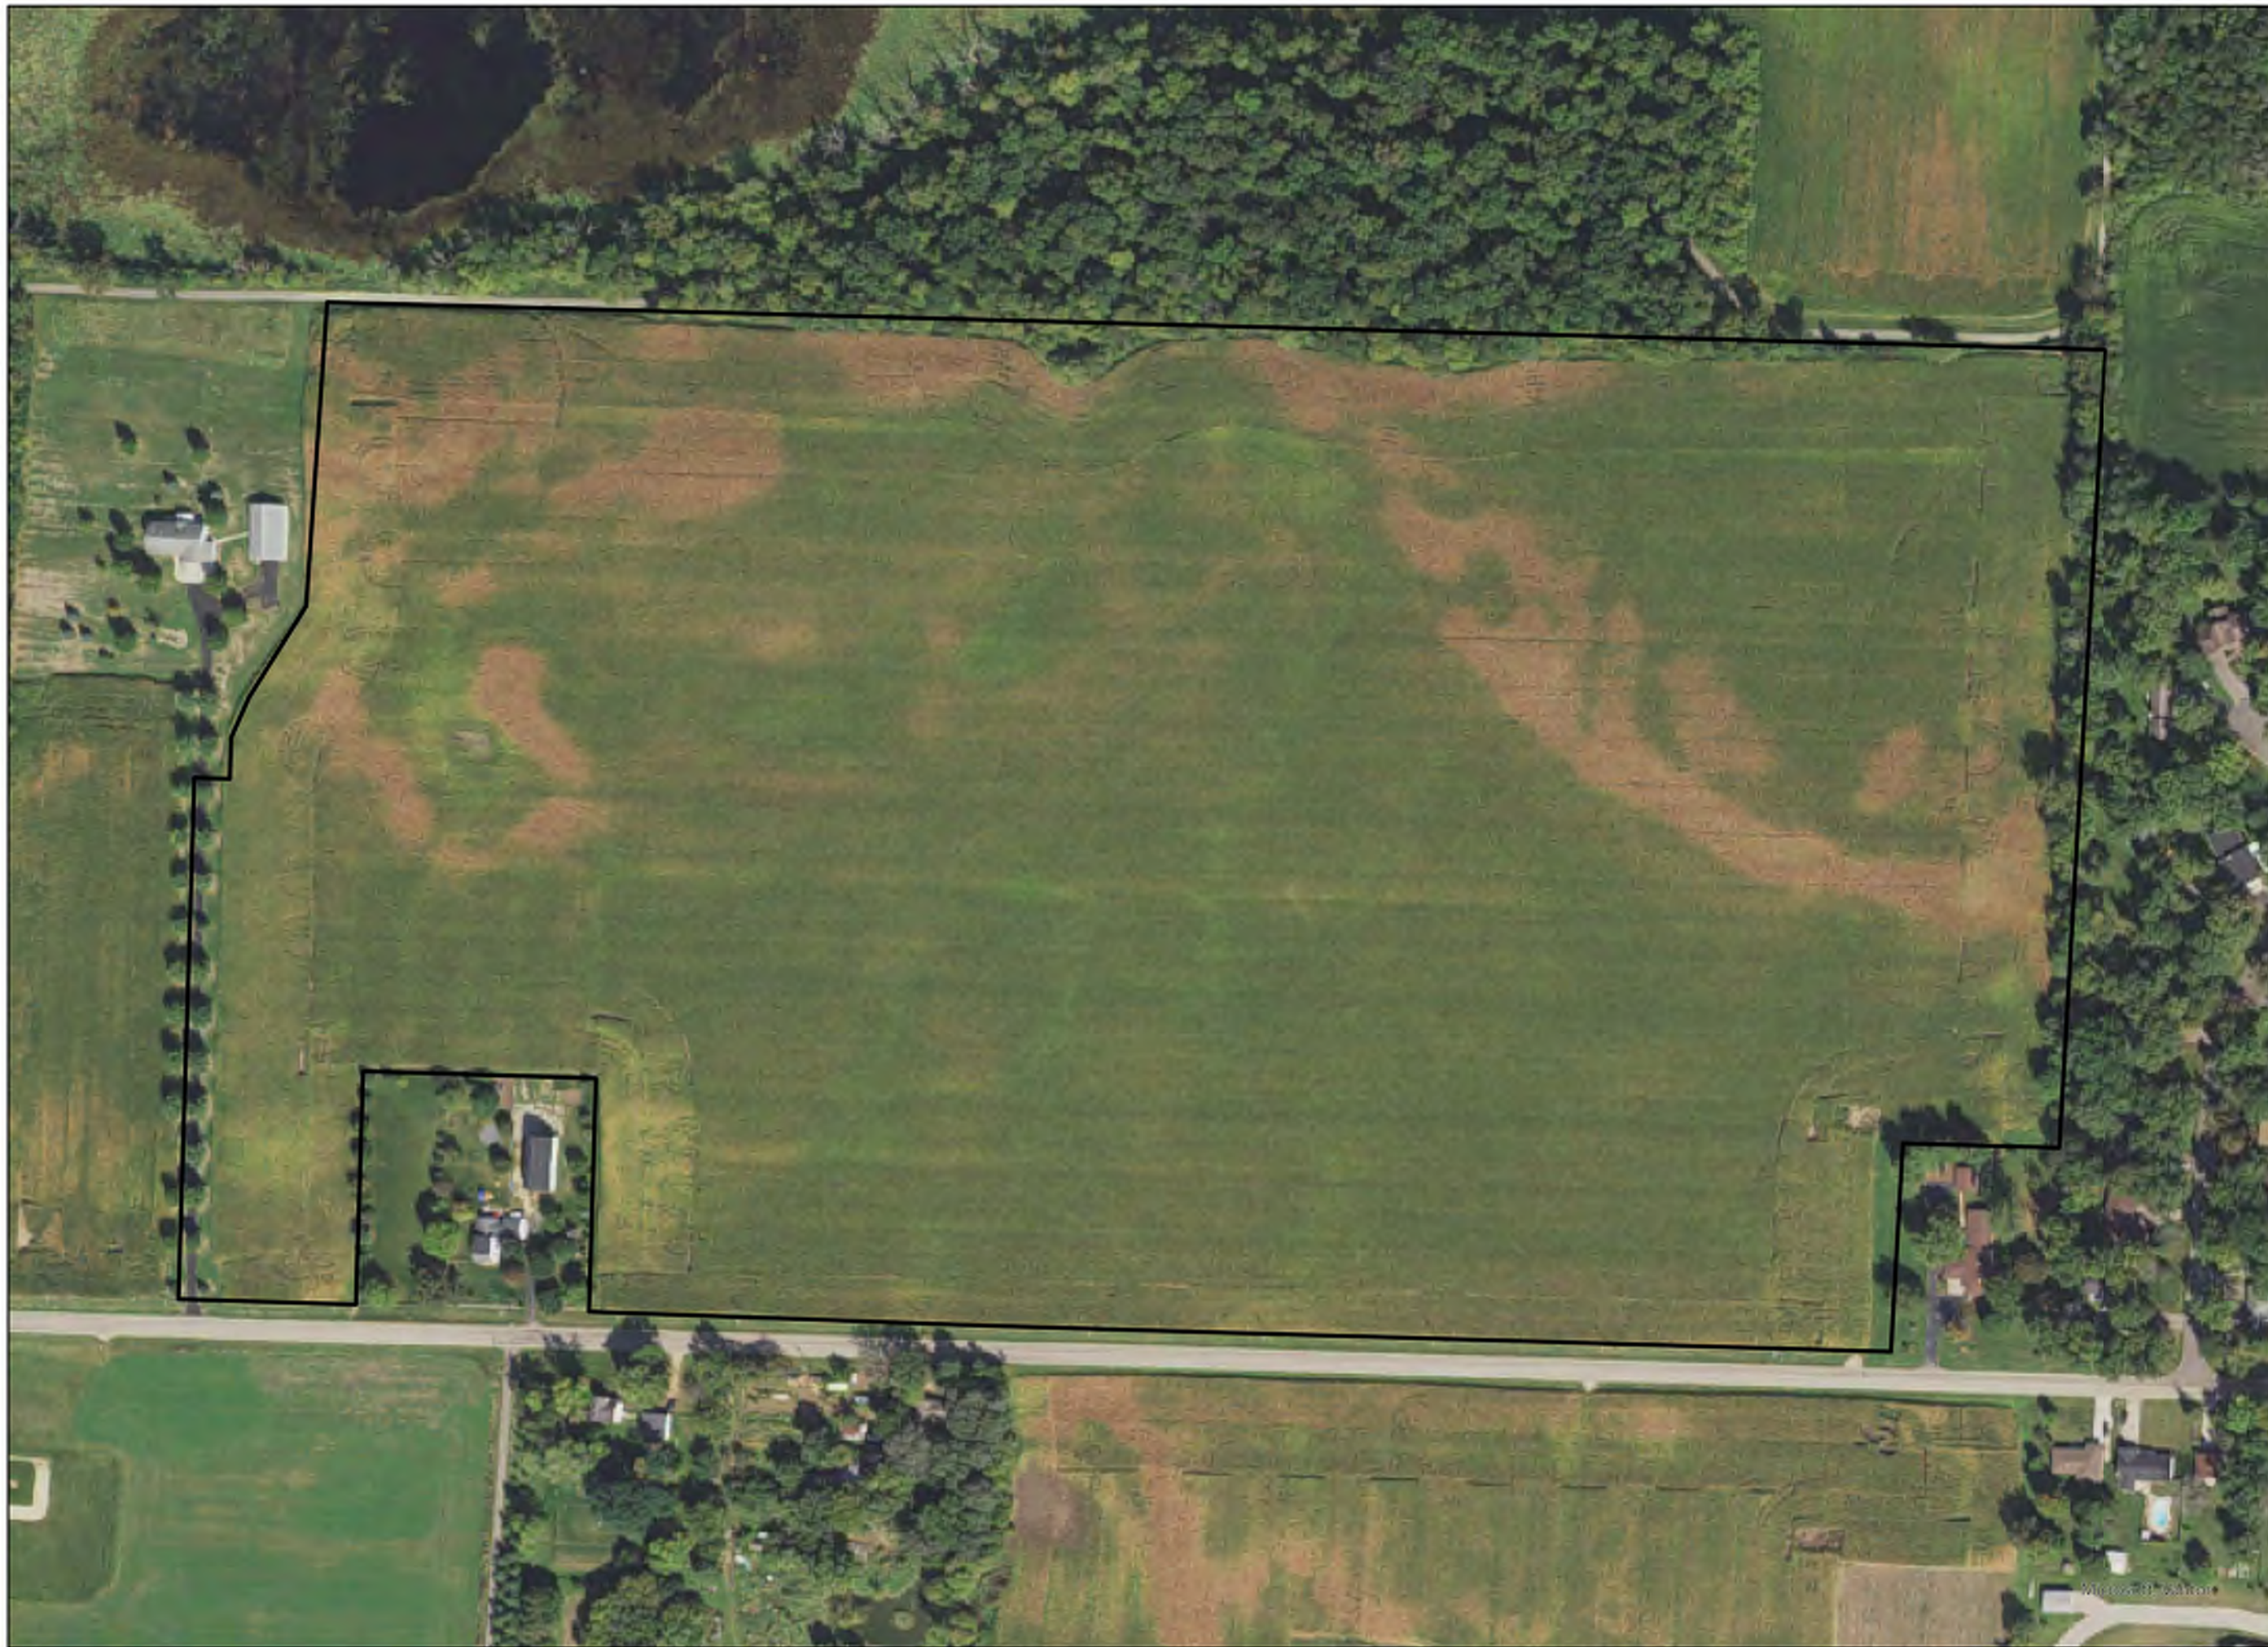
**Heartland**  
 ECOLOGICAL GROUP INC  
 2015-10-11 NAIP Aerial  
 Imagery  
 Featherwood Trails  
 Project # 20261736  
 T5N, R9E, S3  
 T Oregon, Dane Co  
 2015 NAIP  
 USDA

Study Area (66.12 ac)

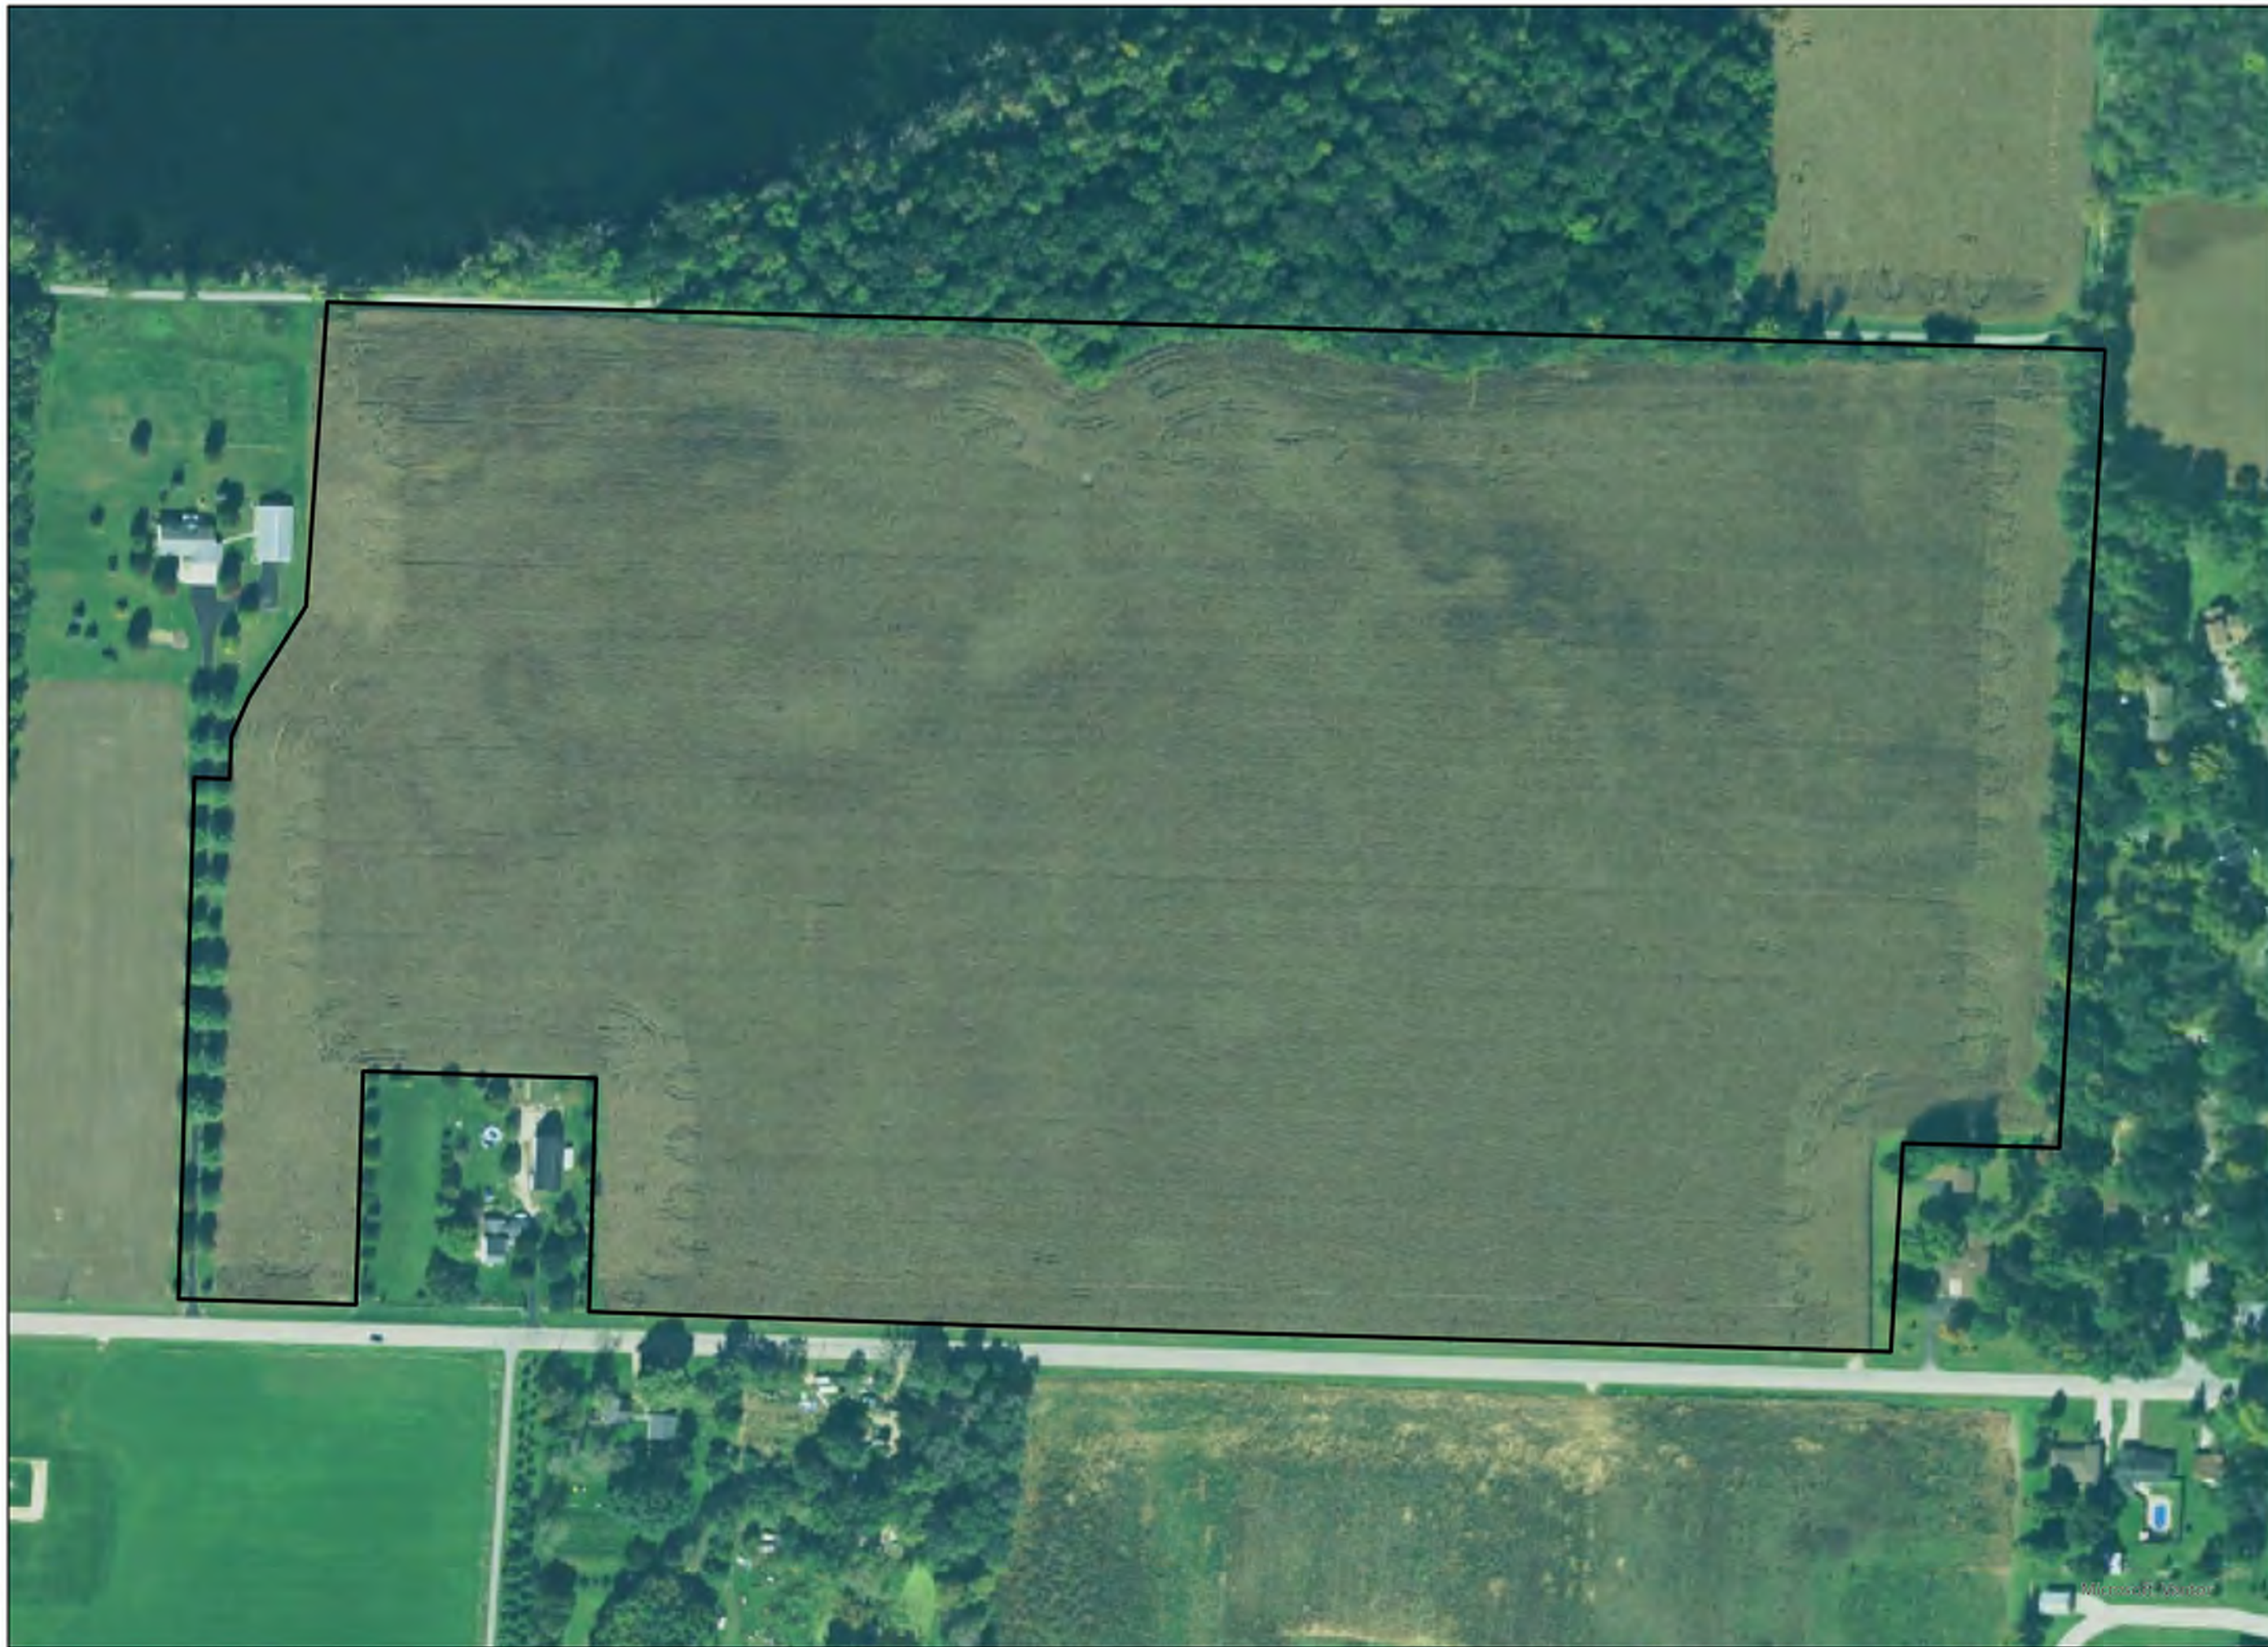
**Heartland**  
ECOLOGICAL GROUP INC  
2017-09-22 NAIP Aerial  
Imagery  
Featherwood Trails  
Project # 20261736  
T5N, R9E, S3  
T Oregon, Dane Co  
2017 NAIP  
USDA

Study Area (66.12 ac)
