**VILLAGE OF OREGON**

**URBAN SERVICE AREA AMENDMENT REQUEST: FEATHERWOOD TRAIL**

JULY 13, 2026

VANDEWALLE & ASSOCIATES

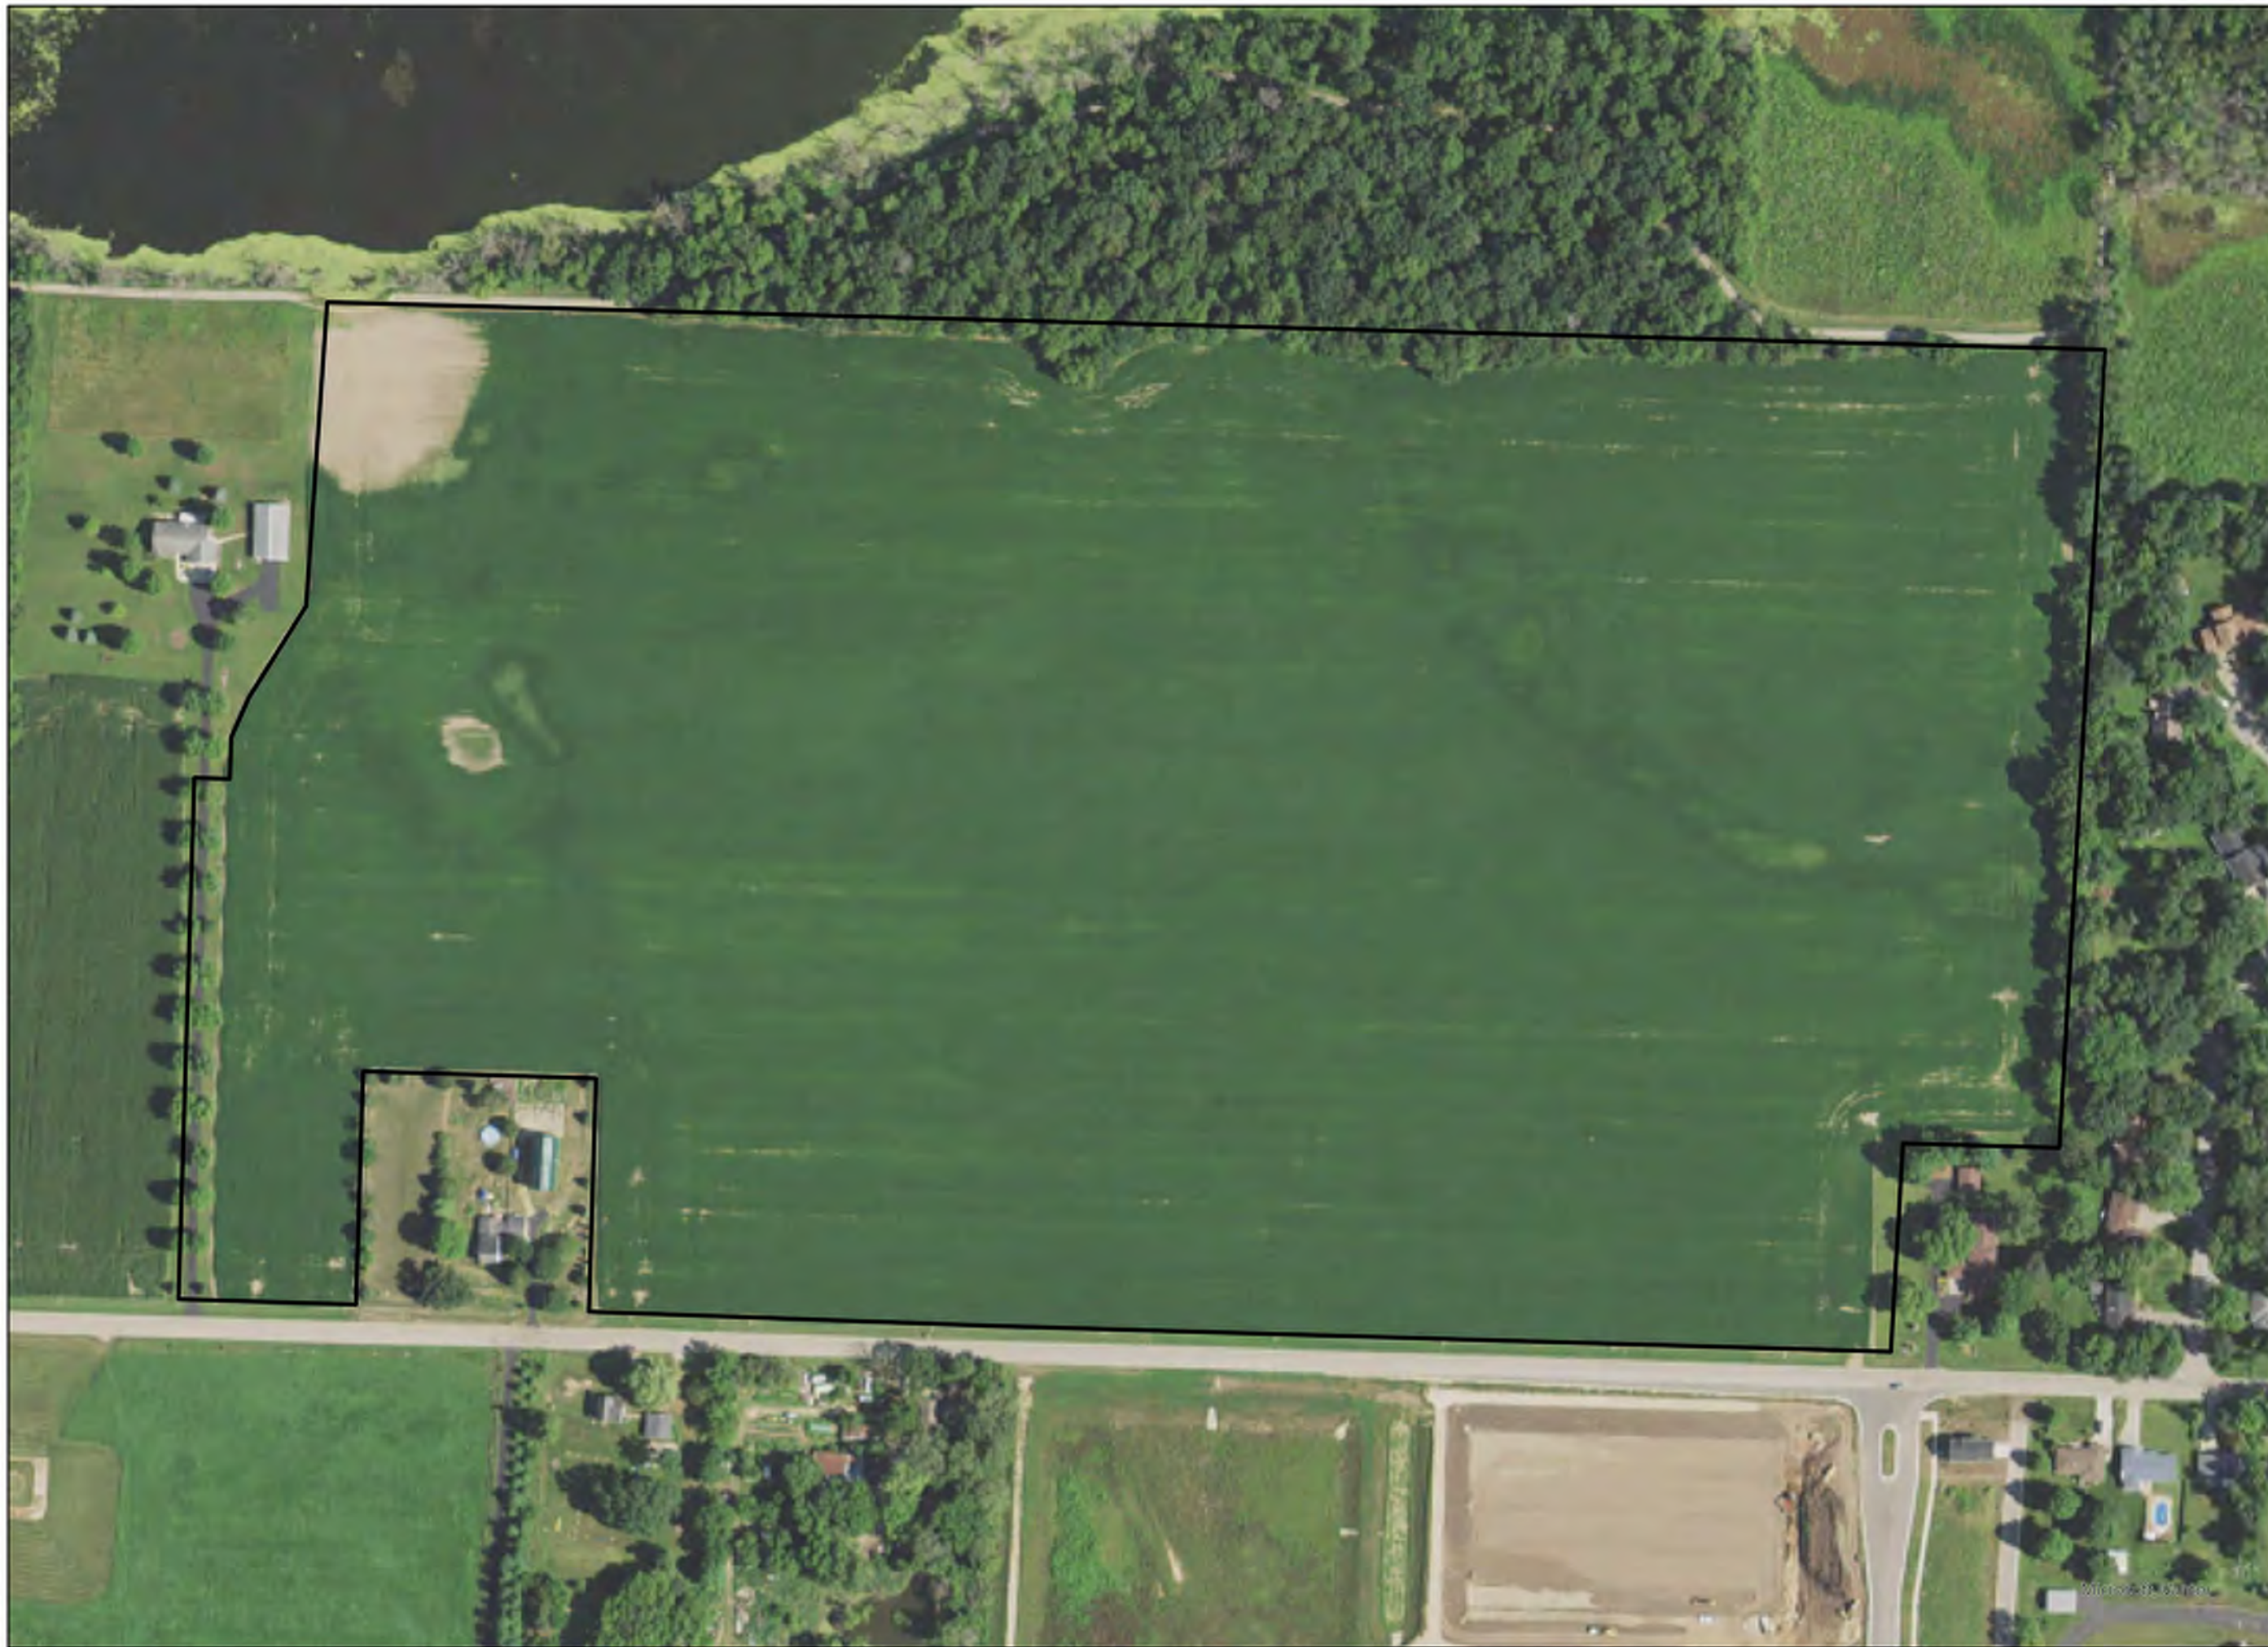
2018-10-04 NAIP Aerial Imagery  
Featherwood Trails  
Project # 20261736  
T5N, R9E, S3  
T Oregon, Dane Co

Study Area (66.12 ac)

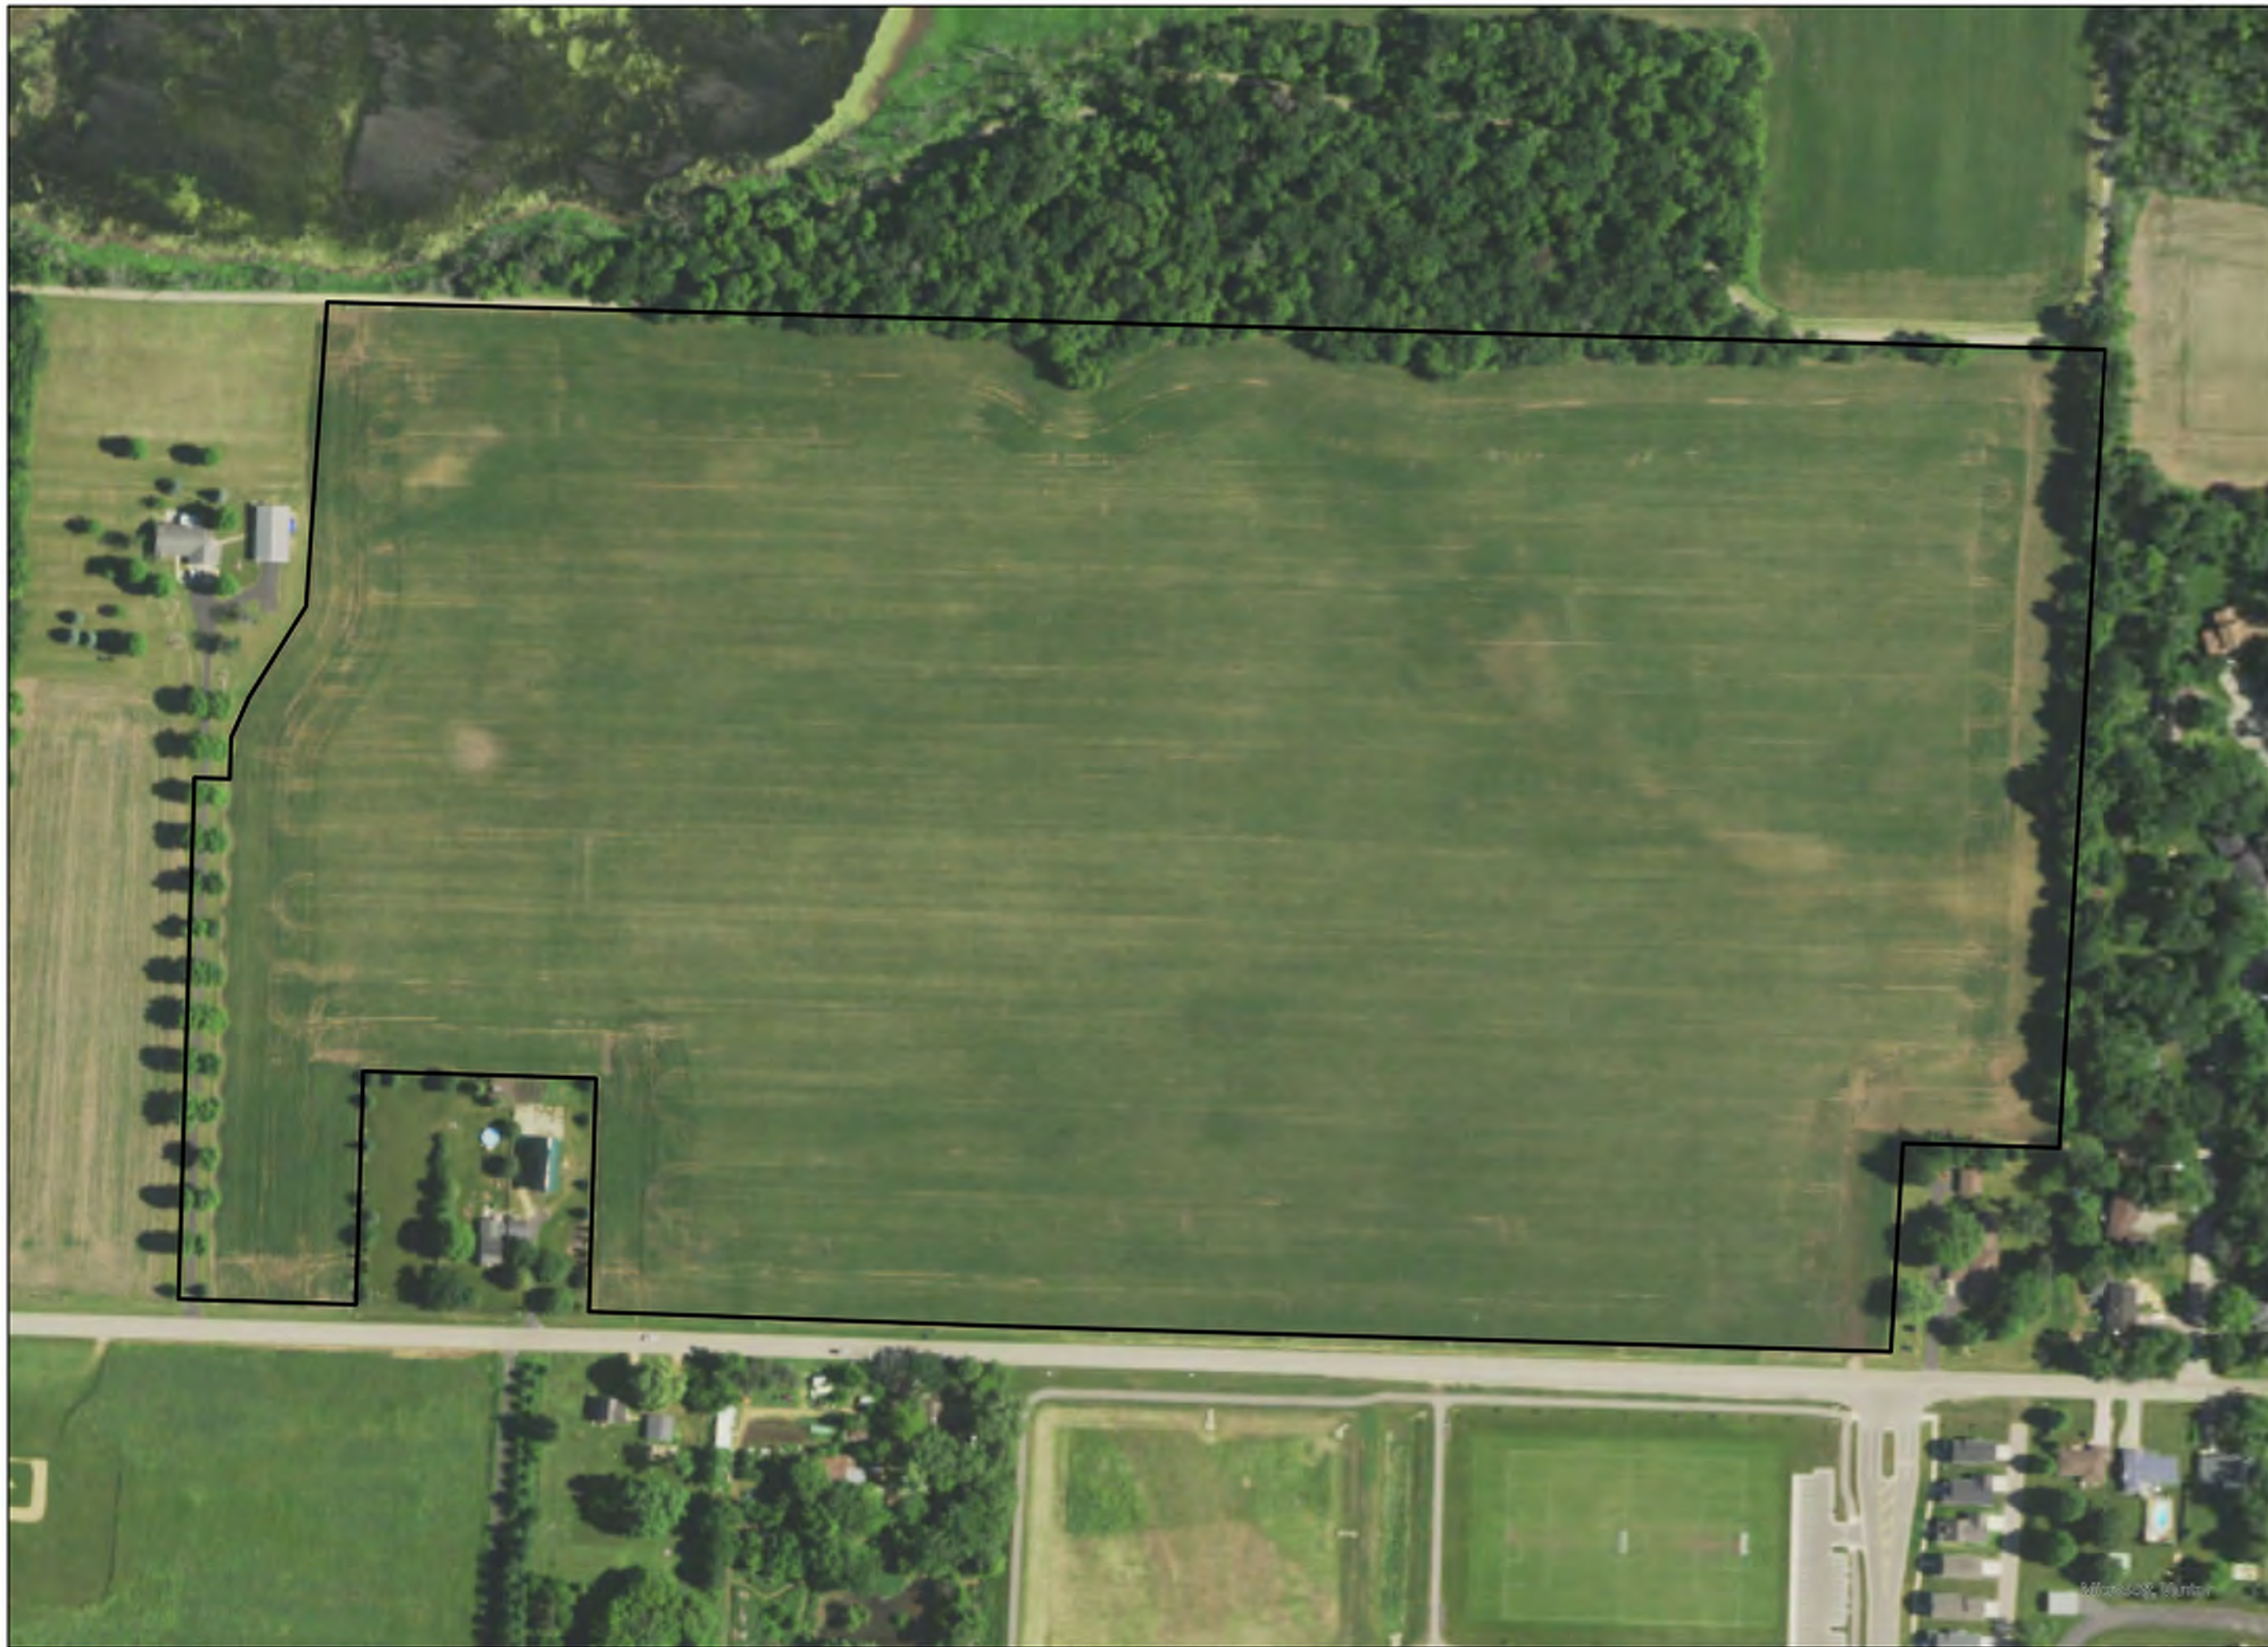
2020 NAIP  
USDA

Study Area (66.12 ac)

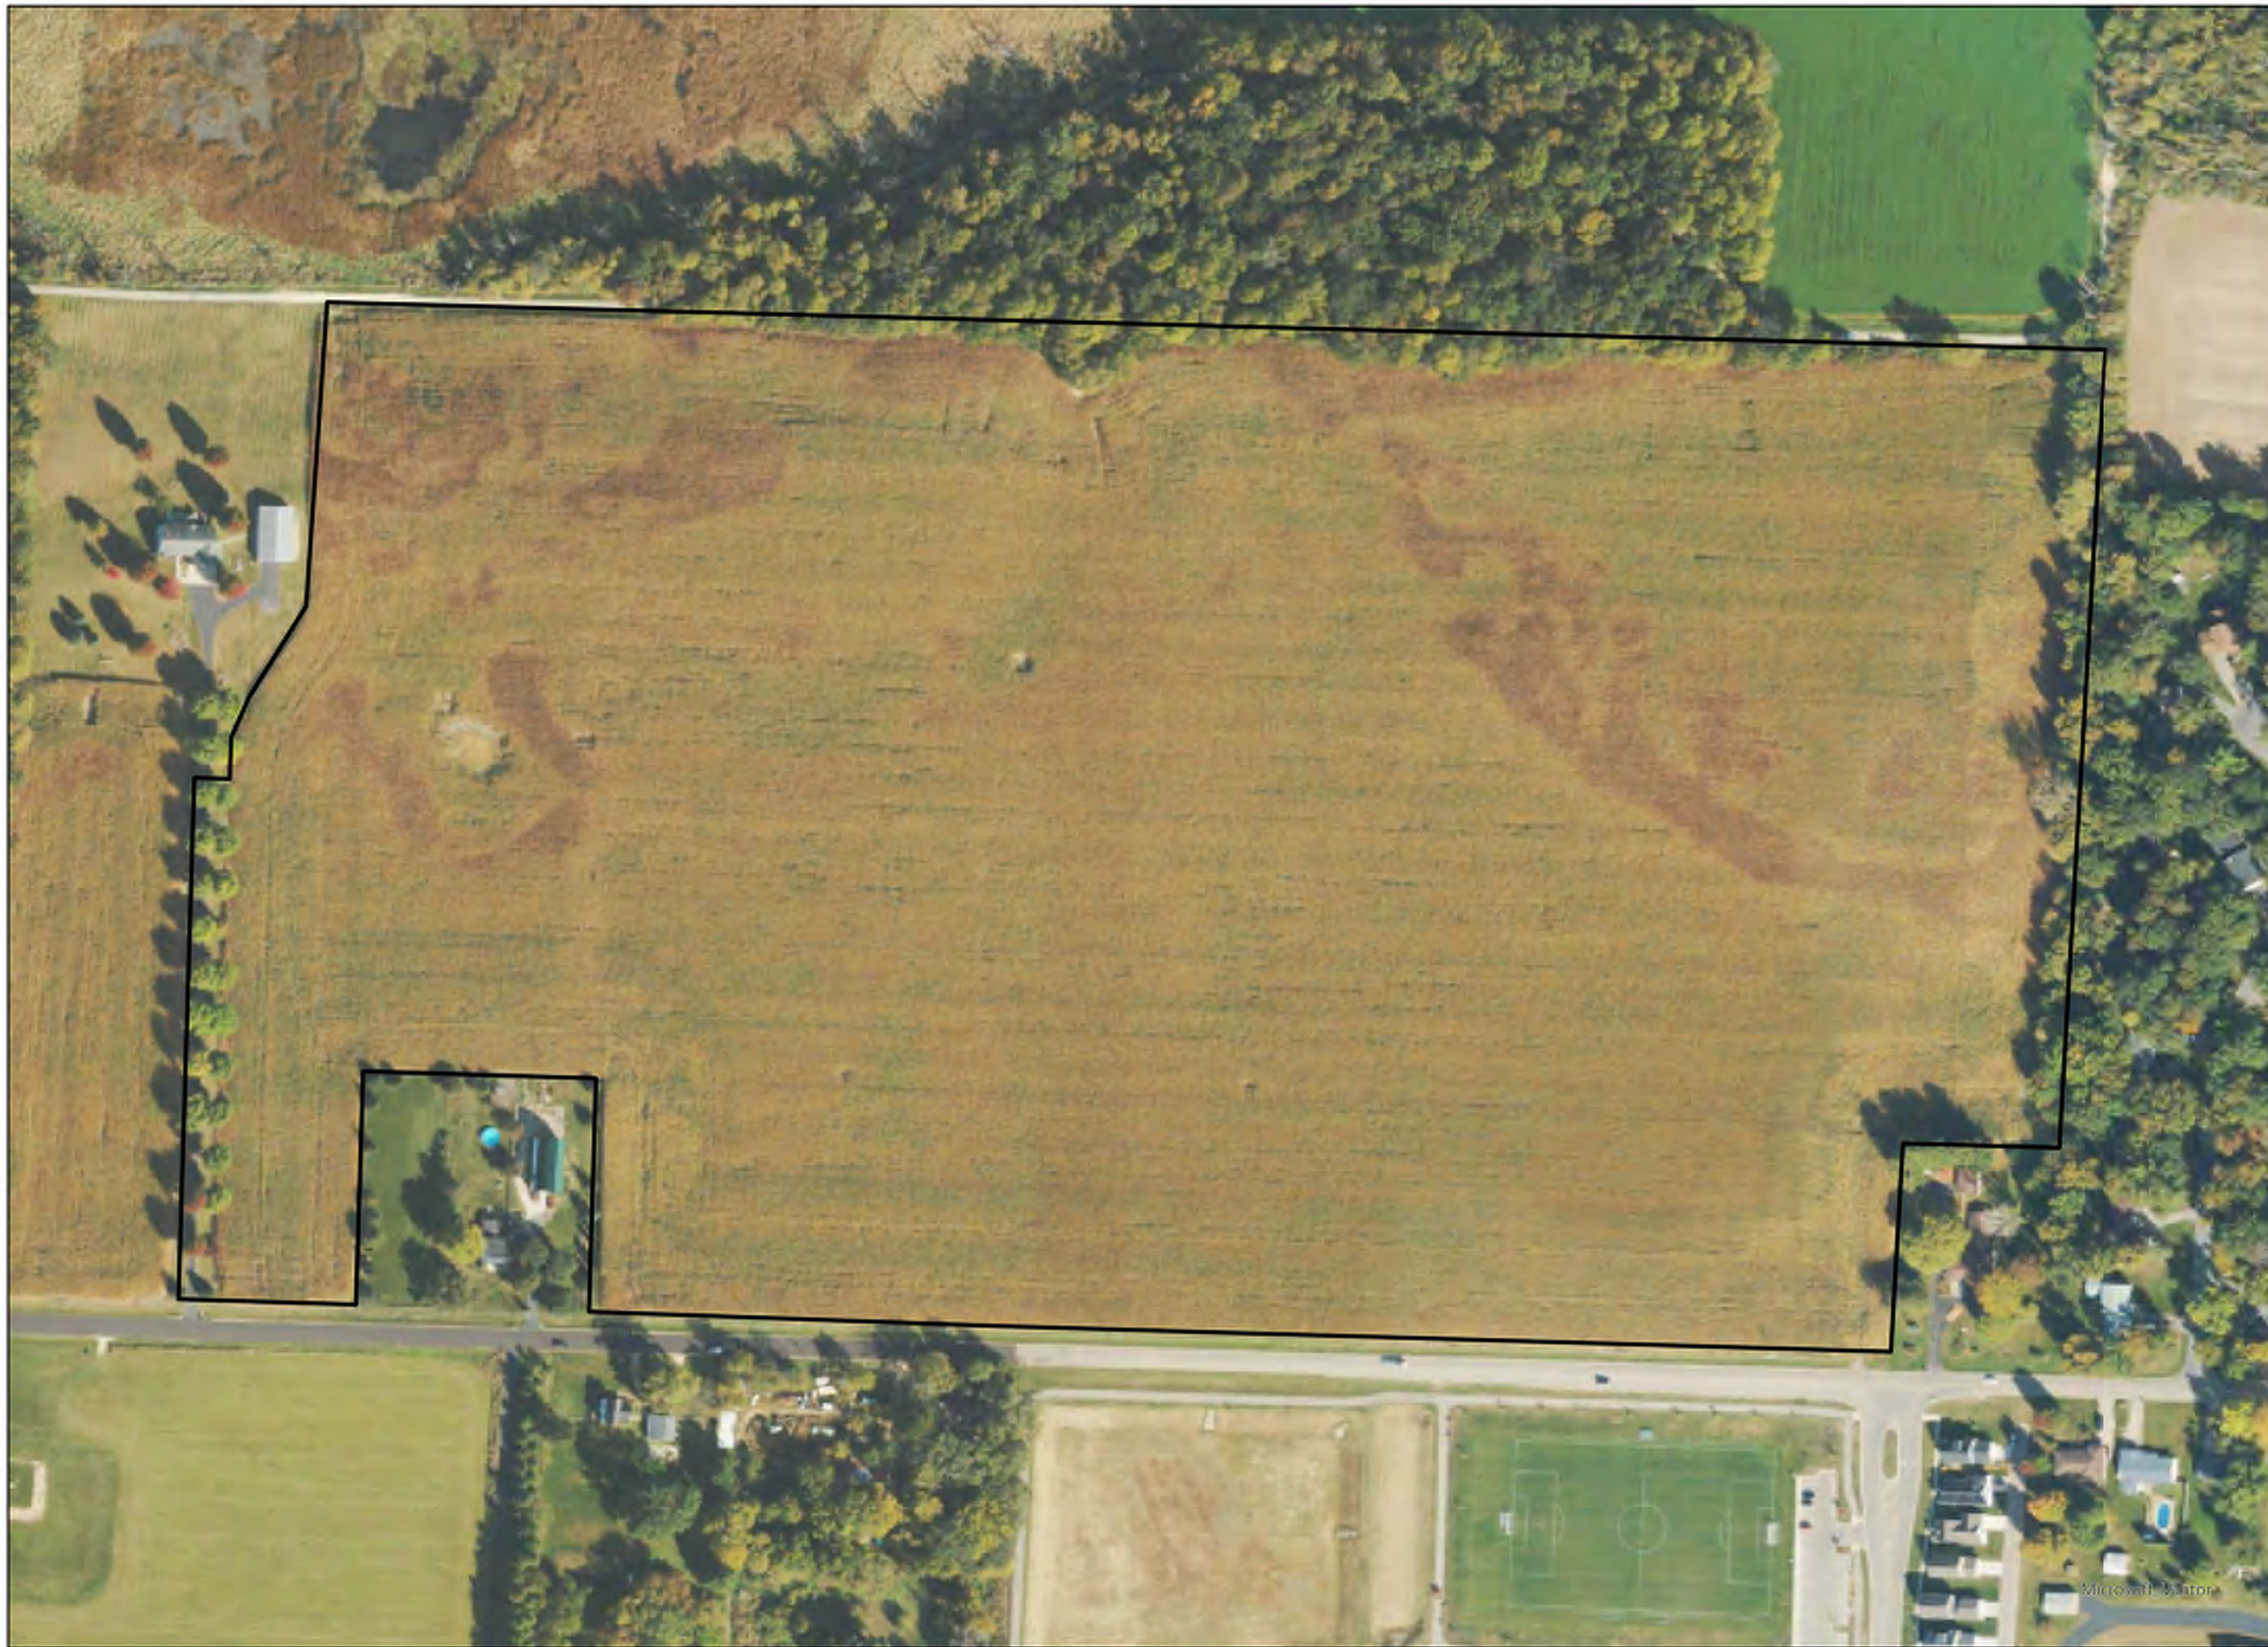
2022 NAIP  
USDA

Study Area (66.12 ac)
