Total Maximum Daily Load: Little Willow Creek Richland County, WI

**Little Willow Creek, Richland County, WI
Report Prepared by Mike Gilbertson**

Sediment Total Maximum Daily Load for Little Willow Creek

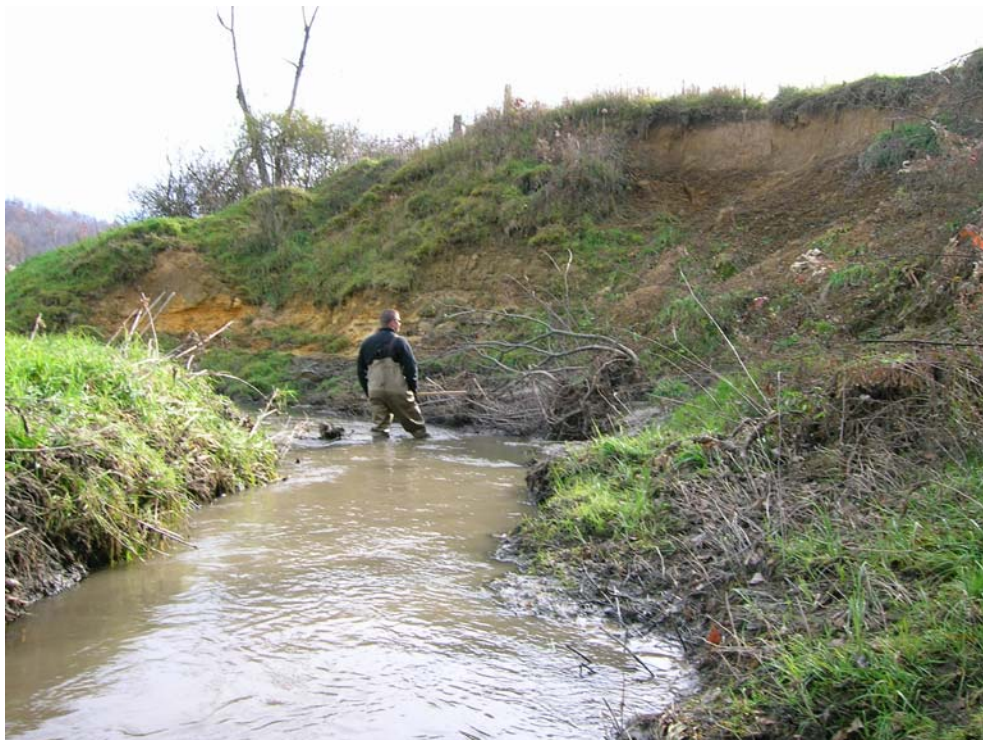
Figure E-3. Typical bank erosion along Little Willow Creek downstream of Spiral Road

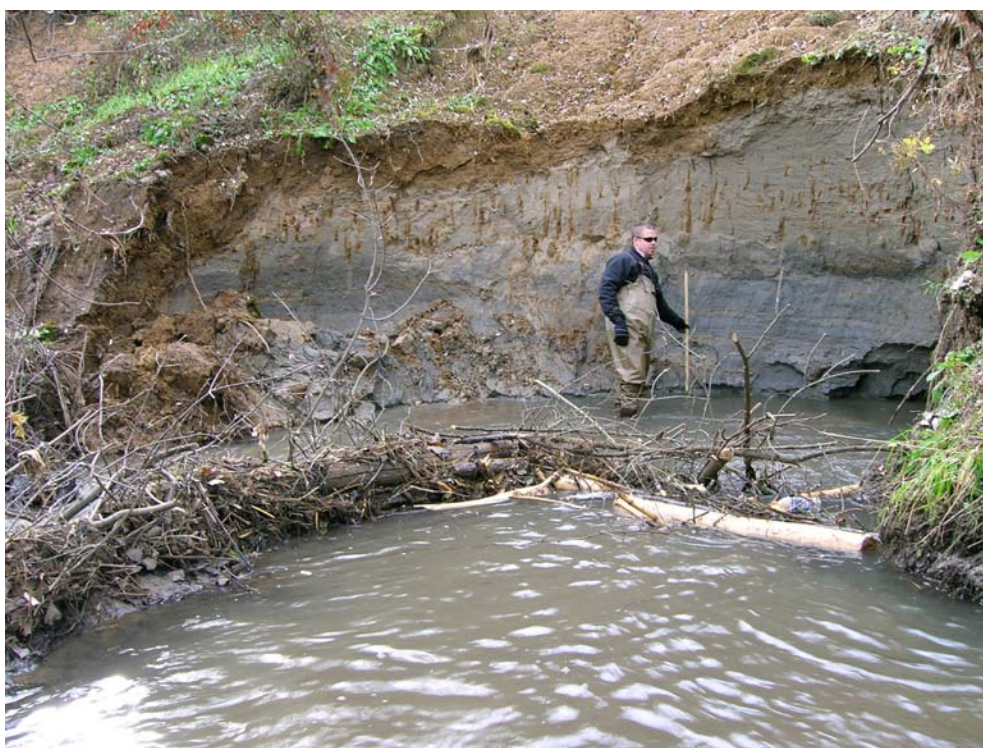
Figure E-4. A section of the stream bank was carved out as a result of the August 2007 flooding.

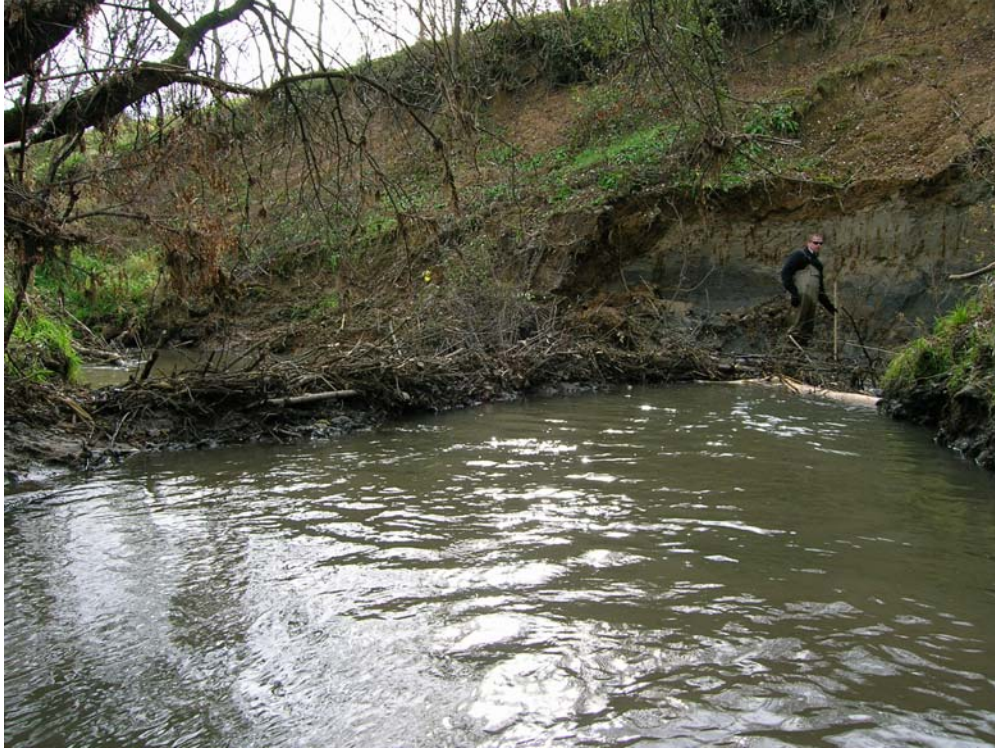
Figure E-5. A section of the stream bank was carved out as a result of the August 2007 flooding.

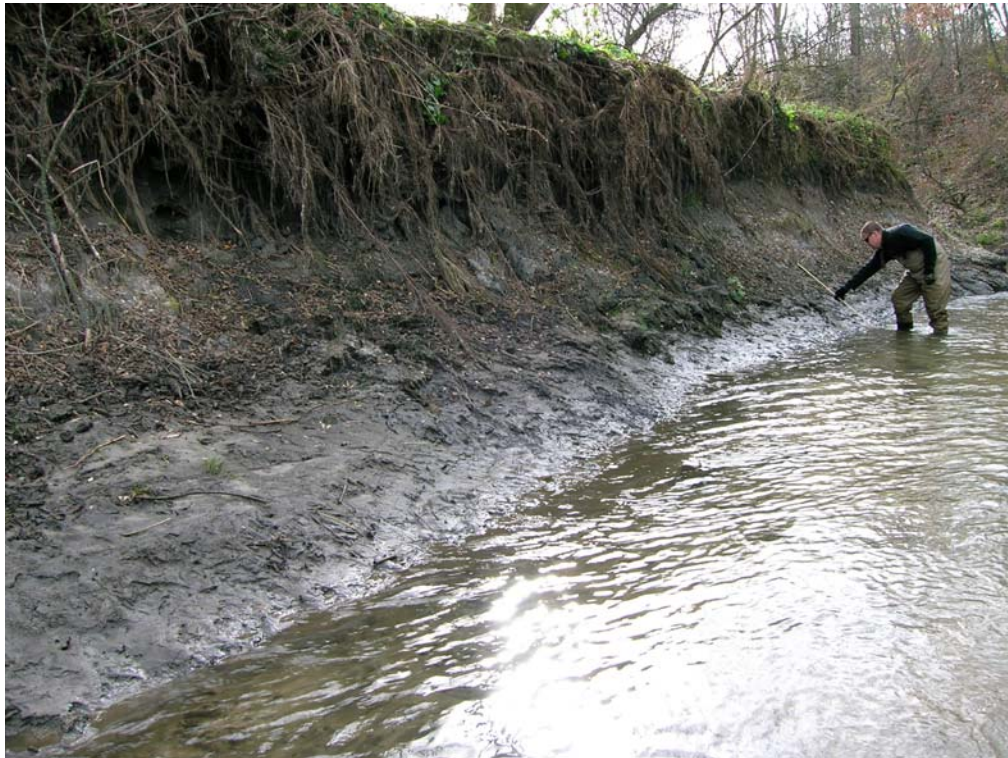
Figure E-6. Typical bank erosion along Little Willow Creek downstream of Spiral Road
