APPENDIX B

SURFACE WATER QUALITY CONDITIONS

Agrecol Environmental Consulting

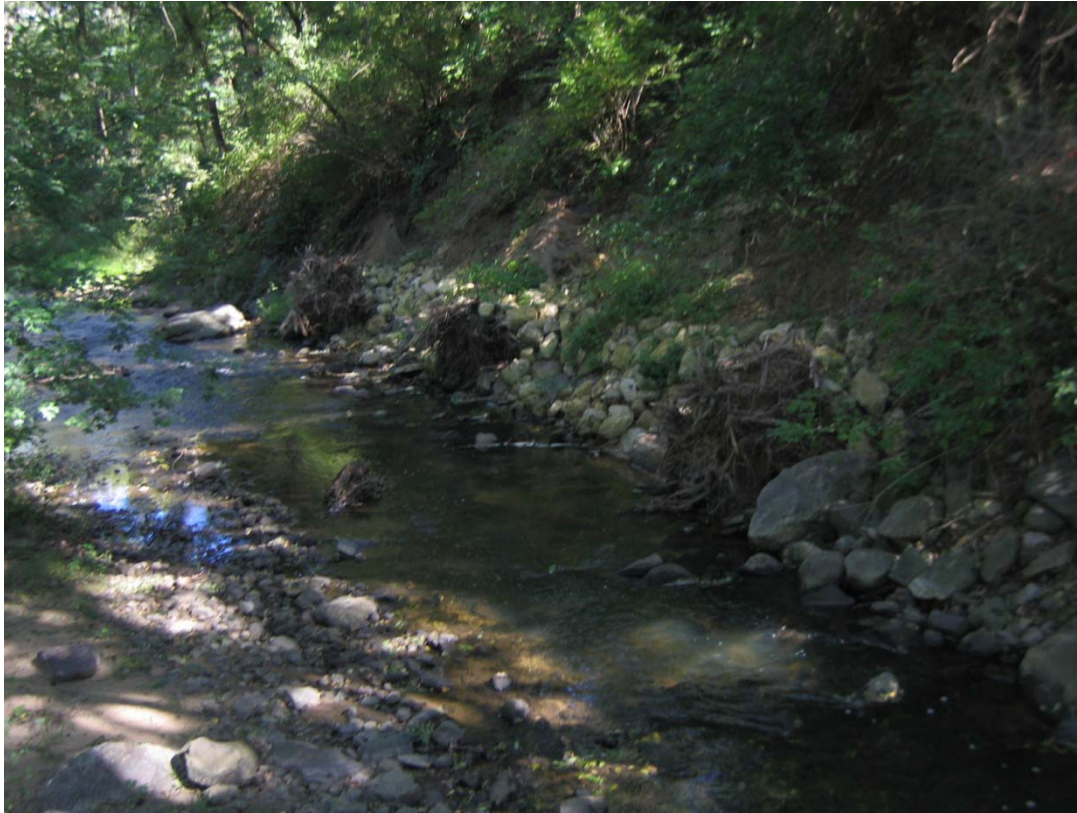
Failing Bank Stabilization Along Pheasant Branch in 2010

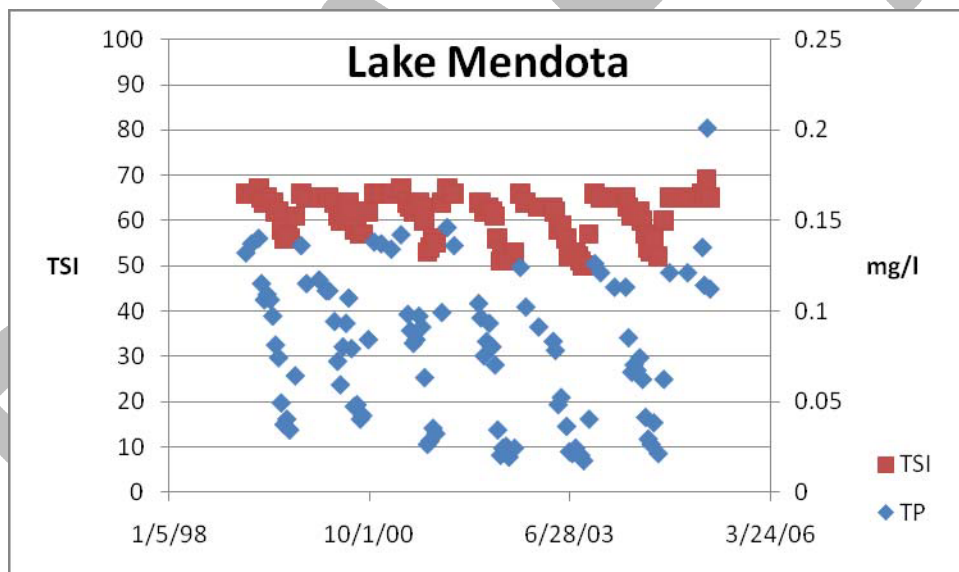
Figure 1a: Recent surface total phosphorus levels in Lake Mendota and associated TSI ($\geq 50 - 70$ = eutrophic). LTER database

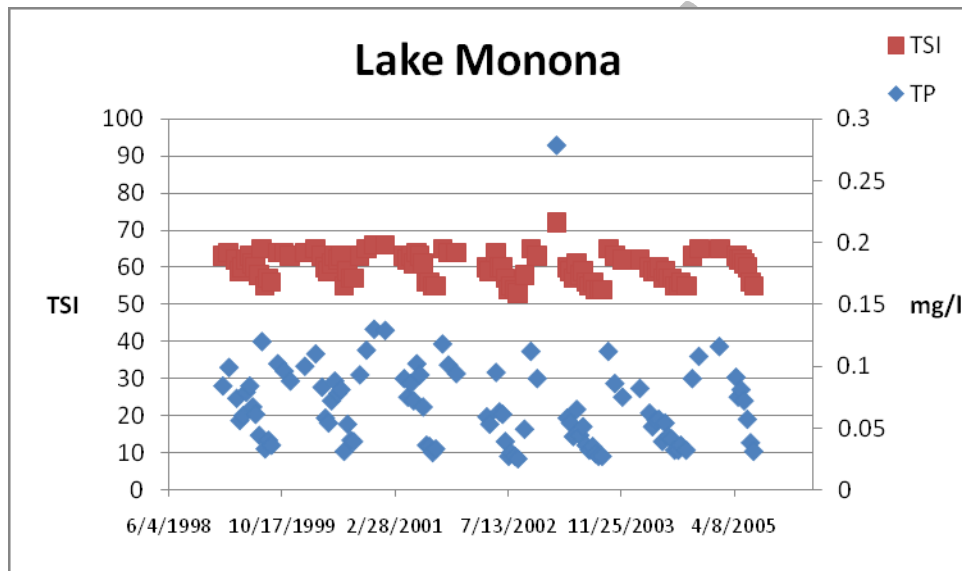
Figure 2a: Recent surface concentrations of total phosphorus in Lake Monona and associated TSI values ($\geq 50 - 70 =$ eutrophic). LTER database.

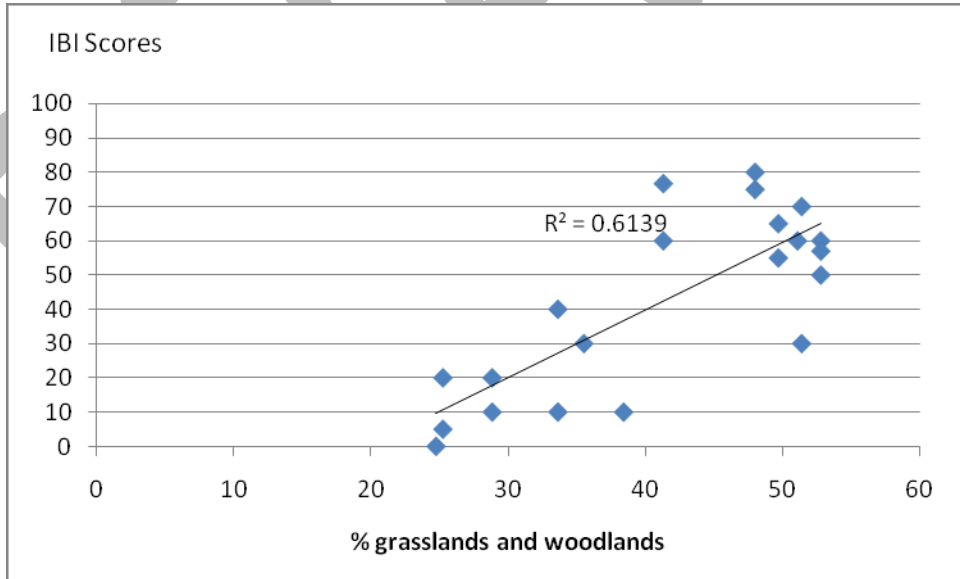
Figure 4: Lower IBI scores (left side) coincided with lower grasslands and woodlands

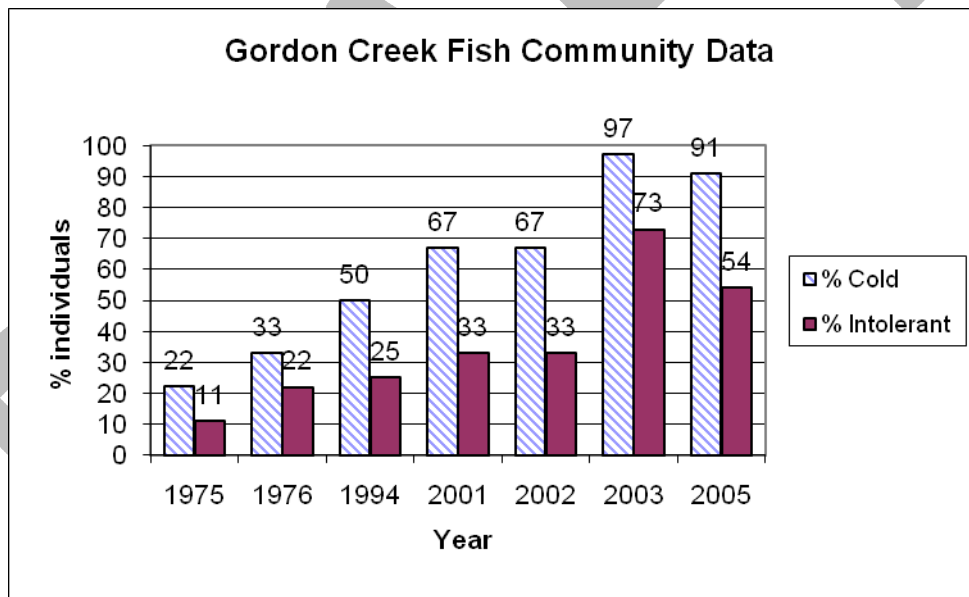
Figure 5: Fish community changes in Gordon Creek

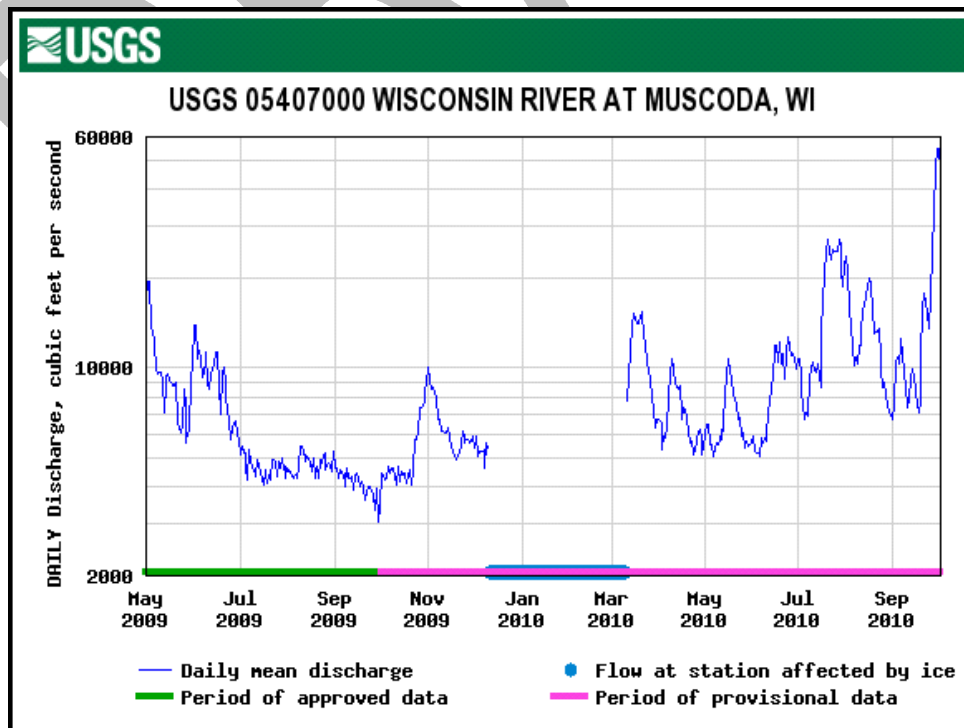
Figure 8: Lower Wisconsin River Flow Rates in 2009-10 demonstrate variable conditions within the river floodplain

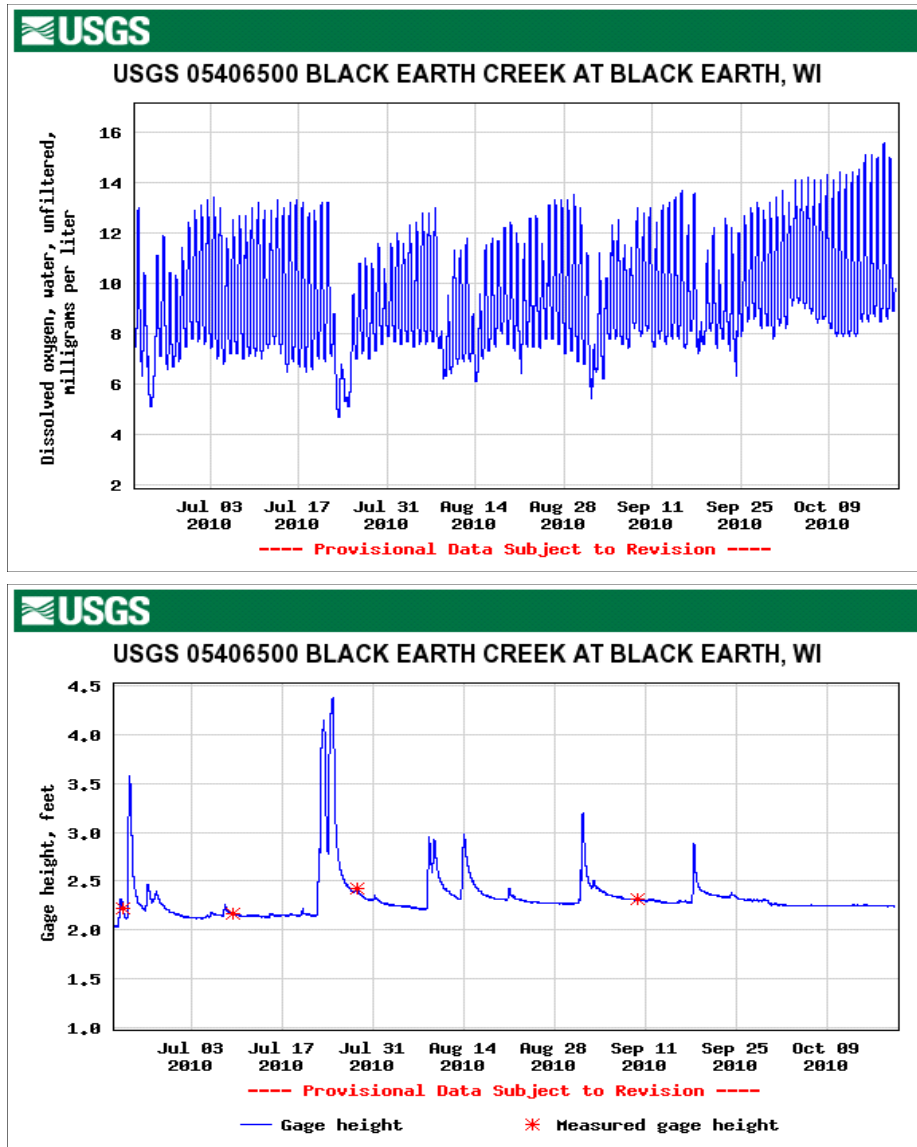
Figure 10: 2010 dissolved oxygen and gage height from the Black Earth Realtime Monitoring Site (USGS)

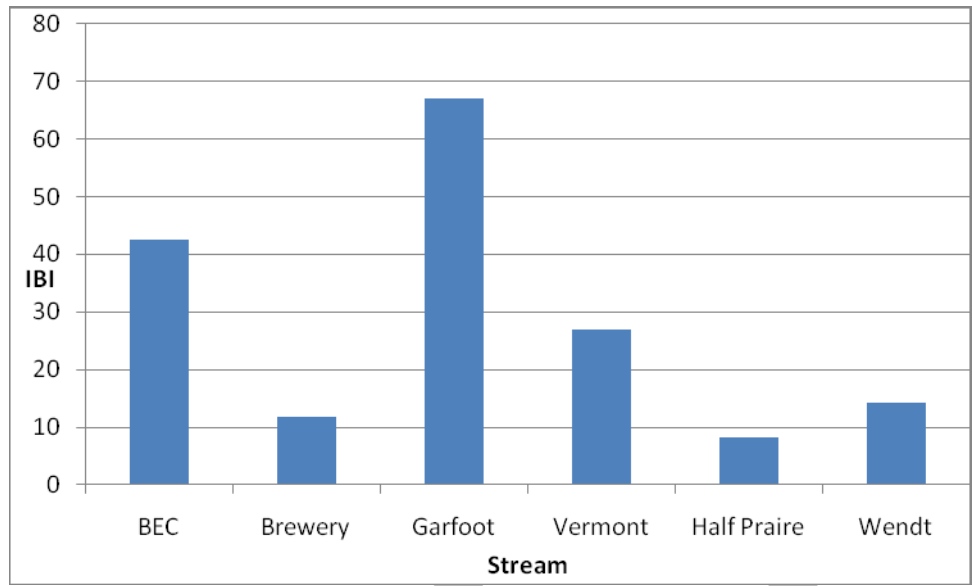
Figure 12: Mean coldwater IBI scores for Black Earth Creek Watershed streams

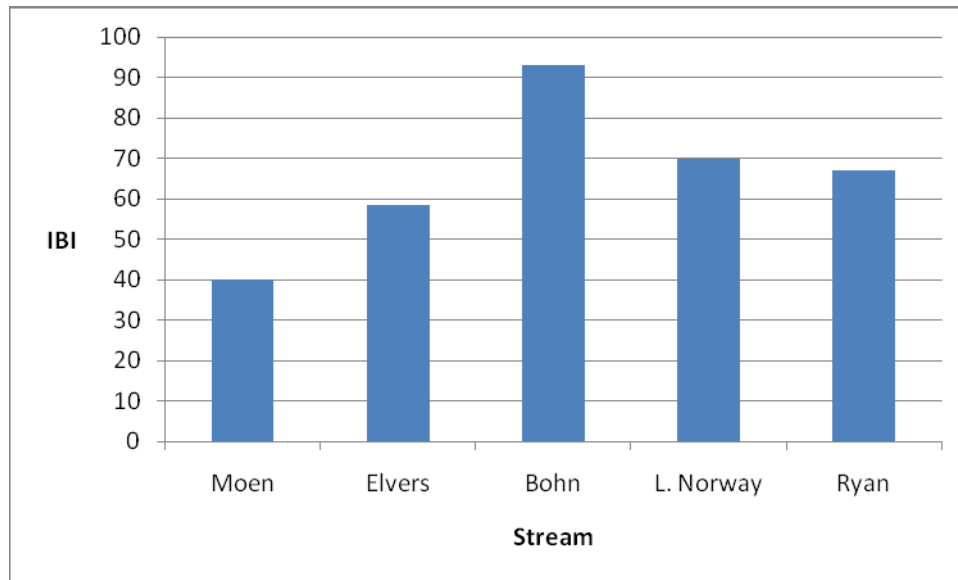
Figure 14: Comparative coldwater IBI scores from Mill and Blue Mounds Creek Watershed
