**Aquatic Macrophyte Survey for
Lower Turtle Lake
Barron County, Wisconsin
WBIC: 2692900**

Project Sponsored by:
The Lower Turtle Lake Management District

Survey Conducted by and Report Prepared by:
Endangered Resource Services, LLC
Matthew S. Berg, Research Biologist
St. Croix Falls, Wisconsin
Summer 2008

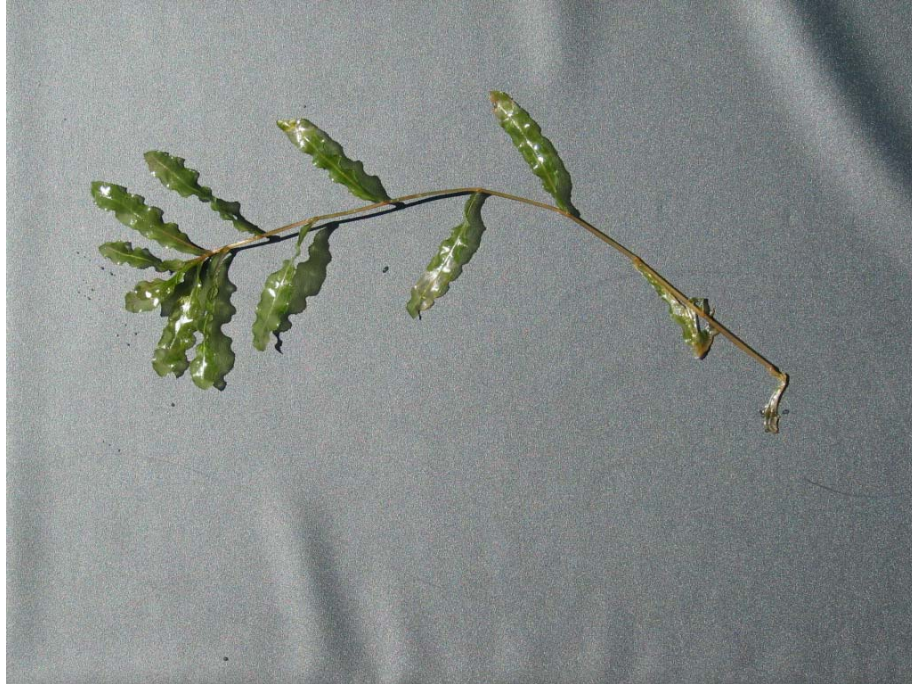
DESCRIPTION: Curly-leaf pondweed is an invasive aquatic perennial that is native to Eurasia, Africa, and Australia. It was accidentally introduced to United States waters in the mid-1880s by hobbyists who used it as an aquarium plant. The leaves are reddish-green, oblong, and about 3 inches long, with distinct wavy edges that are finely toothed. The stem of the plant is flat, reddish-brown and grows from 1 to 3 feet long. The plant usually drops to the lake bottom by early July

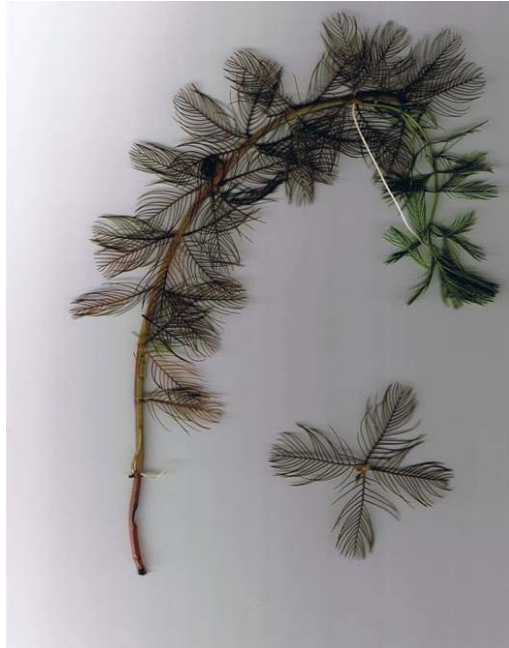
DESCRIPTION: Eurasian water milfoil is a submersed aquatic plant native to Europe, Asia, and northern Africa. It is the only non-native milfoil in Wisconsin. Like the native milfoils, the Eurasian variety has slender stems whorled by submersed feathery leaves and tiny flowers produced above the water surface. The flowers are located in the axils of the floral bracts, and are either four-petaled or without petals. The leaves are threadlike, typically uniform in diameter, and aggregated into a submersed terminal spike. The stem thickens below the inflorescence and doubles its width further down, often curving to lie parallel with the water surface. The fruits are four-jointed nut-like bodies. Without flowers or fruits, Eurasian water milfoil is nearly impossible to distinguish from Northern water milfoil. Eurasian water milfoil has 9-21 pairs of leaflets per leaf, while Northern milfoil typically has 7-11 pairs of leaflets. Coontail is often mistaken for the milfoils, but does not have individual leaflets.

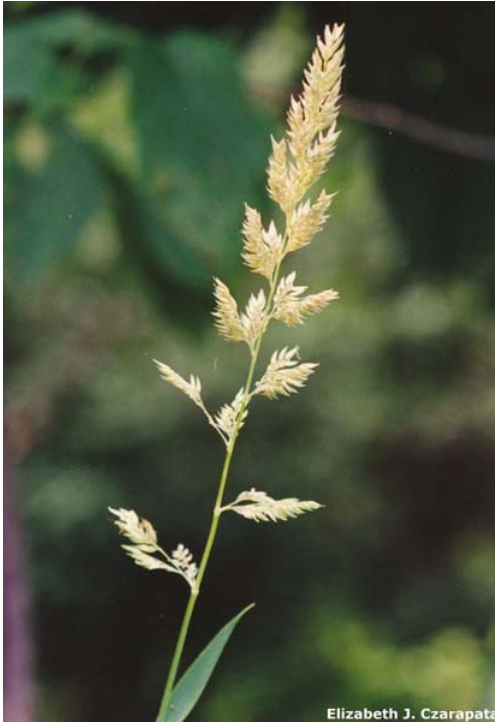
DESCRIPTION: Reed canary grass is a large, coarse grass that reaches 2 to 9 feet in height. It has an erect, hairless stem with gradually tapering leaf blades 3 1/2 to 10 inches long and 1/4 to 3/4 inch in width. Blades are flat and have a rough texture on both surfaces. The lead ligule is membranous and long. The compact panicles are erect or slightly spreading (depending on the plant's reproductive stage), and range from 3 to 16 inches long with branches 2 to 12 inches in length. Single flowers occur in dense clusters in May to mid-June. They are green to purple at first and change to beige over time. This grass is one of the first to sprout in spring, and forms a thick rhizome system that dominates the subsurface soil. Seeds are shiny brown in color.

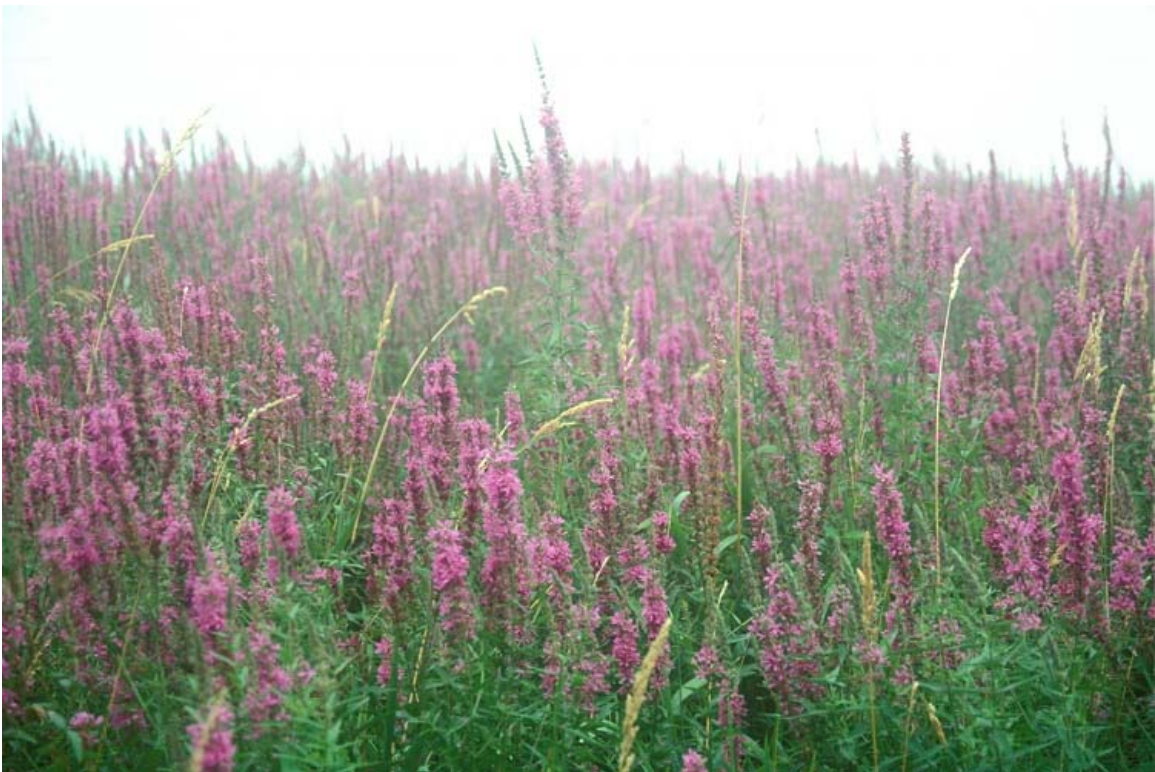
DESCRIPTION: Purple loosestrife is a perennial herb 3-7 feet tall with a dense bushy growth of 1-50 stems. The stems, which range from green to purple, die back each year. Showy flowers vary from purple to magenta, possess 5-6 petals aggregated into numerous long spikes, and bloom from July to September. Leaves are opposite, nearly linear, and attached to four-sided stems without stalks. It has a large, woody taproot with fibrous rhizomes that form a dense mat.
