**LAKE MANAGEMENT PLAN
LAKE BEULAH
WALWORTH COUNTY
WISCONSIN**

DECEMBER 2010

RJN Project Number 09-201

Lake Beulah Management District

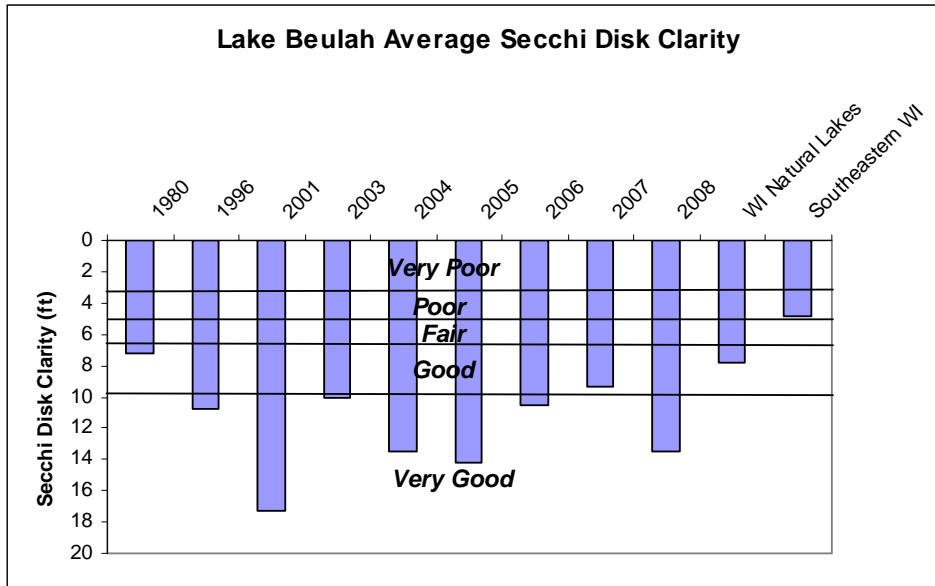
Figure 2. Lake Beulah Average Secchi Disk Clarity Values. The mean secchi values from random natural lakes in Wisconsin and lakes in Southeastern Wisconsin were derived from Lillie & Mason (1983).

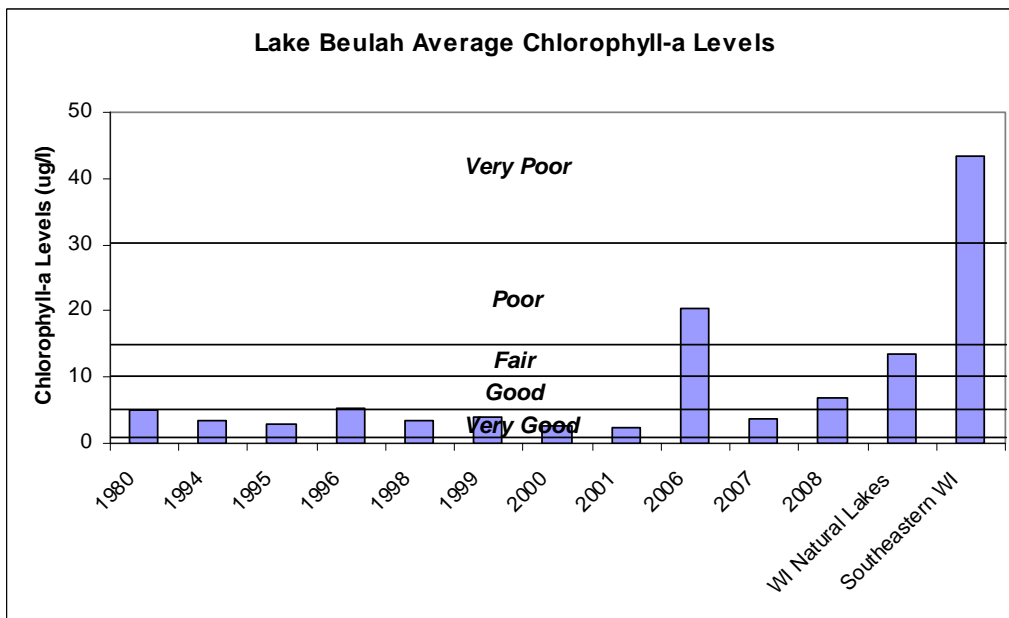
Figure 3. Lake Beulah Average Chlorophyll-a Levels. The mean chlorophyll-a values from random natural lakes in Wisconsin and lakes in Southeastern Wisconsin were derived from Lillie & Mason (1983).

Chlorophyll-a levels in Lake Beulah have generally been very good and significantly lower than mean values for other natural lakes in the state and for lakes in the southeast region of Wisconsin. The low chlorophyll-a levels are related to the high secchi disk clarities. The overall average chlorophyll-a value based on the Citizen Lake Monitoring database was 5.45 µg/L. This value was based on sampling events during the growing season, June through October.

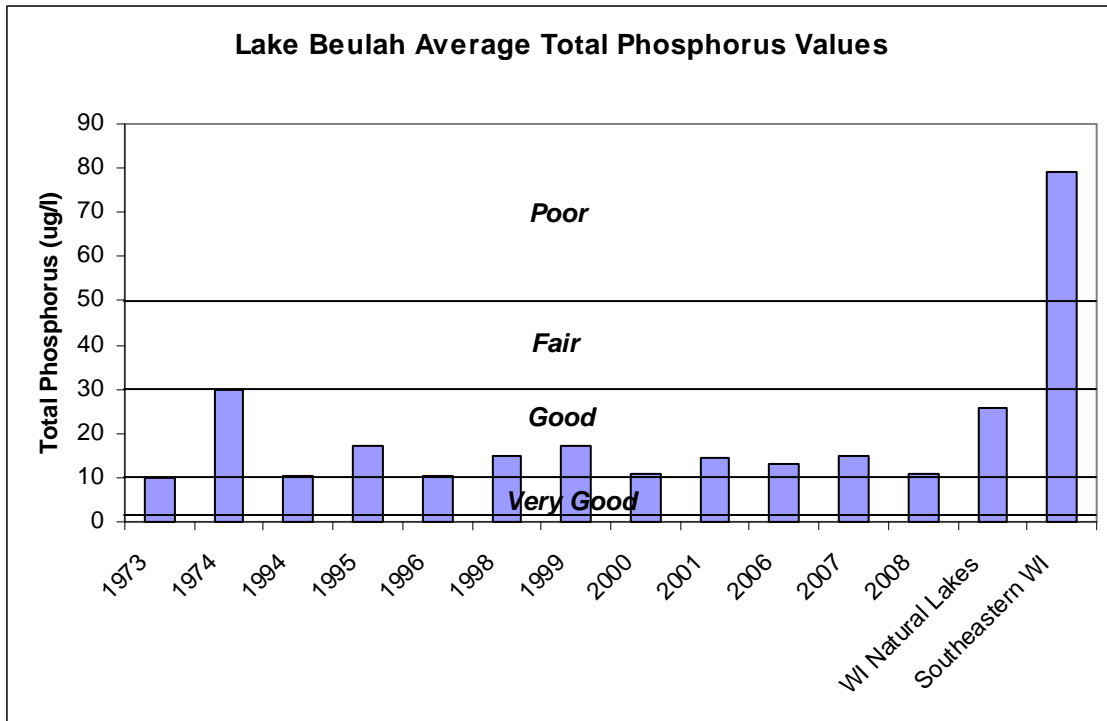
Figure 4. Lake Beulah Average Total Phosphorus Values. The mean total phosphorus values from random natural lakes in Wisconsin and lakes in Southeastern Wisconsin were derived from Lillie & Mason (1983).

Total phosphorus values in Lake Beulah, plotted on Figure 4, have generally been good and lower than mean values for other natural lakes in the state and for lakes in the southeast region of Wisconsin. The overall average total phosphorus value based on the Citizen Lake Monitoring database was 14.54 µg/L. This value was based on sampling events during the growing season, May through October.

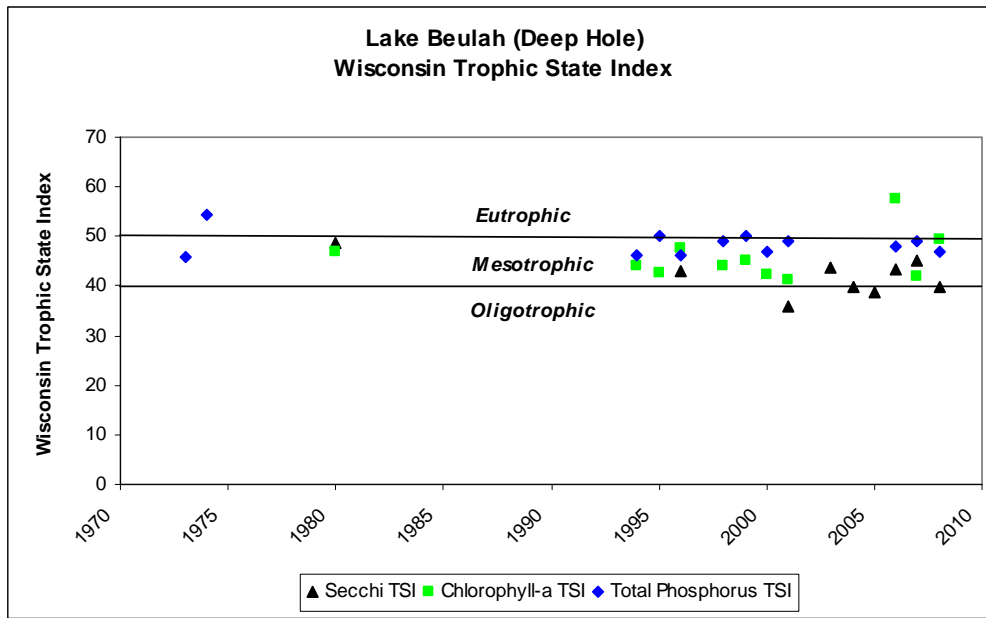
Figure 5. Lake Beulah Wisconsin Trophic State Index. Calculations based upon Lillie, et al. (1993).

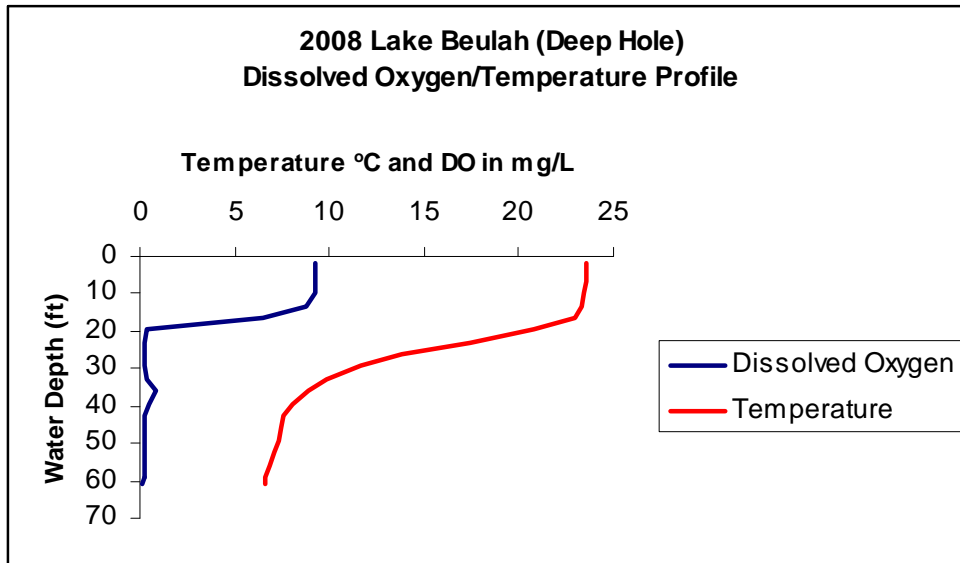
Figure 6. 2008 Lake Beulah (Deep Hole) Dissolved Oxygen and Temperature Profile.

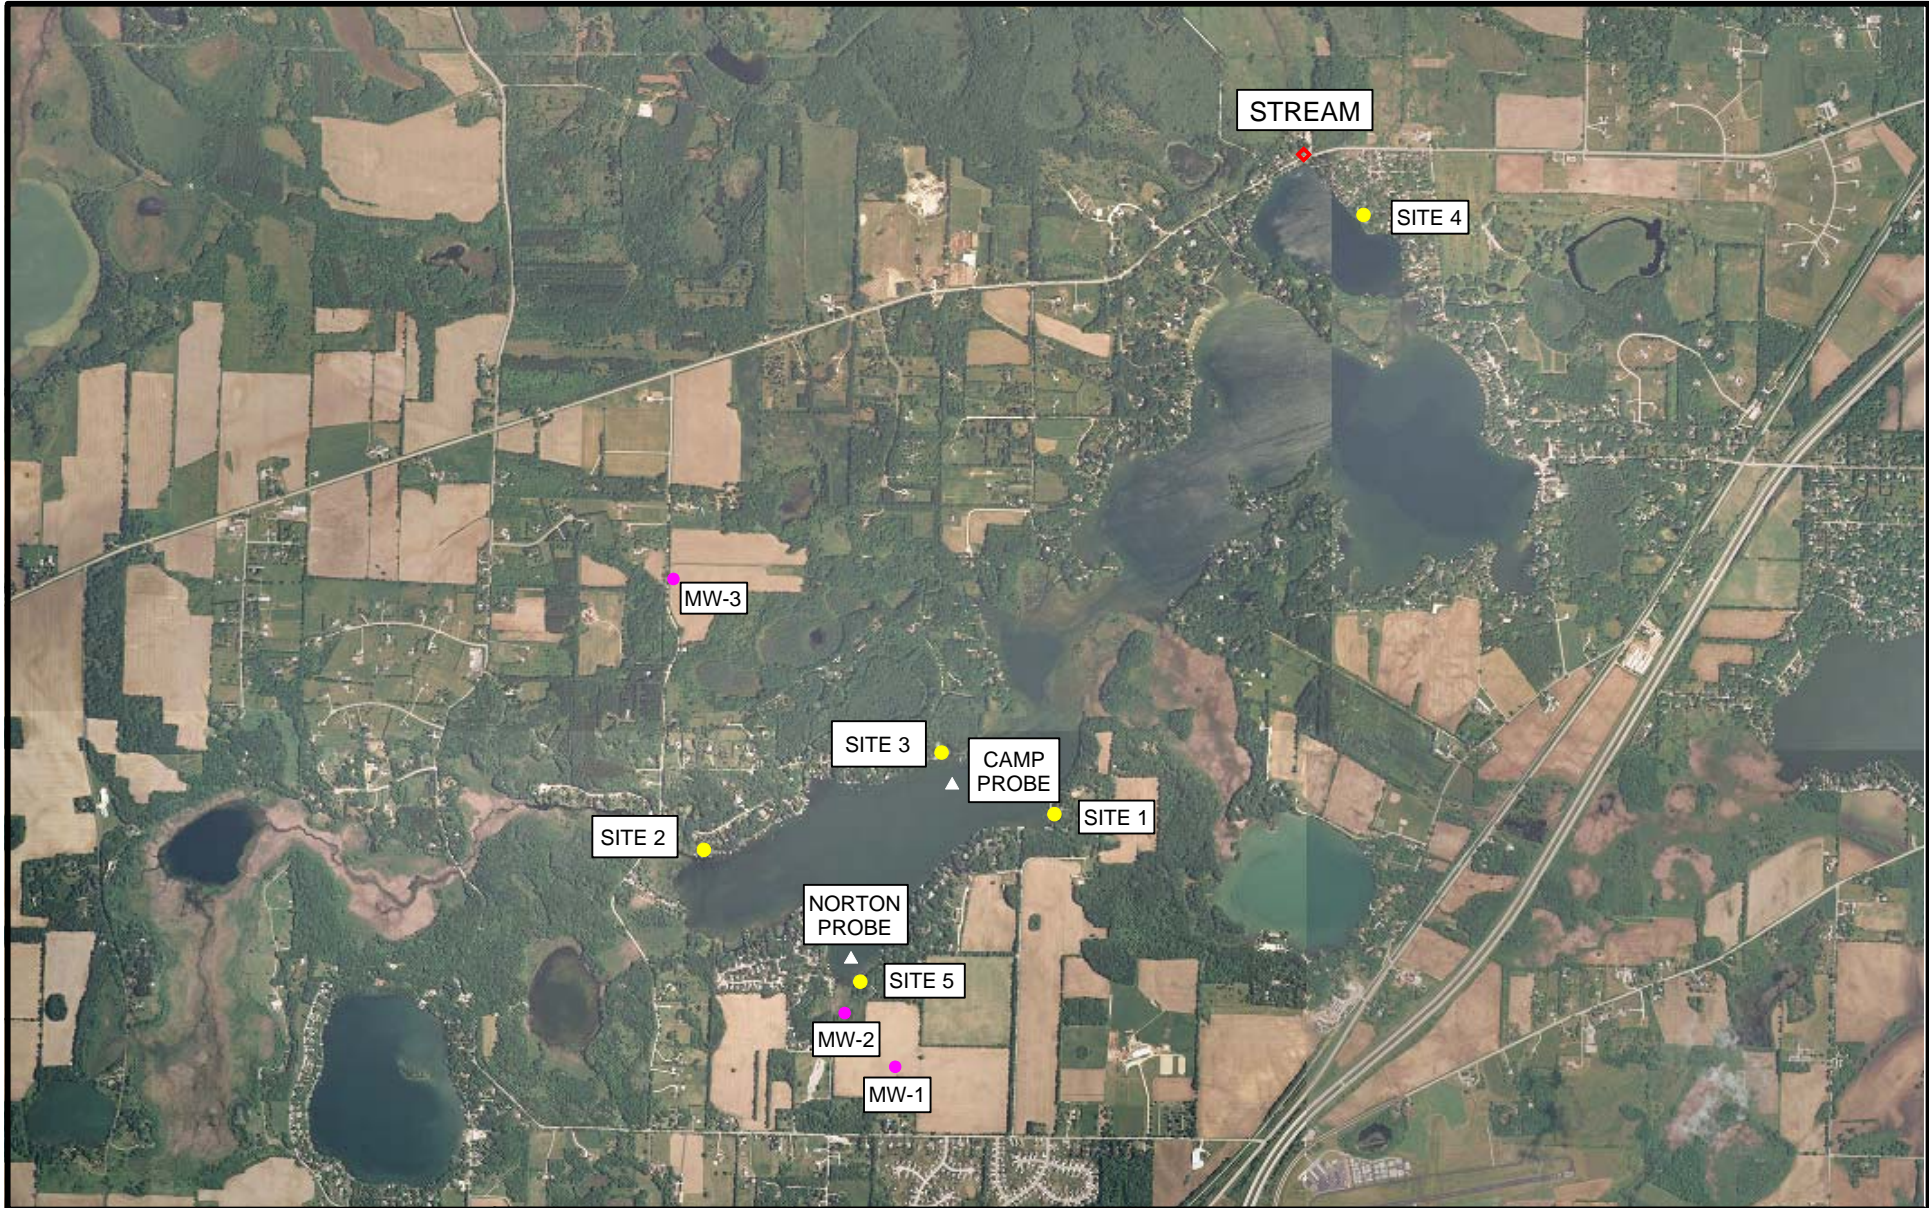
**FIGURE
B-1**

- DRIVE POINT NEST
- EAST TROY WELL NEST
- ▲ TEMPERATURE PROBE
- ◆ STREAM FLOW

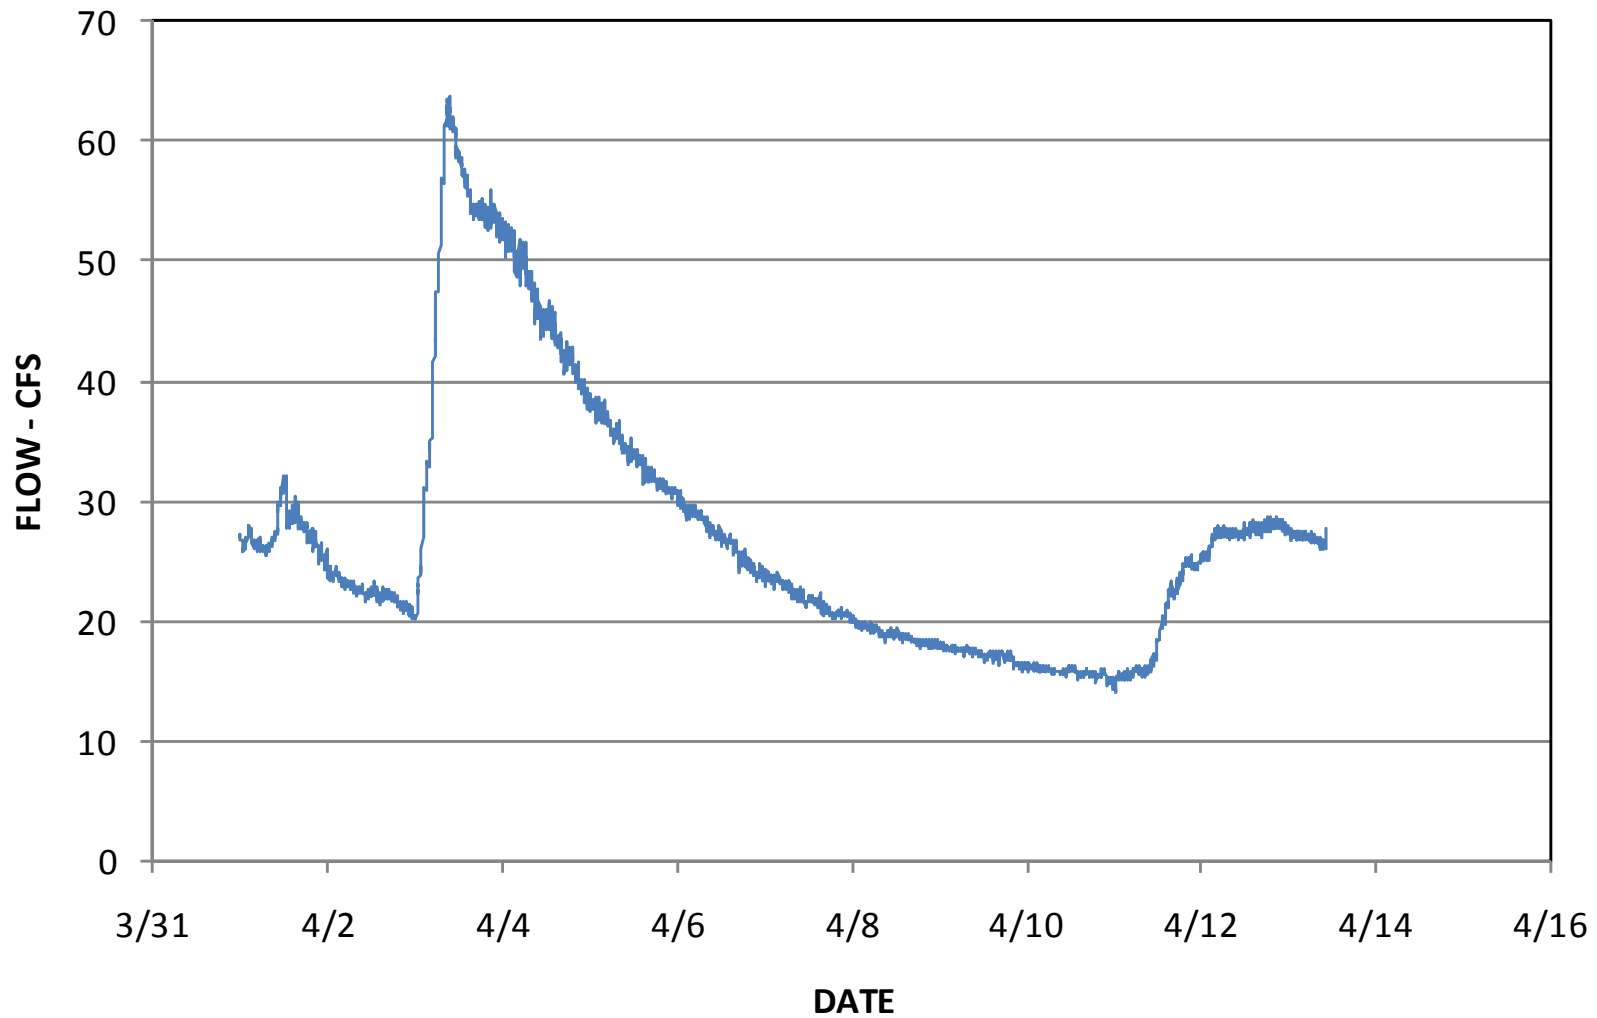
**FIGURE
B-3**

Figures B-2 through B-10 show stream flows for the months of March 2007 through November 2007; Figures B-11 through B-17 show flows for the months of May 2008 through November 2008. In general, flows are in the 20 to 30 cubic foot per second (CFS) range; however, some spikes occur due to precipitation. As Figures B-10 (November 2007) and B-17 (November 2008) show, ice caused anomalously high readings, so monitoring was discontinued during winter months.

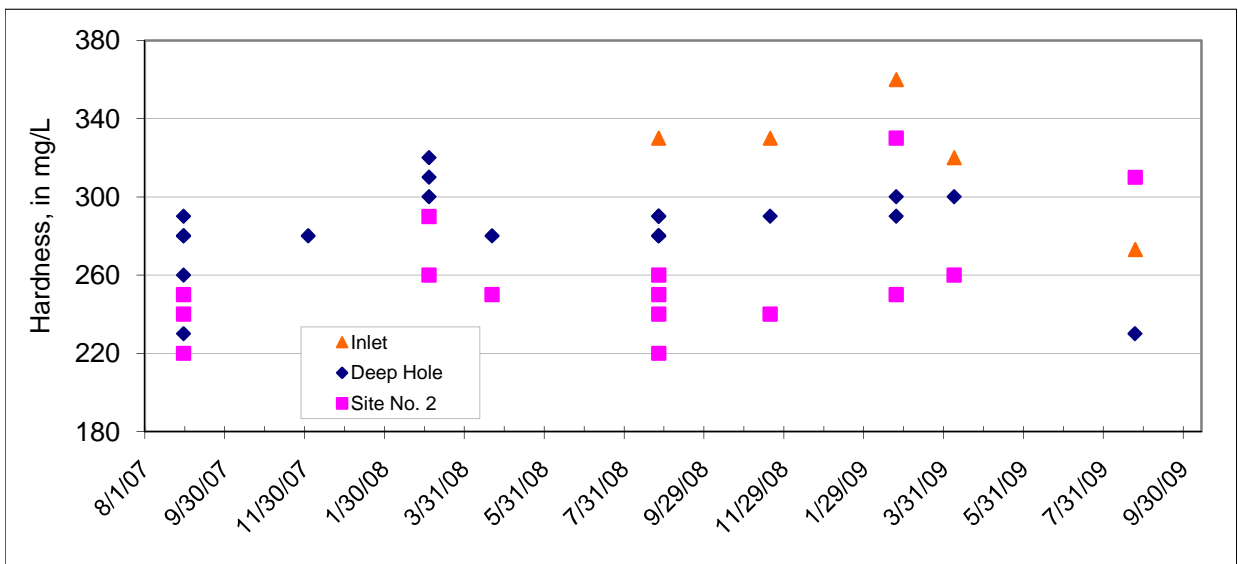
Notes: USGS data from top graph are from Deep Hole location. Second graph contains all USGS data.
