2011 Water Quality Management Plan Update

Lake Superior Basin, Wisconsin

December 2011 (2015)

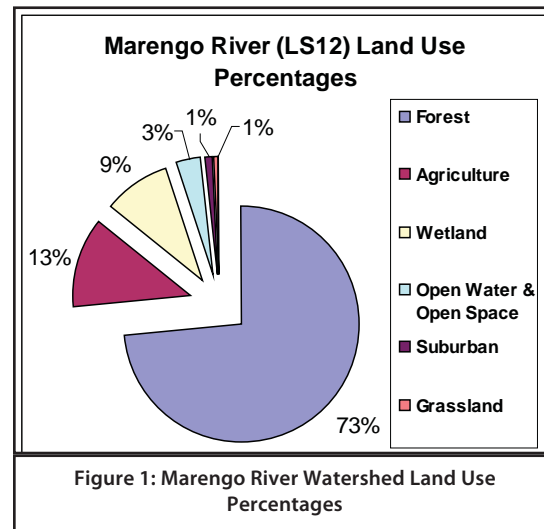
As indicated earlier, according to the National Land Cover Dataset (NLCD) from 2001, forest dominates the landscape in the Marengo River Watershed, covering almost three quarters (73%) of the total area. Farmland and wetland are the next most common land uses in the watershed with 13% and 9% of the total area, respectively. Open water and space, suburban landscapes, and grassland encompass the remaining area in the watershed with three percent, one percent, and six-tenths of one percent of the area, respectively. Urban environments are minimal, accounting for only two-hundredths of one percent of the watershed’s area.

Land Use	Acres	Percent of Area
Forest	102,034.53	73.29%
Agriculture	17,576.09	12.63%
Wetland	12,681.62	9.11%
Open Water & Open Space	4,539.08	3.26%
Suburban	1,469.14	1.06%
Grassland	883.13	0.63%
Urban	31.80	0.02%
Barren	1.11	0.00%
Total Acres in Watershed	139,216.50

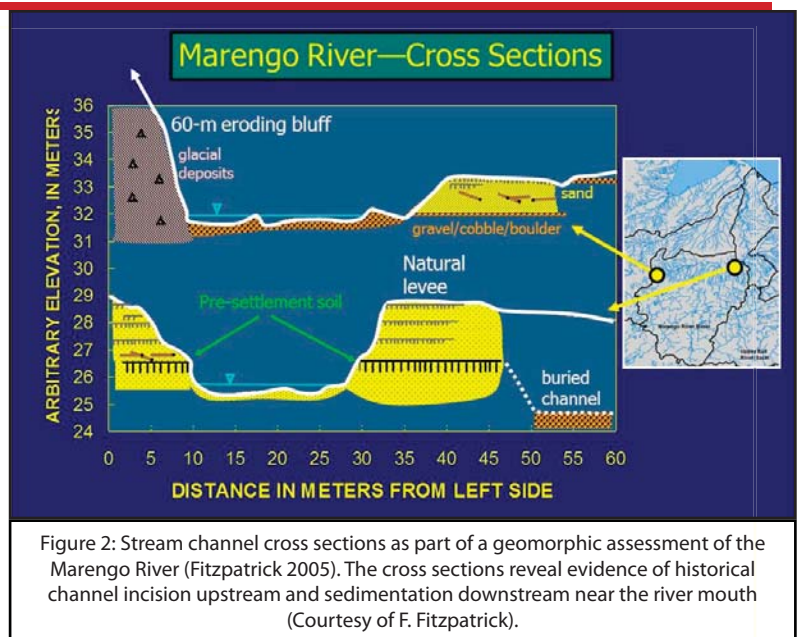
The lower portion of the Marengo River displays evidence of sediment overload, likely transported during episodic flood events (Figure 2).

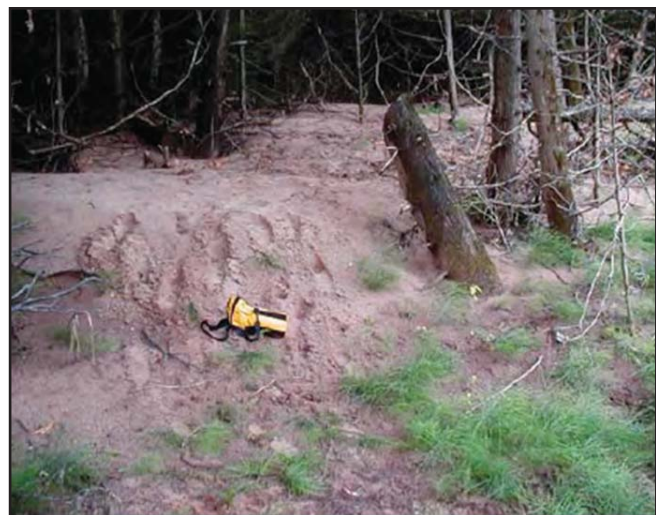
Figure 3: Levee building as a result of sand deposition near the mouth of the Marengo River (photo courtesy of Bad River Natural Resources Department).

igration and channel instability exist at the confluence of the Marengo and Bad rivers. Increased overbank sedimentation (levee building) disconnects the river from its floodplain and increases flood power to downstream reaches (Fitzpatrick 2005). The overbank sedimentation is primarily sand, presumably eroded from the wave-planned topography in the soil transition zone (Figure 3).

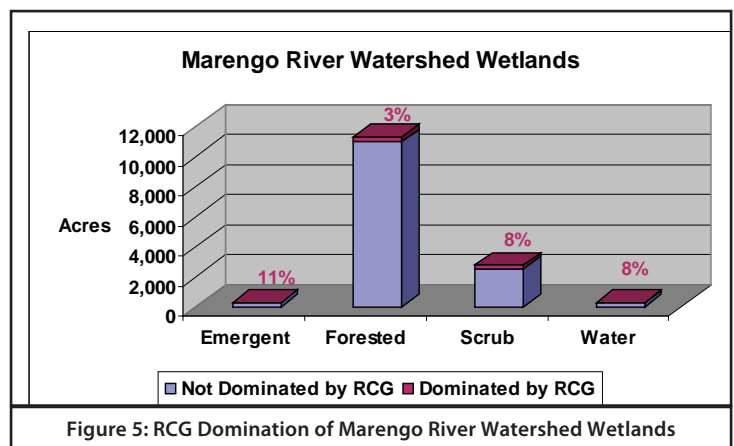
Figure 5: RCG Domination of Marengo River Watershed Wetlands

Little is known about the condition of the remaining wetlands, but estimates of reed canary grass (RCG) infestations, an opportunistic aquatic invasive wetland plant, into different wetland types has been estimated based on satellite imagery. This shows reed canary grass dominates 3% of the existing forested wetlands and 8% of the remaining shrub wetlands (See Figure 5). Reed canary grass domination inhibits successful establishment of native wetland species.

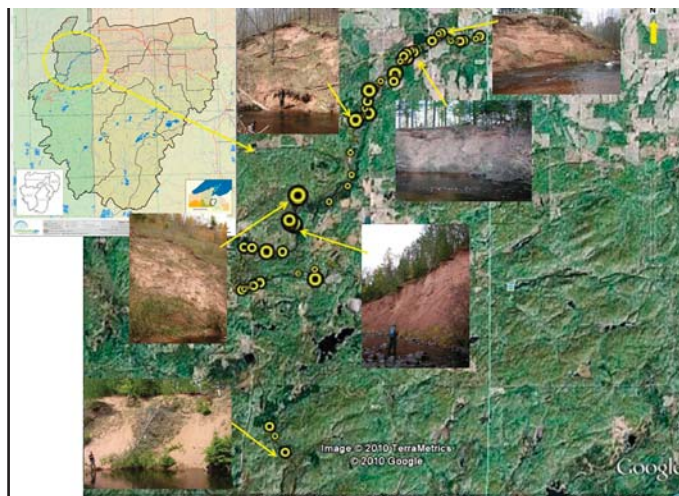
Figure 6: Bad River Watershed Association “Get to Know Your Watershed” survey stream bank erosion locations and example pictures of some erosion sites. The size of the dots is based on the area (in ft²) of the eroding stream bank. The surveys were conducted in the high sedimentation area of concern identified in the Marengo Test Case (LSBPT 2007). Erosion photos by Bad River Watershed Association. Aerial photo from Google Earth and USDA Farm Service Agency.

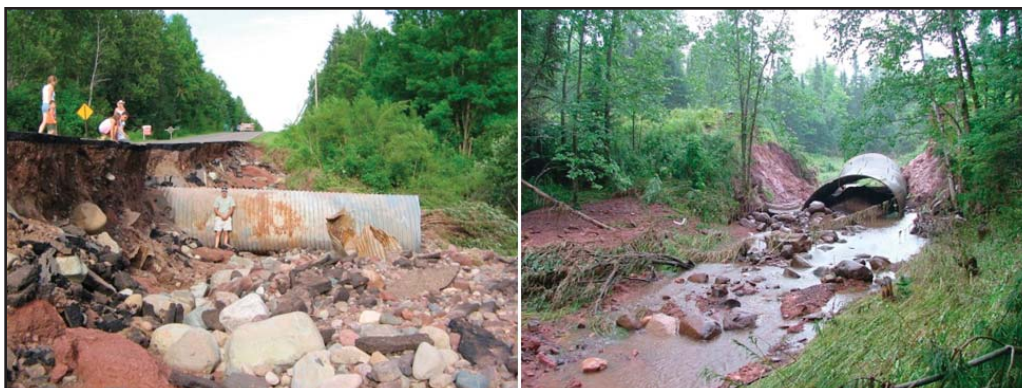
Figure 7: Examples of failed culverts in the soil transition zone of the Marengo River Watershed. Left photo by Diane Daulton, right photo by Bad River Watershed Association.

Road and agricultural drainage systems are an important and poorly understood impact to hydrologic function and as a source of sediment to Marengo River Watershed streams. Both of these types of drainage systems create hydrologic connectivity between uplands and river systems. Harr (1975) showed that when the amount of total road right-of-way area exceeds 12% of a watershed area, peak flows increased significantly. Extra sediment can come from a road failure or from a regularly eroding stream crossing. There are 406 known crossings in the Marengo River Watershed. Crossings within the soil transition zone are particularly susceptible to failure (Figure 7).
