**Warm Water Point/Intercept Macrophyte Survey
Balsam Lake
Polk County, Wisconsin
WBIC: 2620600**

Endangered Resource Services, LLC
Matthew S. Berg, Research Biologist
St. Croix Falls, Wisconsin
July 19-23, 2009

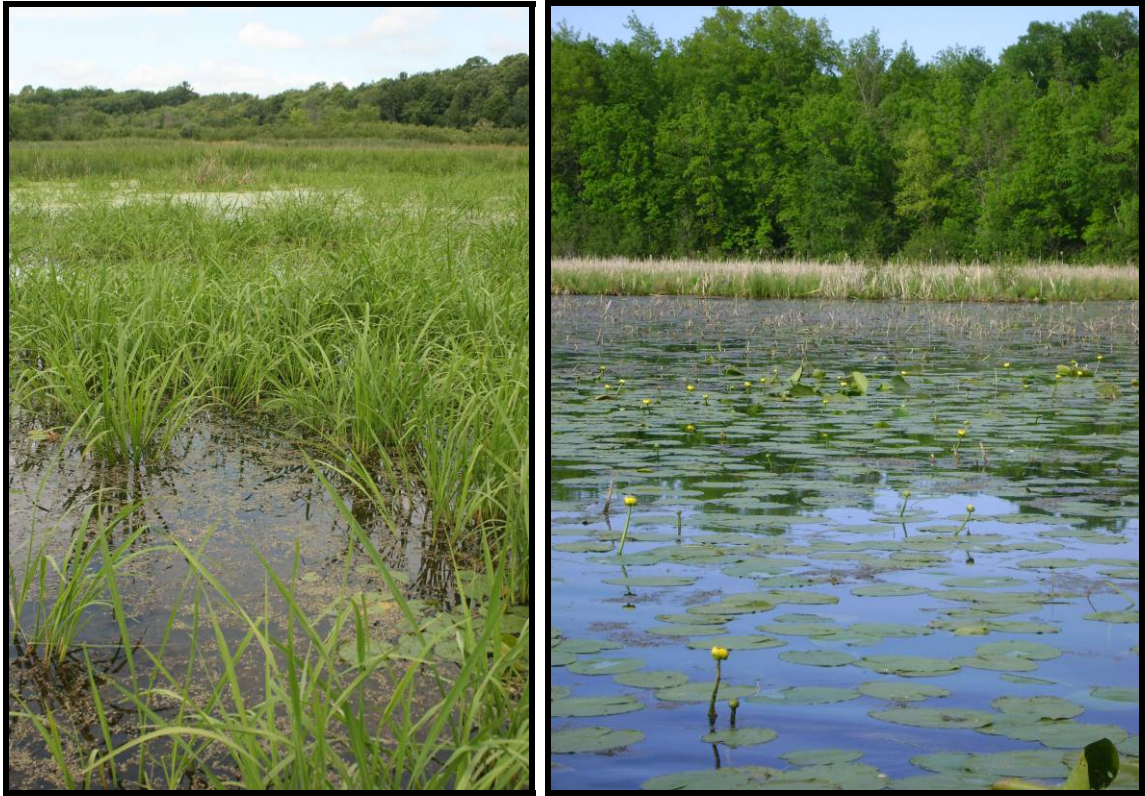
Figure 6: Emergent and Floating Vegetation in Muck Bottom Bays

The lake's shallow bays (Stump Bay is pictured) supported expansive submergent, floating, and emergent plant beds. Their shallow water and thick organic muck promoted both plant density and species richness (Figure 6). Of these bays, Idlewild, Stump and Raskin were the most diverse. Each bay had unique species not found anywhere else on the lake. Idlewild in particular had several species more commonly associated with acidic lakes that had floating bogs on them.

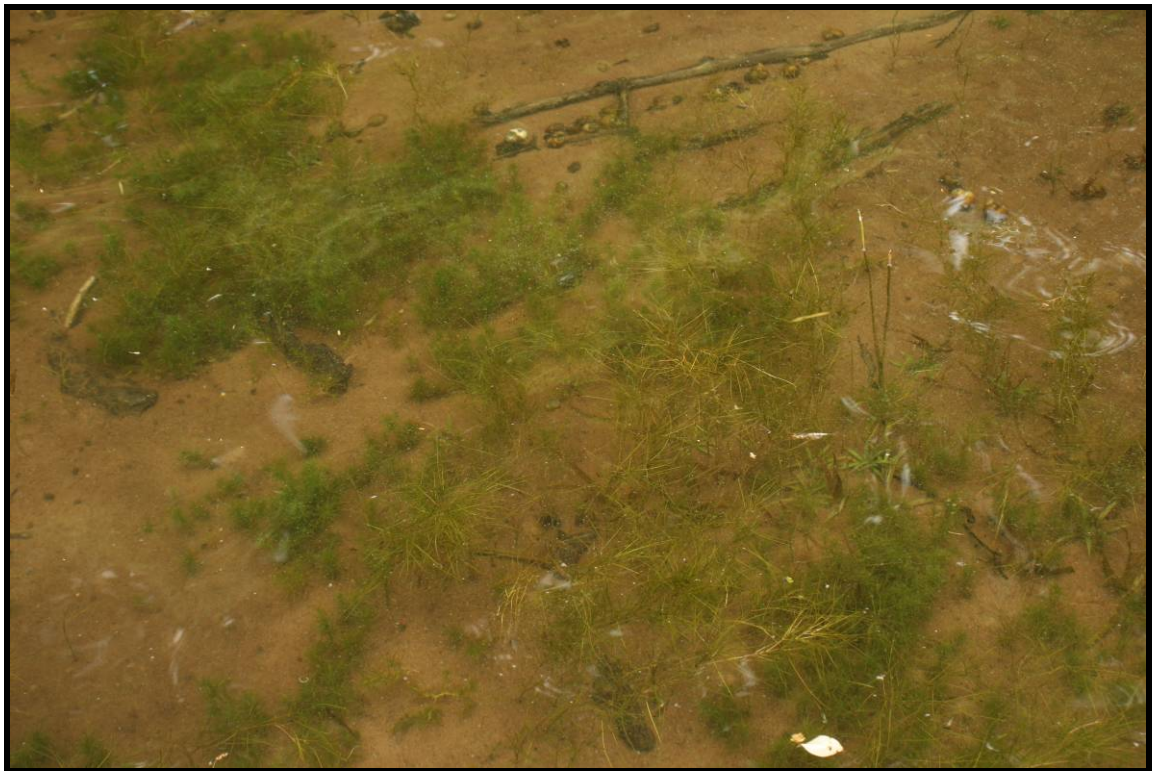
Figure 7: Submergent Vegetation in Sand/Rock Shoreline Areas

The sandy/rocky bottom areas (Big Island is pictured) and relatively narrow littoral zone of Little Balsam, Boston Bay and most of Balsam north shore and island borders supported fewer species in lower densities albeit ones unique to these habitats (Figure 7).

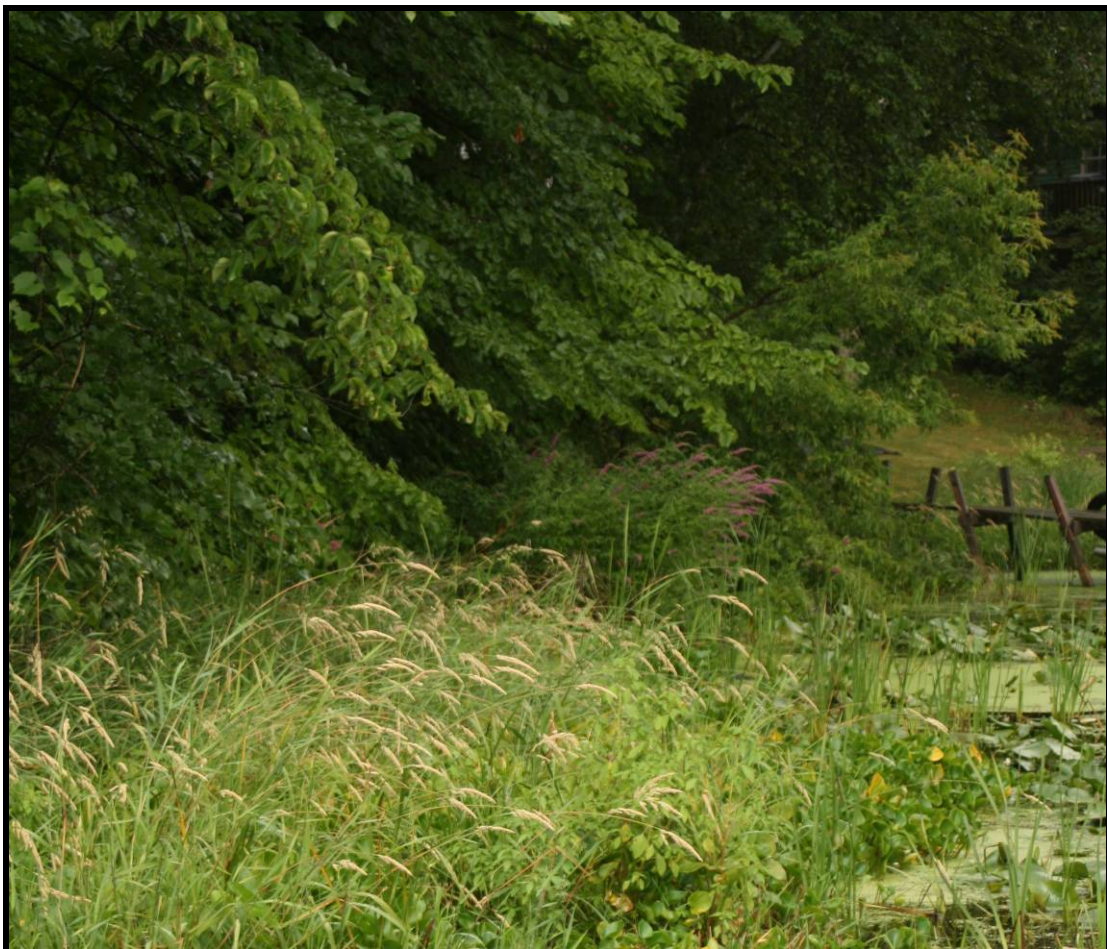
Figure 9: Reed Canary Grass and Purple Loosestrife

We did NOT find any evidence of Eurasian water milfoil in Balsam Lake. However, several large clusters of Purple loosestrife (*Lythrum salicaria*), another invasive species, were noted along the west Mill Street Boat Landing shoreline (Figure 9). Plants were few in number and could/should be hand removed before they spread to other areas of the lake shore. Reed canary grass (also pictured below) is widely distributed in undeveloped shoreline areas of the lake. Curly-leaf pondweed, which was so prevalent in June, had largely senesced by the time of the July survey (Figure 10) (For more information on exotic invasive species, see Appendix IX).

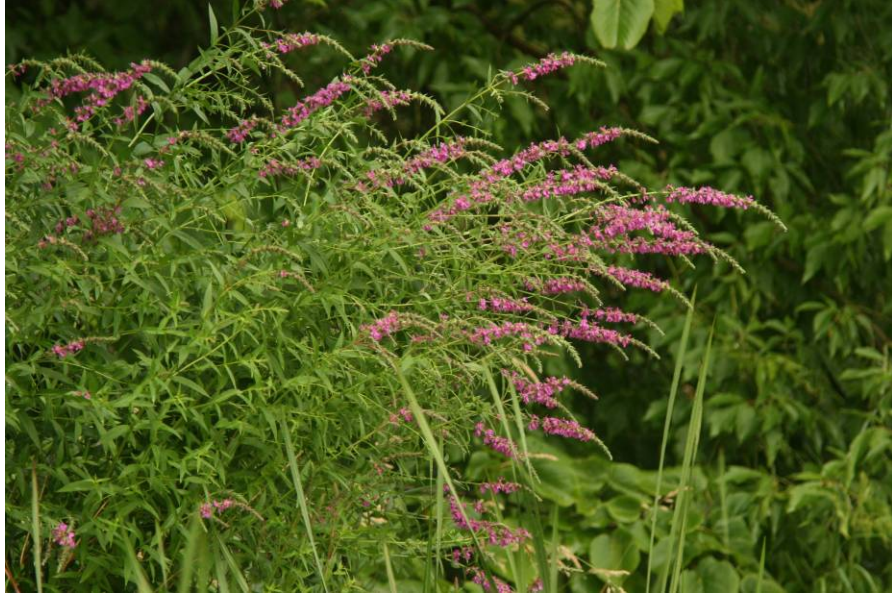
Purple loosestrife near Mill St. Boat Landing
