2011 Water Quality Management Plan Update

Upper Rock Basin, Wisconsin

December 2011

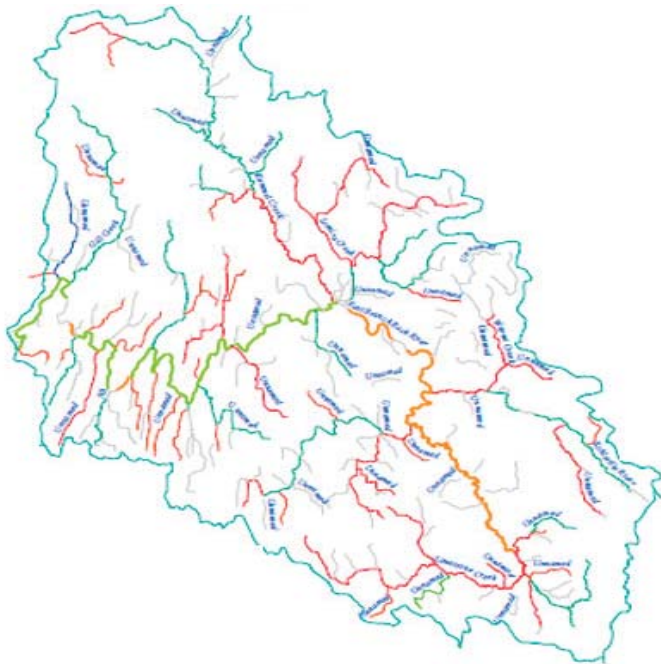
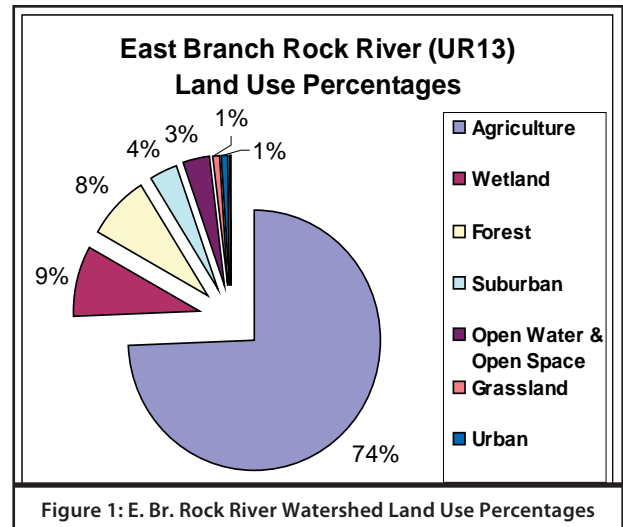
Figure 1: E. Br. Rock River Watershed Land Use Percentages

Nearly three-quarters of the area of the East Branch Rock River Watershed is devoted to agricultural use. Wetlands and forests also make up sizeable proportions of the watershed with nine and eight percent of the total area, respectively. Suburban environments equal about four percent of the watershed's area and open water and open space account for another three percent. Scarcer still, Grasslands and urban landscapes each amount to a little less than one percent of the total area.

Land Use	Acres	Percent of Area
Agriculture	94,715.52	74.37%
Wetland	11,139.98	8.75%
Forest	10,133.20	7.96%
Suburban	4,654.95	3.65%
Open Water & Open Space	4,321.58	3.39%
Grassland	1,113.09	0.87%
Urban	1,038.36	0.82%
Barren	242.19	0.19%
Total Acres in Watershed	127,358.86

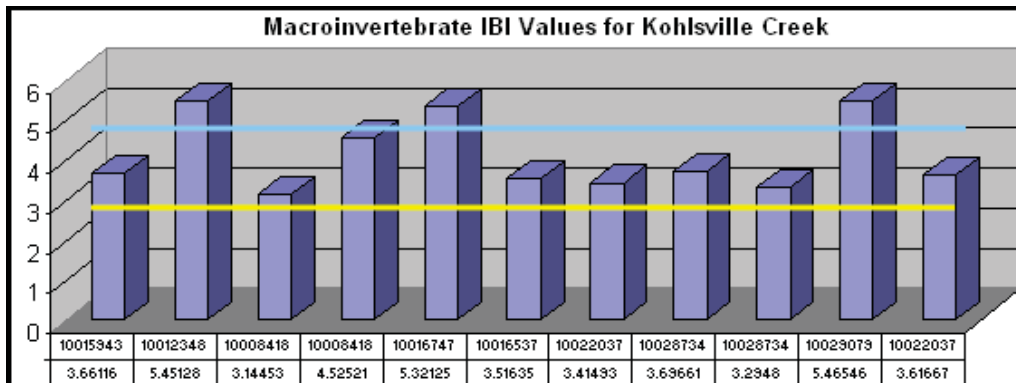
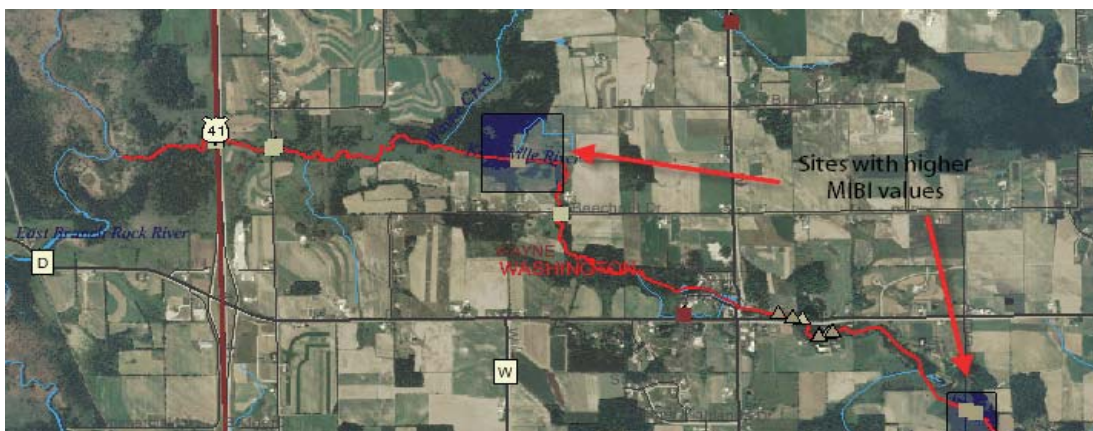
Map of MIBI values on Kohlsville River, Rock River Basin.

The table and graph below show macroinvertebrate values for the river over time at multiple stations. Multiple sites show fair values at many years over time. The three “good” values are connected to the stream near Aurora Road and Beechnut Road. A map of these locations is displayed below.

Station ID	Station Name	Value	Date
10008418	Kohlsville R.: Midland Rd. Bridge	3.14453	13-Nov-95
10008418	Kohlsville R.: Midland Rd. Bridge	4.52521	07-Nov-01
10012348	Kohlsville River At Aurora Road North	5.45128	13-Nov-95
10015943	Kohlsville River - Downstream Of Townline Rd ~ 45 Feet	3.66116	13-Nov-95
10016537	Kohlsville River - Upstream Of Beechnut Dr.	3.51635	08-Oct-02
10016747	Kohlsville River - Downstream Of Beechnut Dr.	5.32125	08-Oct-02
10022037	Kohlsville River - Upstream of Midland Drive	3.41493	21-Oct-07
10022037	Kohlsville River - Upstream of Midland Drive	3.61667	20-Oct-10
10028734	Kohlsville River At Hwy 41	3.69661	08-Oct-08
10028734	Kohlsville River At Hwy 41	3.2948	08-Oct-08
10029079	Kohlsville River - Upstream of Aurora Drive	5.46546	27-Oct-08

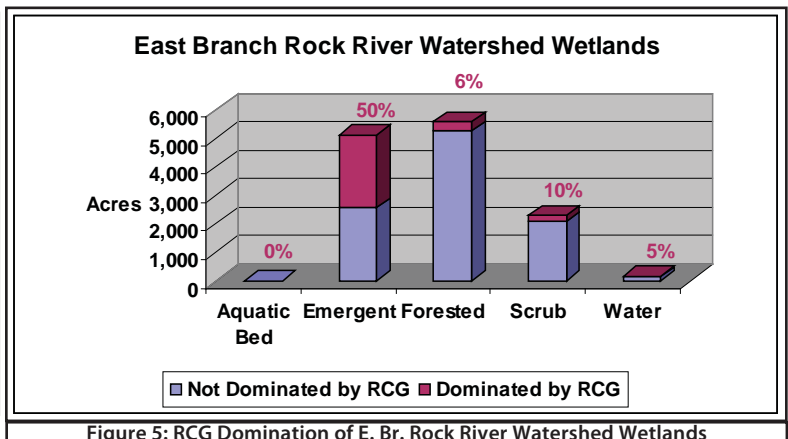
Figure 5: RCG Domination of E. Br. Rock River Watershed Wetlands

Little is known about the condition of the remaining wetlands but estimates of reed canary grass (RCG) infestations, an opportunistic aquatic invasive wetland plant, into different wetland types has been estimated based on satellite imagery. This information shows that reed canary grass dominates six percent of the existing forested wetlands and just over half of the remaining emergent wetlands (See Figure 5). Reed canary grass domination inhibits successful establishment of native wetland species.
