2011 Water Quality Management Plan Update

Lower Rock Basin, Wisconsin

December 2011 (2015)

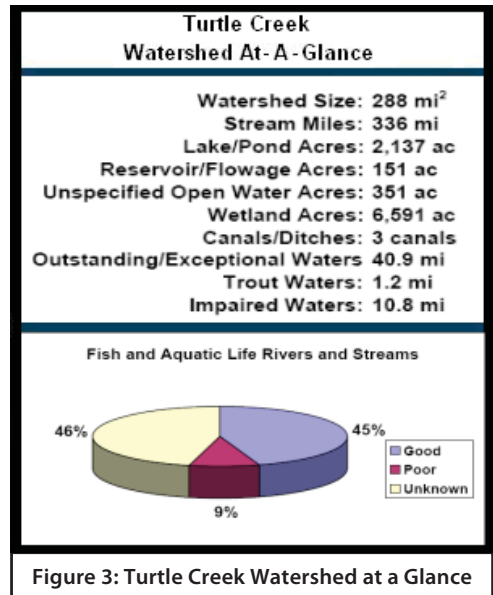
**Table 2: Designated Use Support Summary for Turtle Creek Watershed Rivers and Streams (all values in miles)**

| Use | Fully Supporting | Supporting | Not Supporting | Not Assessed | Total Size |
| Fish Consumption | | | | 121.75 | 121.75 |
| Fish and Aquatic Life | 11.91 | 42.77 | 10.81 | 56.26 | 121.75 |
| General | | | | 121.75 | 121.75 |
| Public Health and Welfare | | | | 121.75 | 121.75 |
| Recreation | | | | 121.75 | 121.75 |

Additional uses for which the waters are evaluated include Fish Consumption, General Uses, Public Health and Welfare, and Recreation. As Table 2 shows, these uses have not been directly assessed for the watershed. However, a general fish advisory for potential presence of mercury is in place for all waters of the state.

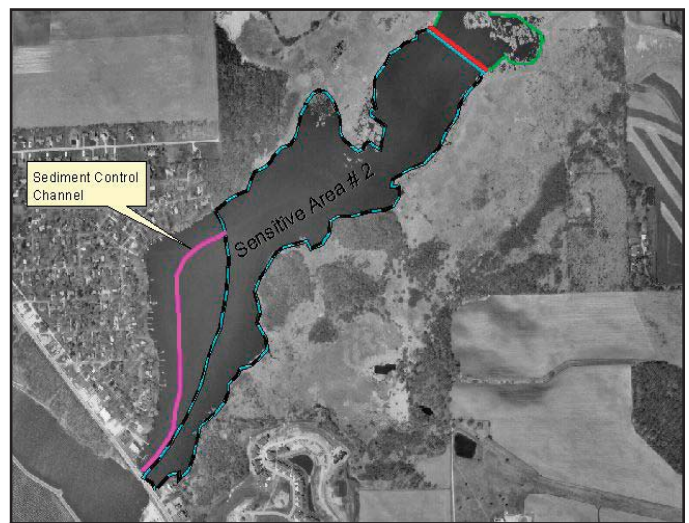
Map 4: Delavan Lake Sensitive Area #2

Sensitive Area 2, in the lower inlet of Delavan Lake, serves as a fish and wildlife refuge and has diverse aquatic vegetation, terrestrial vegetation and wildlife populations. The site acts as a nutrient buffer reducing algae blooms, a biological buffer reducing the likelihood of exotic invasions, a physical buffer against shoreline erosion, a micro-habitat increasing biodiversity, and allows for sediment stabilization. This site provides a visual buffer from shoreline structures. Aquatic plants in the sensitive area include emergents, algae, potamogetons, exotics, free floating, floating leaf, and submergents. Wet edge plants include herbs, sedges, rushes, shrubs, and grasses. Game fish, panfish, young of the year fry and forage fish are present in the sensitive area. Wildlife present include furbearers, waterfowl, shore birds (including wood ducks and brood), amphibians, and reptiles. The undeveloped shoreline is extremely valuable for wildlife. This site could be used to educate citizens about wetlands and sensitive areas, possibly by canoe.

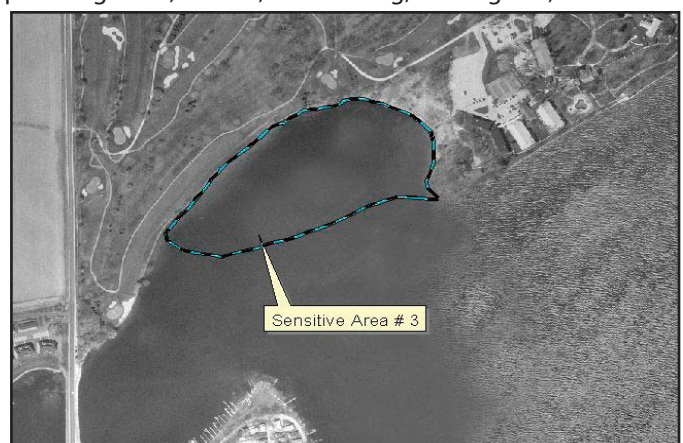
Map 5: Delavan Lake Sensitive Area #3

Sensitive Area 3, in Lake Lawn Bay of Delavan Lake, serves as a fish and wildlife refuge and has a diverse wildlife population. The area acts as a nutrient buffer to reduce algae blooms, a biological buffer reducing the likelihood of exotic invasions, a physical buffer against shoreline erosion, a micro-habitat that increases biodiversity, and allows for sediment stabilization. Sensitive Area 3 is very important as a refuge for fish and wildlife, away from active boating lanes. Important habitat components at this site include

gravel bottom, submerged vegetation, and over-hanging vegetation. This area offers a spawning area, nursery area, feeding area, and protective cover to walleye, northern pike, musky, small mouth bass, large mouth bass, centrarchid, perch, sucker, and minnows. Many bird species utilize the complex of trees and shrubs and would not be present on Delavan Lake without this refuge.

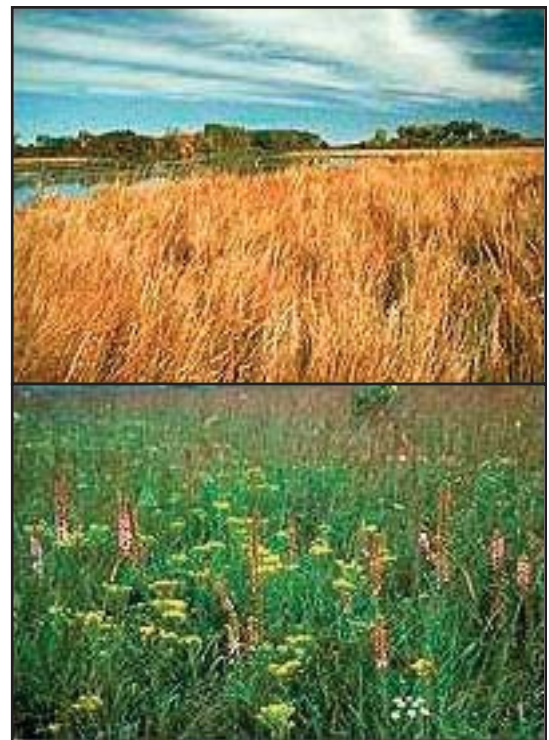
Figure 4: Marshes (above); Sedge or "Wet" Meadows (below) (Photos courtesy of WDNR)

wetlands. Reed canary grass domination inhibits its successful establishment of native wetland species.

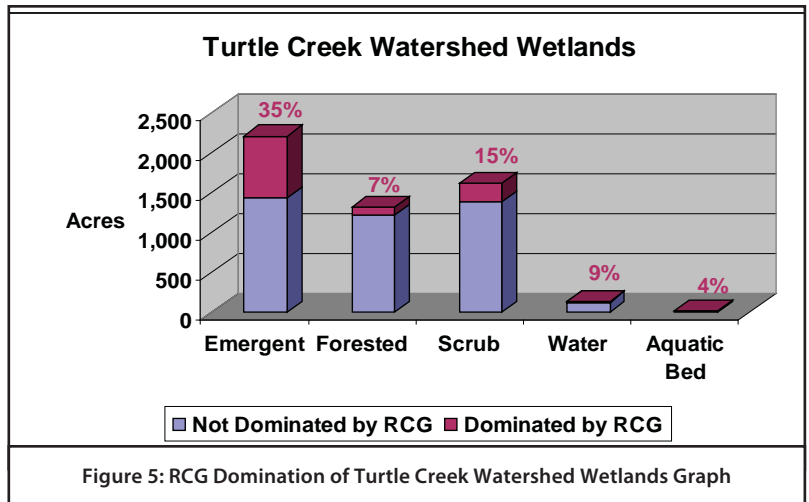
Figure 5: RCG Domination of Turtle Creek Watershed Wetlands Graph

Little is known about the condition of the remaining wetlands but estimates of reed canary grass (RCG) infestations, an opportunistic aquatic invasive wetland plant, into different wetland types has been estimated based on satellite imagery. This information shows that reed canary grass dominates 35% of the existing emergent wetlands, 15% of shrub wetlands, and 7% of the remaining forested

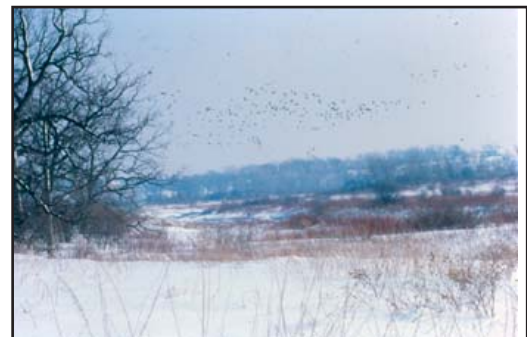
Turtle Creek Wildlife Area is a 1,035-acre property located in western Walworth and eastern Rock counties. The property snakes along ten miles of Turtle Creek in four segments from Delavan to South O'Riley Road. There are ten road crossings and/or parking lots scattered through the length of the property.

Figure 6: Turtle Creek State Wildlife Area

The habitat consists of sedge meadow, shrub carr, hardwood forest, and small prairie remnants. Large fall and winter concentrations of Canada geese can be seen at Turtle Creek. It is also home to a number of rare fish and reptile species. Hunting/viewing opportunities include deer, waterfowl, small game, and partridge. Mourning dove hunting is available on natural field/dike edges as well as sharecropped fields of corn, hay, and soybeans.

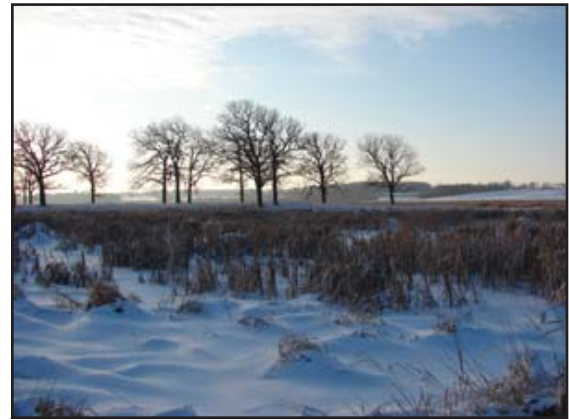
The shallow marshes are managed to maintain fifty percent open water. This hemi-marsh environment is ideal for waterfowl production and provides excellent hunting opportunity. Management activities to promote grassland and savanna are conducted on the surrounding uplands.

The habitats throughout the entire wildlife area will be maintained and improved using a number of techniques including prescribed fire, brush removal, planting native species, and removal of invasive species. Water level manipulation is used in conjunction with the aforementioned management tools. Be sure to prescout your hunting as flowages may be drawn down in the fall. A waterfowl refuge exists in the middle of the property to hold birds in the area.

Figure 7: Turtle Valley Wildlife Area

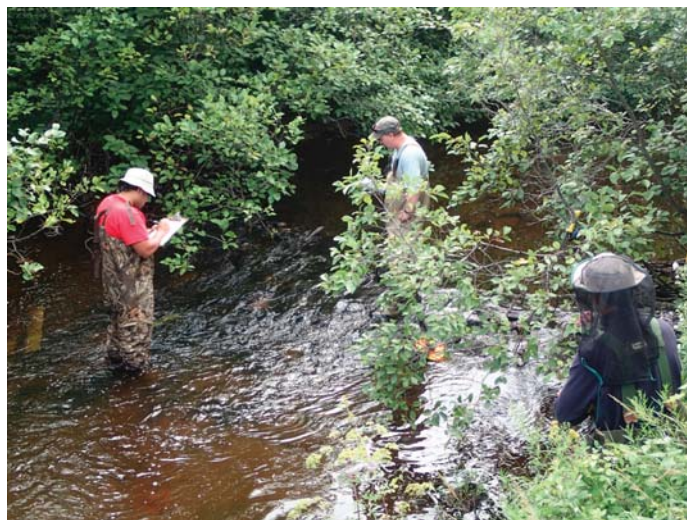
Monitoring in the Rock River Basin
