**Manitowoc River Watershed  
Baseline Survey 2005-2006**

**By  
Steve Hogler, Steve Surendonk and Mary Gansberg**

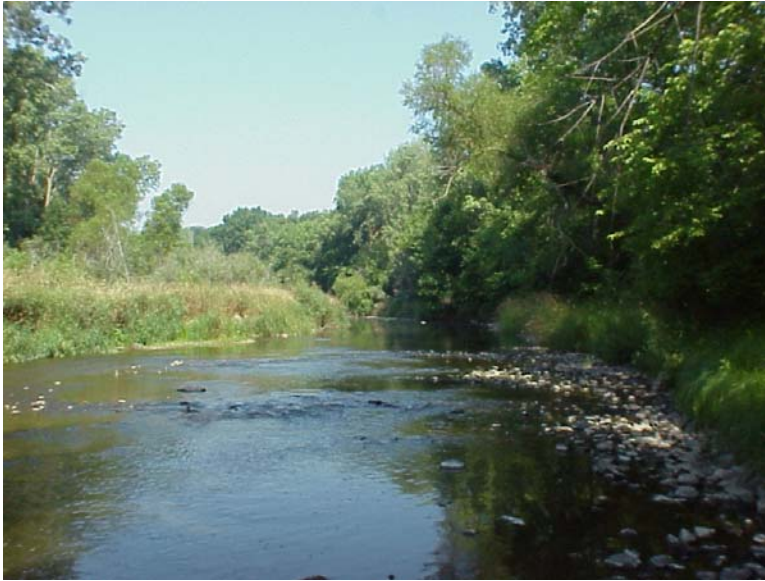
The survey site was located just upstream of County Highway S and was the site of the former Oslo Dam that failed in the 1960's and was completely removed in 1985 (N44.0994, W-087.8230 to N44.1007, W-087.8286). The survey section averaged 15.0 meters in width and was 510 meters in length. The Manitowoc River at this location is a sixth order stream with a gradient of 0.8 meters per kilometer and a sinuosity of 1 to 1.24. The study reach of the river ran through a meadow-shrub-woodland complex (Figure 2).

**Figure 2. Looking upstream at the Manitowoc River just above County Highway S. This site was the mill pond of the former Oslo Dam.**

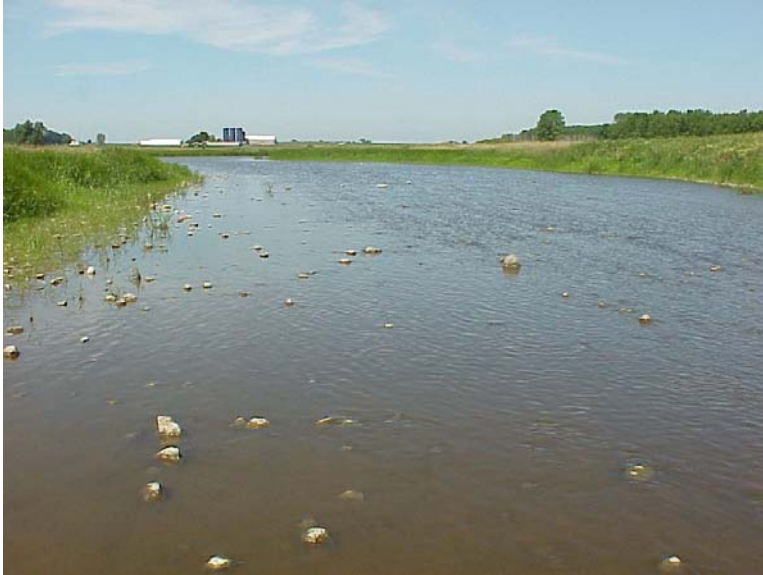
The survey site was located just upstream of County Highway W (N44.0744, W-087.9774 to N44.0788, W-087.9856). The survey section averaged 41.3 meters in width and was 1080 meters in length. The Manitowoc River at this location has a stream order of six, a gradient of 0.07 meters per kilometer and a sinuosity of 1 to 1.53. The study reach of the river ran through 100% meadow (Figure 4).

**Figure 4. Looking upstream from the starting riffle on the Manitowoc River just above Highway W.**

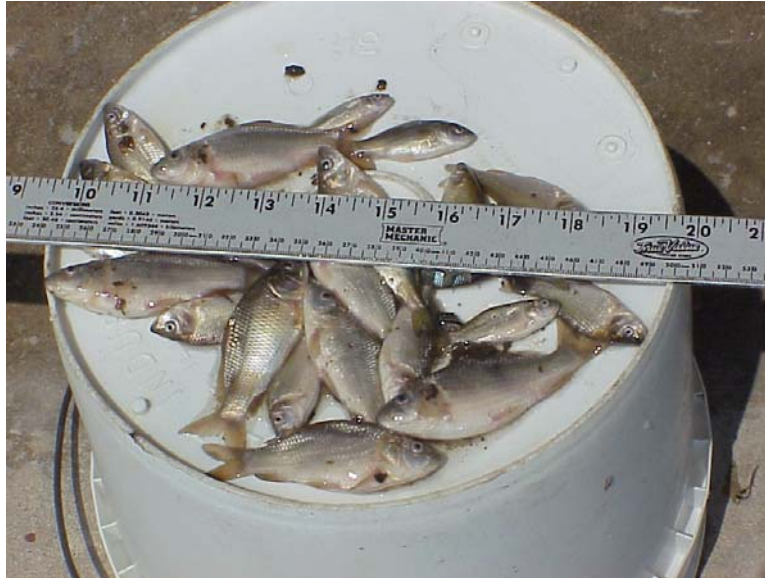
**Figure 6. Young of year carp captured at Highway W during electroshocking on the Manitowoc River.**

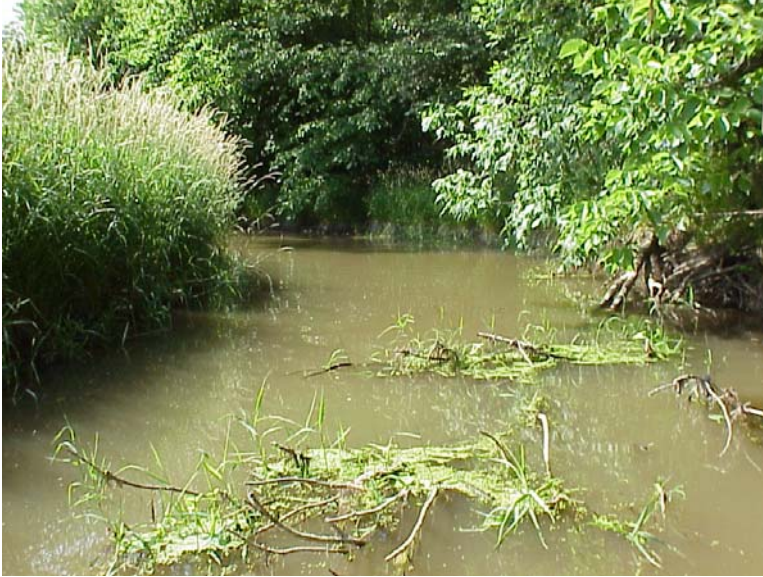
The survey site was located just upstream of State Highway 151 (N44.0365, W-087.9386 to N44.4351, W-087.9371). The survey section averaged 5.9 meters in width and was 210 meters in length. Mud Creek at this location is a fourth order stream with a gradient of 0.351 meters per kilometer and a sinuosity of 1 to 1.48. The study reach of the river ran through a meadow-woodland complex (Figure 7).

**Figure 7. This upstream view of Mud Creek above Highway 151 is a typical sight for this section of Mud Creek.**

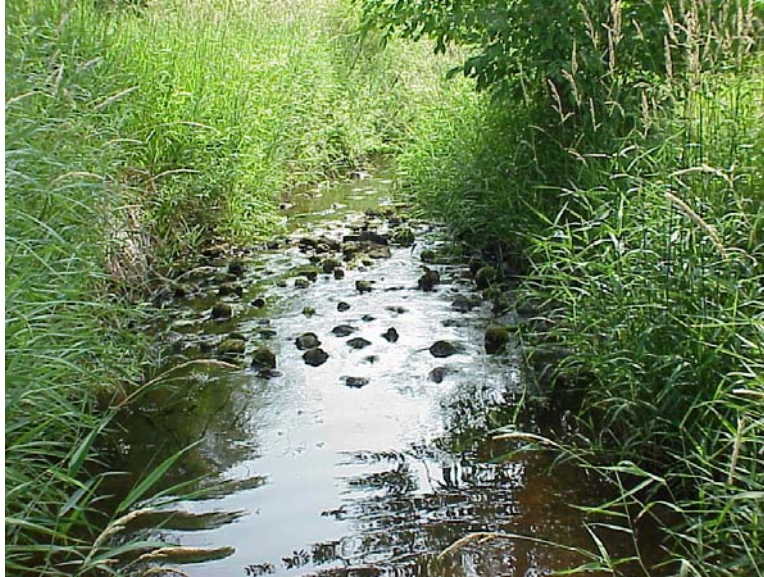
The survey site was located just upstream of Tompkins Road (N44.0358, W-087.9121 to N44.0361, W-087.9108). The survey section averaged 2.2 meters in width and was 102 meters in length. Mud Creek at this location is a third order stream with a gradient of 1.547 meters per kilometer and a sinuosity of 1 to 1.12. The study reach of the river ran through a meadow-shrub complex with mowed lawn also present (Figure 10).

**Figure 10.** This upstream view of Mud Creek above Tompkins Road was a typical sight for this section of Mud Creek.

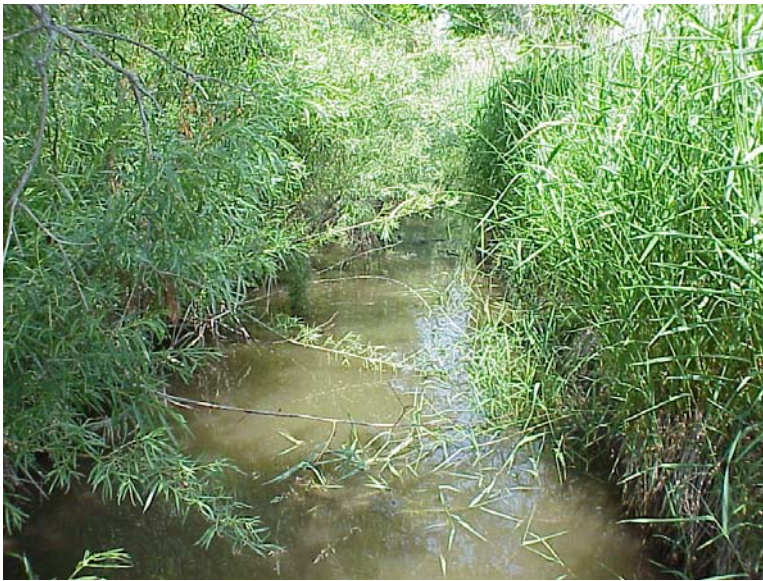
The survey site was located just upstream of Greendale Road (N44.0264, W-087.9425 to N44.0270, W-087.9434). The survey section averaged 1.8 meters in width and was 100 meters in length. The unnamed tributary of Mud Creek at this location is a third order stream with a gradient of 0.351 meters per kilometer and a sinuosity of 1 to 1.06. The study reach of the river ran through a meadow-shrub complex (Figure 12).

**Figure 12.** This view of the unnamed tributary to Mud Creek above Greendale Road that was surveyed was a typical of this creek section.

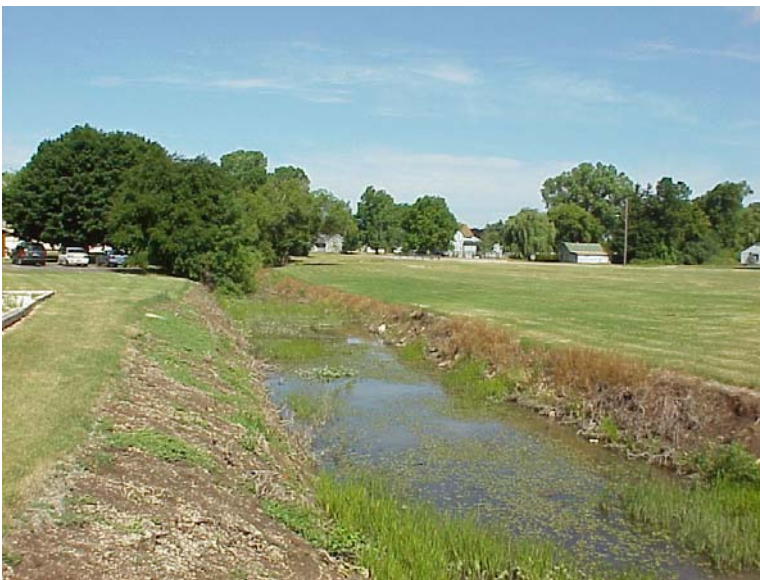
The survey site was located just upstream of Menasha Street in the village of Reedsville (N44.1543, W-087.9540 to N44.1552, W-087.9557). The survey section averaged 4.6 meters in width and was 170 meters in length. Mud Creek at this location is a third order stream with a gradient of 1.645 meters per kilometer and a sinuosity of 1 to 1.31. The study reach of the river ran through an urban setting that was 100% developed (Figure 14).

**Figure 14. The urbanized stream corridor of Mud Creek as it flows through Reedsville.**

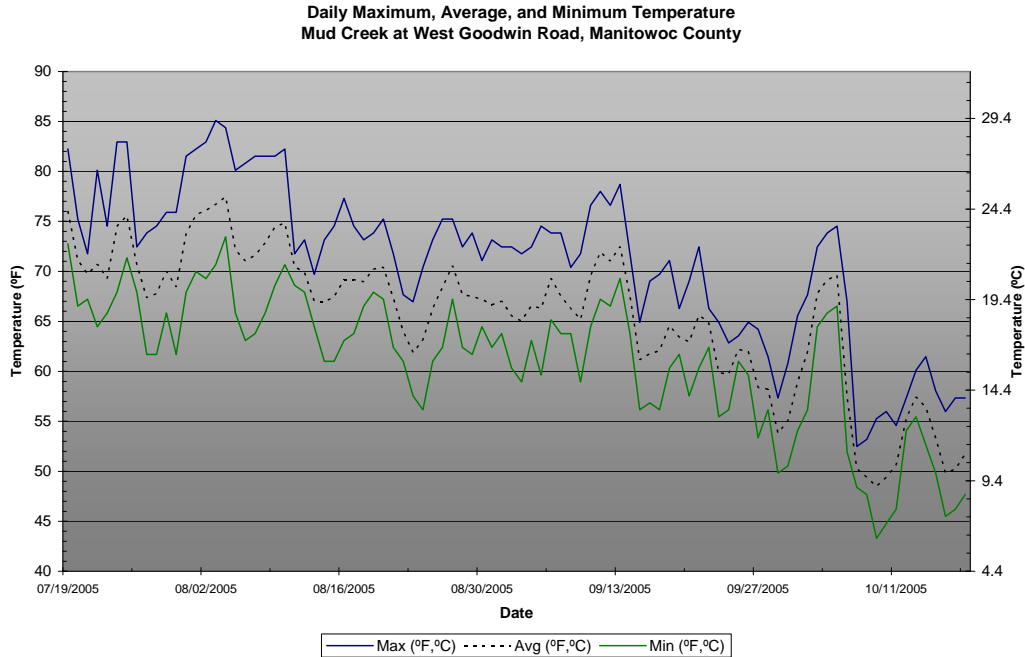
A continuous temperature monitor was placed in Mud Creek at Goodwin Road, approximately two kilometers downstream of the survey station. The continuous water temperature monitor showed that water temperature ranged from 43F to 85°F from July 19 to October 18, 2005 (Figure 16). The average water temperature during this time period was 66°F.

**Figure 16. Continuous stream temperature readings above Goodwin Road on Mud Creek, July through October 2005.**

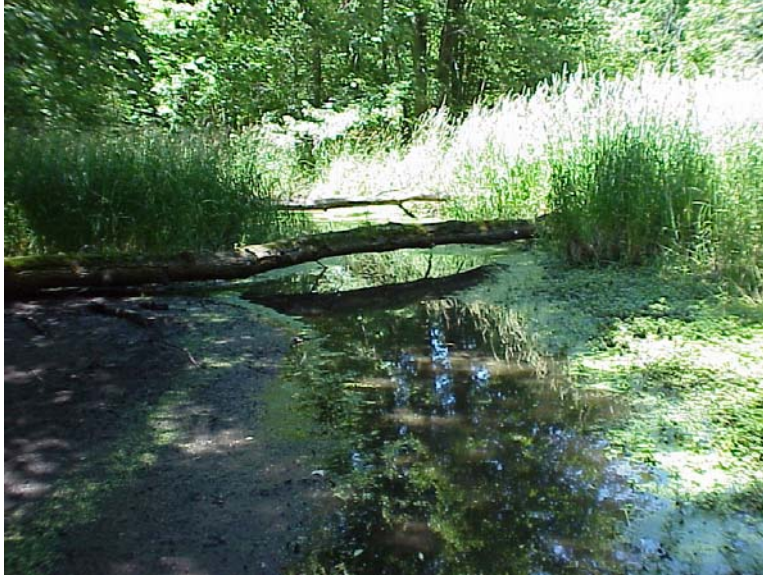
The survey site was located just upstream of County K (N44.2258, W-087.9783 to N44.2259, W-087.9795). The survey section averaged 1.96 meters in width and was 100 meters in length. Mud Creek has a stream order of two at this location, a gradient of 0.611 meters per kilometer and a sinuosity of 1 to 1.148. The study reach of the river ran through a meadow-shrub-woodland complex (Figure 17). Upper sections of the stream at this survey site were found in the roadside ditch of County K.

**Figure 17. Looking upstream at Mud Creek above County Highway K. The bare soil, duckweed and low water was common throughout the surveyed section of river.**

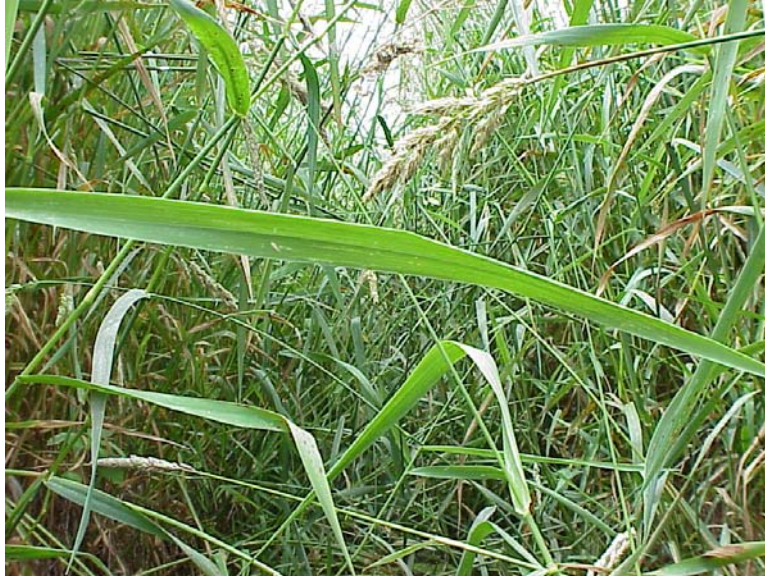
The survey site was located just upstream of County W (N44.1448, W-087.9636 to N44.1451, W-087.9647). The survey section averaged 1.6 meters in width and was 100 meters in length. The unnamed tributary to Mud Creek at this location has a stream order of three, a gradient of 4.86 meters per kilometer and a sinuosity of 1 to 1.03. The study reach of the river ran through 100% meadow (Figure 19).

**Figure 19.** Looking upstream through a dense stand of reed canary grass on an unnamed tributary of Mud Creek above County Highway W. The dense reed canary grass was common throughout the survey site.

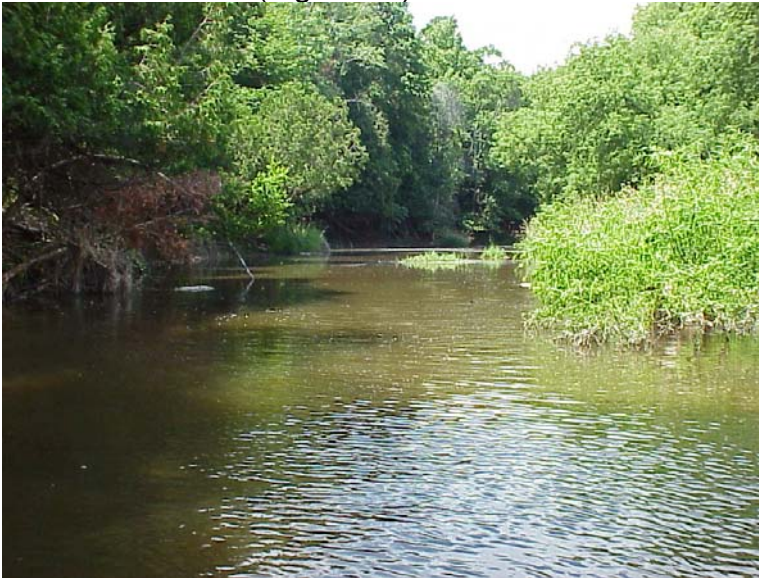
The survey site was located just upstream of Danmar Road (N44.1640, W-087.7801 to N44.1674, W-087.7822). The survey section averaged 13.0 meters in width and was 442 meters in length. The Branch River at this location has a gradient of 1.583 meters per kilometer, a sinuosity of 1 to 1.43 and is a fourth order stream. The study reach of the river ran through a mainly a meadow-woodland complex, although shrubs, wetland and lawn riparian land uses were also encountered (Figure 21).

Figure 21. An upstream view of the Branch River from Danmar Road.

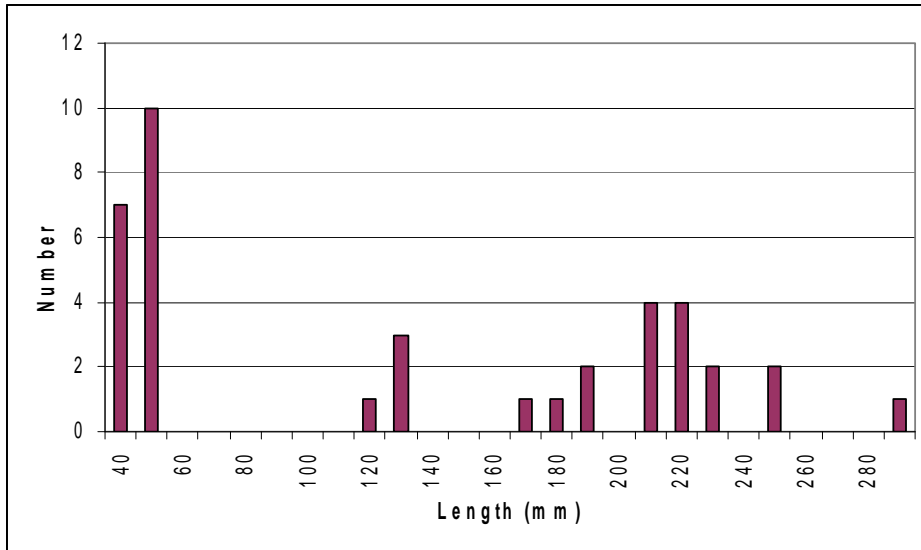
**Figure 23. Length frequency of smallmouth bass captured during electroshocking on the Branch River.**

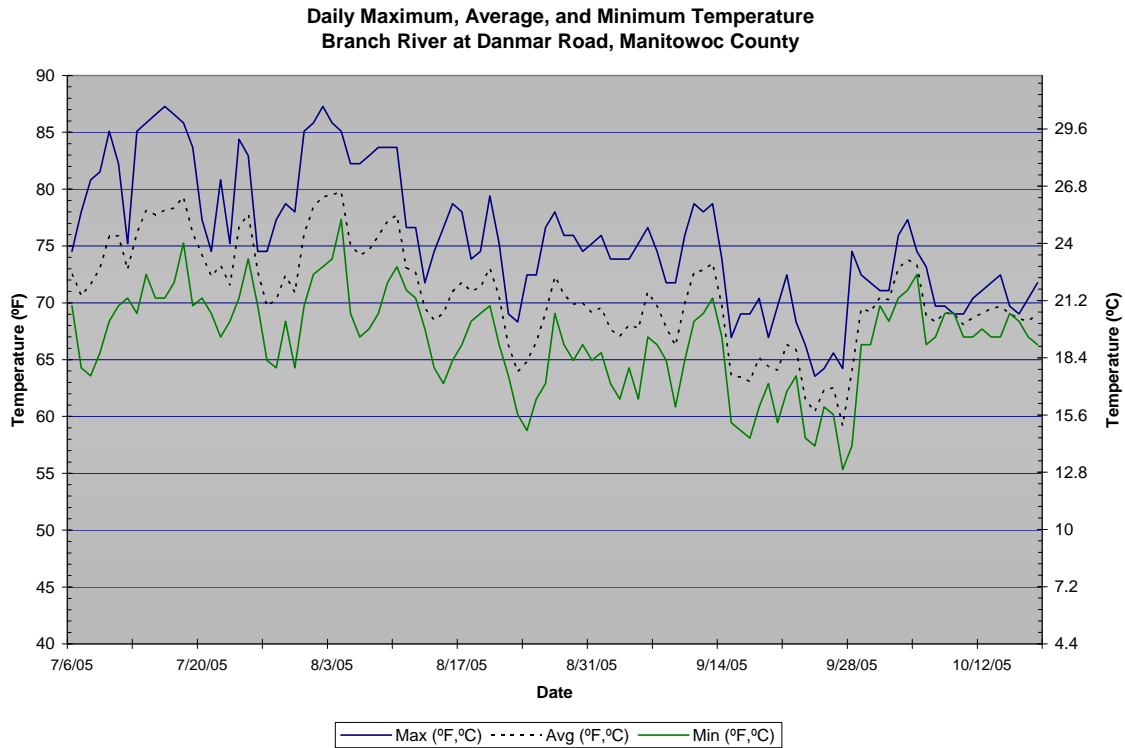
**Figure 24. Continuous stream temperature readings of the Branch River at Danmar Road during July through October 2005.**

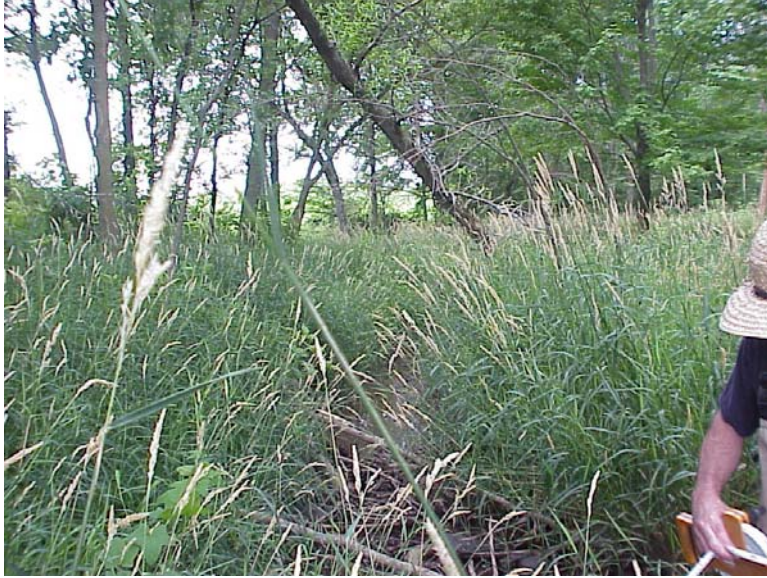
The survey site was located just upstream of Morrison Road (N44.3206, W-087.9886 to N44.3209, W-087.9894). The survey section averaged 1.6 meters in width and was 100 meters in length although water was found in only the first 68 meters of the survey site. The Branch River at this location is a third order stream with a gradient of 1.28 meters per kilometer and a sinuosity of 1 to 1.02. The study reach of the river ran through a mainly a meadow-woodland complex (Figure 25).

**Figure 25. An upstream view of the Branch River from Morrison Road.**

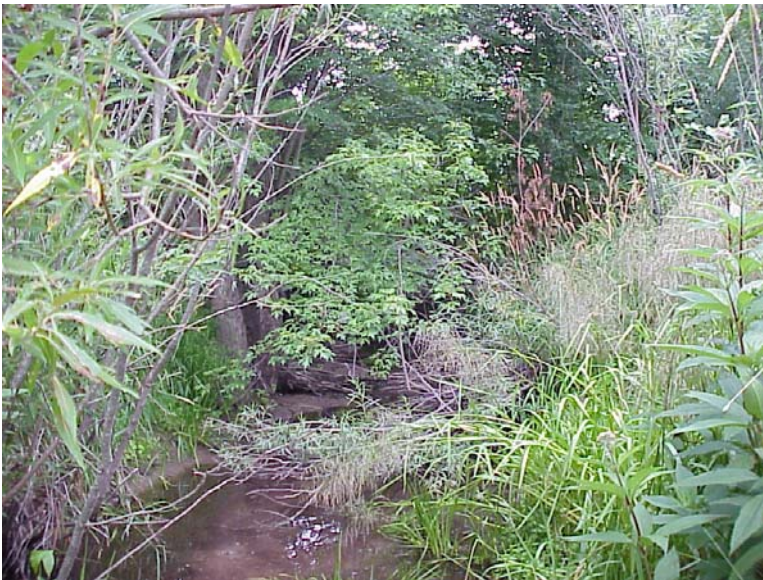
**Figure 27. An upstream view of the unnamed tributary to Branch River from Grimms Road showing a typical view of the stream.**

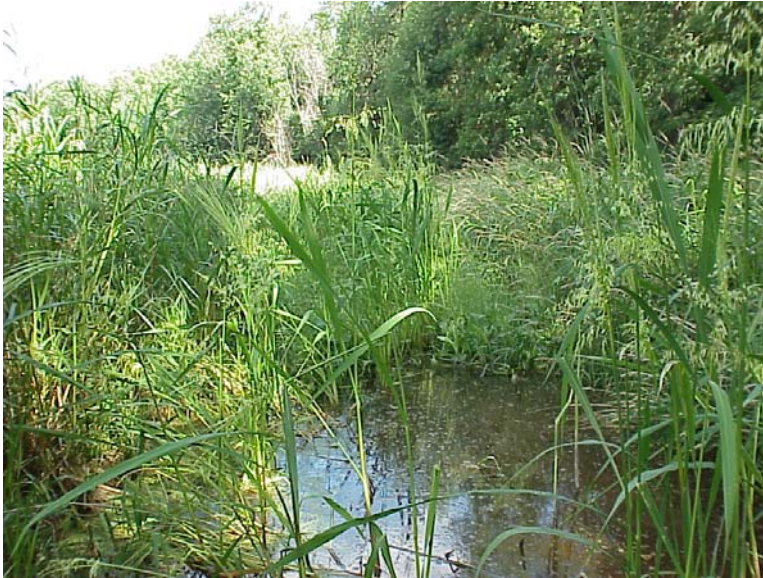
**Figure 29. An upstream view of the North Branch of the Manitowoc River from the Brillion Wildlife Area showing a typical view of the stream that includes wild rice and reed canary grass.**

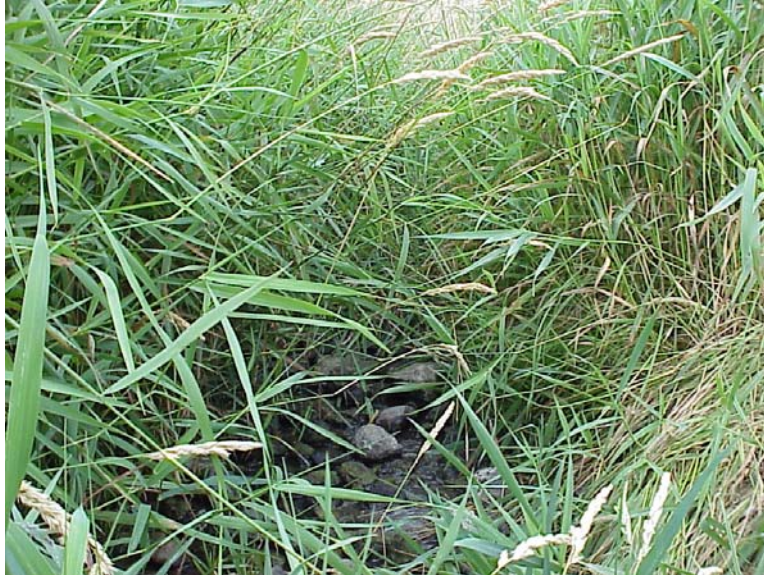
**Figure 31. An upstream view of Hilbert Creek showing a dense growth of reed canary grass.**

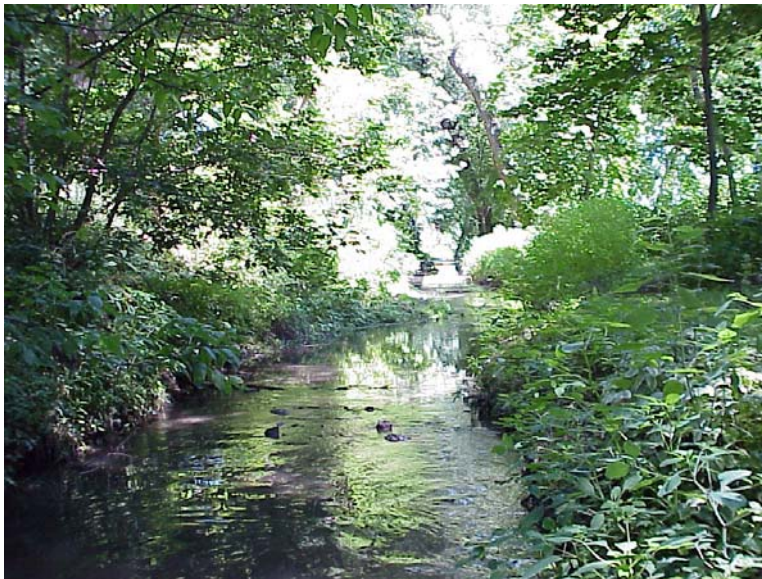
The survey site was located just upstream of Madison Street in the city of Brillion (N44.1744, W-088.0607 to N44.1755, W-088.0607). The survey section averaged 3.3 meters in width and was 100 meters in length. Spring Creek at this location has a stream order of 3 with a gradient of 2.171 meters per kilometer and a sinuosity of 1 to 1.24. The study reach of the river ran through a residential neighborhood (Figure 33).

**Figure 33. An upstream view of Spring Creek showing residential land use.**

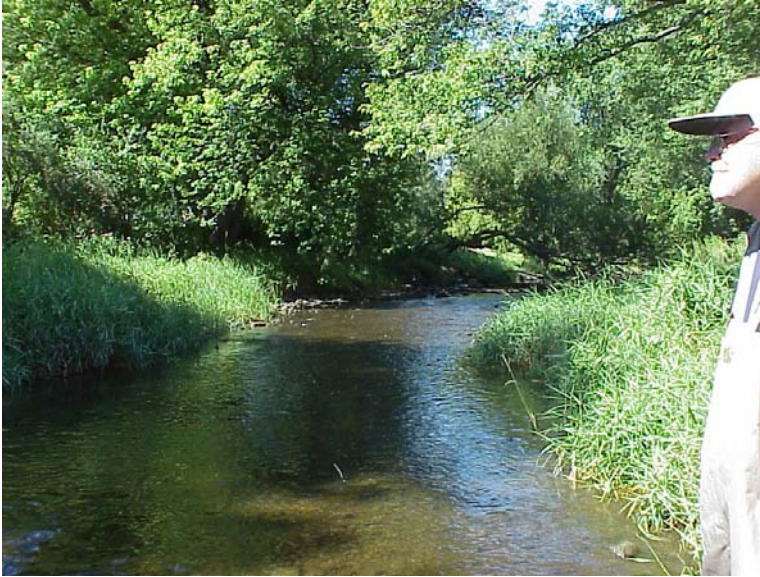
The survey site was located just upstream of Irish Road in the city of Chilton (N44.0360, W-088.1429 to N44.0353, W-088.1445). The survey section averaged 7 meters in width and was 238 meters in length. The South Branch at this location has a stream order of 3 with a gradient of 3.37 meters per kilometer and a sinuosity of 1 to 1.45. The study reach of the river ran through an urban setting that had land uses which included lawn, meadow, forest and wetland (Figure 35). The stream channel appeared to be natural, although at transect 7 an old dam could have been present.

**Figure 35. An upstream view of the South Branch of the Manitowoc River as it flows through Chilton.**

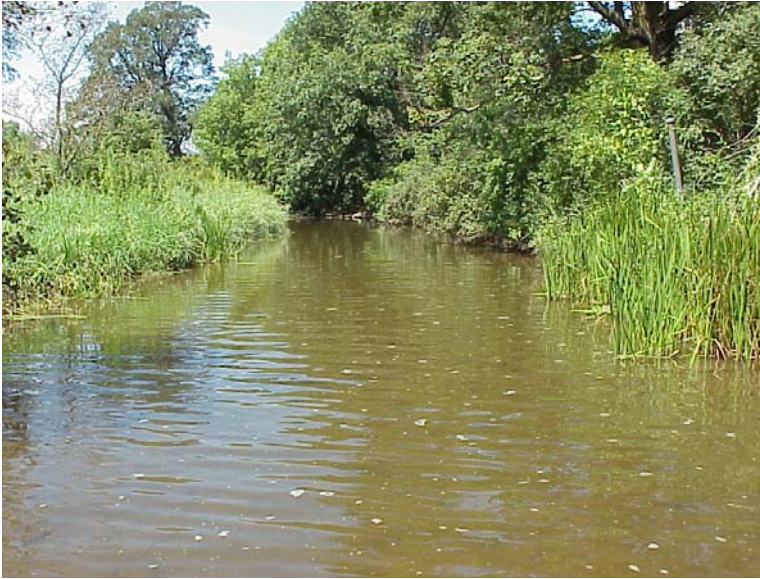
The survey site was located just upstream of Irish Road (N44.0591, W-088.1434 to N44.0576, W-088.1459). The survey section averaged 9.7 meters in width and was 306 meters in length. The Killsnake River at this location has a stream order of 3, a gradient of 1.48 meters per kilometer and a sinuosity of 1 to 1.85. The study reach of the river ran through a meadow-wetland and a shrub-forest complex (Figure 38).

**Figure 38. Looking upstream at the Killsnake River just above Irish Road.**

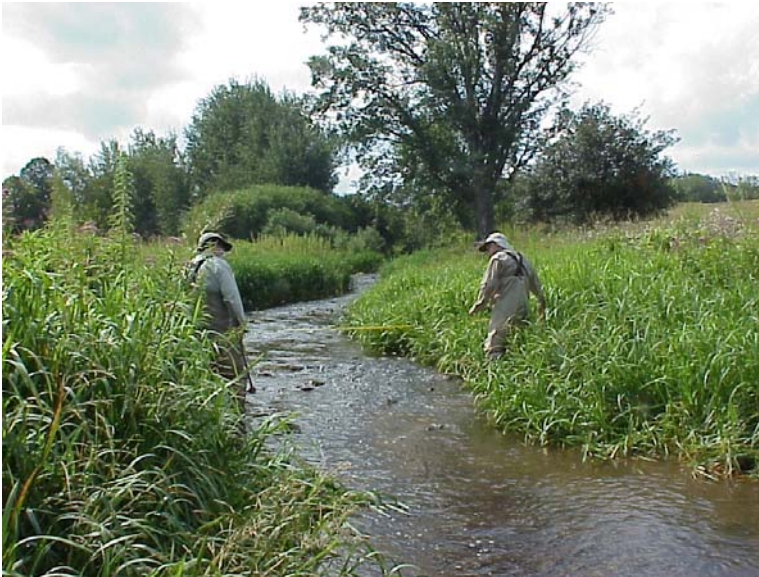
**Figure 41. Looking upstream at a fisheries crew measuring stream width on Pine Creek just above Danes Road.**

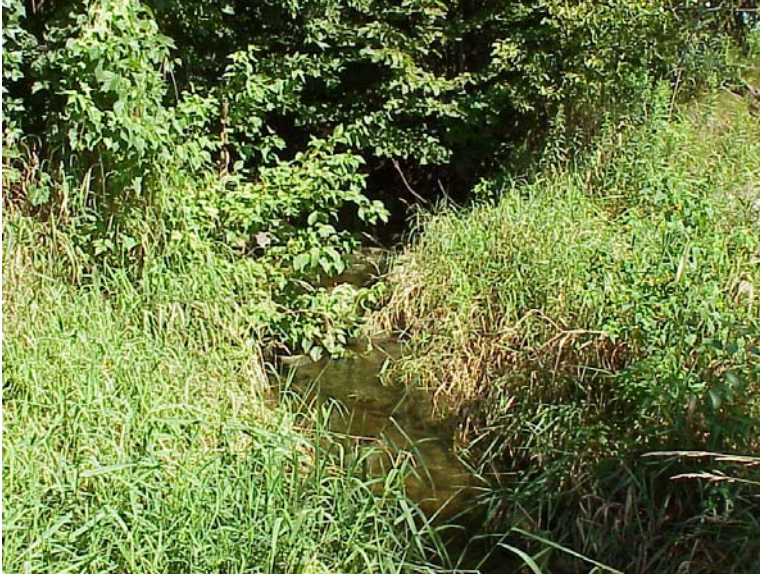
The survey site was located just upstream of Highway 32 (N43.9774, W-088.1128 to N43.9783, W-088.1135). The survey section averaged 2.6 meters in width and was 100 meters in length. The unnamed tributary Pine Creek at this location has a stream order of 2, a gradient of 8.89 meters per kilometer and a sinuosity of 1 to 1.06. The study reach of the river ran through 100% woodland, although steeply sloped agricultural fields were located just outside the riparian buffers (Figure 43).

**Figure 43. Looking upstream at a heavily forested tributary to Pine Creek just above Highway 32. The open area in the foreground of the photo is near where the stream crosses underneath Highway 32.**

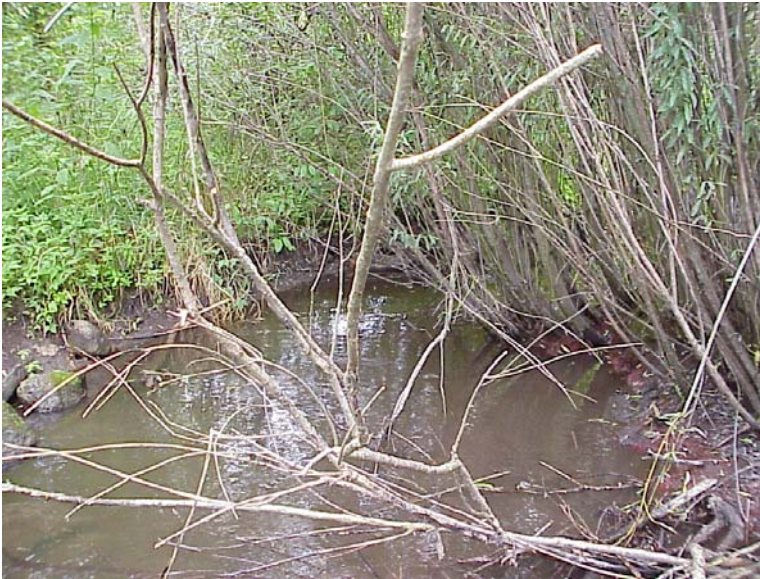
The survey site was located just upstream of Quinney Road (N44.0224, W-088.2198 to N44.0232, W-088.2199). The survey section averaged 2.9 meters in width and was 100 meters in length. Stony Brook at this location has a stream order of 1, a gradient of 3.13 meters per kilometer and a sinuosity of 1 to 1.56. The study reach of the river ran through a shrub-woodland complex (Figure 45).

**Figure 45. Looking upstream at Stony Brook just upstream of Quinney Road.**

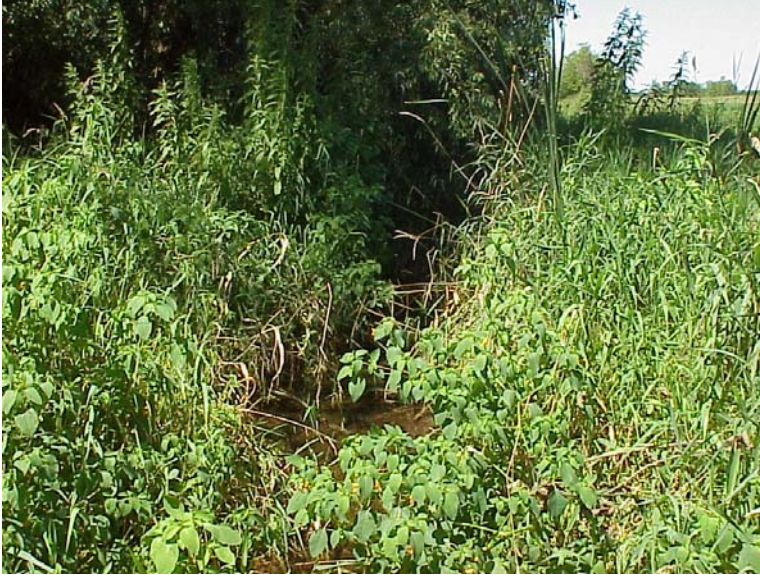
The survey site was located just upstream of Long Road (N44.0515, W-088.2458 to N44.0518, W-088.2468). The survey section averaged 1.22 meters in width and was 100 meters in length. Stony Brook at this location has a stream order of 1, a gradient of 1.29 meters per kilometer and a sinuosity of 1 to 1.79. The study reach of the river ran through a meadow-shrub-woodland complex (Figure 47).

**Figure 47. Looking upstream at Stony Brook just upstream of Long Road.**

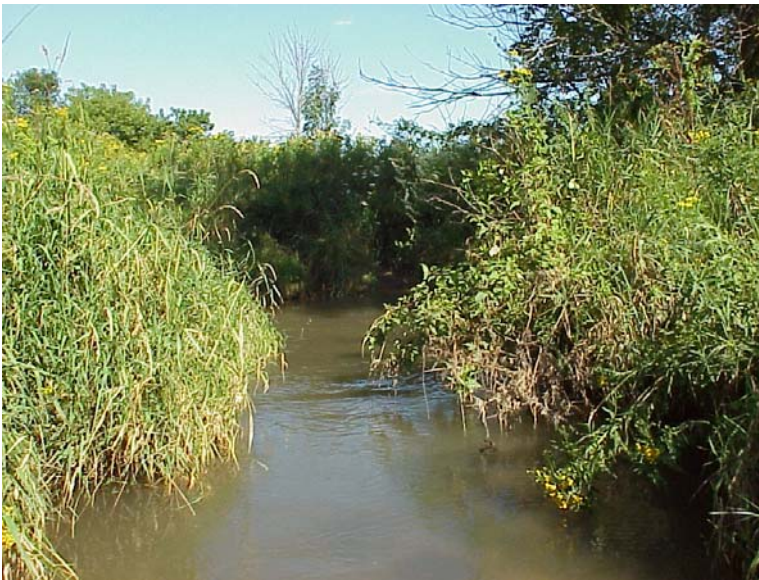
The survey site was located just downstream of County Highway B on City of Manitowoc Property (N44.1219, W-087.6547 to N44.1223, W-087.6548). The survey section averaged 3.46 meters in width and was 136 meters in length. The Little Manitowoc River at this location has a gradient of 0.18 meters per kilometer, a sinuosity of 1 to 1.94 and is a third order stream. The study reach of the river ran through a mainly a meadow-shrub complex (Figure 49).

**Figure 49. An upstream view of the Little Manitowoc River that shows the meadow-shrub character of the stream.**
