Curly-leaf Pondweed (*Potamogeton crispus*) Pre/Post Herbicide and Bed Mapping Surveys Balsam Lake - WBIC: 2620600 Polk County, Wisconsin

Spring 2012 CLP Treatment Beds

Endangered Resource Services, LLC
Matthew S. Berg, Research Biologist
St. Croix Falls, Wisconsin
April 15, May 30, June 4-5, 9, 2012

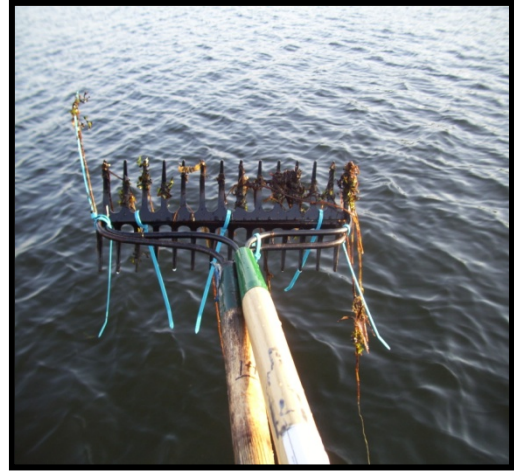
Dead CLP – Posttreatment Survey in East Balsam

Beds 12, 13, 14, and 14B – All of East Balsam’s CLP beds showed complete control – including Bed 14B which wasn’t treated. Despite raking outside of the treatment areas during the post treatment survey, we failed to locate any viable CLP that was more than a few inches tall anywhere in East Balsam - a dramatic change from 2011 (Figure 15).
