***Concept Design Documentation Report
Kinnickinnic River, Wisconsin
Milwaukee Estuary Area of Concern
Sediment Removal***

***Prepared for
U.S. Army Corps of Engineers
Detroit District***

Kinnickinnic River, Wisconsin Milwaukee Estuary Area of Concern Deepening/Remediation Concept Design Documentation Report

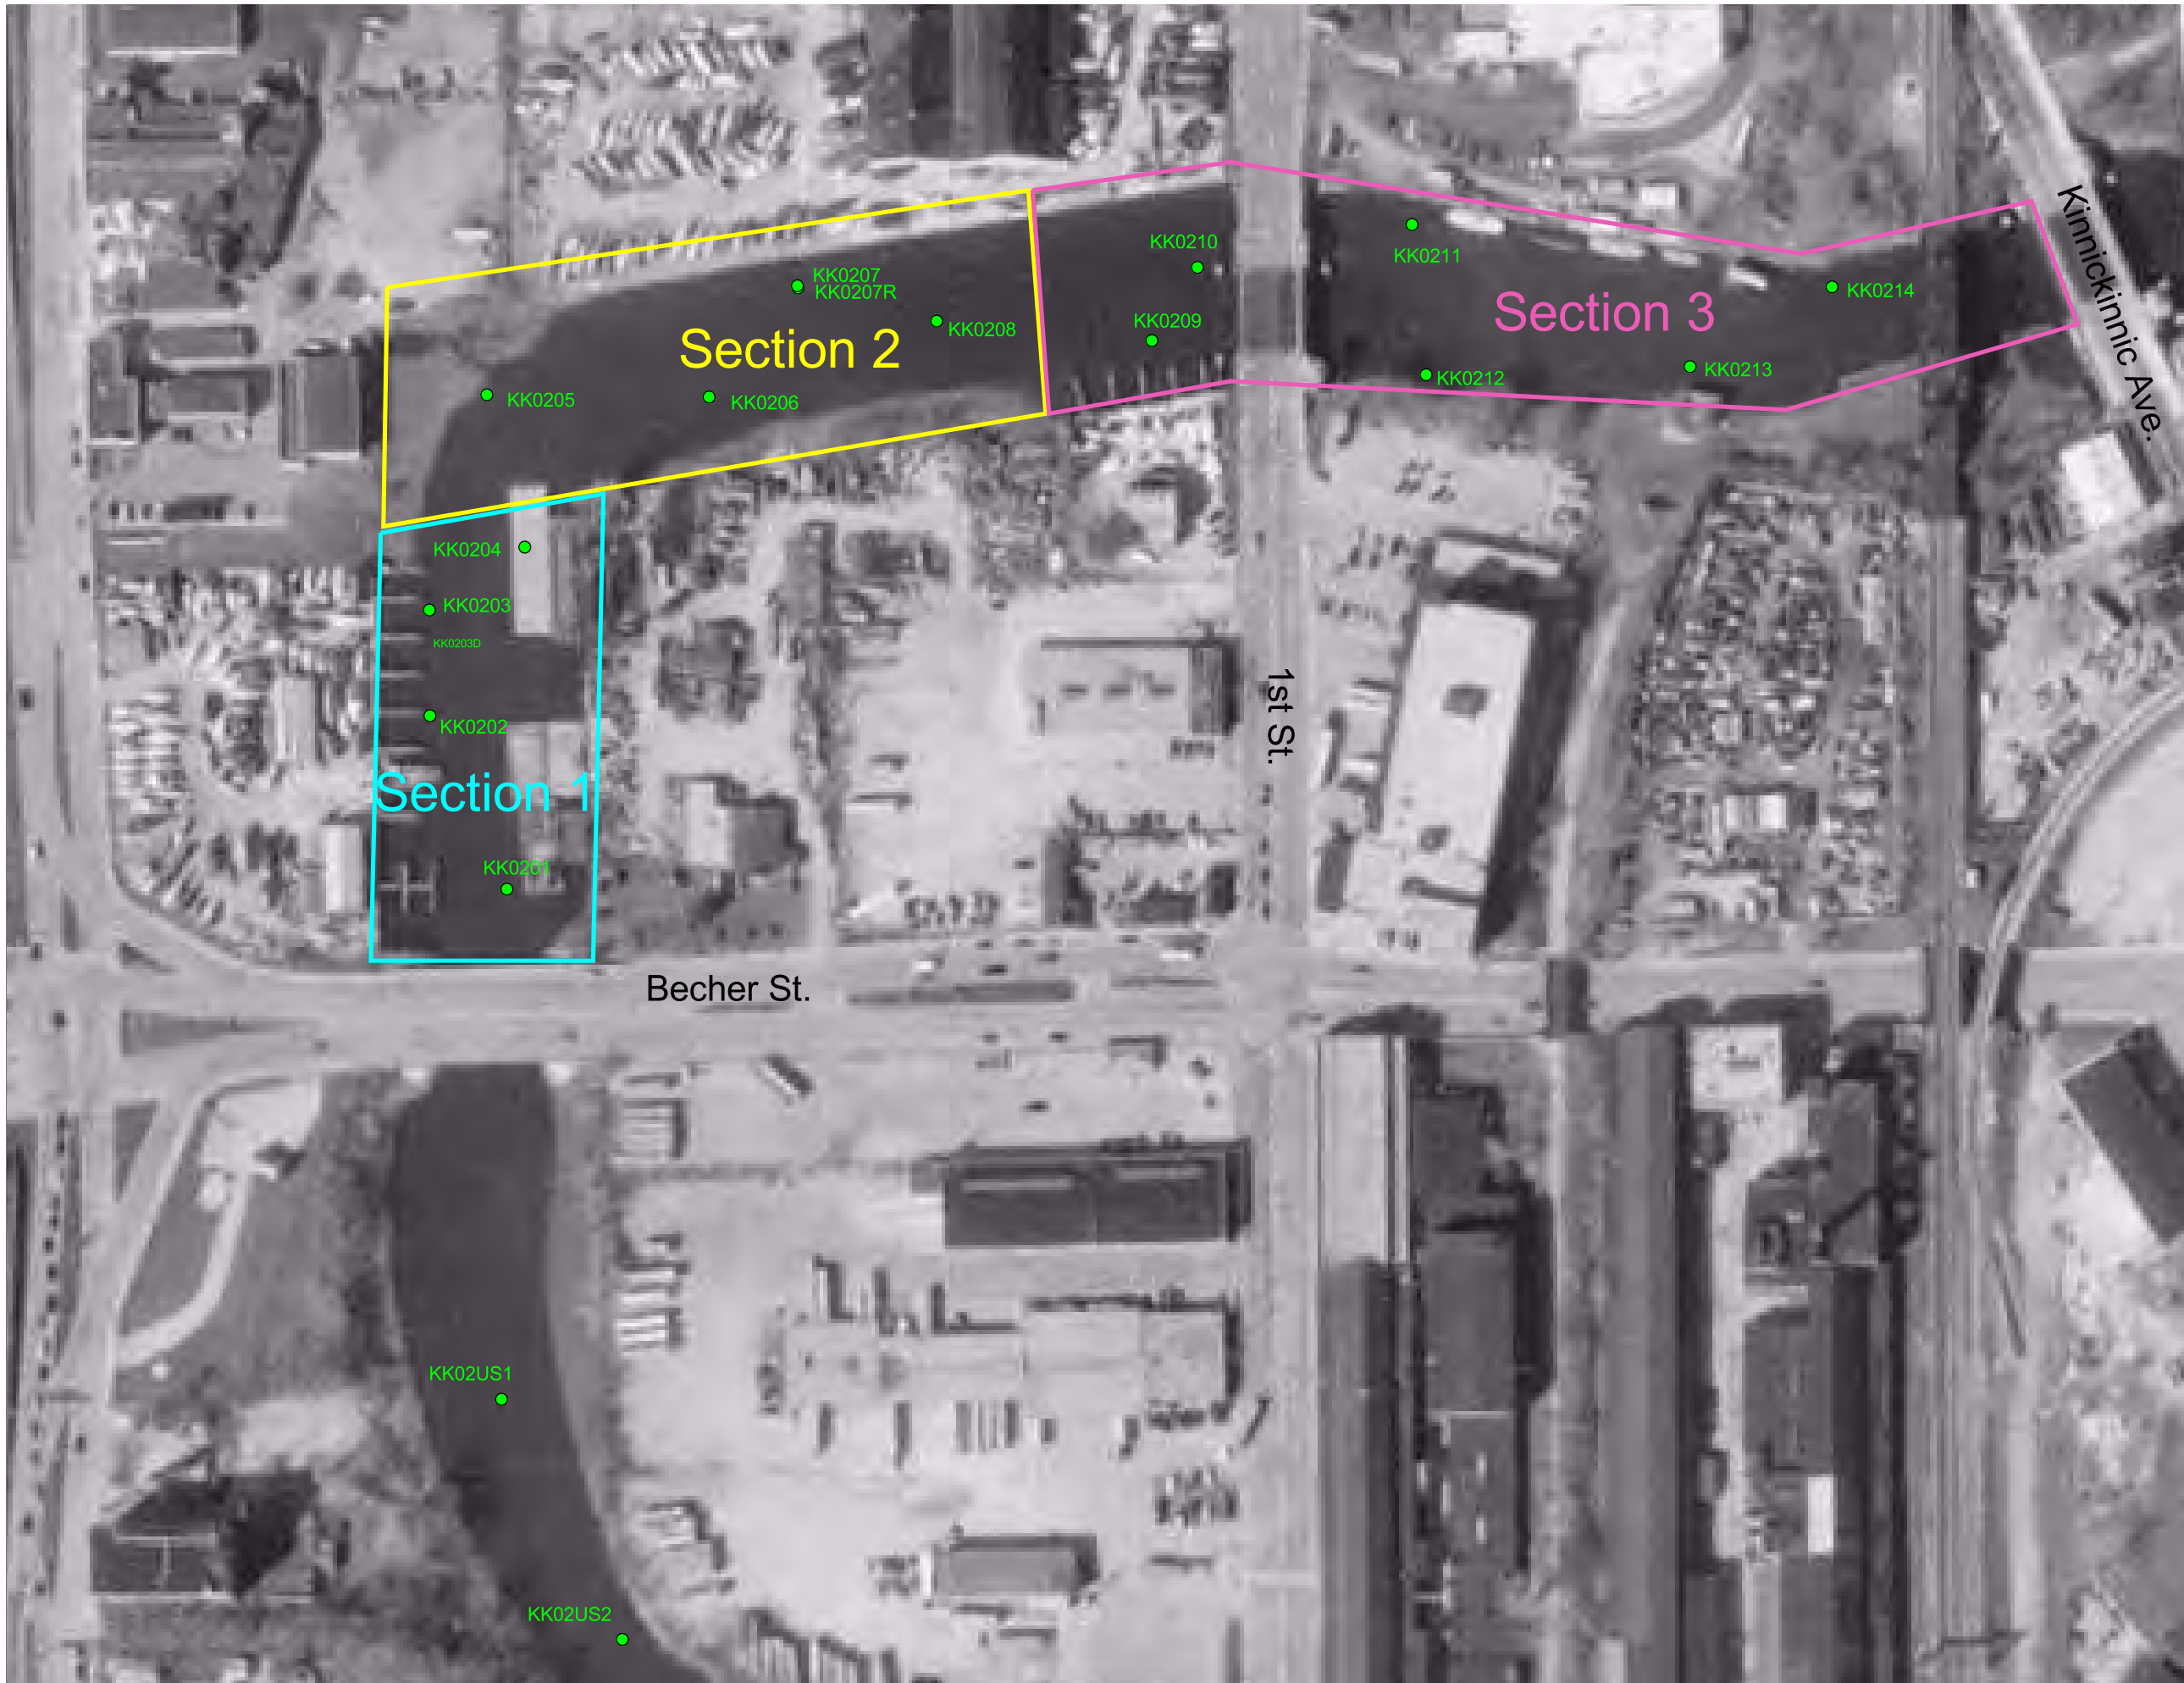
- 2002 Boring Locations
- Section Locations
- Section 1
- Section 2
- Section 3

Figure 2
 Section and Sampling Locations
 Kinnickinnic River
 Sediment Removal Concept Plan
 Milwaukee, WI

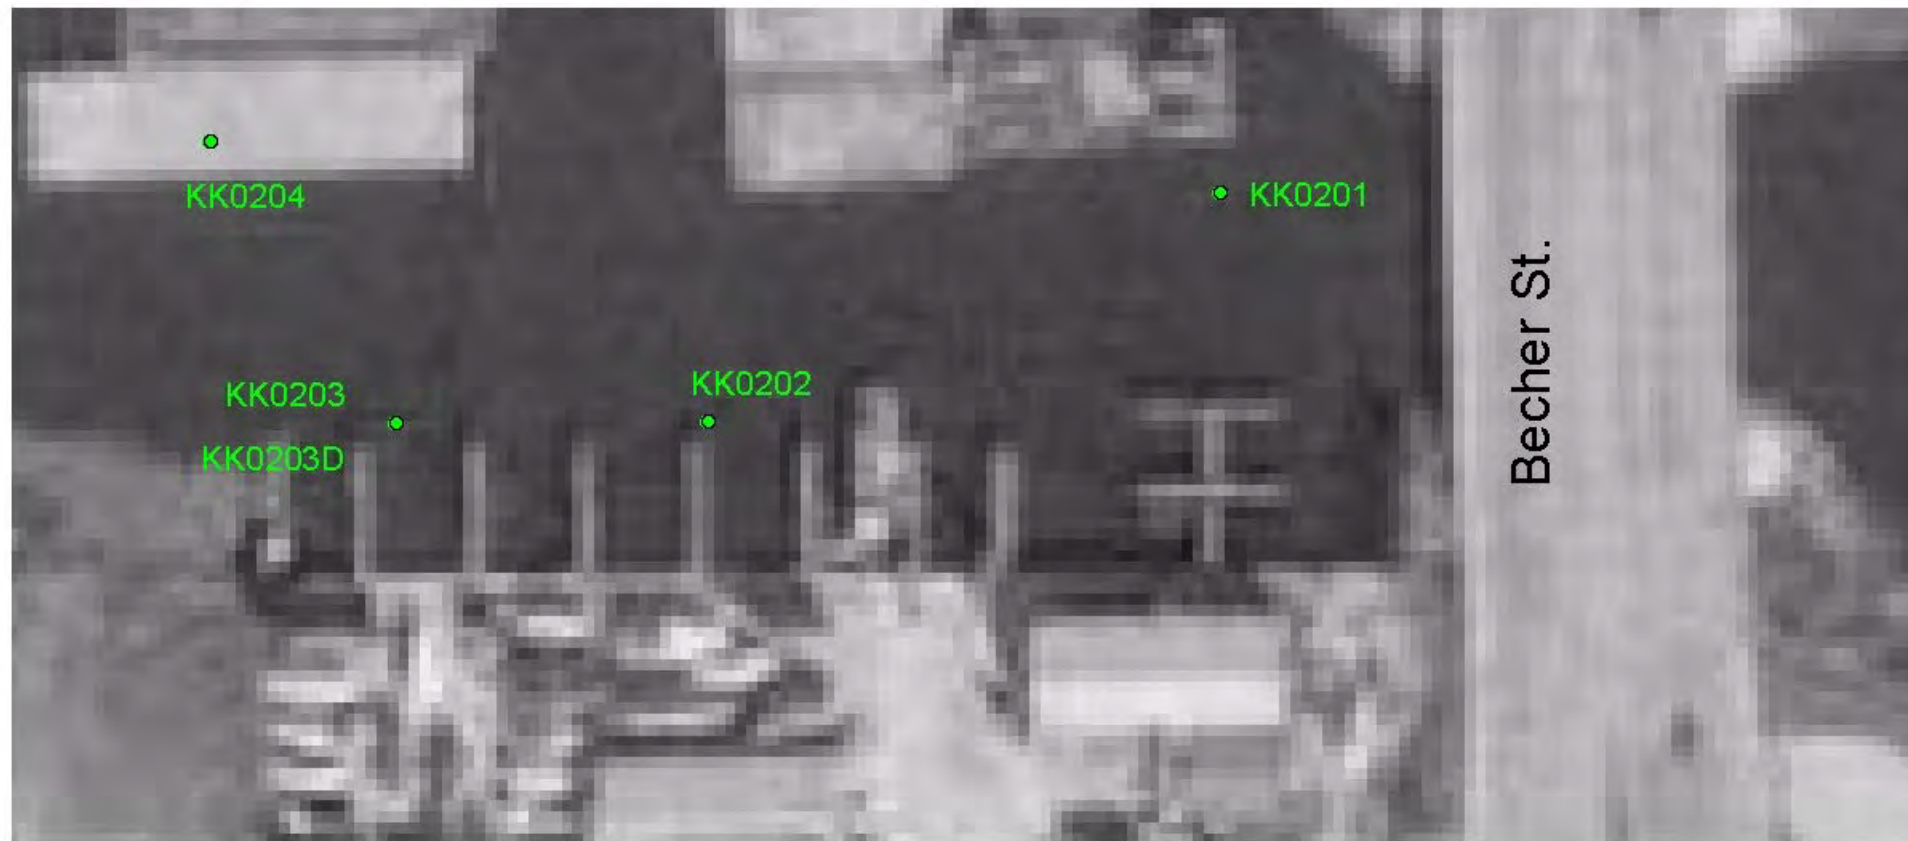
Figure 3
 Section 1
 September 2002 PCB Sediment Profile
 Kinnickinnic River
 Sediment Removal Concept Plan
 Milwaukee, WI

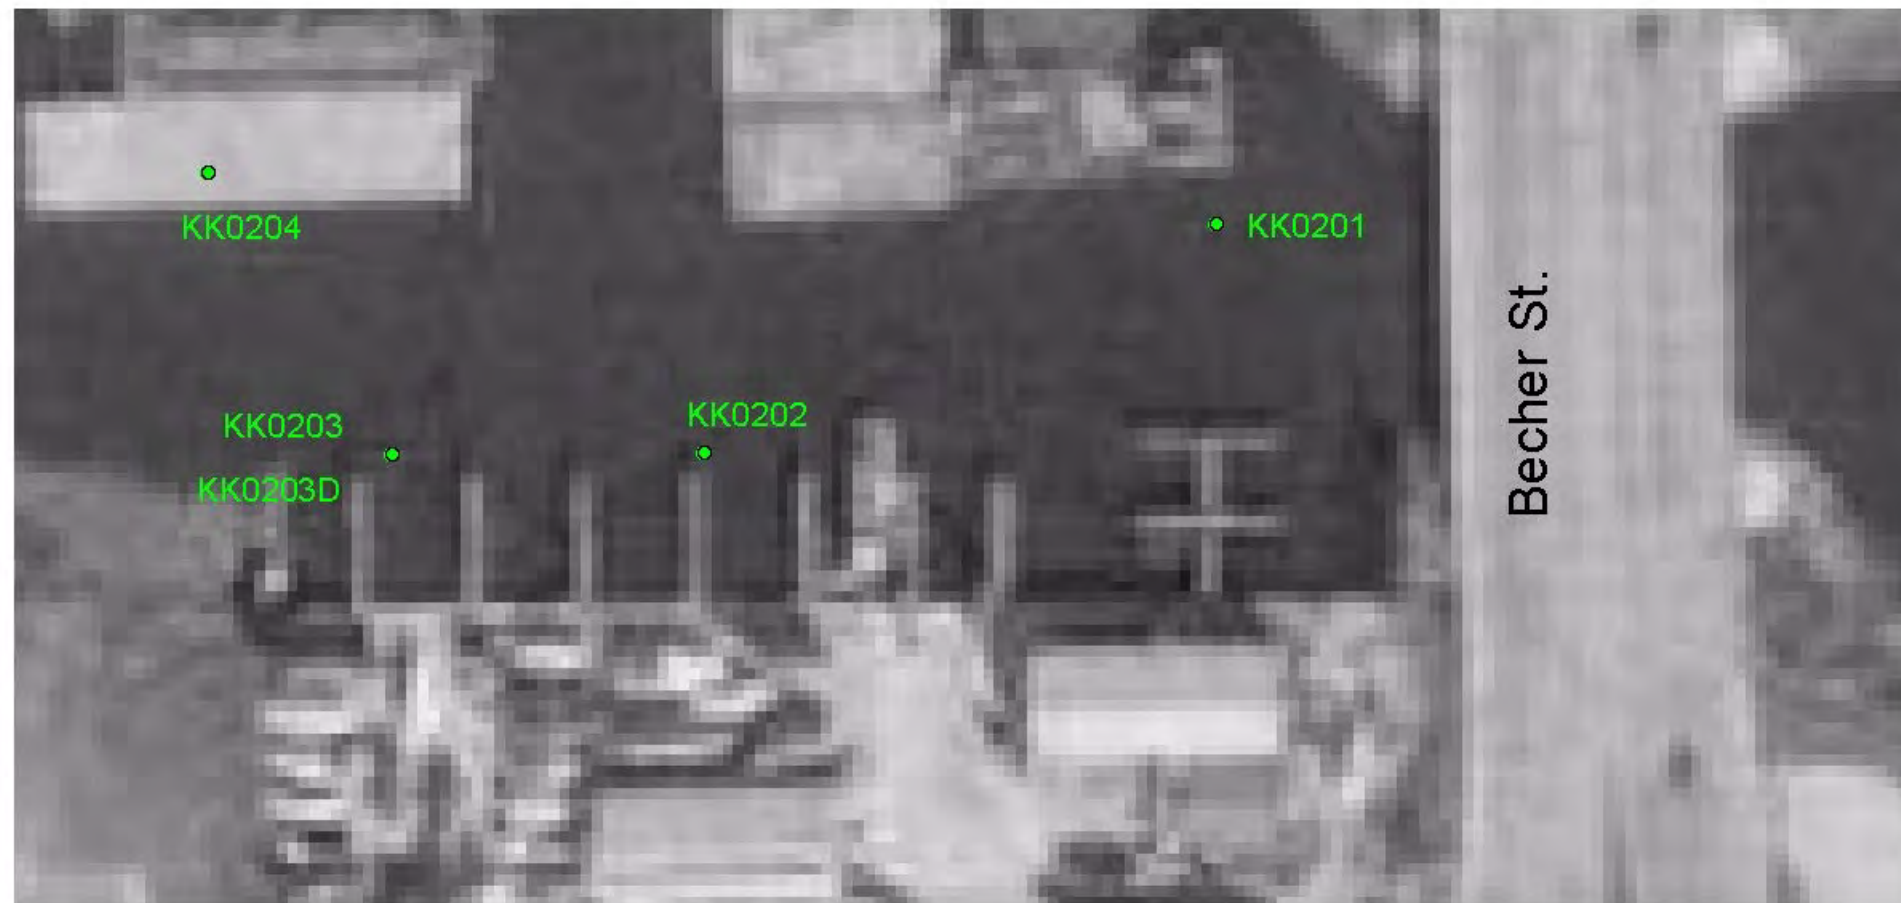
NOTE: Dredging lines and soil boring logs are for illustration purposes only. The actual dredging elevation will be determined in the final design. Contaminant concentrations and lithology will vary across the project area.

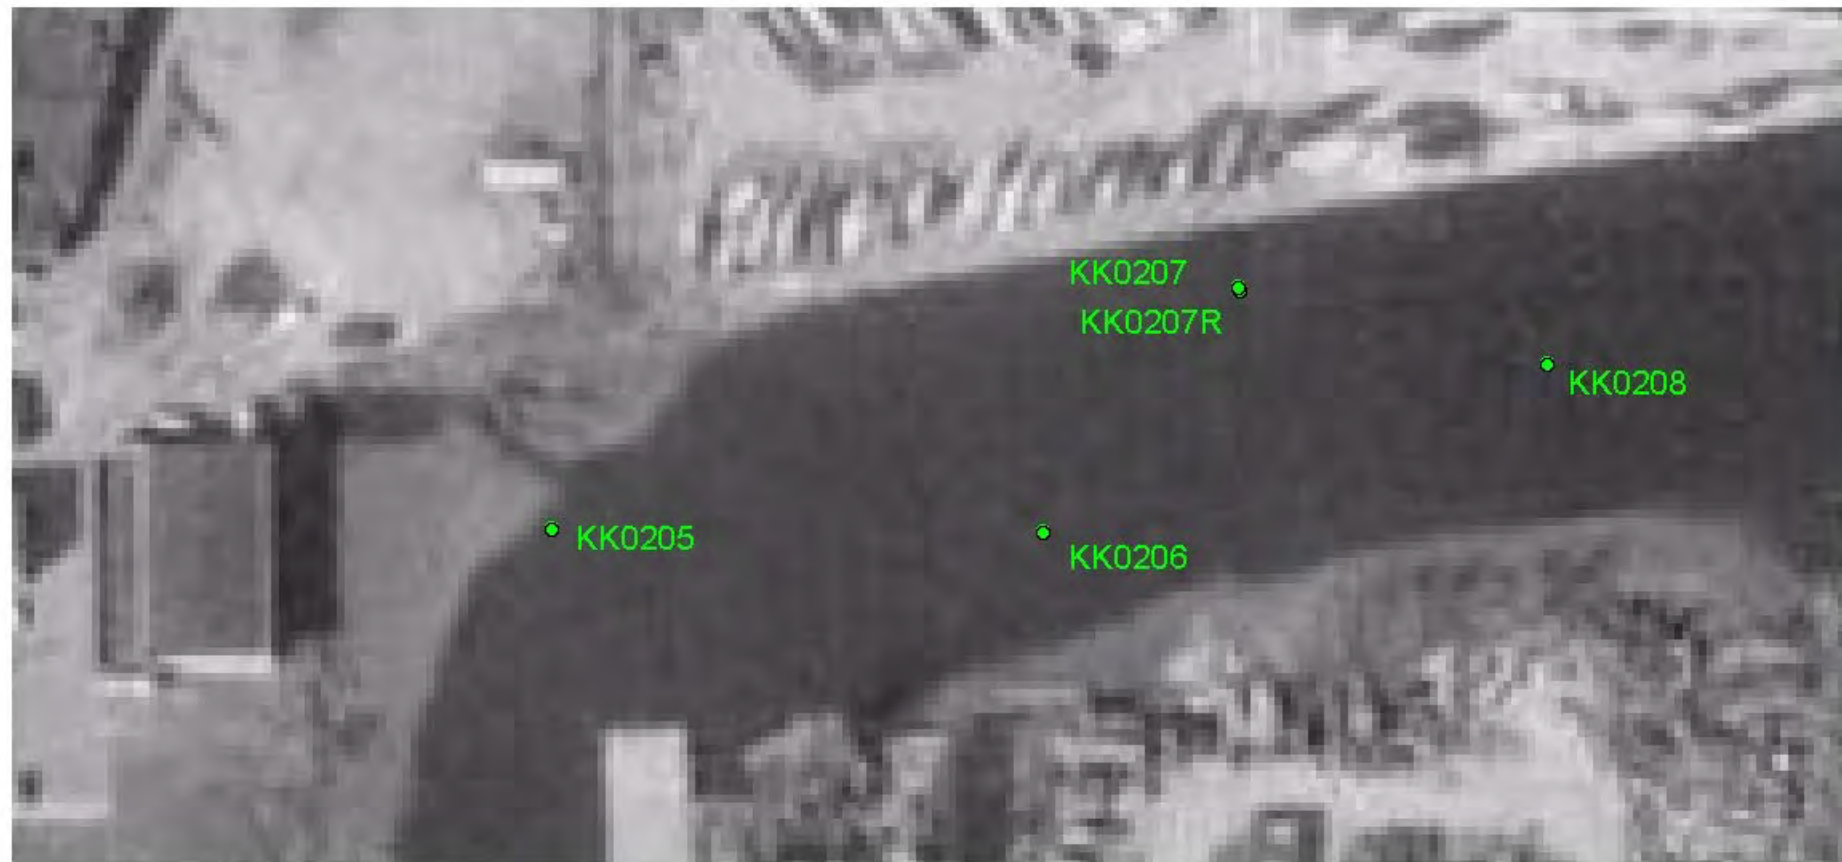
Figure 5
 Section 2
 September 2002 PCB Sediment Profile
 Kinnickinnic River
 Sediment Removal Concept Plan
 Milwaukee, WI

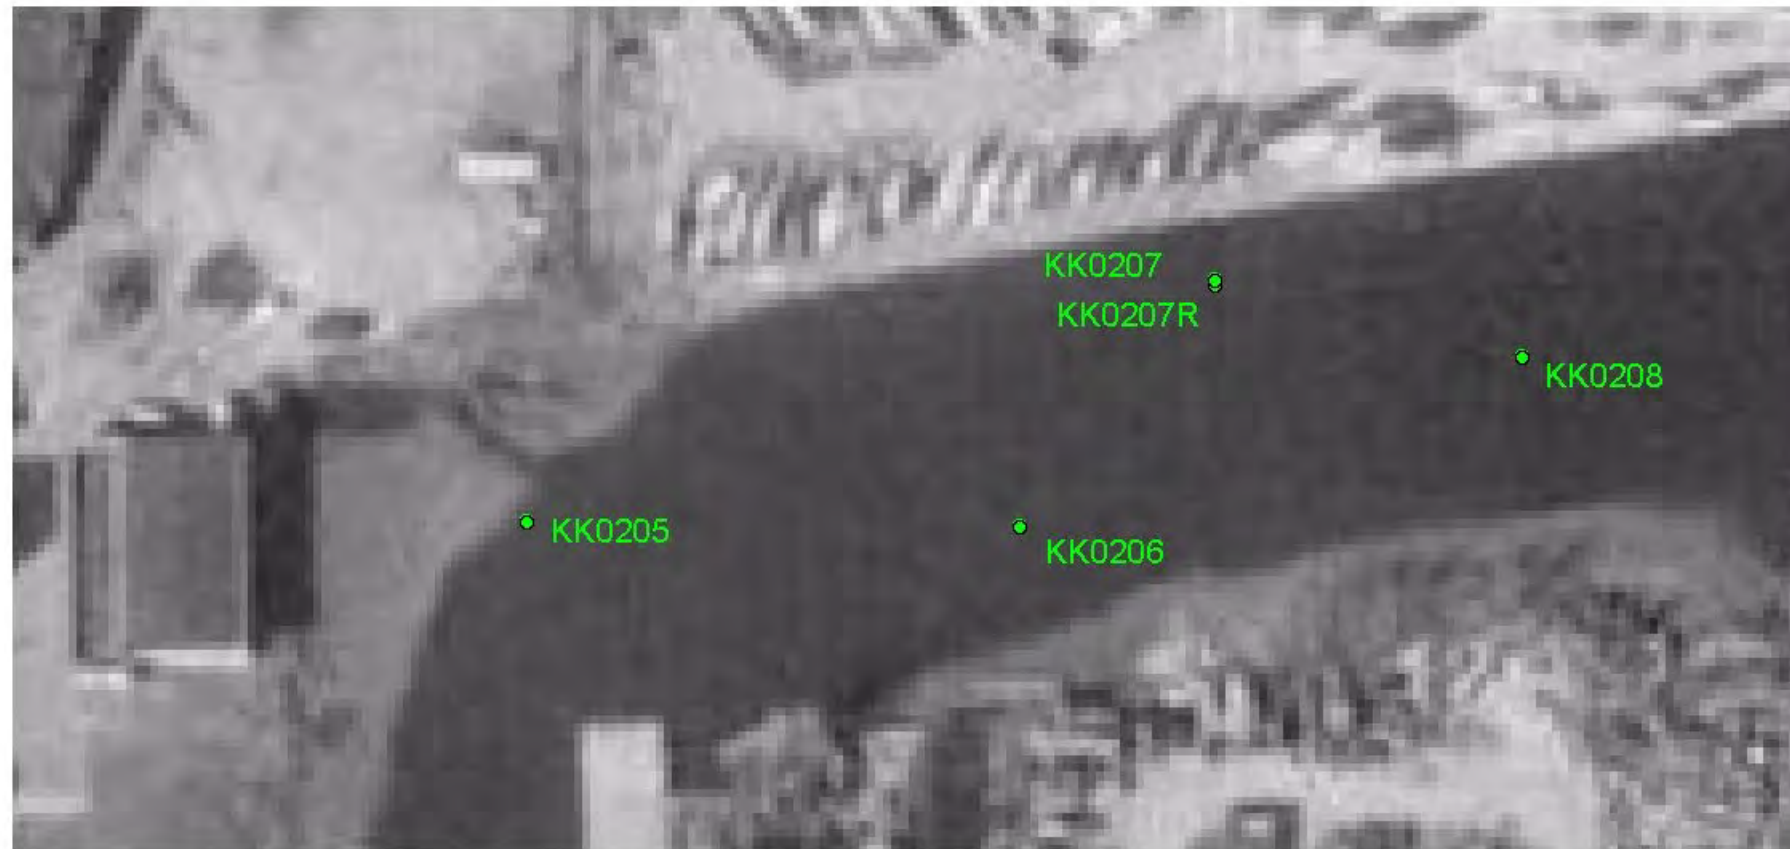
Figure 6
 Section 2
 September 2002 PAH Sediment Profile
 Kinnickinnic River
 Sediment Removal Concept Plan
 Milwaukee, WI

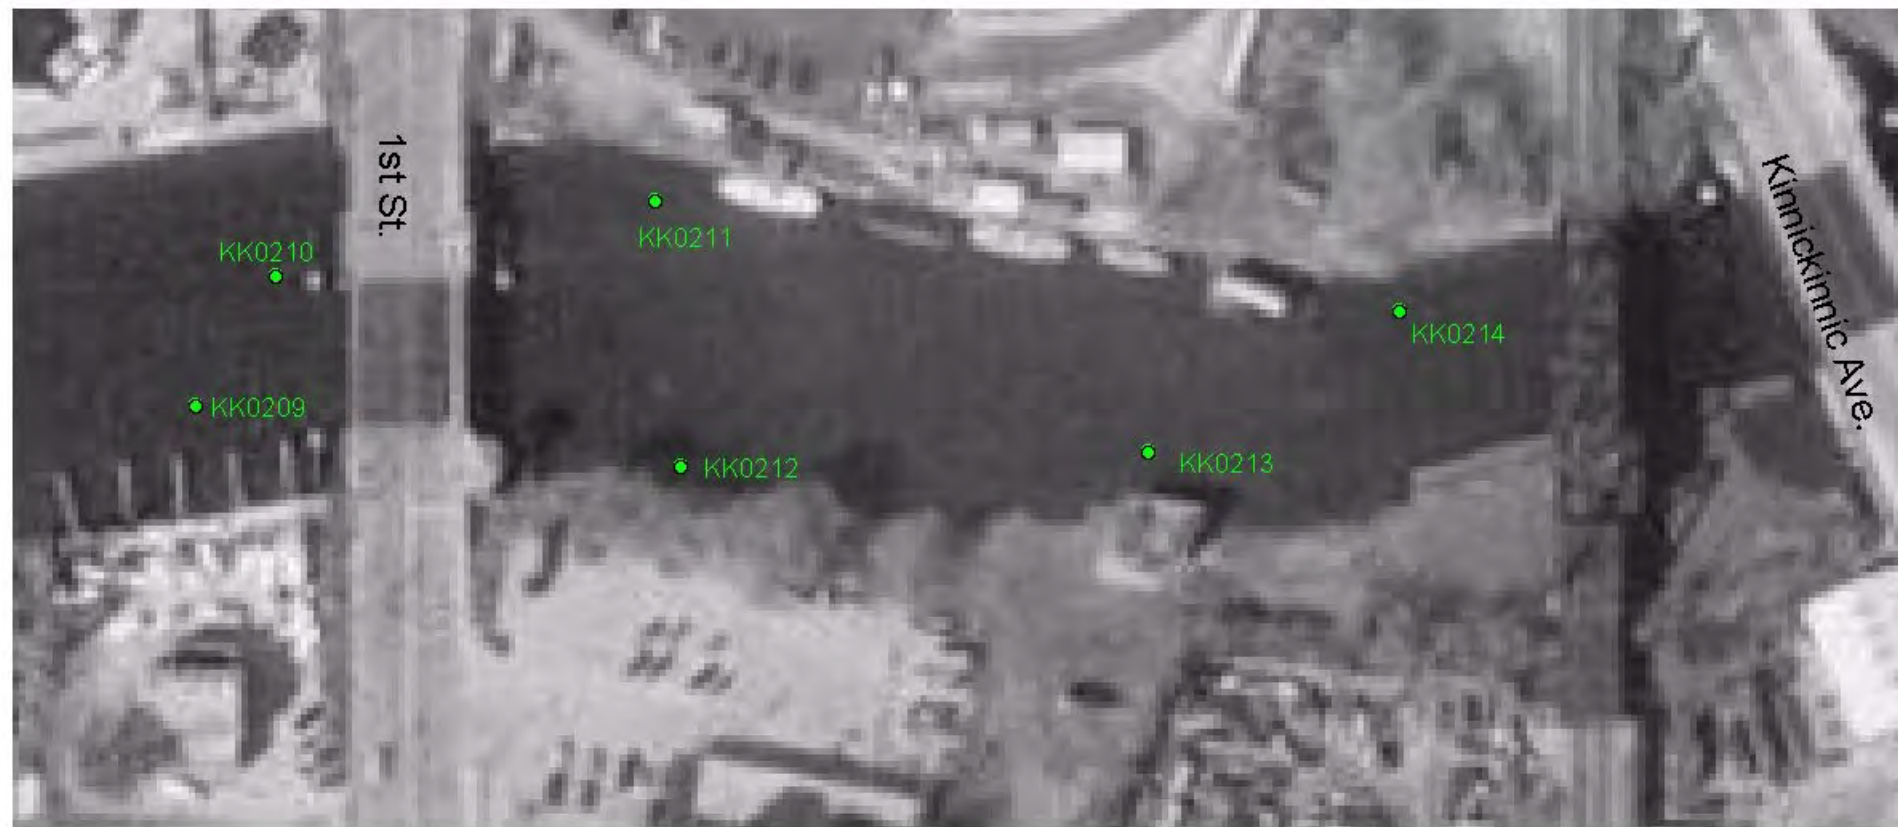
Figure 7
 Section 3
 September 2002 PCB Sediment Profile
 Kinnickinnic River
 Sediment Removal Concept Plan
 Milwaukee, WI

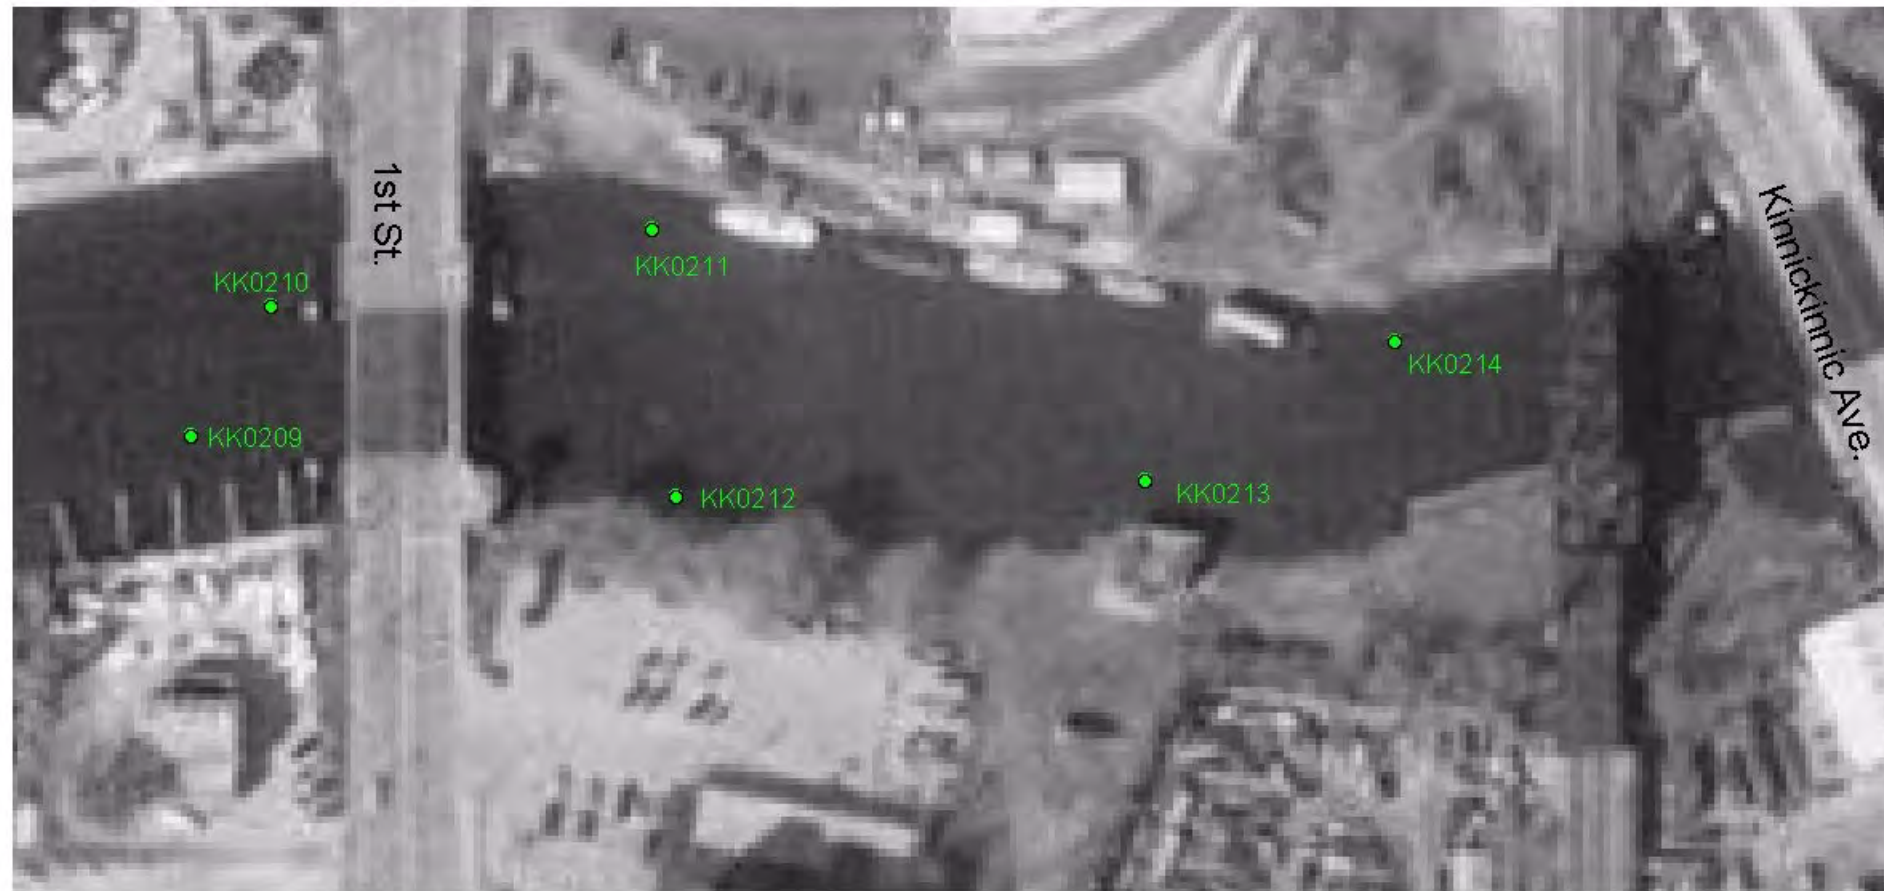
Figure 8
Section 3
September 2002 PAH Sediment Profile
Kinnickinnic River
Sediment Removal Concept Plan
Milwaukee, WI

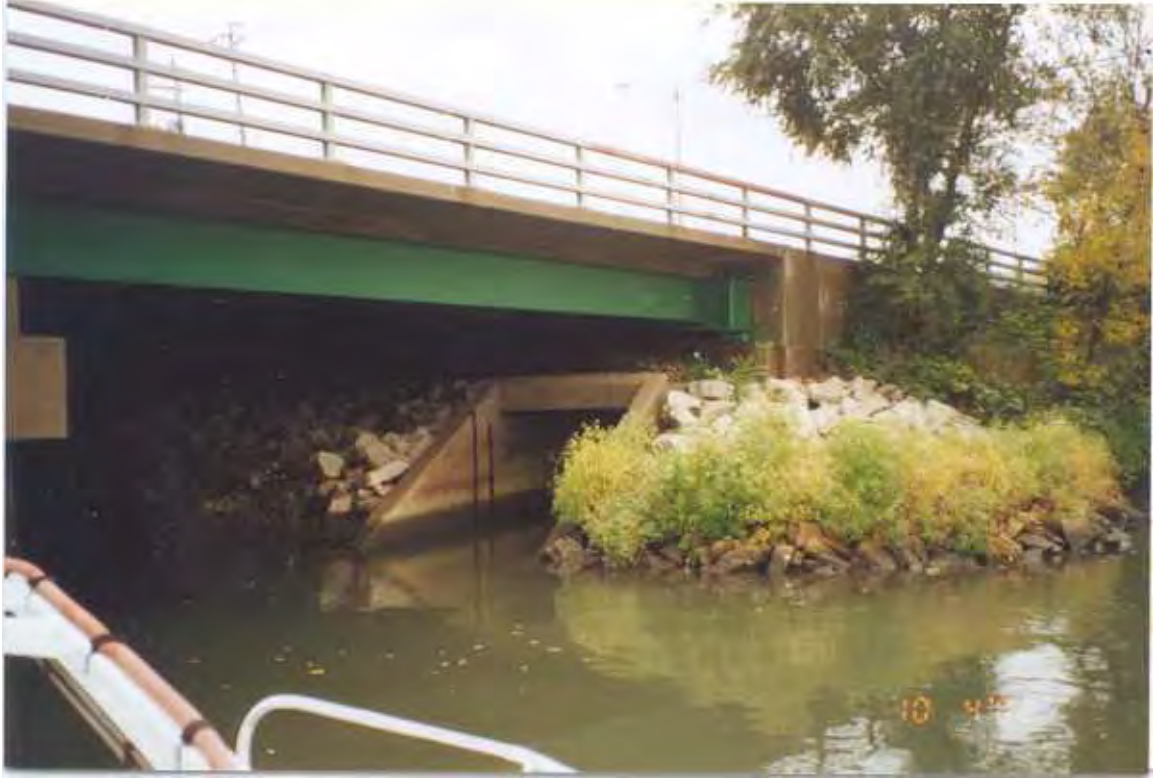
**PHOTO 2 – October 4, 2002 – Kinnickinnic River
Taken by Tor Hansen, Barr Engineering
Left abutment Becher Street Bridge showing concrete box
stormwater outlet. Taken from boat in river while looking
southwest.**

The wall along this parcel is an anchored SSP wall approximately 385 feet long. According to permits 104-C and 128-C the wall is 34 feet deep and was constructed in 1936 and 1941. The wall appears to be in good condition with no visible settlement or movement. There are permanent boat slips constructed on 9-inch pipe piles driven into the river bottom along the wall. A concrete box stormwater outlet at the upstream end of the property is in good condition.

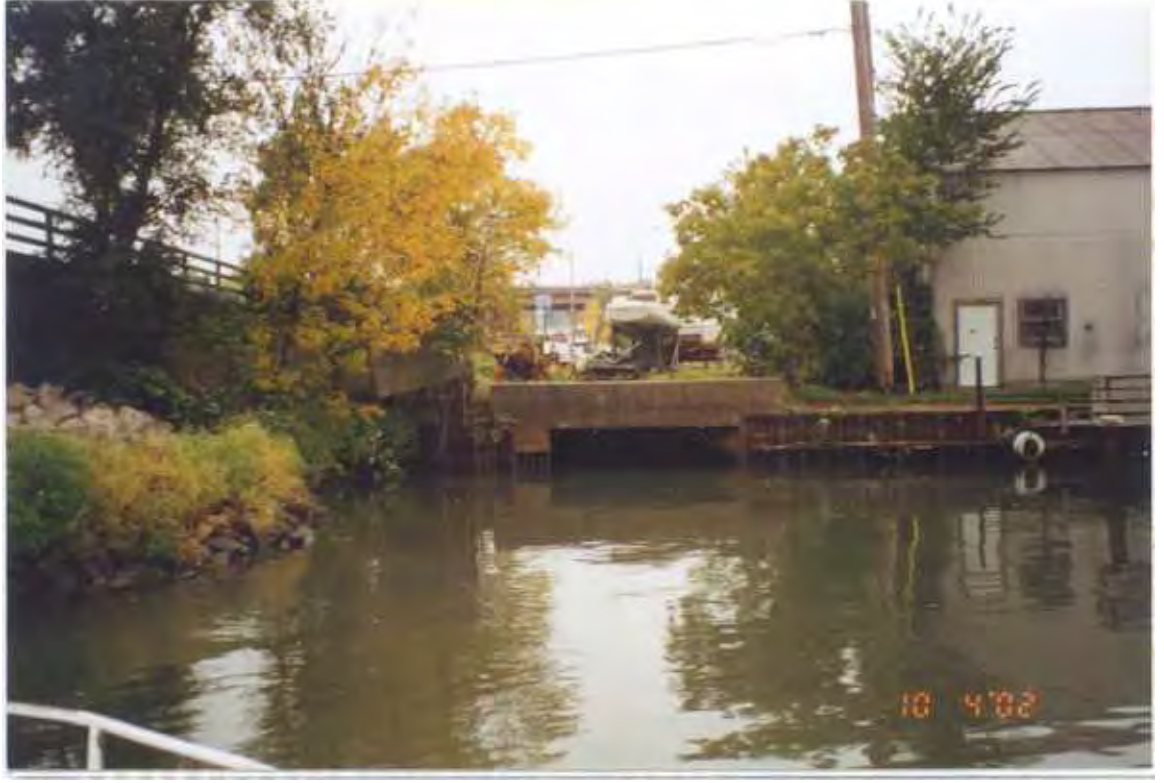
**PHOTO 4 –October 4, 2002 – Kinnickinnic River
Taken by Tor Hansen, Barr Engineering
Steel sheet pile wall along Parcel 429. Looking west.**

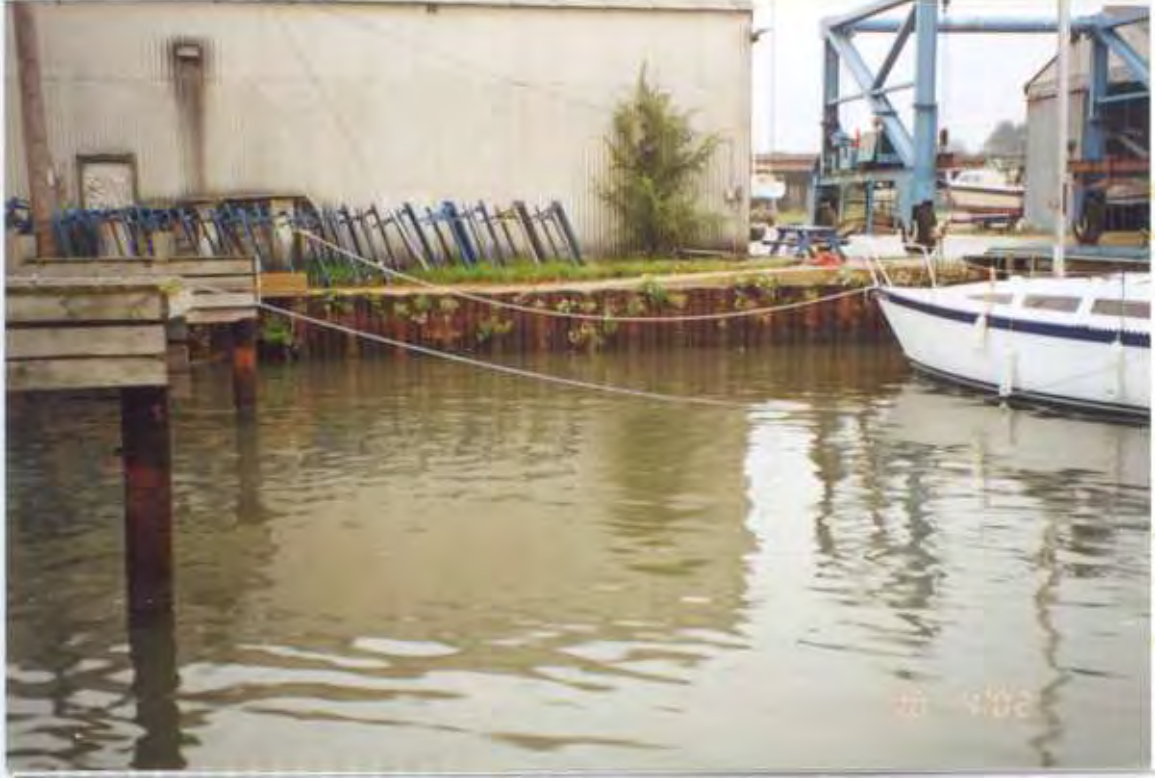
**PHOTO 5 – October 4, 2002 – Kinnickinnic River
Taken by Tor Hansen, Barr Engineering
Steel sheet pile wall along Parcel 429. Looking west.**

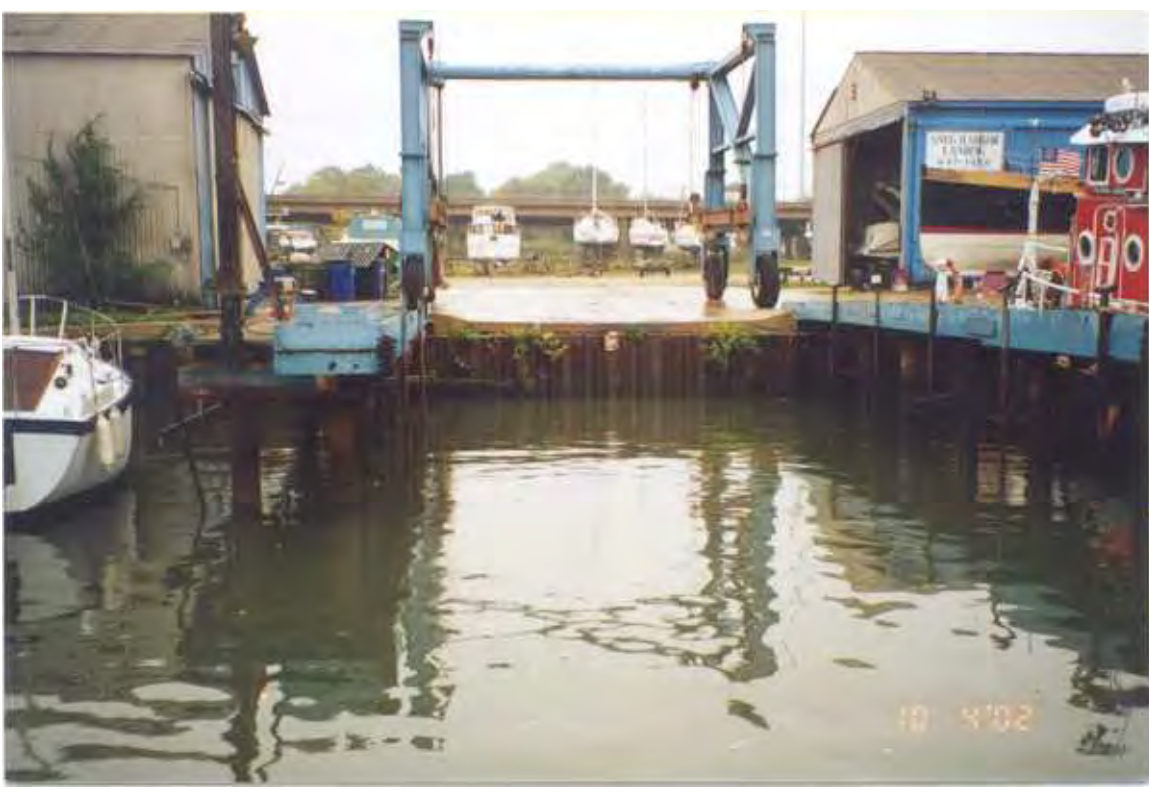
**PHOTO 6 – October 4, 2002 – Kinnickinnic River
Taken by Tor Hansen, Barr Engineering
Steel sheet pile wall along Parcel 429. Looking west.**

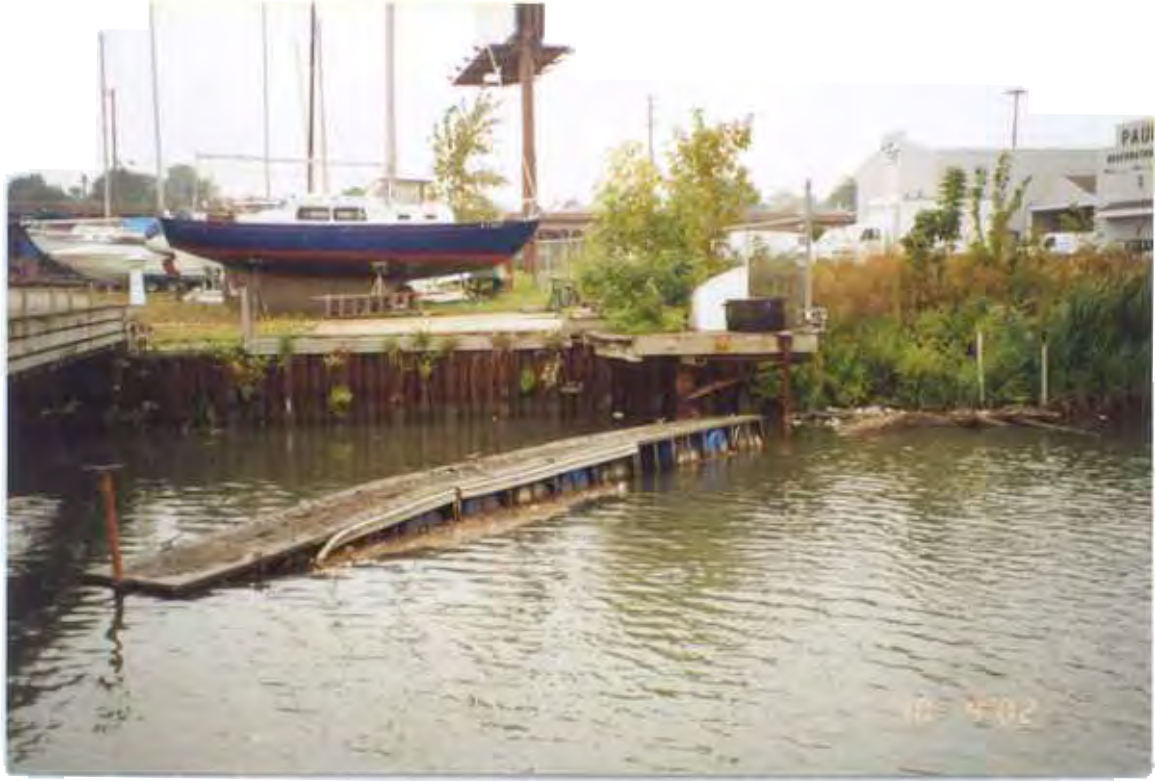
**PHOTO 9 – October 4, 2002 – Kinnickinnic River
Taken by Tor Hansen, Barr Engineering
Steel sheet pile wall along Parcel 429. Looking west.**

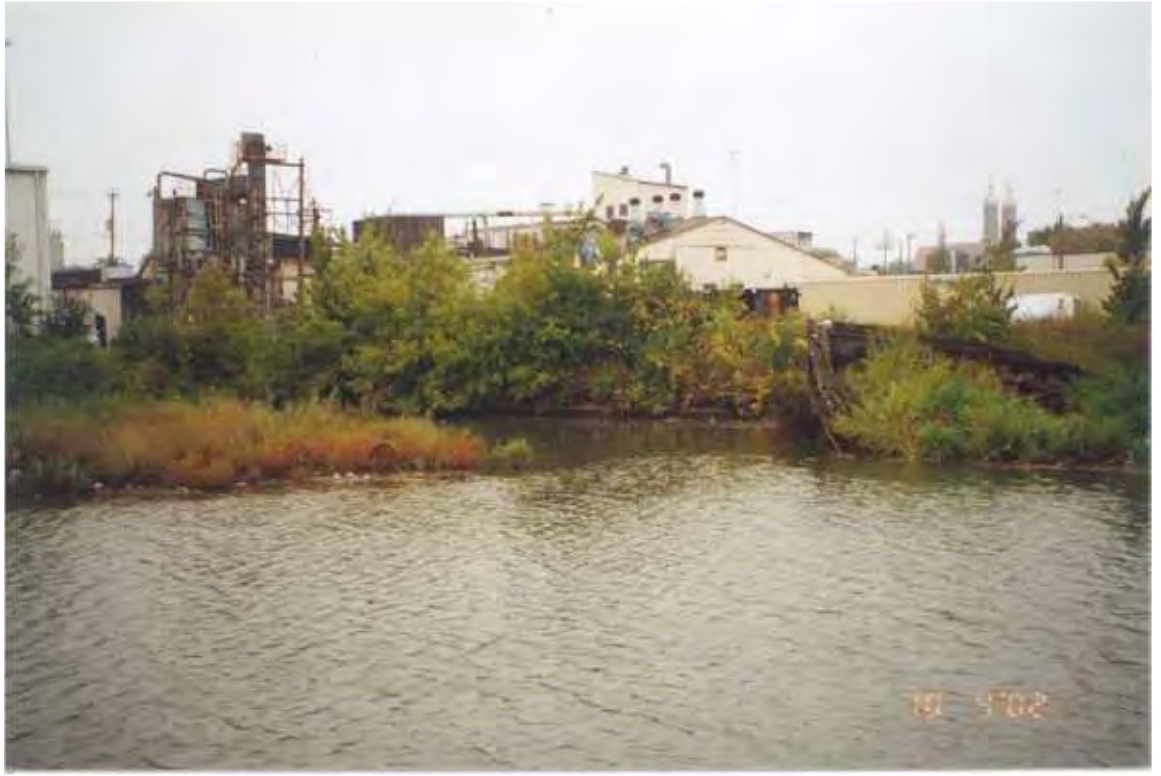
**PHOTO 16 – October 4, 2002 – Kinnickinnic River
Taken by Tor Hansen, Barr Engineering
Vegetation at shoreline along Parcel 427. Looking north.**

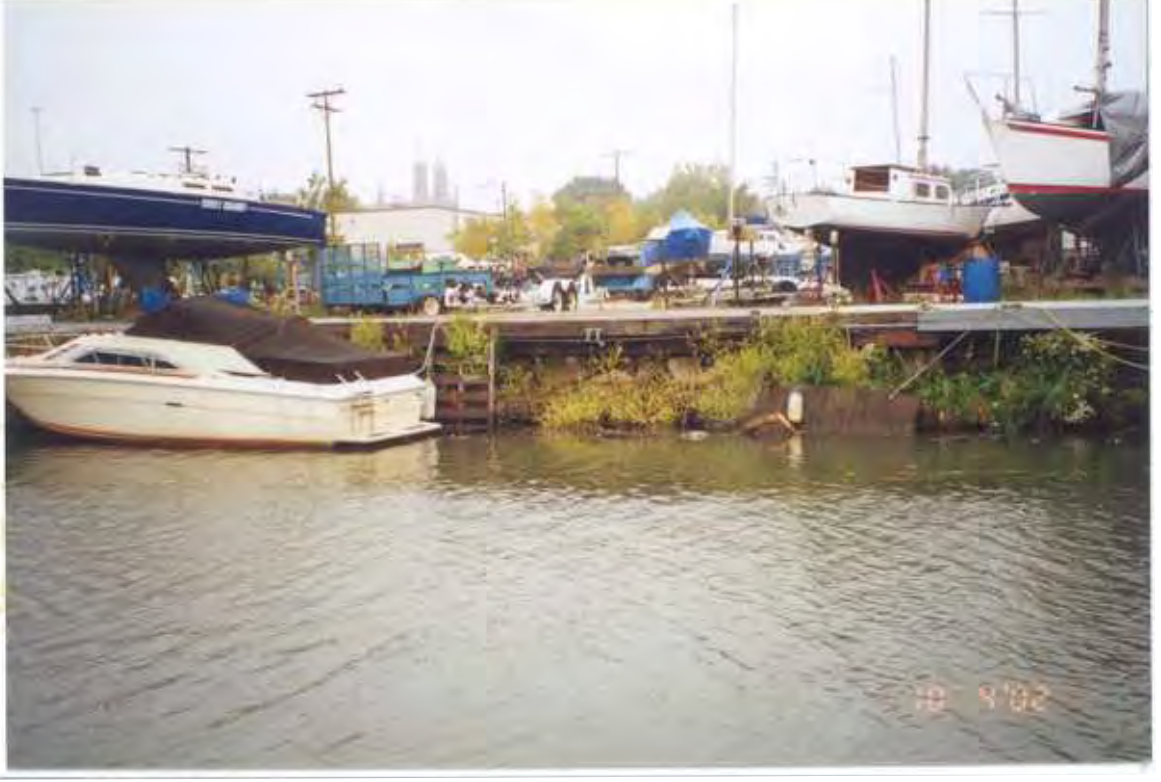
**PHOTO 19 – October 4, 2002 – Kinnickinnic River
Taken by Tor Hansen, Barr Engineering
Timber dock and wall along Parcel 426B. Looking north.**

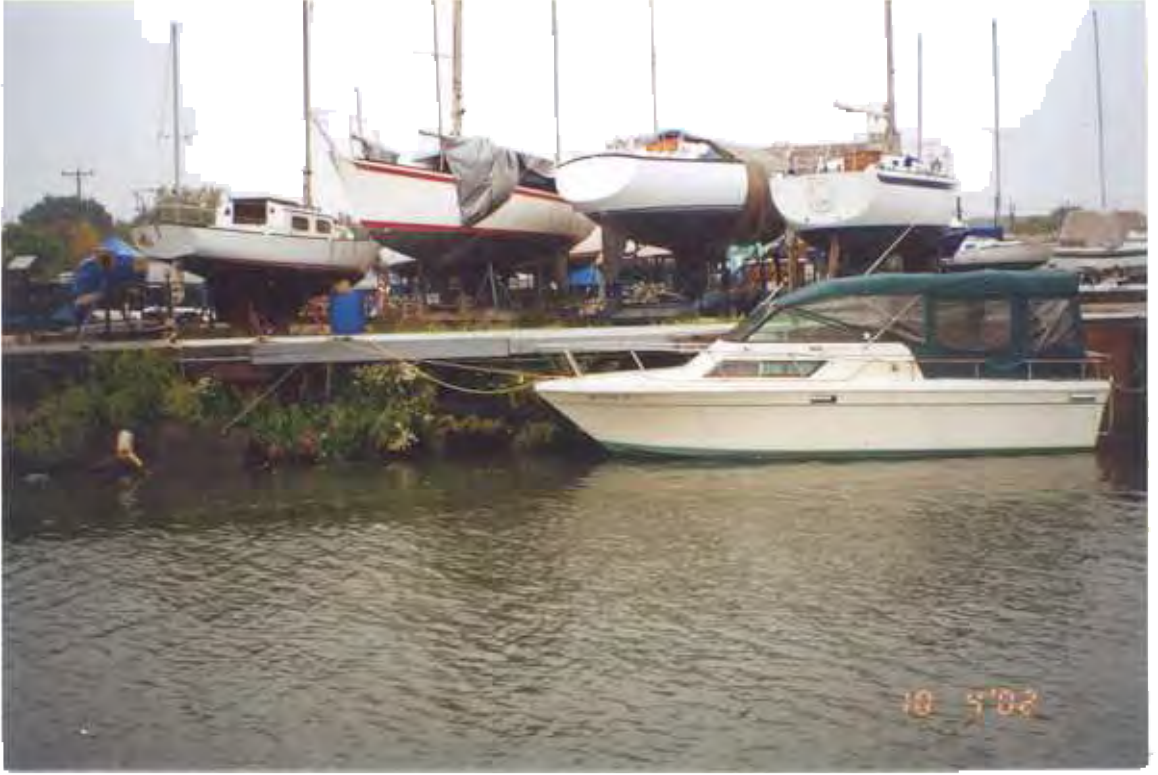
**PHOTO 21 – October 4, 2002 – Kinnickinnic River
Taken by Tor Hansen, Barr Engineering
Timber dock and wall along Parcel 426B. Looking north.**

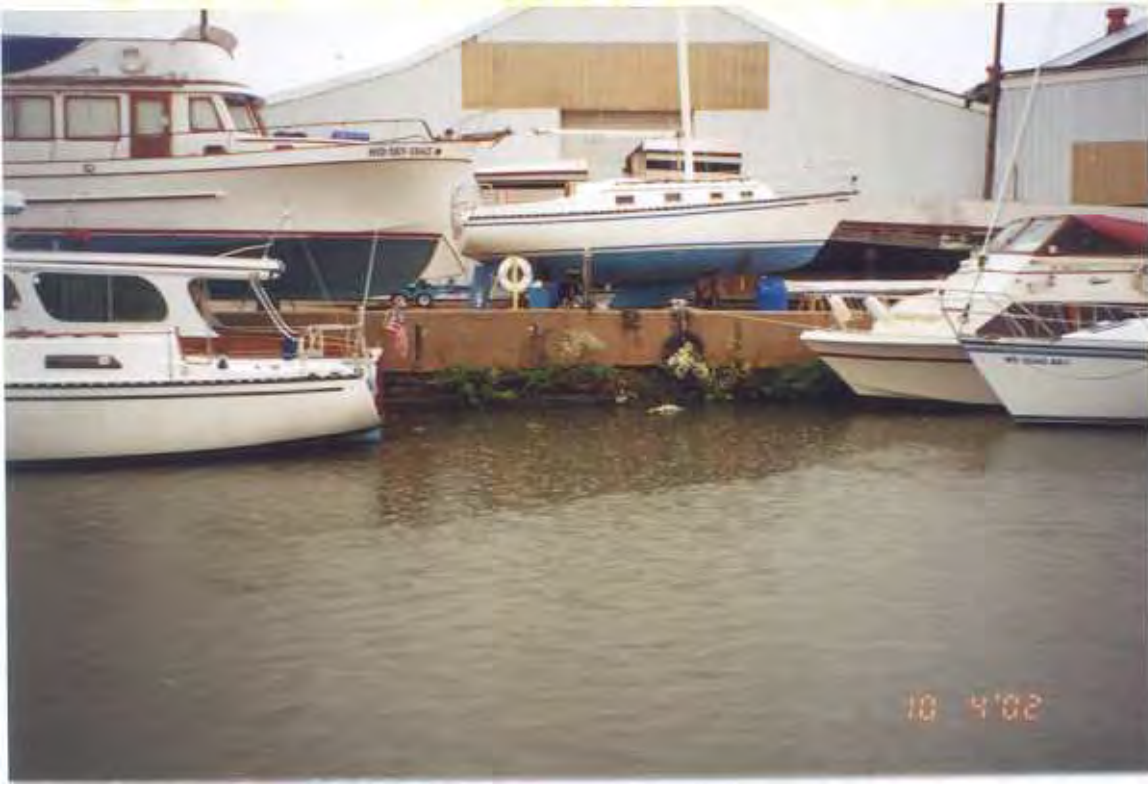
**PHOTO 25 – October 4, 2002 – Kinnickinnic River
Taken by Tor Hansen, Barr Engineering
Concrete dock and timber wall at Parcel 426A. Looking north.**

Records for this 385-foot section of the river indicate a Wakefield timber wall constructed in 194 and 1942. Most of this wall is permitted under Permit Number 131-R. The downstream most 90 feet is covered under Permit 138-R which indicates 28-foot long Wakefield timbers and 50-foot timber support piles. There is a concrete dock built on top and adjacent to the old wall. The concrete dock is not detailed on available records. In general, the wall and dock appear to be in fair to good condition, however, much of the Wakefield timber wall was not visible. There are no visible signs of distress or movement in the wall. Some spalling and deterioration of the concrete is present.
