***Concept Design Documentation Report
Kinnickinnic River, Wisconsin
Milwaukee Estuary Area of Concern
Sediment Removal***

***Prepared for
U.S. Army Corps of Engineers
Detroit District***

Kinnickinnic River, Wisconsin Milwaukee Estuary Area of Concern Deepening/Remediation Concept Design Documentation Report

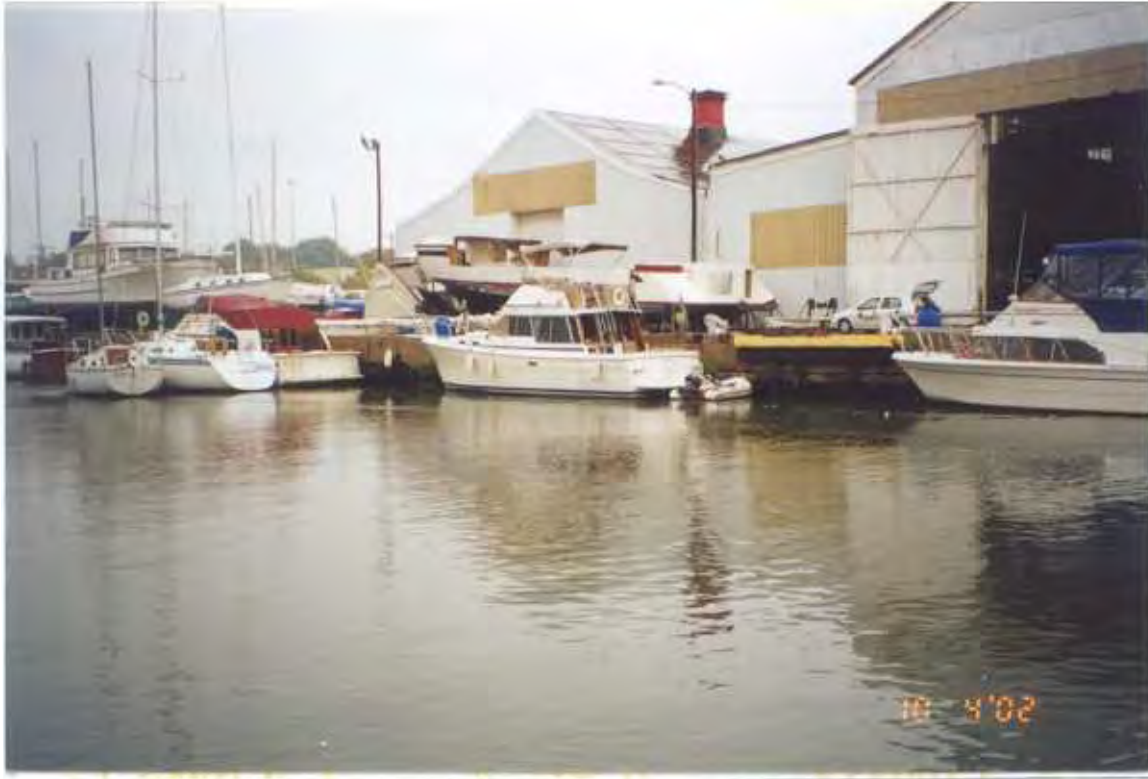
**PHOTO 26 – October 4, 2002 – Kinnickinnic River
Taken by Tor Hansen, Barr Engineering
Concrete dock and timber wall at Parcel 426A. Looking north.**

Records for this 385-foot section of the river indicate a Wakefield timber wall constructed in 194 and 1942. Most of this wall is permitted under Permit Number 131-R. The downstream most 90 feet is covered under Permit 138-R which indicates 28-foot long Wakefield timbers and 50-foot timber support piles. There is a concrete dock built on top and adjacent to the old wall. The concrete dock is not detailed on available records. In general, the wall and dock appear to be in fair to good condition, however, much of the Wakefield timber wall was not visible. There are no visible signs of distress or movement in the wall. Some spalling and deterioration of the concrete is present.

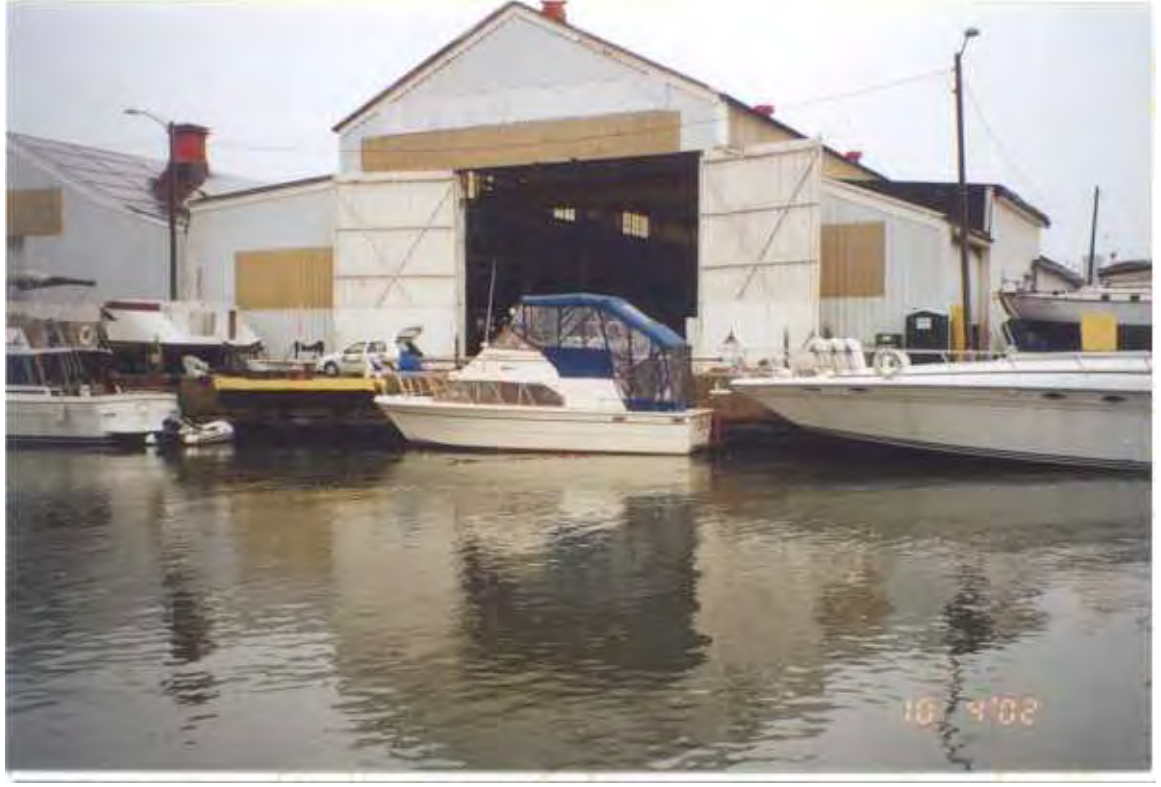
**PHOTO 27 – October 4, 2002 – Kinnickinnic River
Taken by Tor Hansen, Barr Engineering
Concrete dock and timber wall at Parcel 426A. Looking north.**

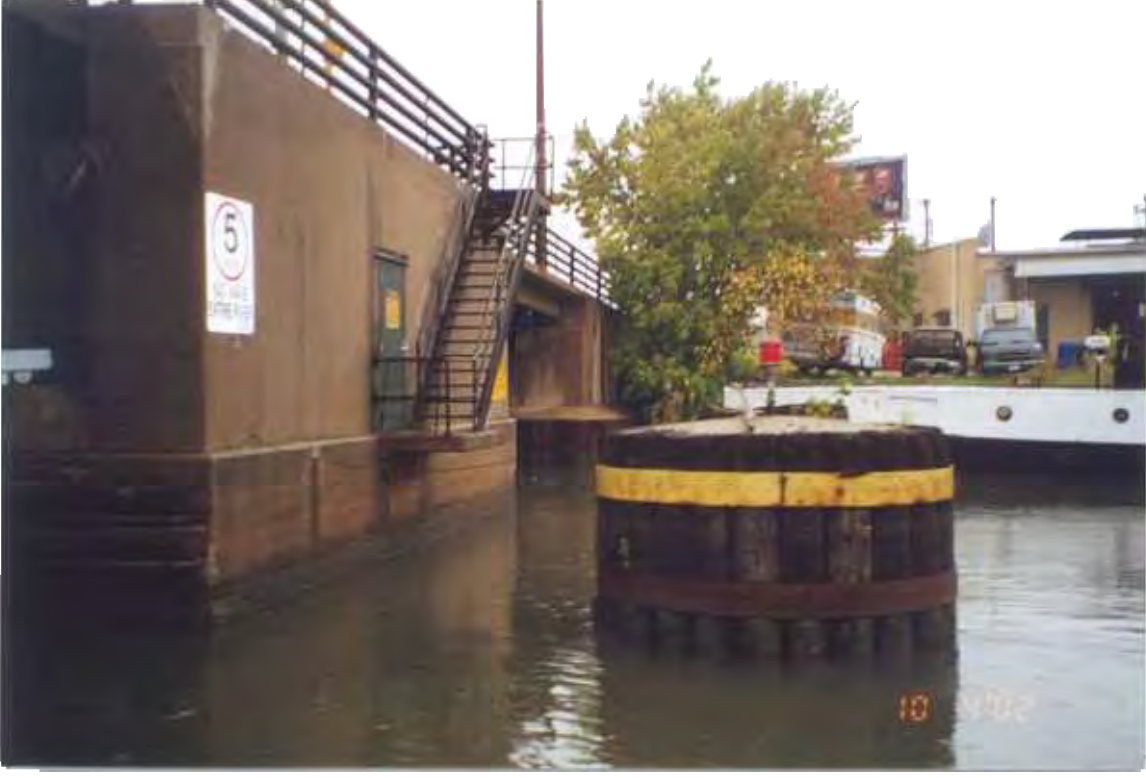
**PHOTO 29 – October 4, 2002 – Kinnickinnic River
Taken by Tor Hansen, Barr Engineering
Downstream face of pier and left abutment for 1st Street Bridge.
Parcel 426 looking north.**

The left bridge abutment for the 1st Street Bridge is the river bank along Parcel 426. The abutment consists of a SSP wall and mass concrete section. The abutment is in excellent condition.

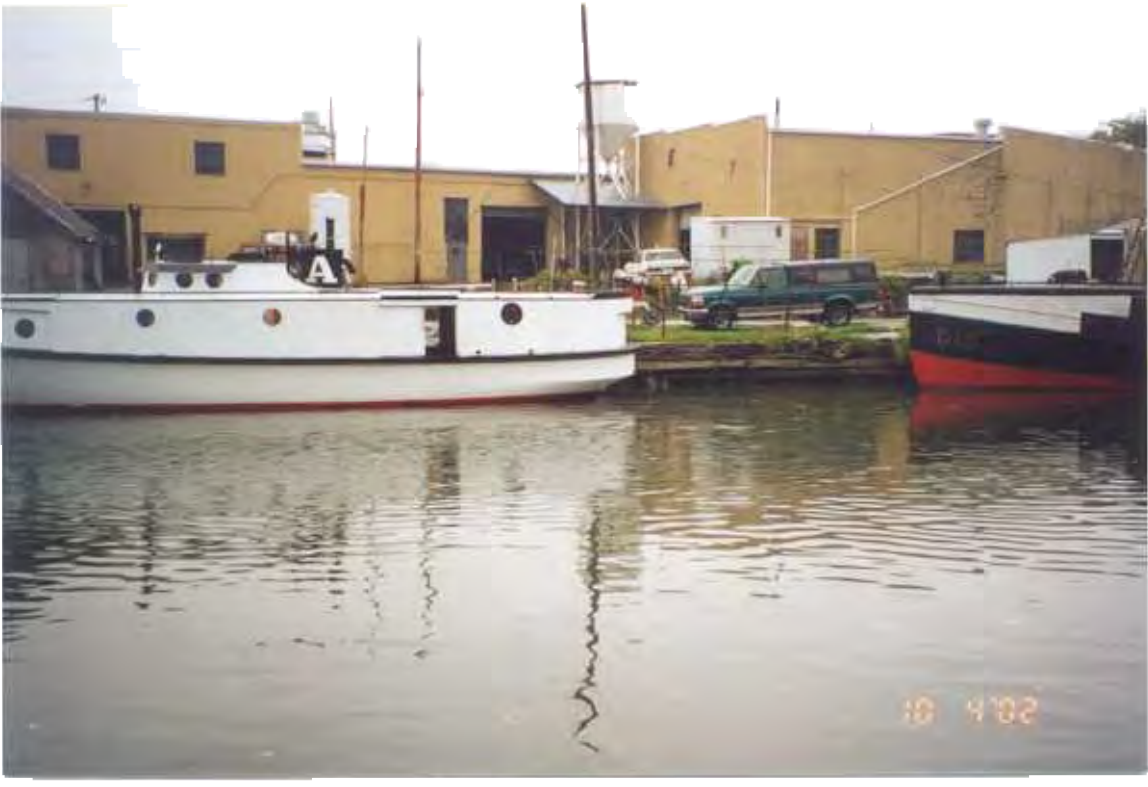
**PHOTO 33 – October 4, 2002 – Kinnickinnic River
Taken by Tor Hansen, Barr Engineering
Timber wall along Parcel 425. Looking north.**

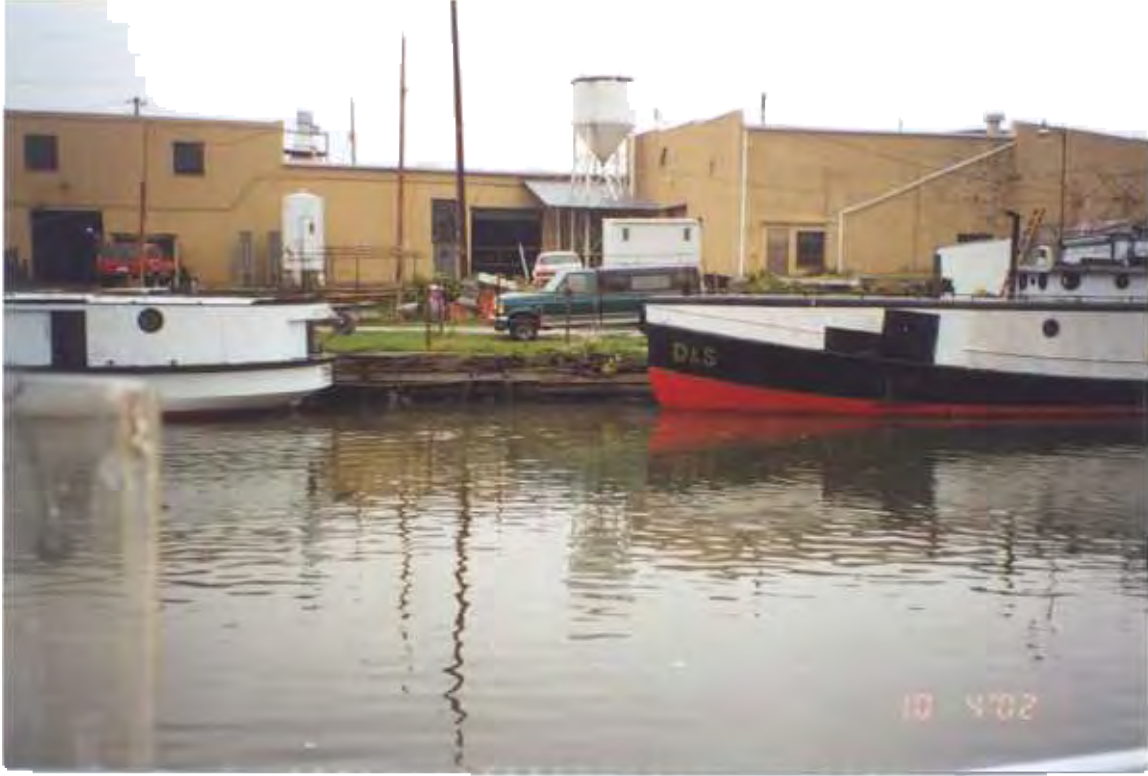
**PHOTO 34 – October 4, 2002 – Kinnickinnic River
Taken by Tor Hansen, Barr Engineering
Timber wall along Parcel 425. Looking north.**

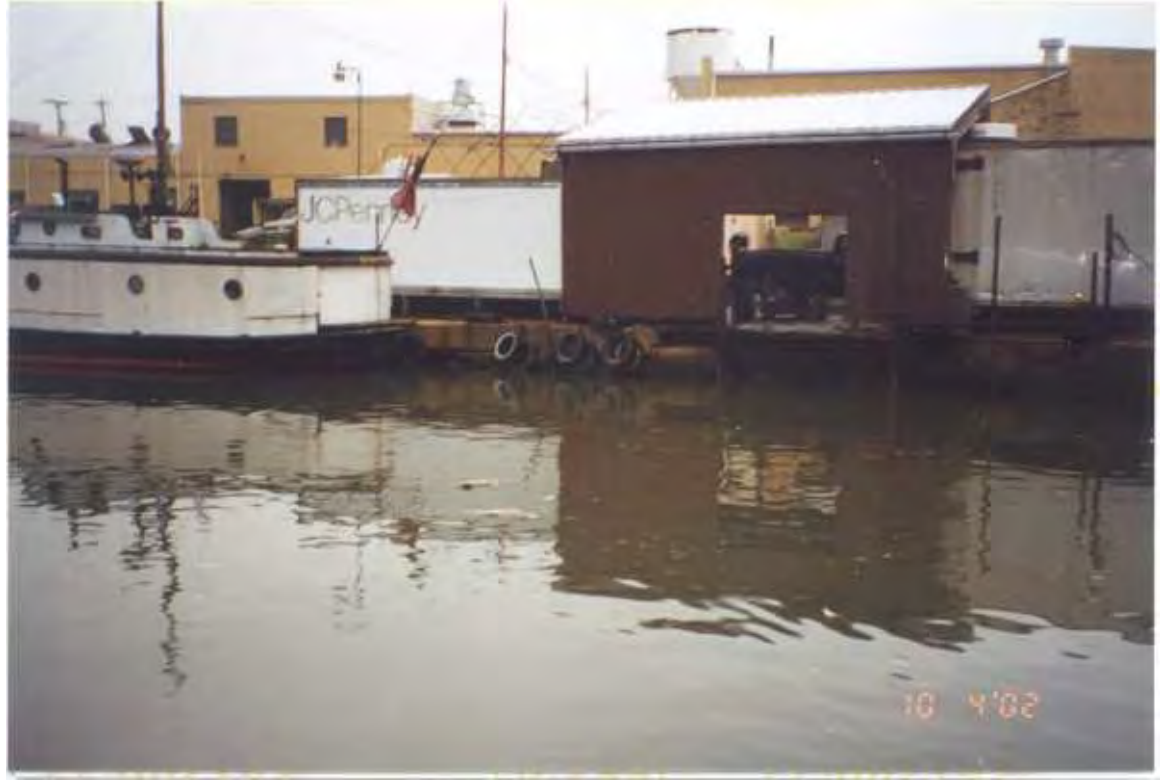
**PHOTO 35 – October 4, 2002 – Kinnickinnic River
Taken by Tor Hansen, Barr Engineering
Concrete and timber wall along Parcel 425. Looking north.**

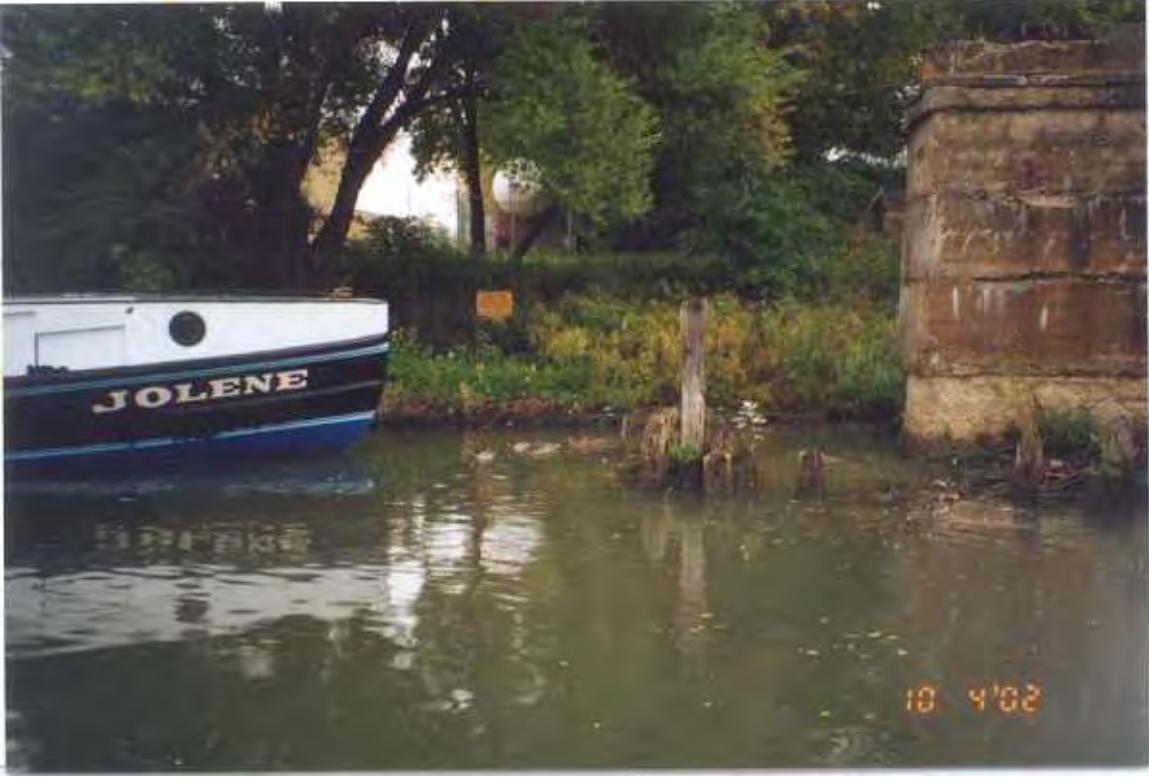
**PHOTO 37 – October 4, 2002 – Kinnickinnic River
Taken by Tor Hansen, Barr Engineering
Vegetation along Parcel 425 downstream from Photo 36.
Looking north.**

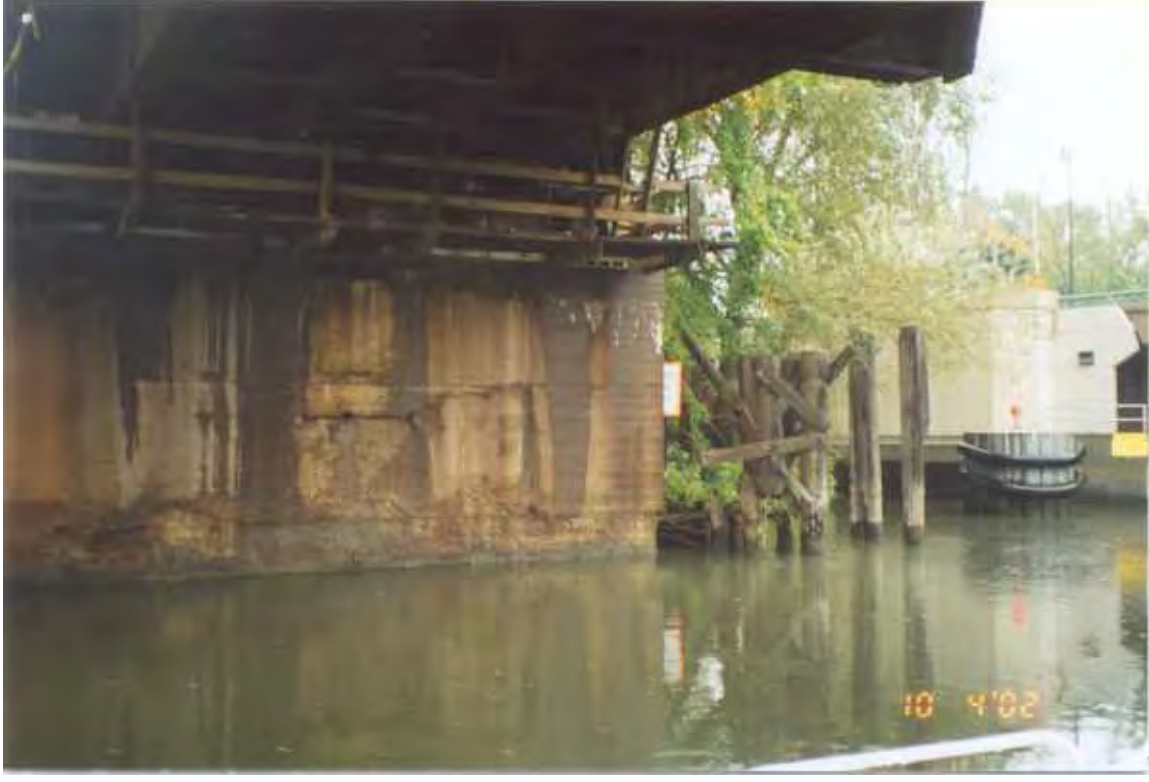
**PHOTO 41 – October 4, 2002 – Kinnickinnic River
Taken by Tor Hansen, Barr Engineering
Railroad bridge abutment at downstream end of Parcel 425.**

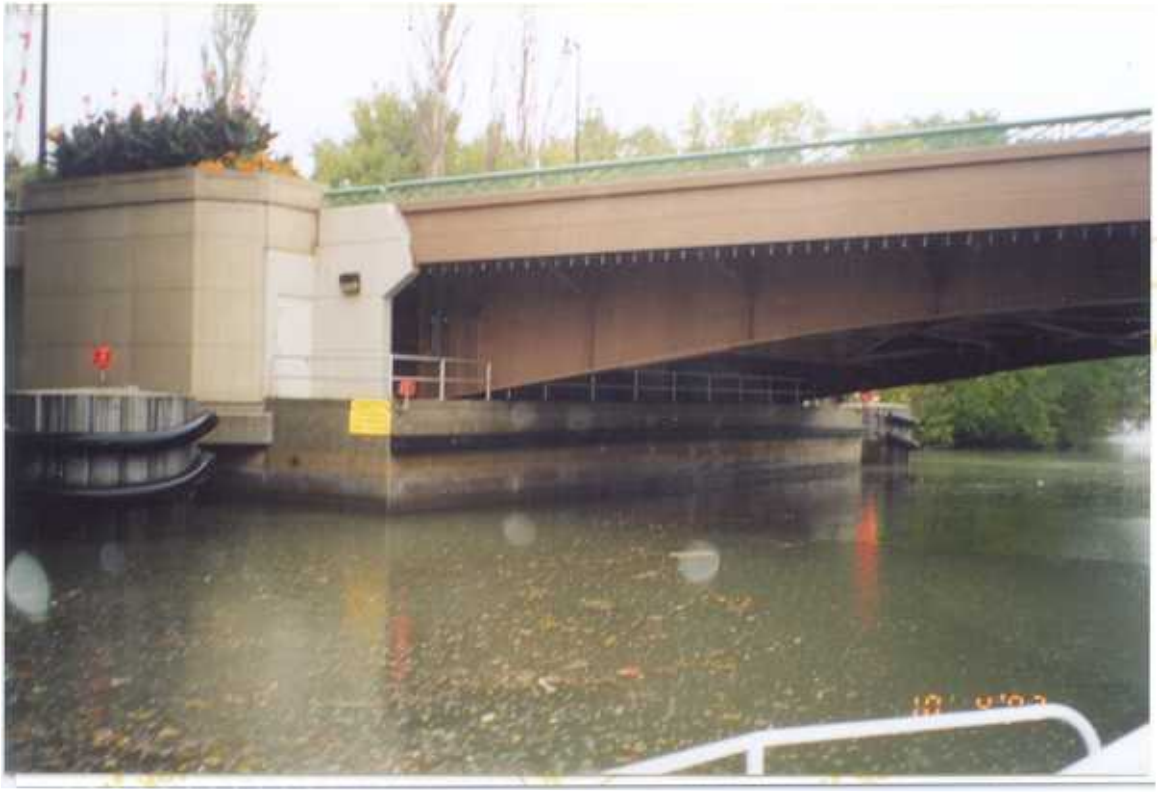
**PHOTO 44 – October 4, 2002 – Kinnickinnic River
Taken by Tor Hansen, Barr Engineering
Upstream face of left abutment and pier of 1st Street Bridge.
Looking downstream or east.**

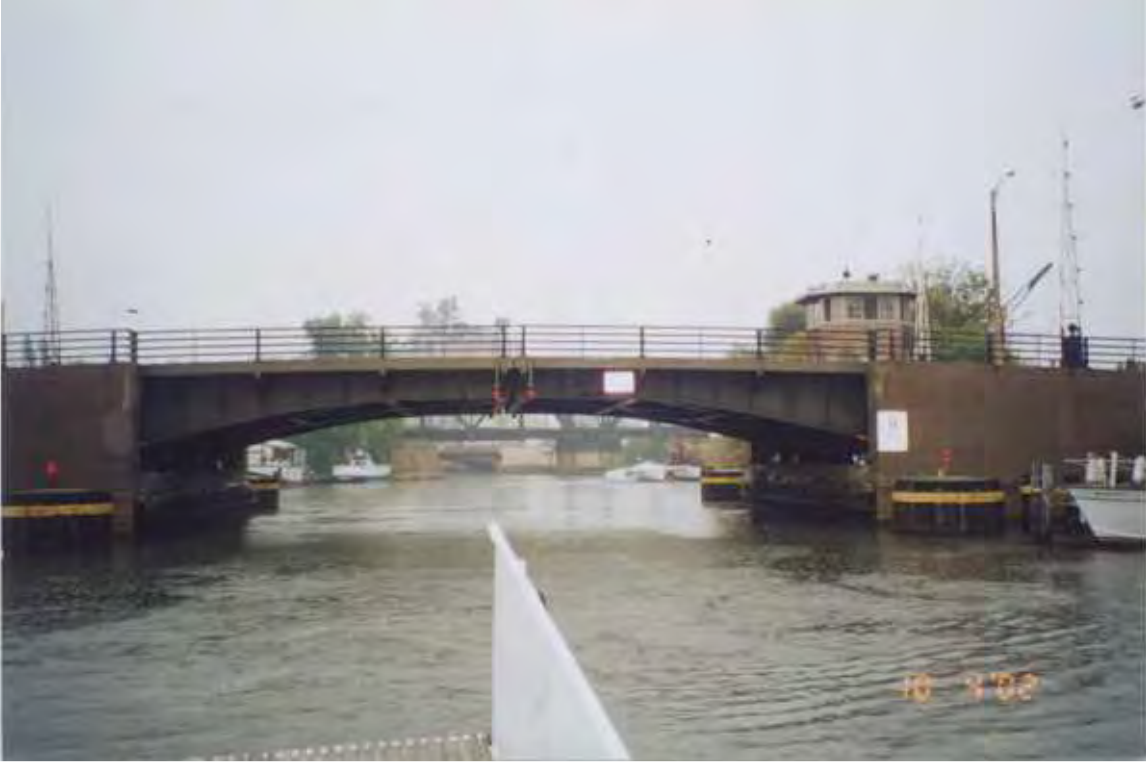
**PHOTO 45 – October 4, 2002 – Kinnickinnic River
Taken by Tor Hansen, Barr Engineering
1st Street Bridge looking downstream or east.**

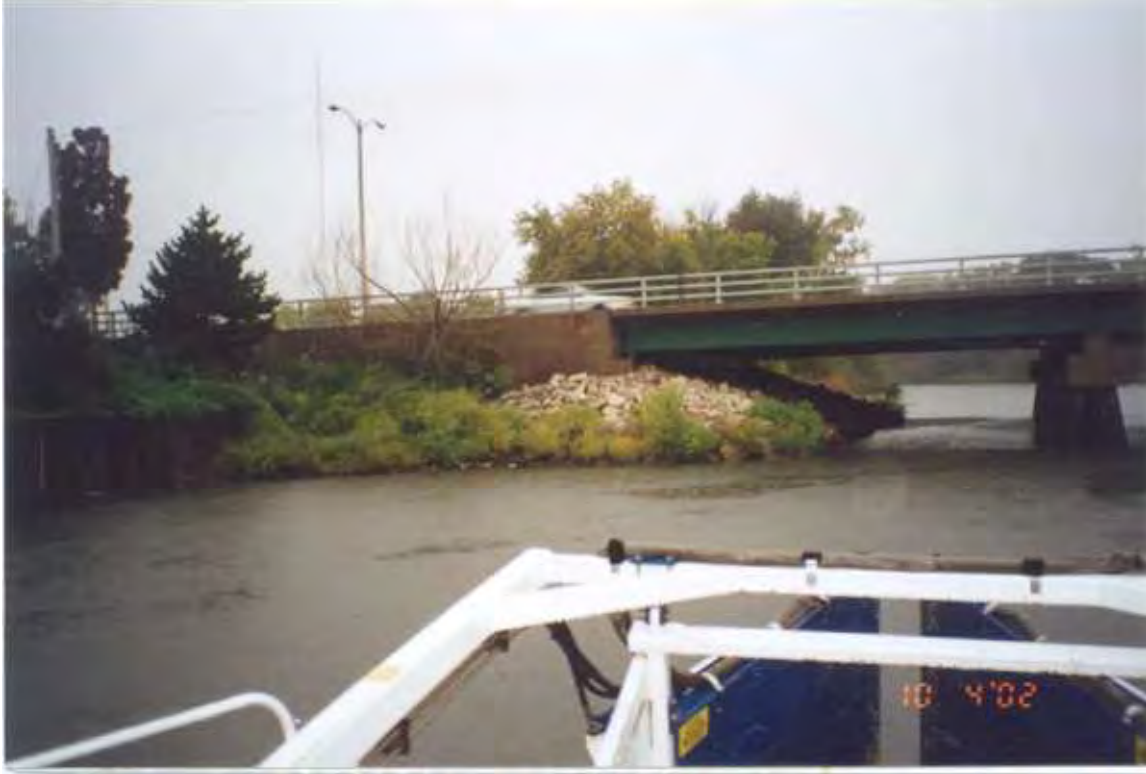
**PHOTO 46 – October 4, 2002 – Kinnickinnic River
Taken by Tor Hansen, Barr Engineering
Right abutment of Becher Street Bridge looking upstream or south.**

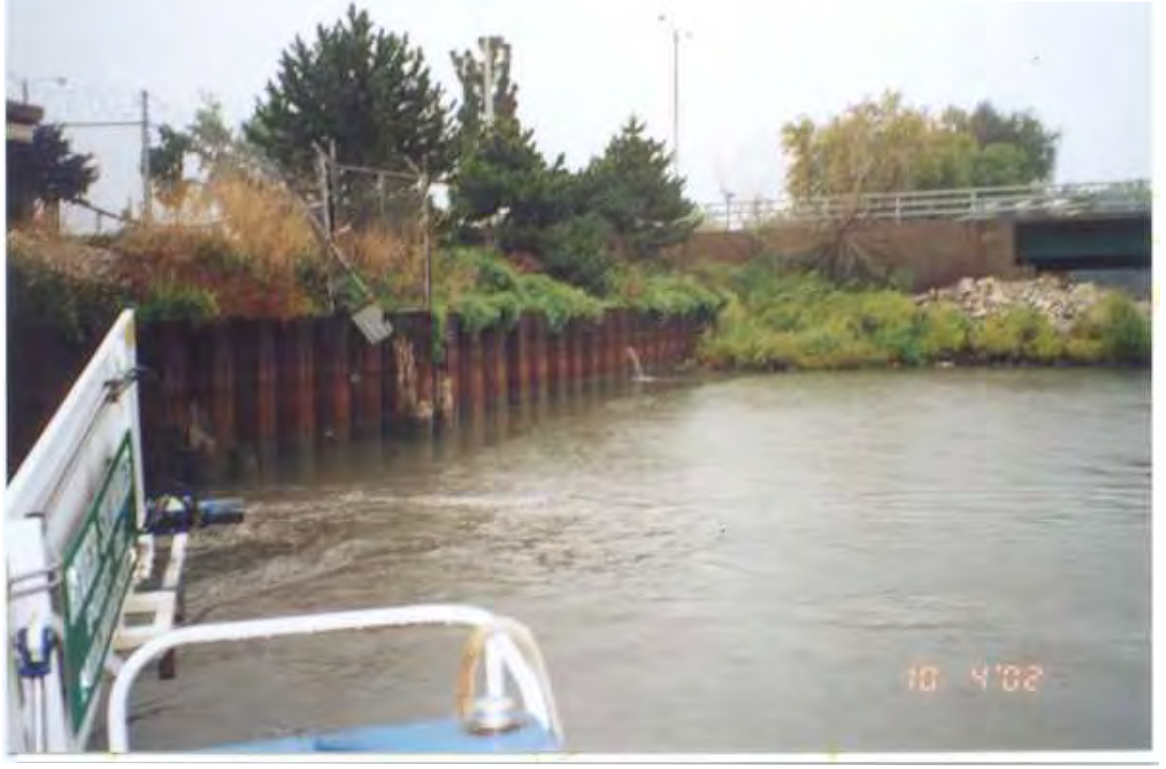
**PHOTO 48 – October 4, 2002 – Kinnickinnic River
Taken by Tor Hansen, Barr Engineering
Steel sheet pile wall along Parcel 433. Looking east.**

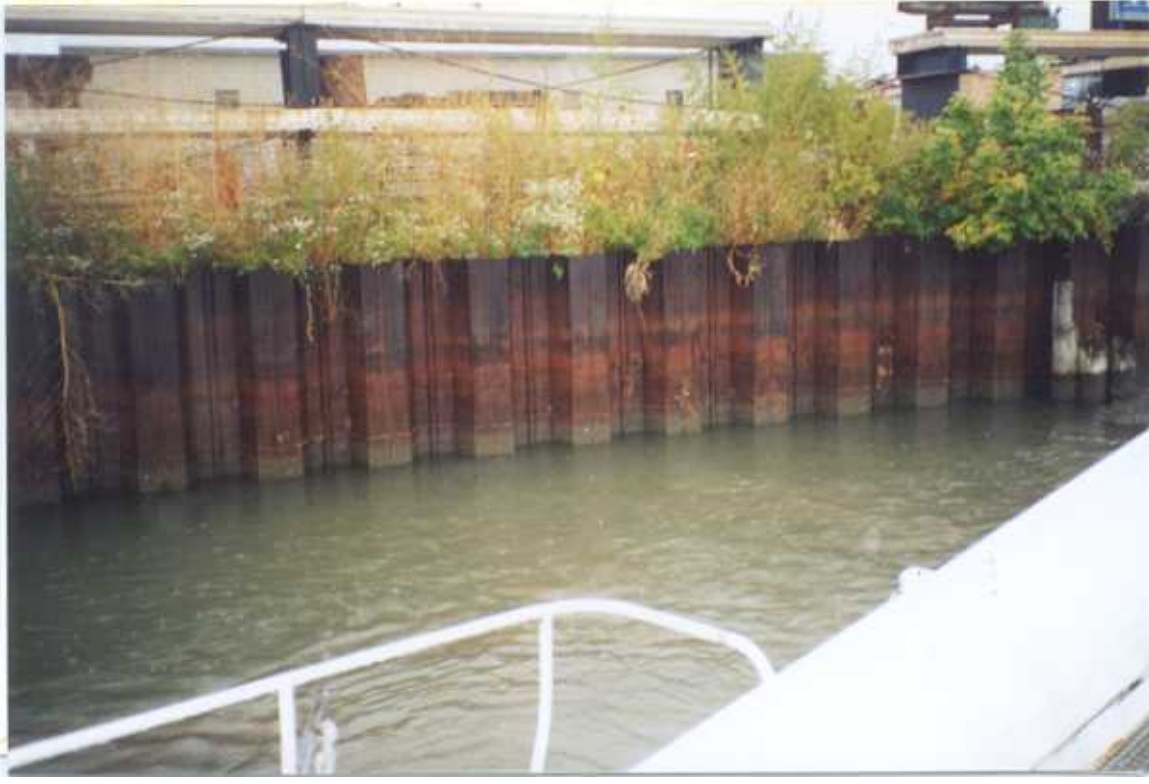
**PHOTO 49 – October 4, 2002 – Kinnickinnic River
Taken by Tor Hansen, Barr Engineering
Steel sheet pile wall along Parcel 433. Looking east.**

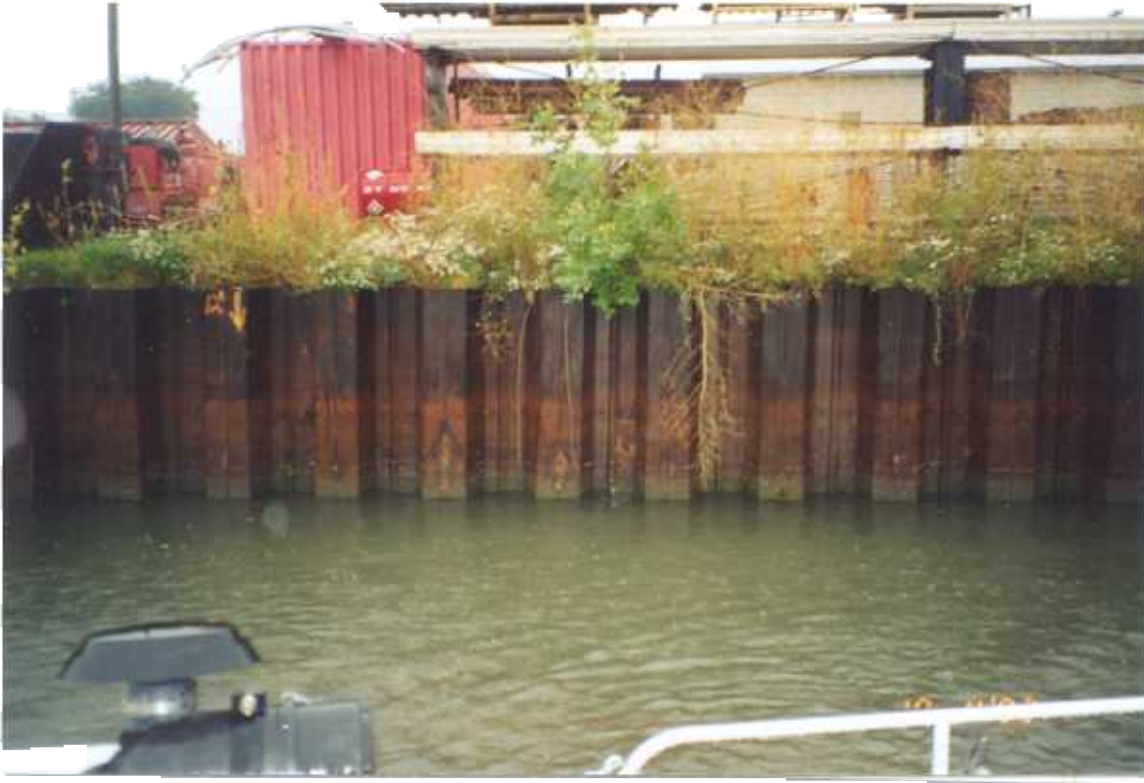
**PHOTO 50 – October 4, 2002 – Kinnickinnic River
Taken by Tor Hansen, Barr Engineering
Steel sheet pile wall along Parcel 433. Looking east.**

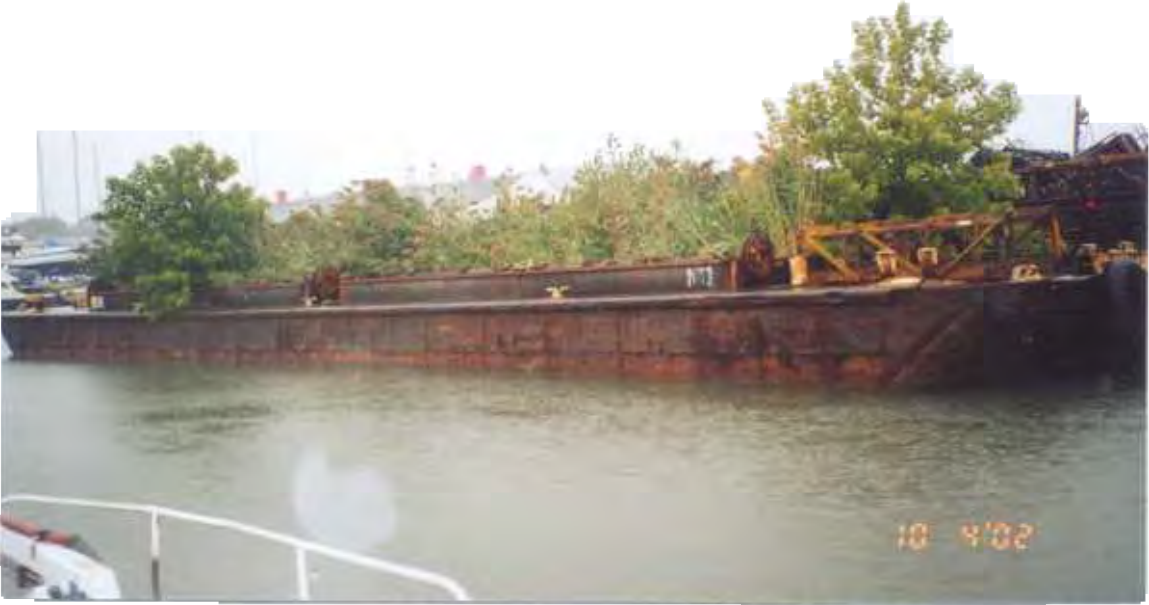
**PHOTO 54 – October 4, 2002 – Kinnickinnic River
Taken by Tor Hansen, Barr Engineering
Barge in front of steel sheet pile wall along Parcel 433. Looking east.**

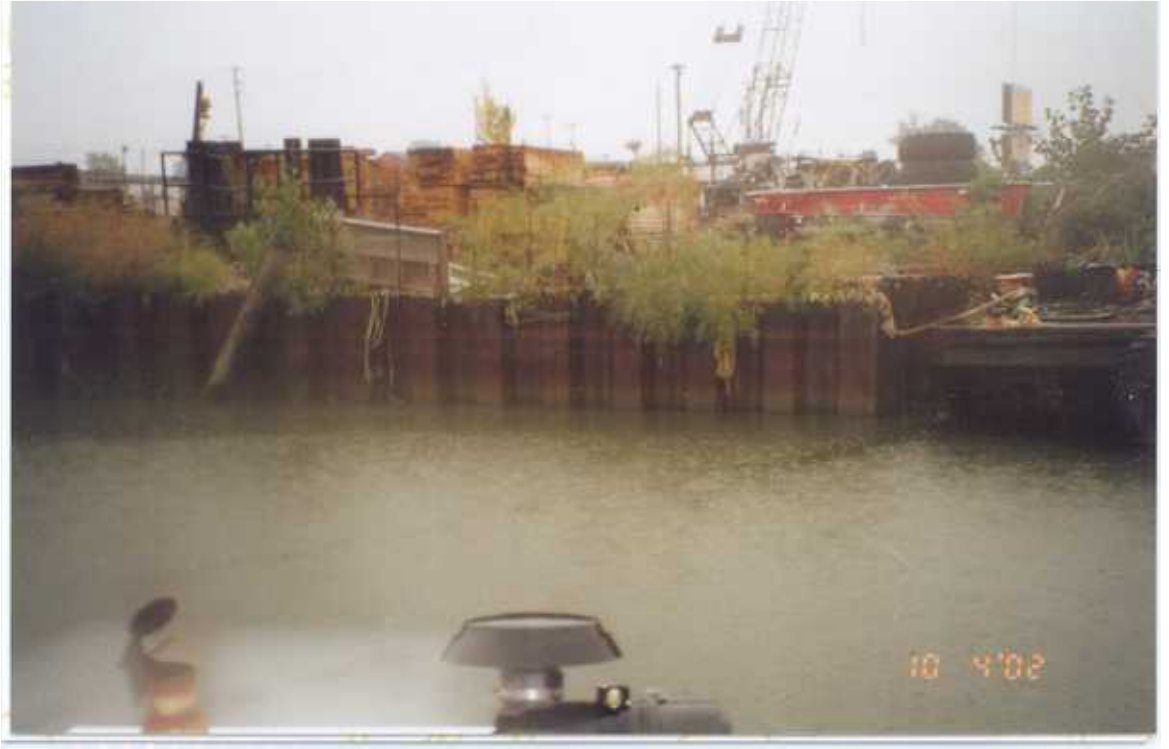
**PHOTO 56 – October 4, 2002 – Kinnickinnic River
Taken by Tor Hansen, Barr Engineering
Steel sheet pile wall along Parcel 433. Looking south.**

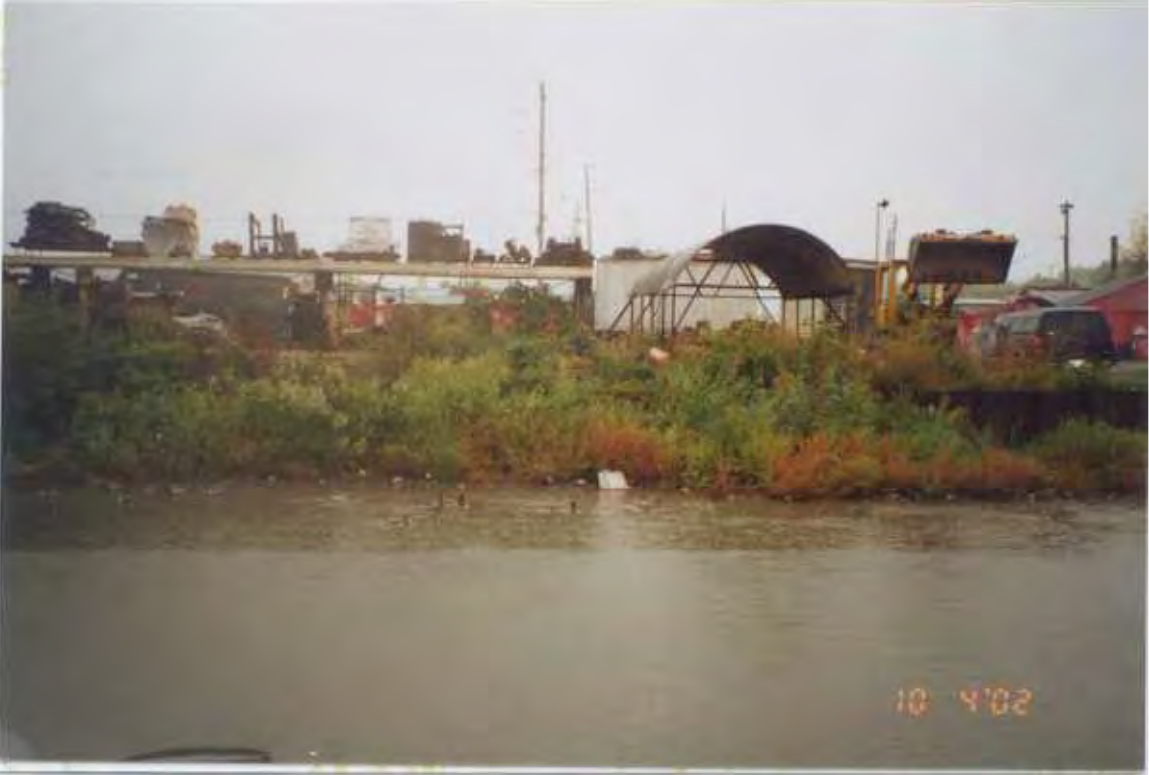
**PHOTO 58 – October 4, 2002 – Kinnickinnic River
Taken by Tor Hansen, Barr Engineering
Downstream end of steel sheet pile wall at Parcel 433 and start of
vegetation along Parcel 436. Looking south.**

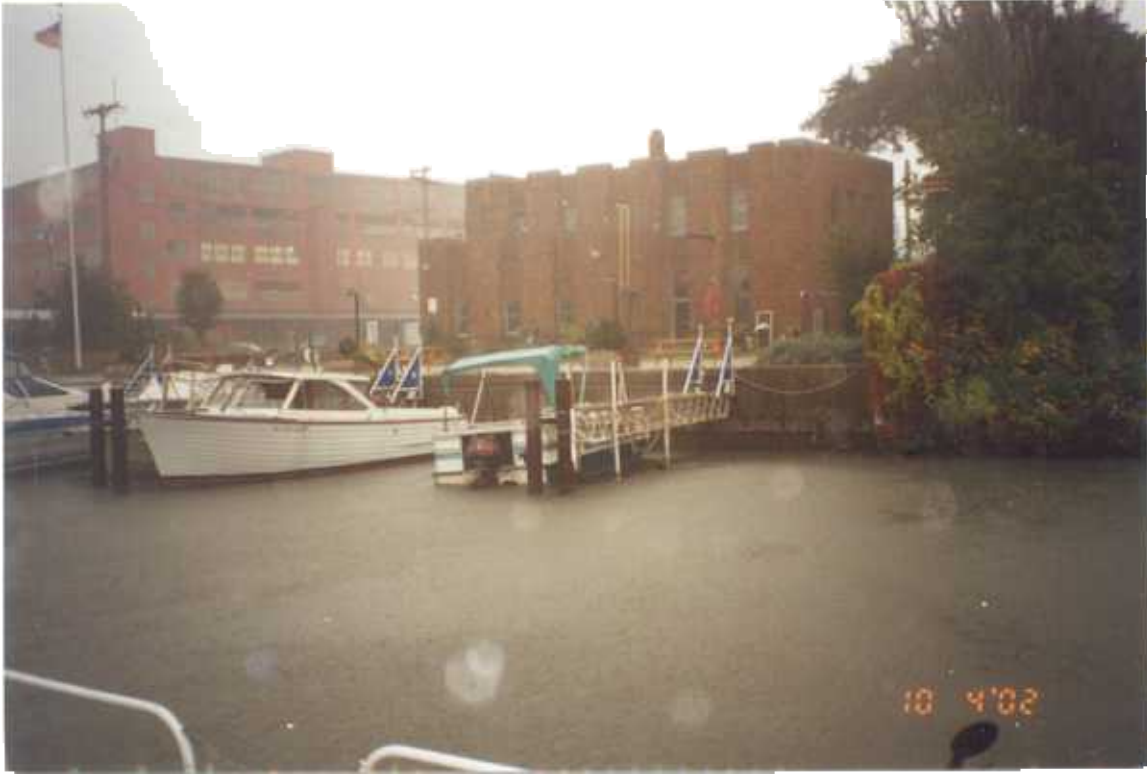
**PHOTO 62 – October 4, 2002 – Kinnickinnic River
Taken by Tor Hansen, Barr Engineering
Upstream end of concrete wall at Parcel 437. Looking south.**

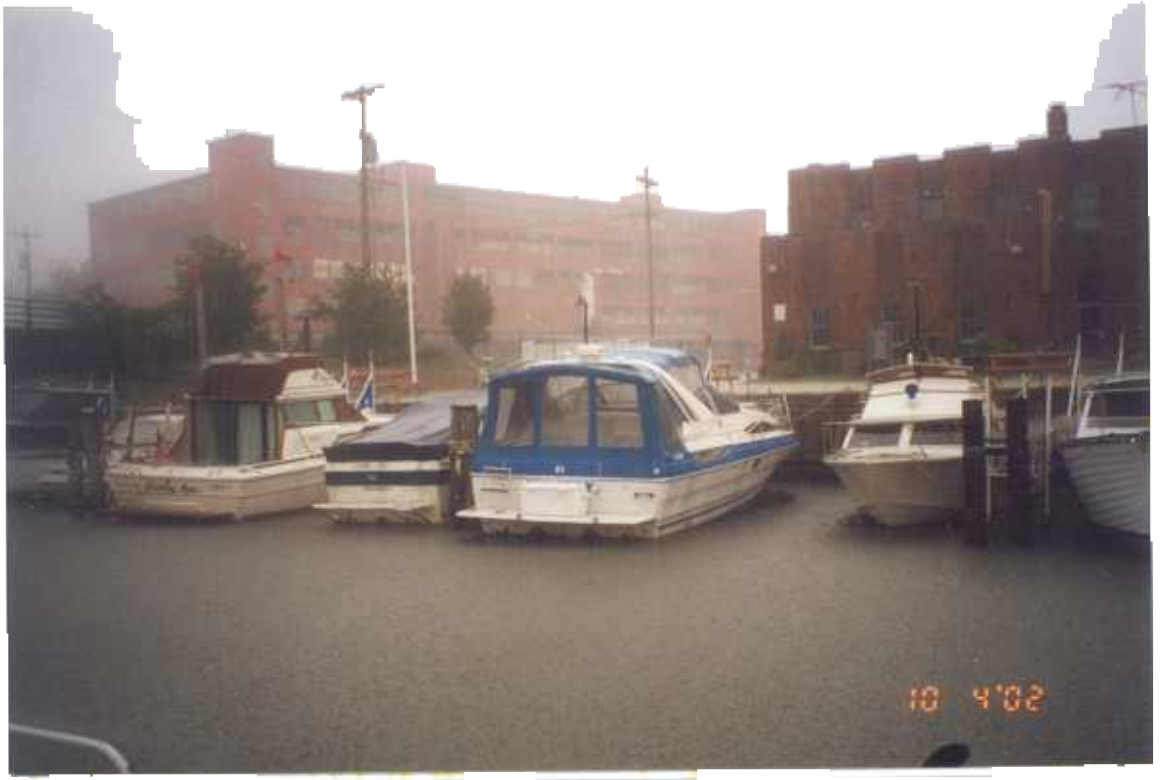
**PHOTO 63 – October 4, 2002 – Kinnickinnic River
Taken by Tor Hansen, Barr Engineering
Concrete wall along Parcel 437. Looking south.**

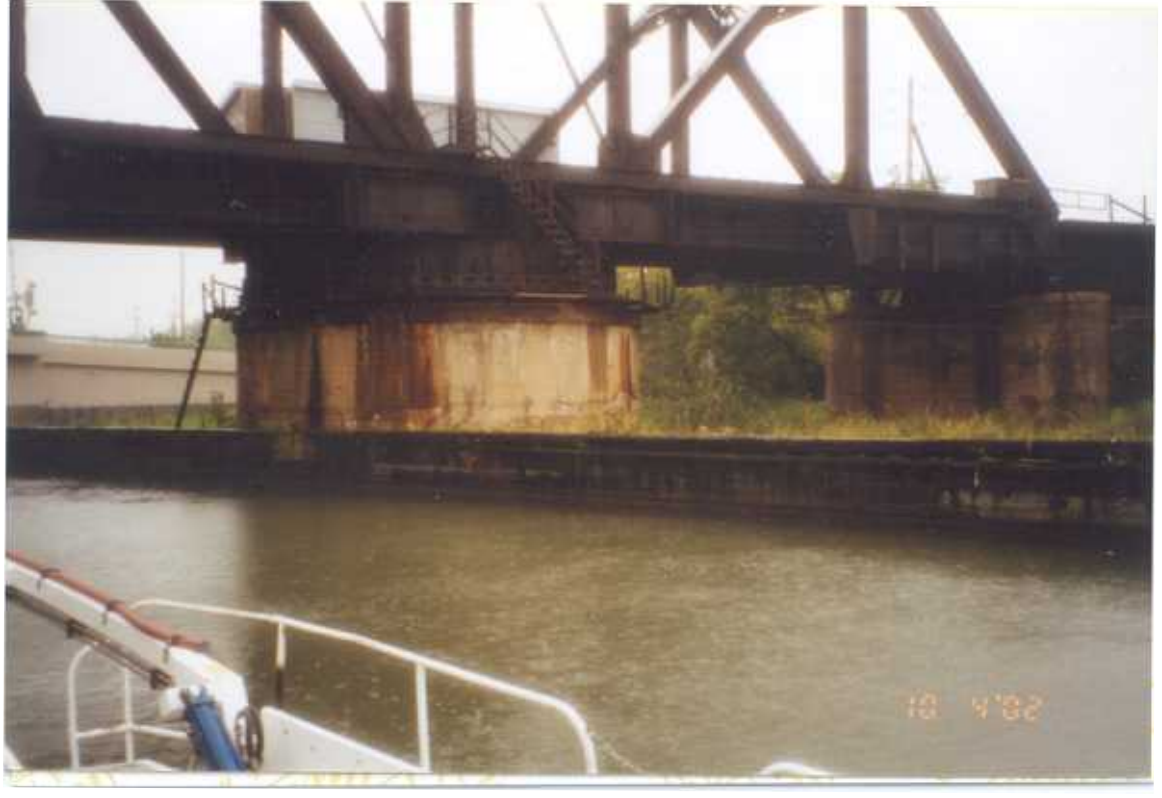
**PHOTO 72 – October 4, 2002 – Kinnickinnic River
Taken by Tor Hansen, Barr Engineering
Timber pile fence protecting bridge pier adjacent to Parcel 443.
Looking south.**

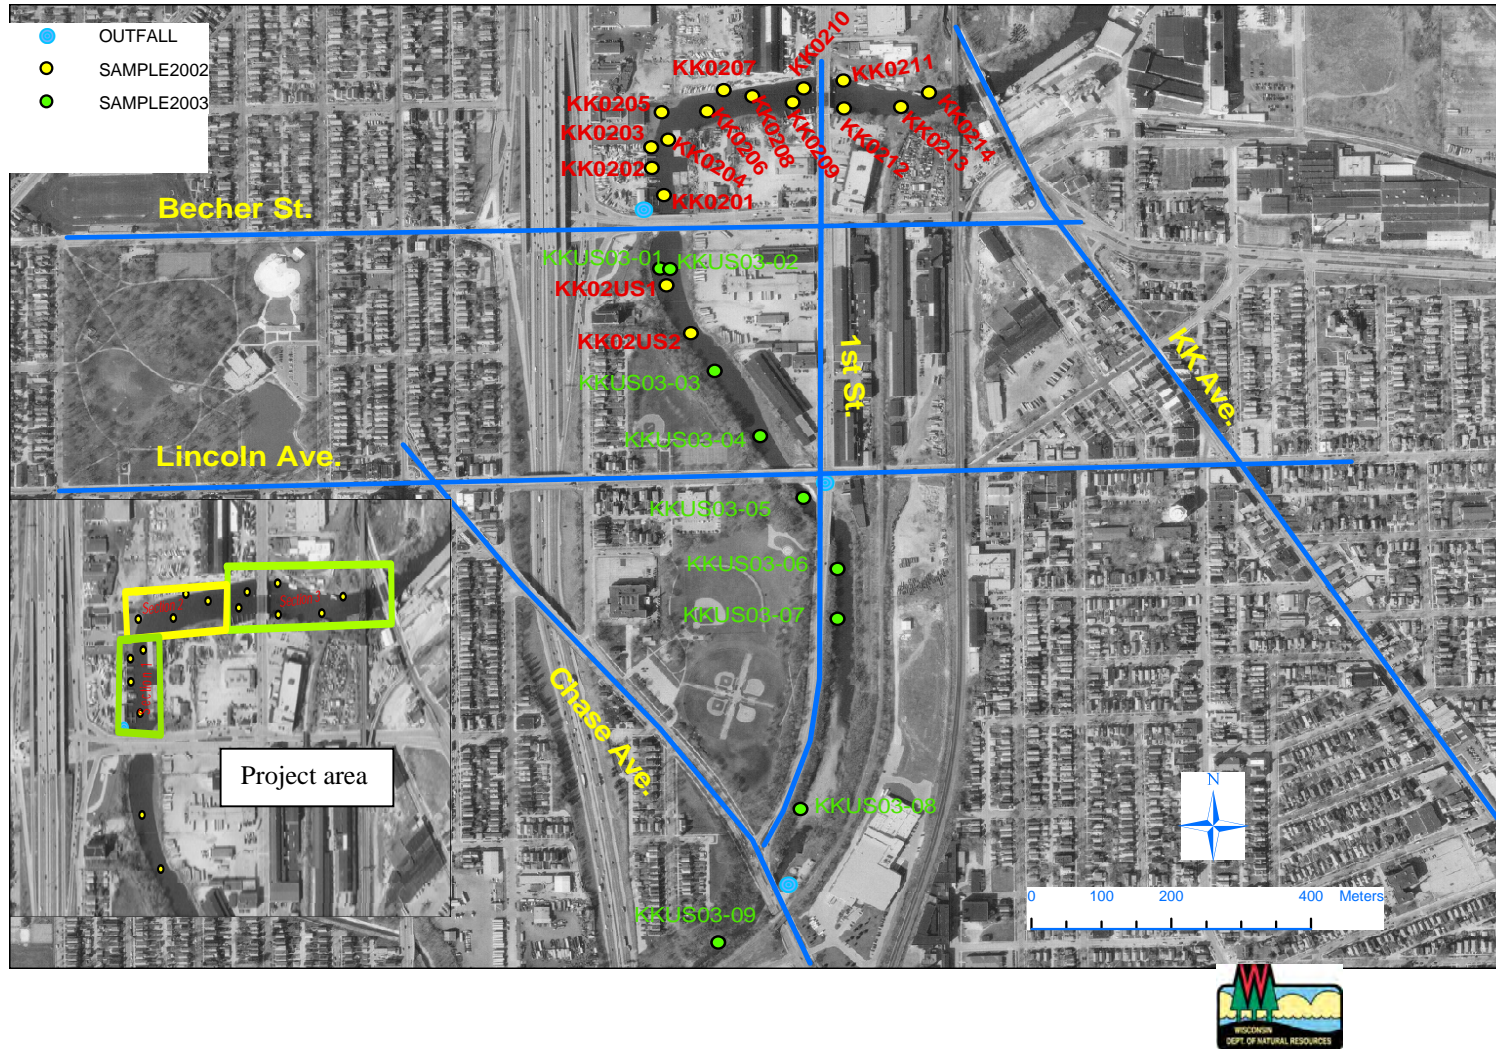
Fig. 1 Project area and sediment sampling locations

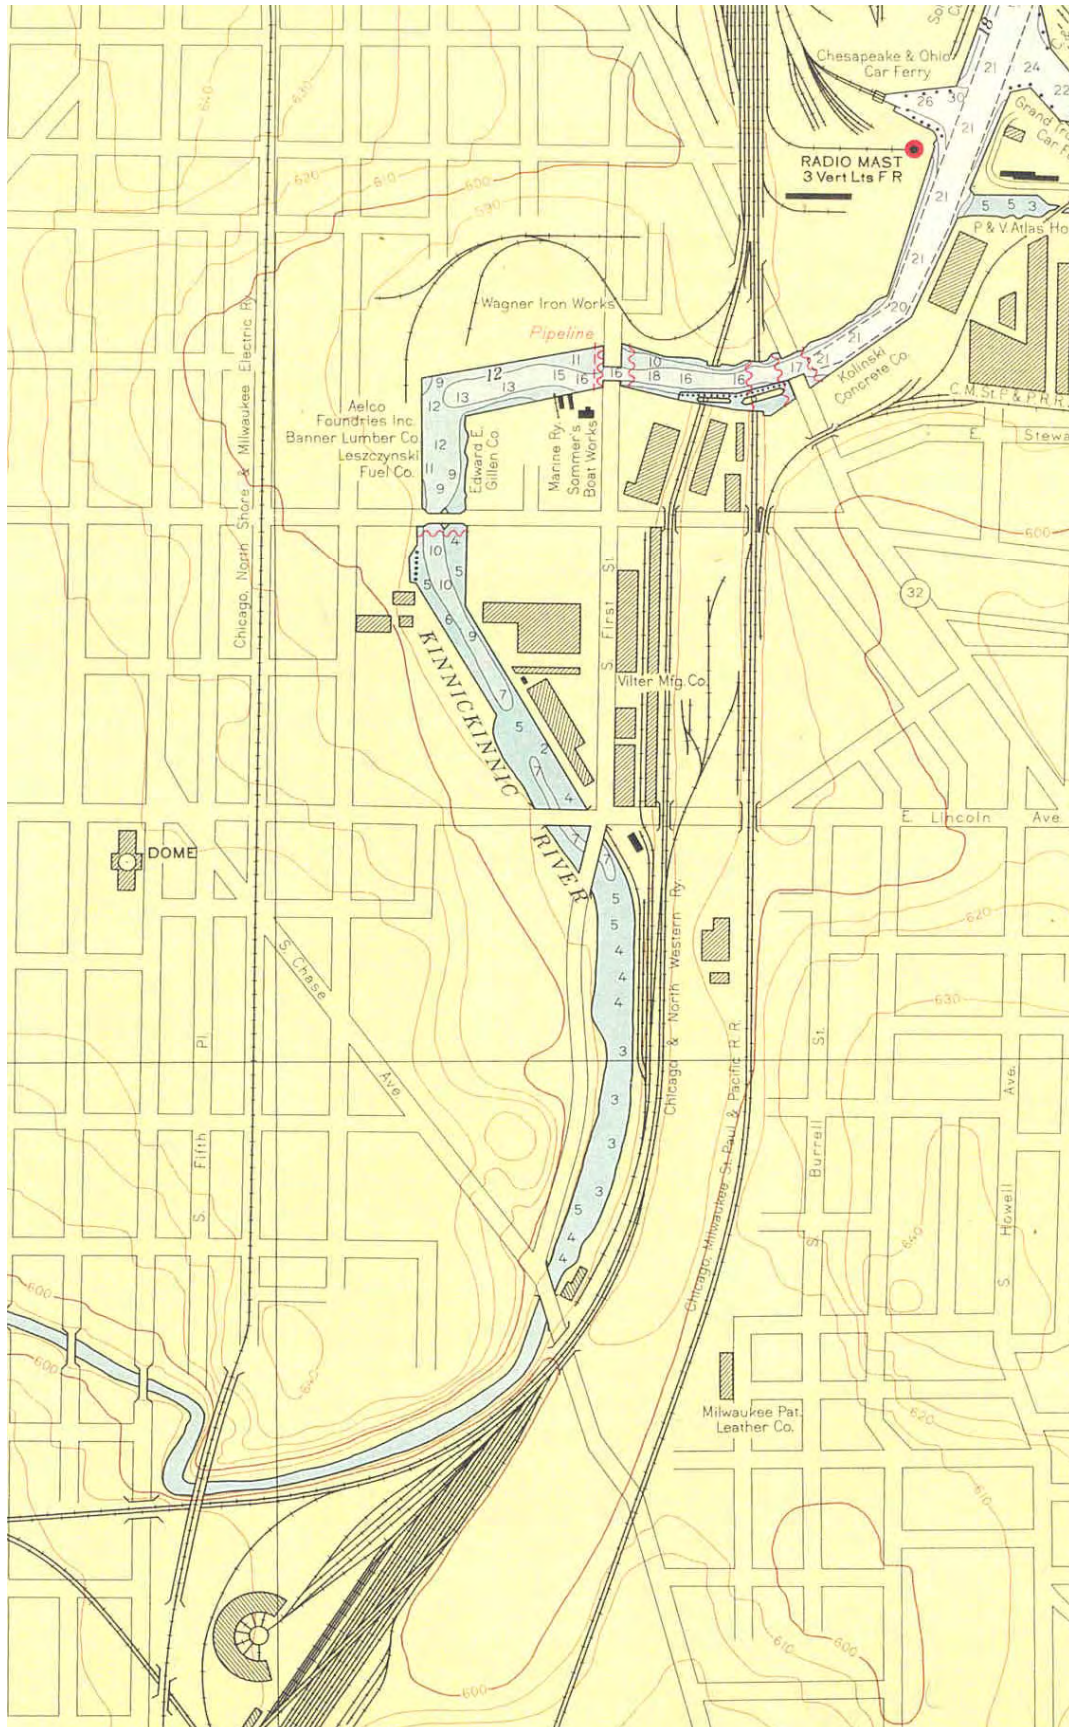
Fig. 9 Sounding data (1960)
