***Concept Design Documentation Report
Kinnickinnic River, Wisconsin
Milwaukee Estuary Area of Concern
Sediment Removal***

***Prepared for
U.S. Army Corps of Engineers
Detroit District***

Kinnickinnic River, Wisconsin Milwaukee Estuary Area of Concern Deepening/Remediation Concept Design Documentation Report

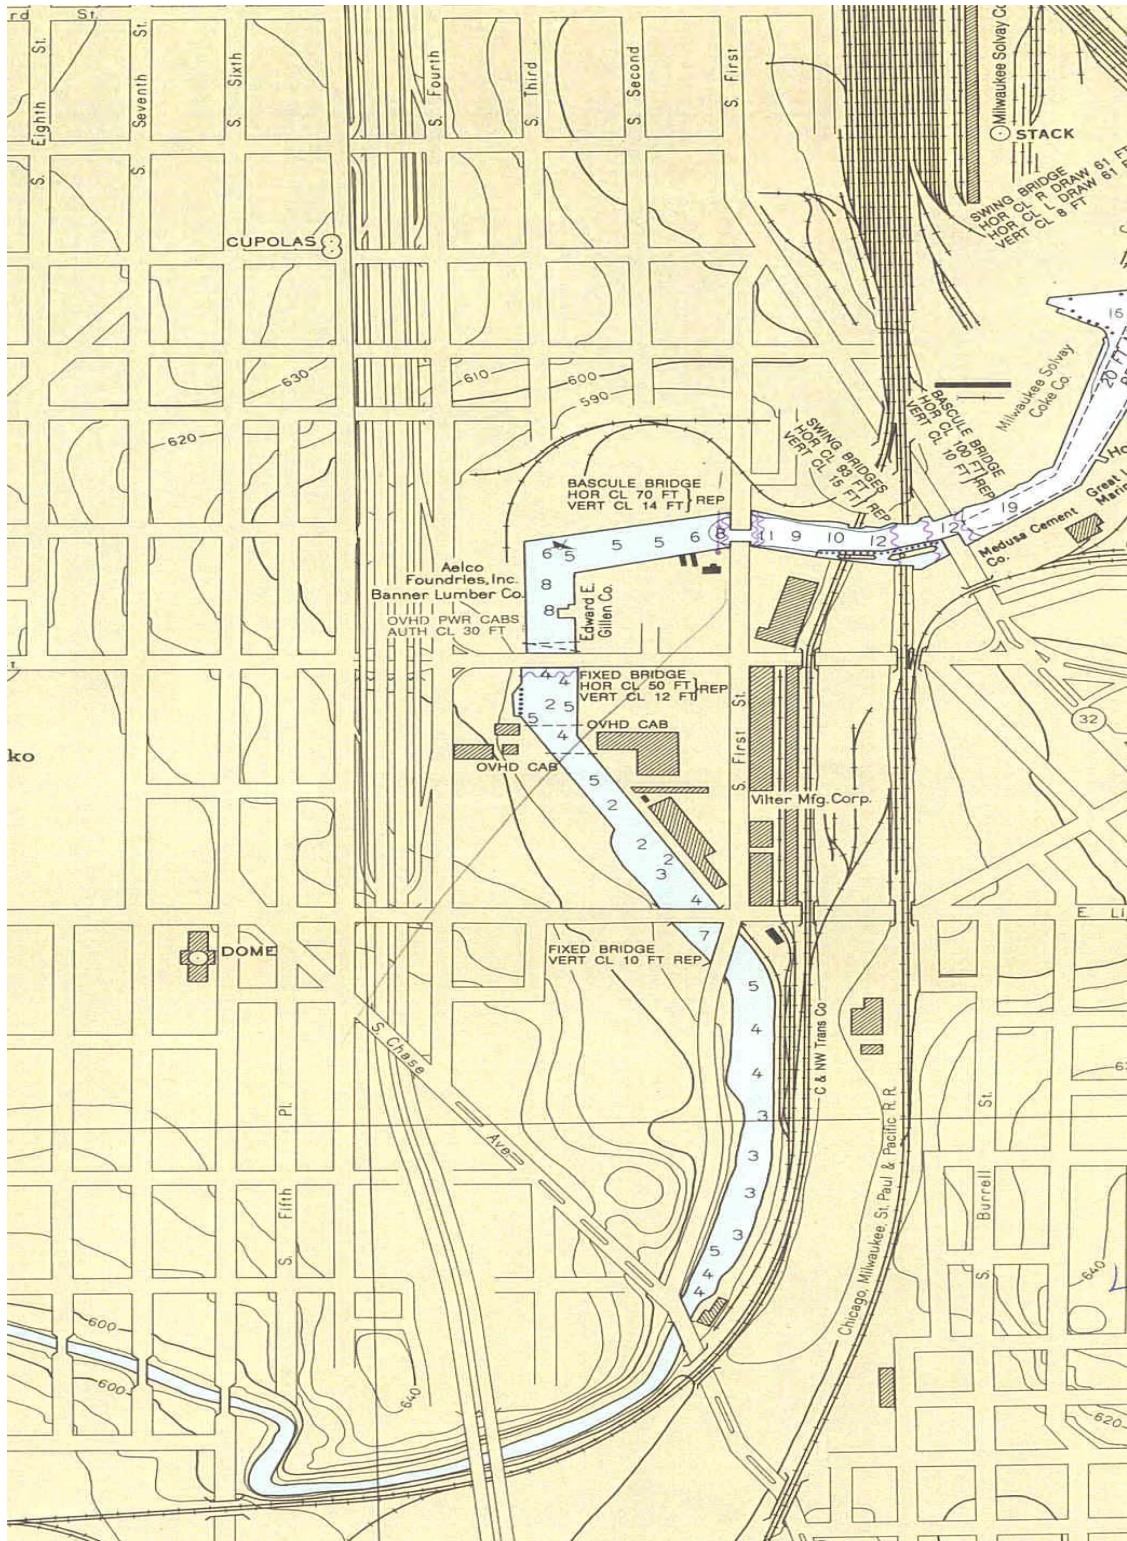
Fig. 10 Sounding data (1978)

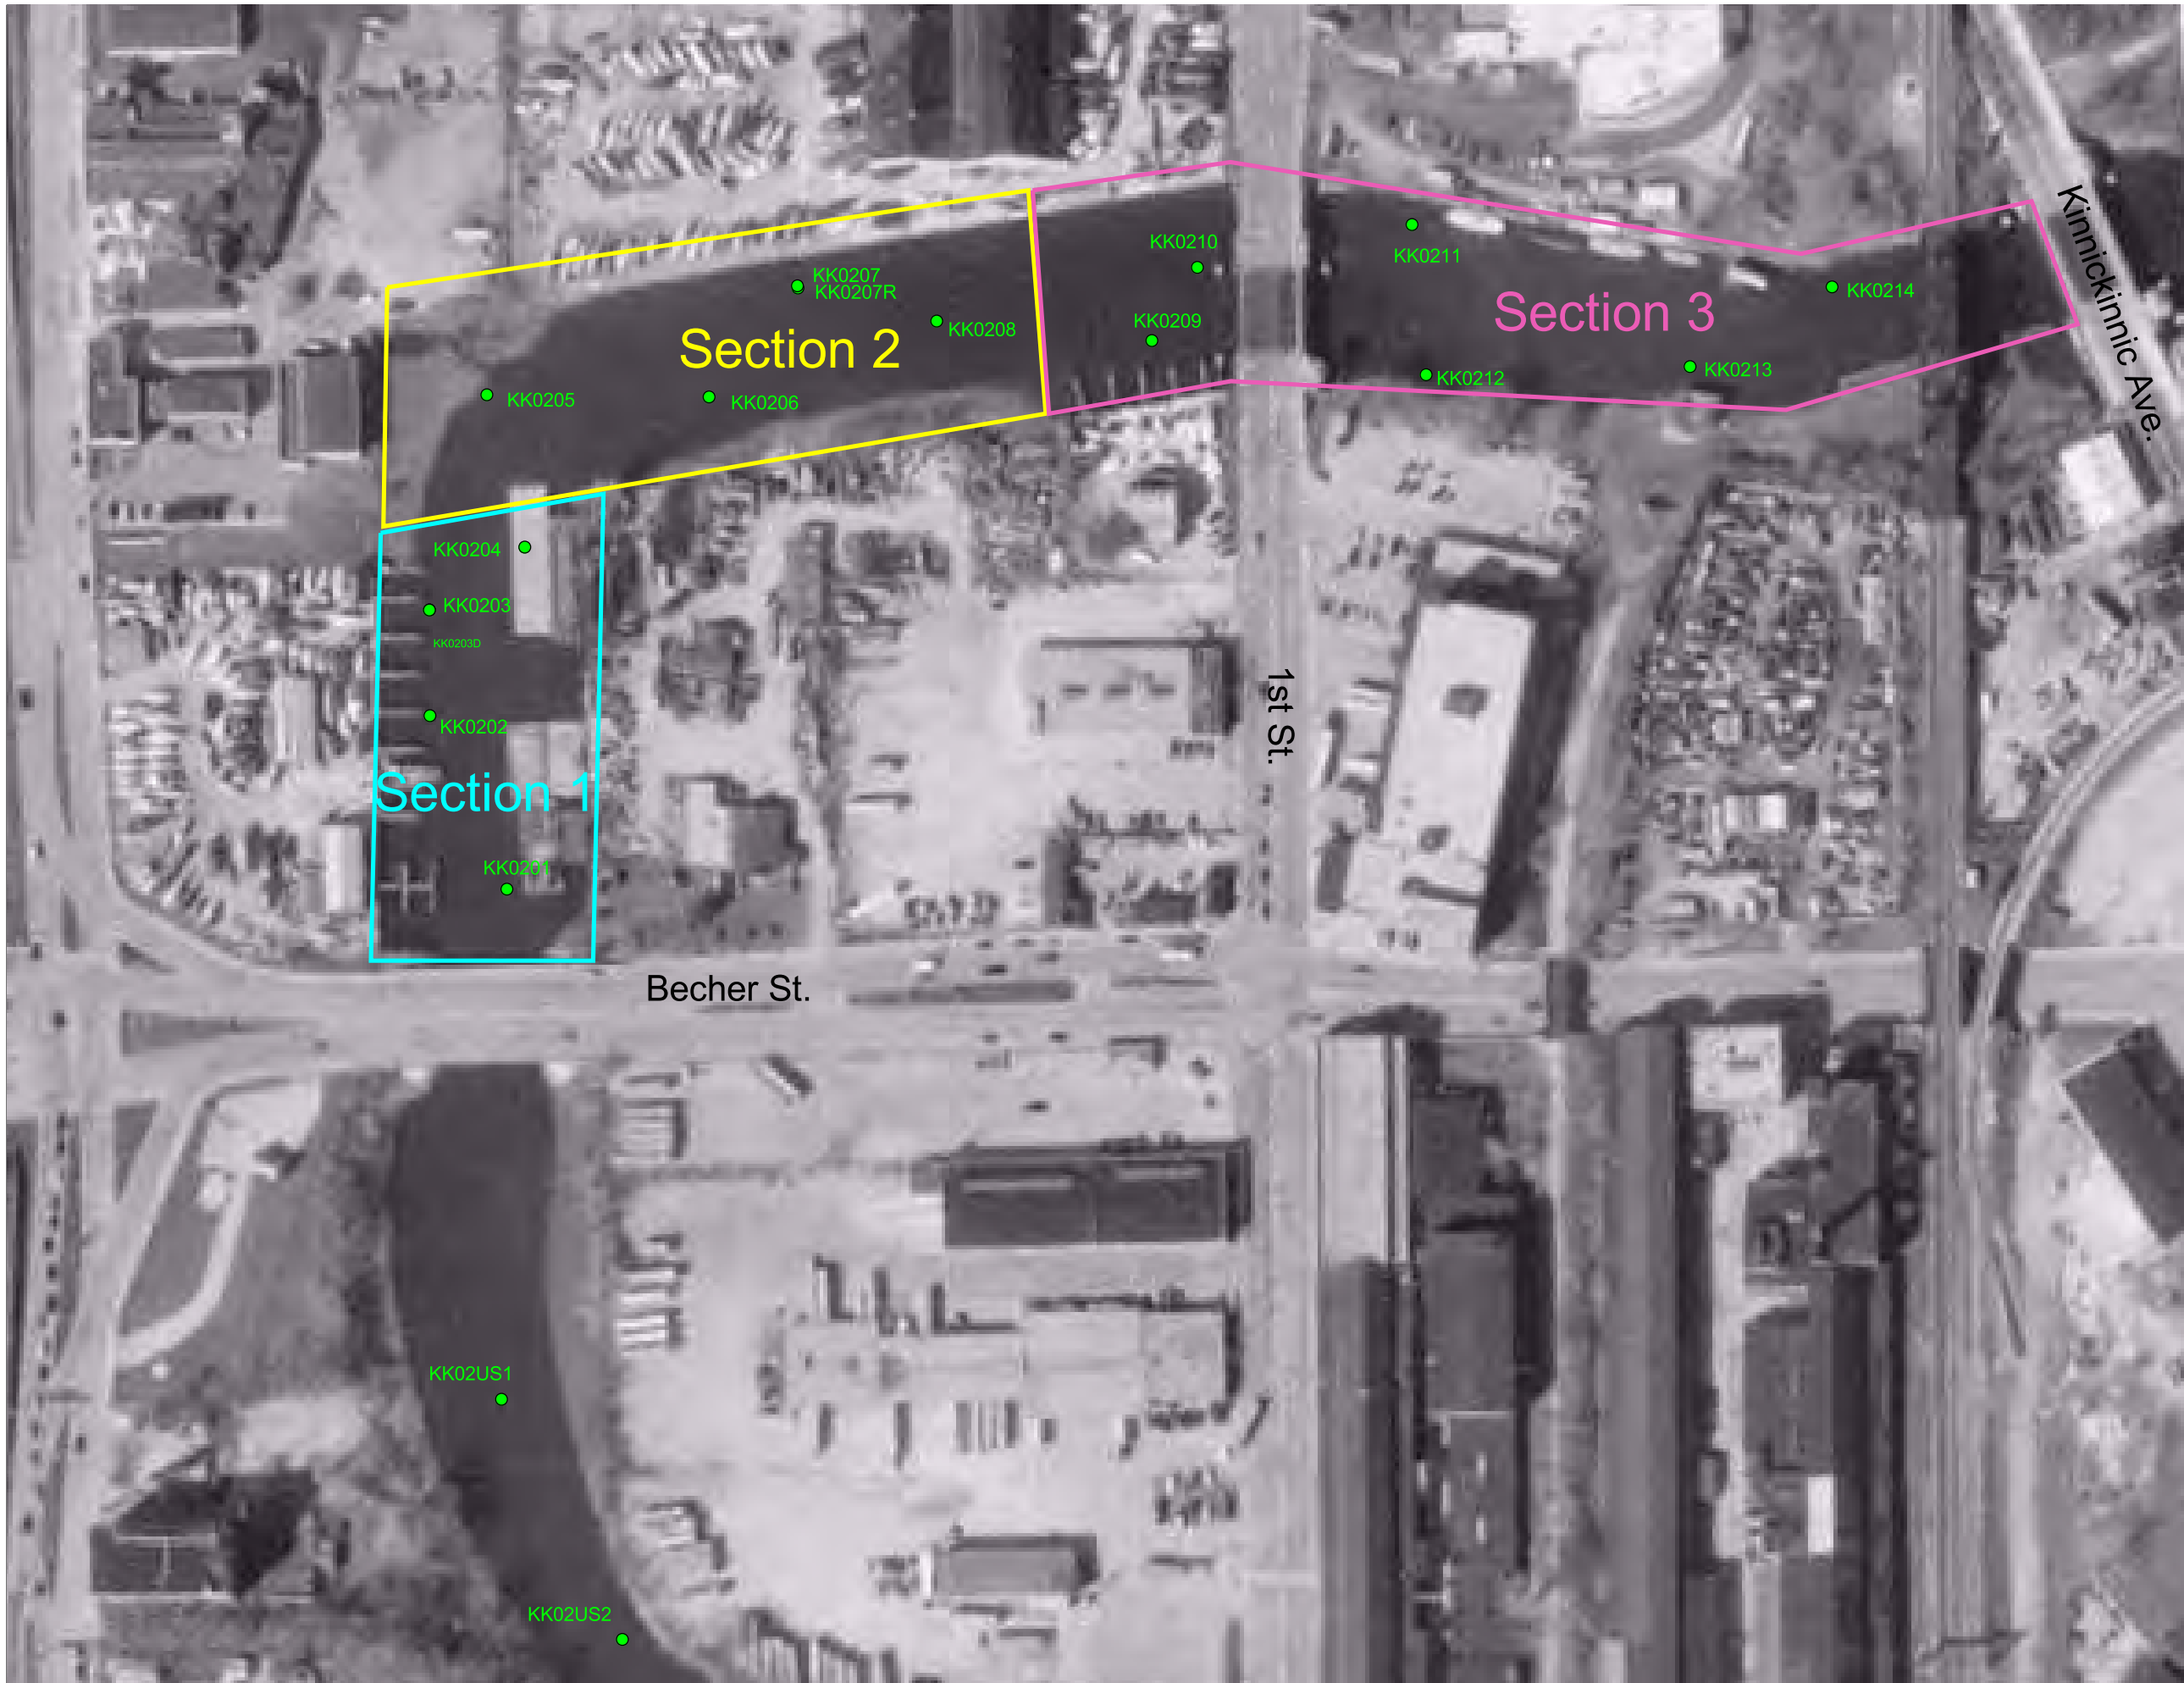
- 2002 Boring Locations
- Section Locations
- Section 1
- Section 2
- Section 3

Figure 2
 Section and Sampling Locations
 Kinnickinnic River
 Sediment Removal Concept Plan
 Milwaukee, WI
