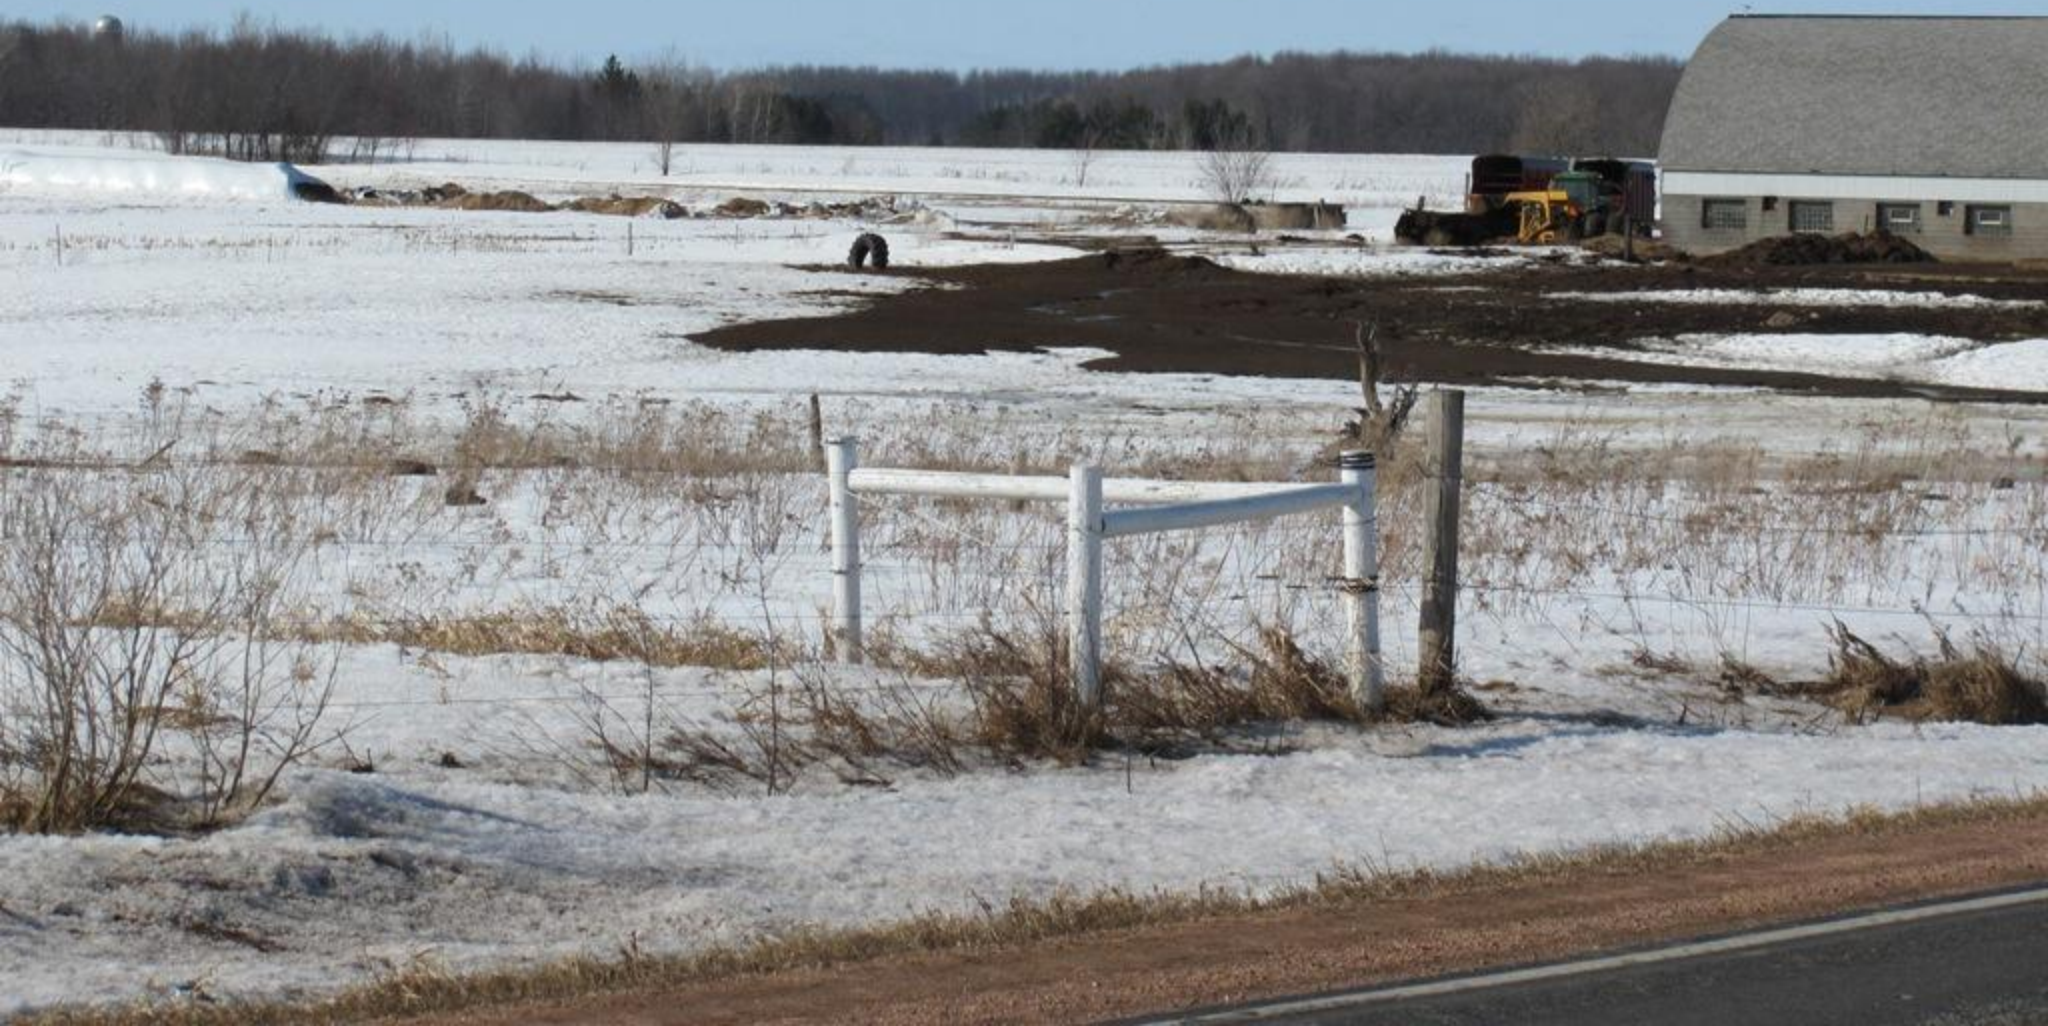
March 18, 2011-photo of Russell Spindler manure storage overflowing and running SE to wetland and channelized flow. Picture was taken from County Road M at SE property corner looking NW.

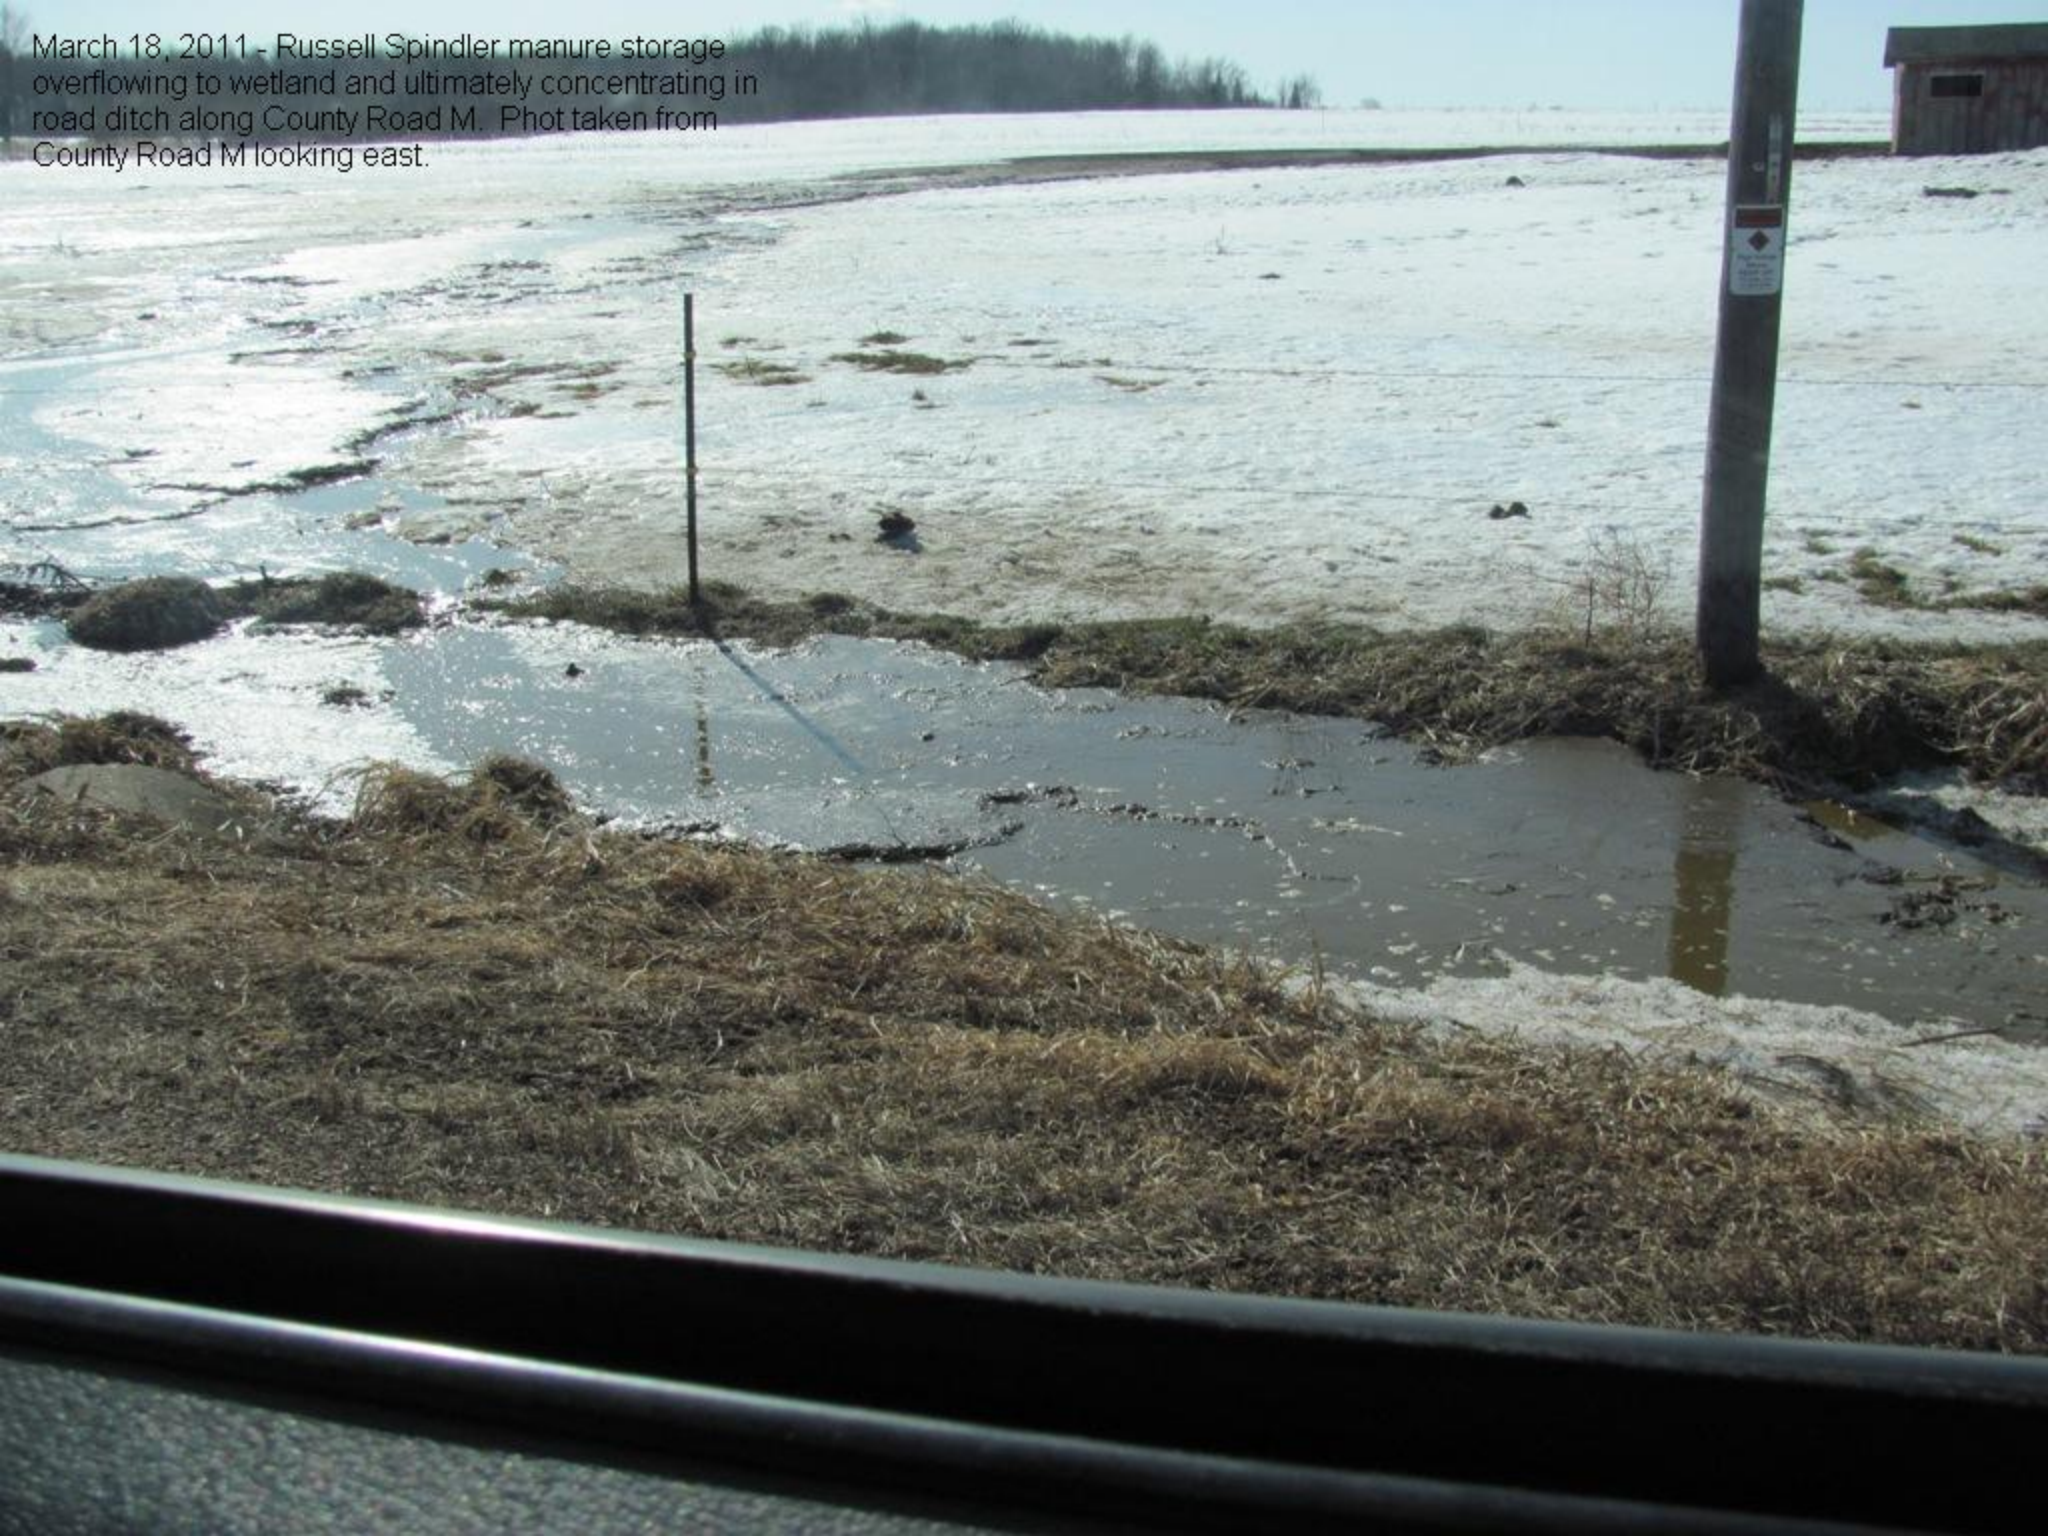
March 18, 2011 - Russell Spindler manure storage overflowing to wetland and ultimately concentrating in road ditch along County Road M. Phot taken from County Road M looking east.

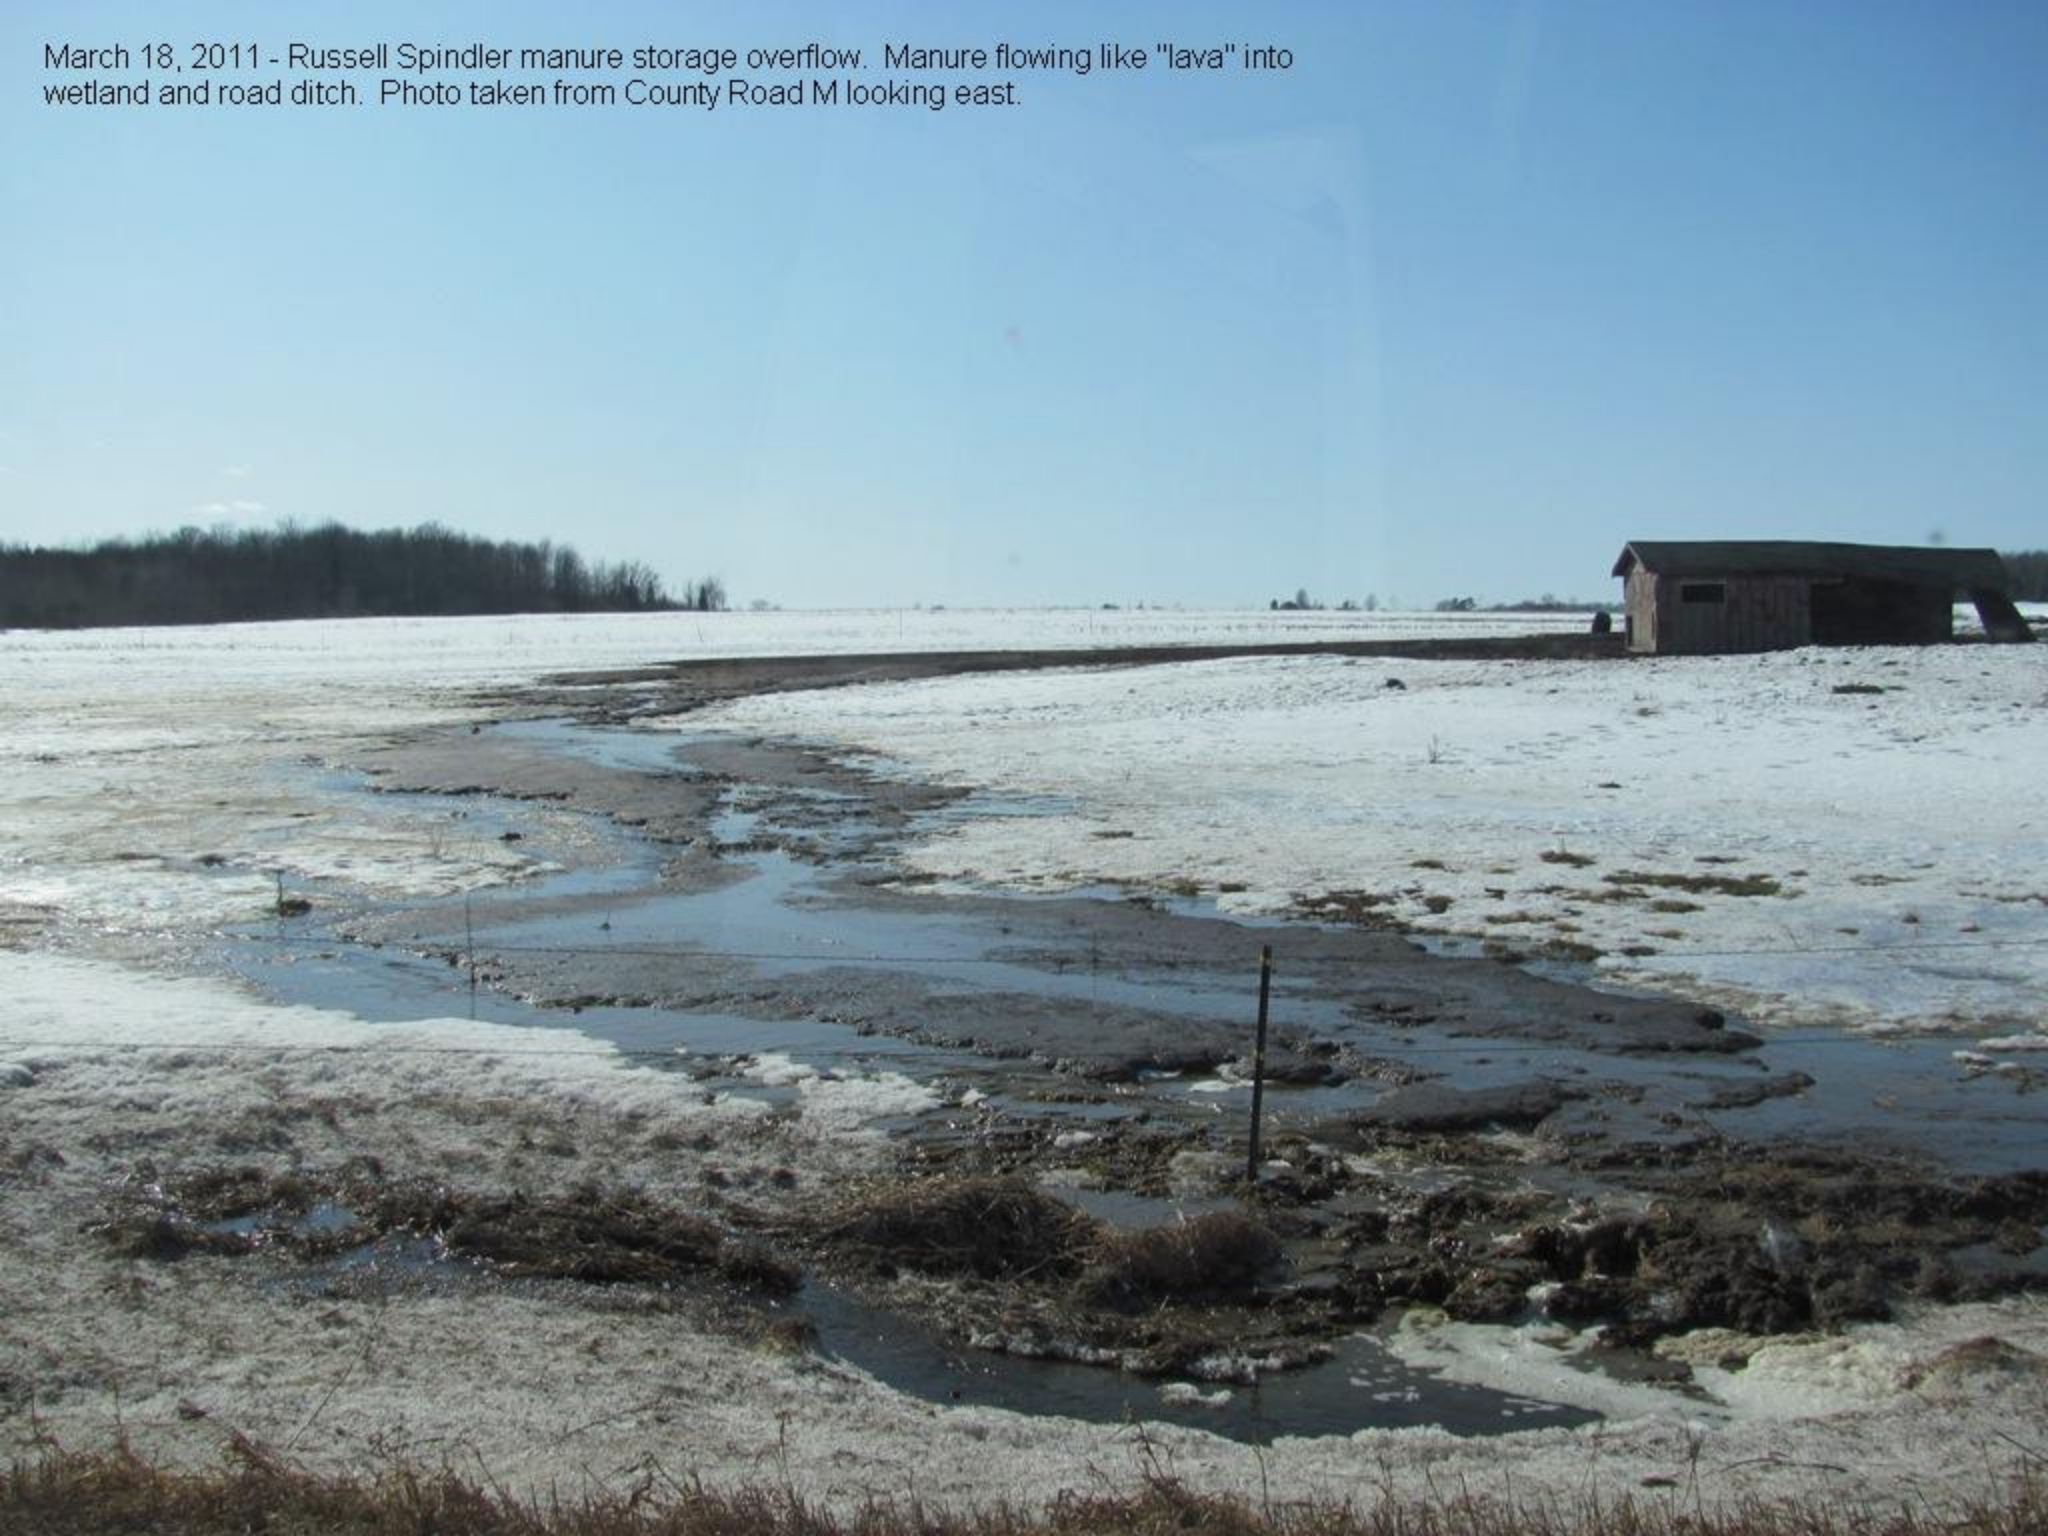
March 18, 2011 - Russell Spindler manure storage overflow. Manure flowing like "lava" into wetland and road ditch. Photo taken from County Road M looking east.

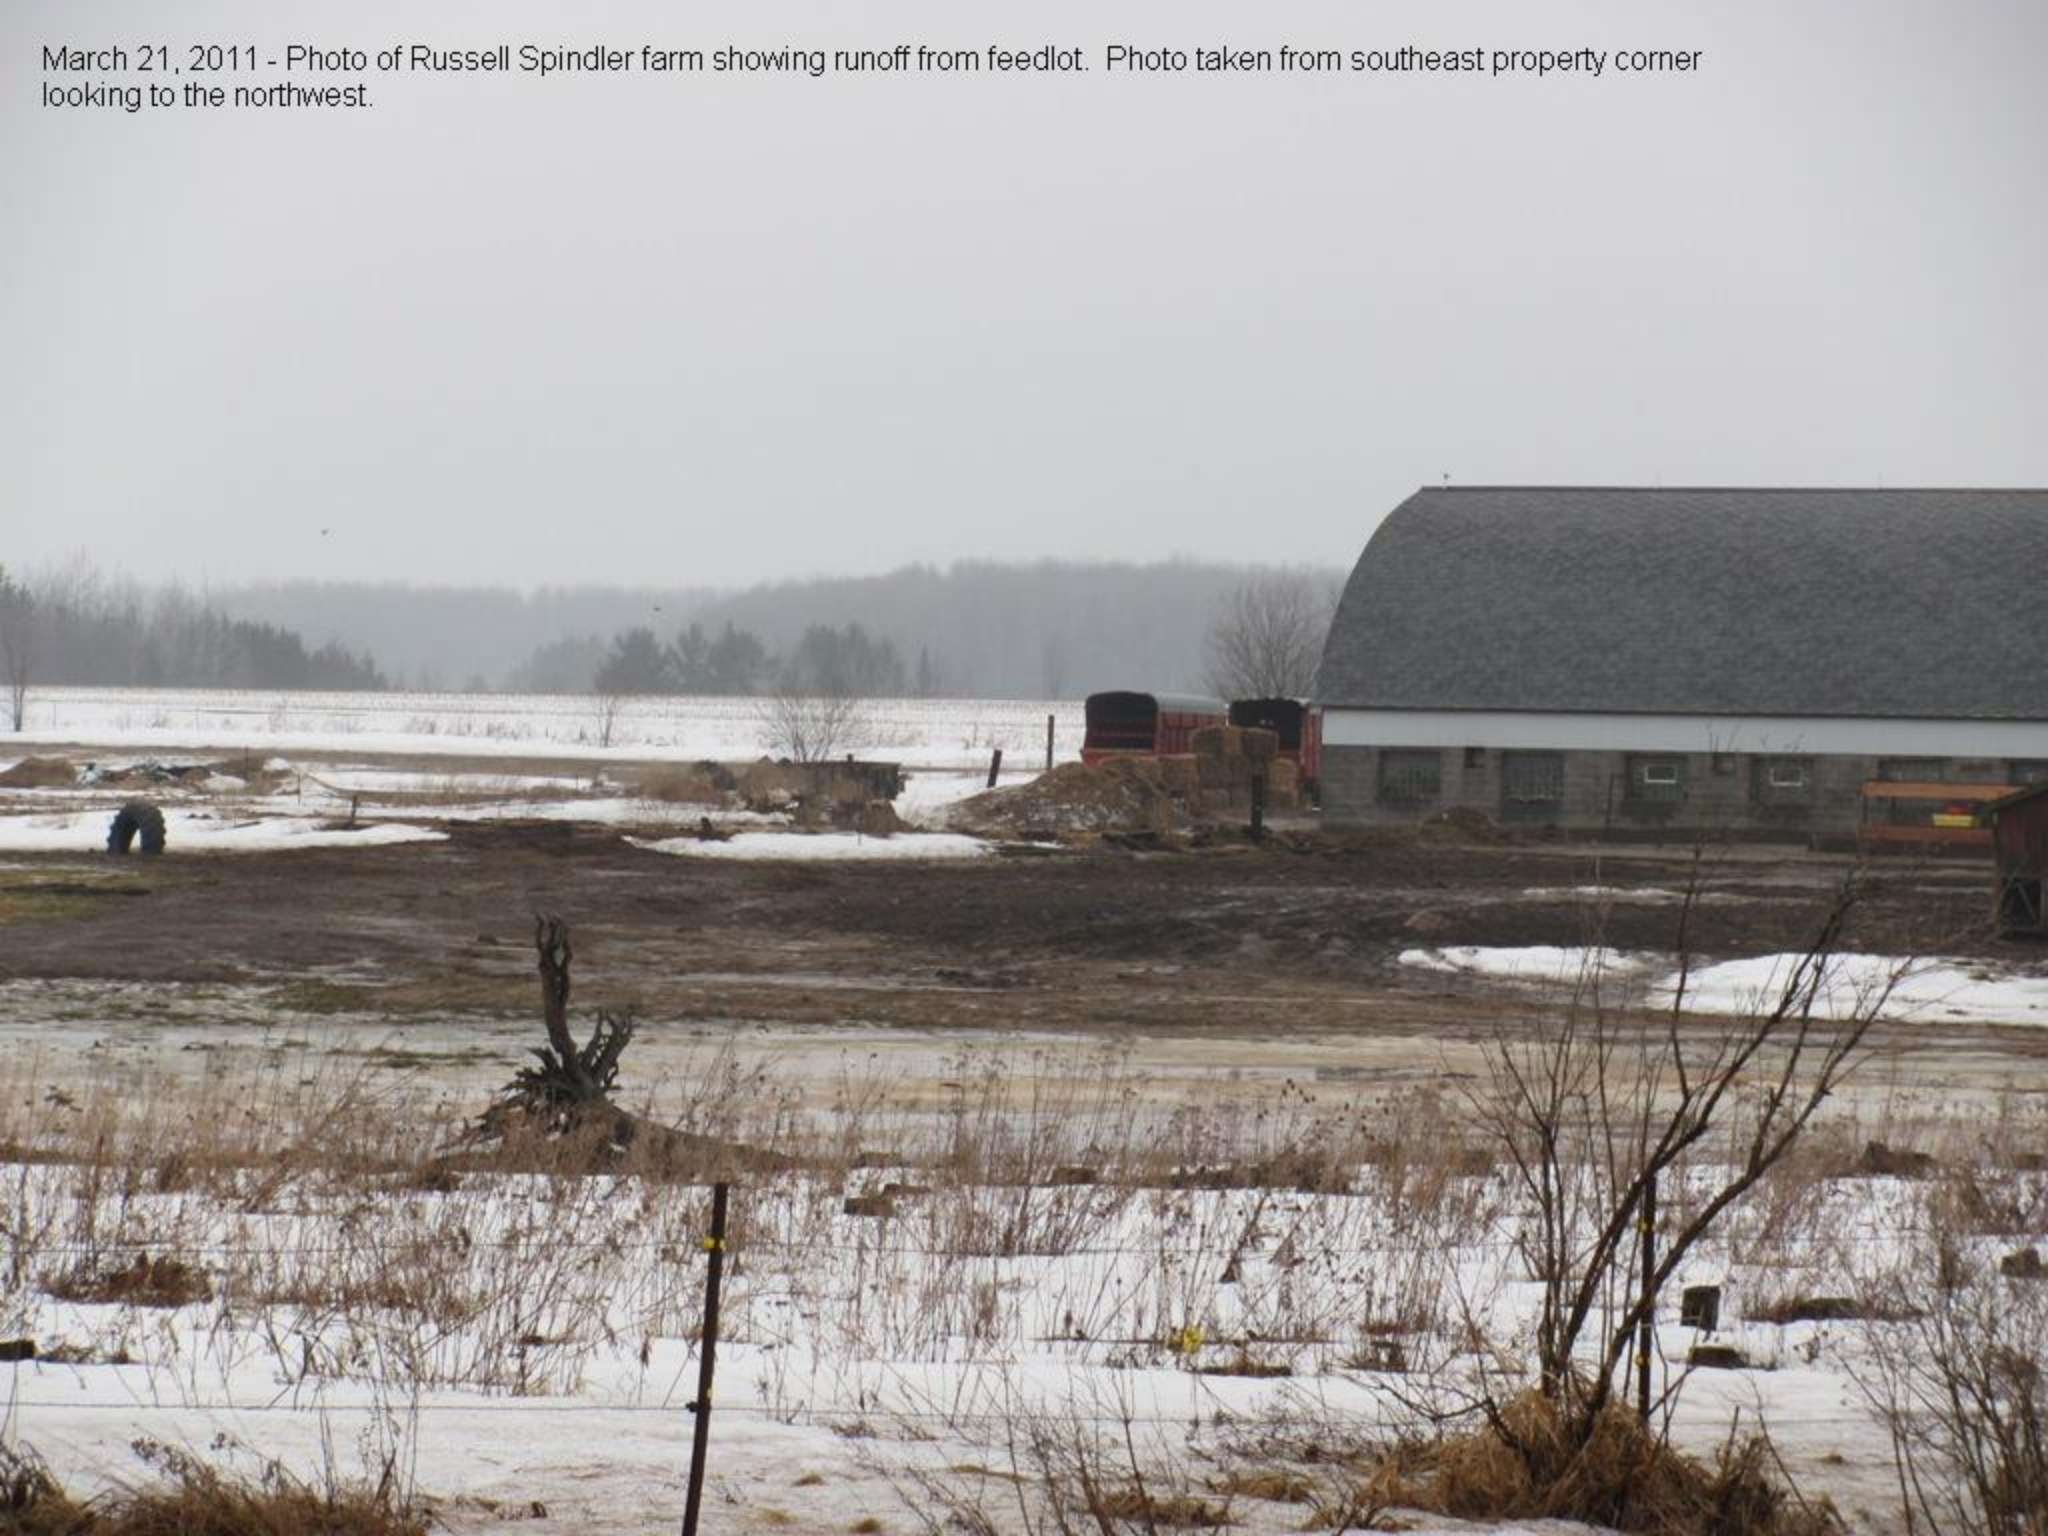
March 21, 2011 - Photo of Russell Spindler farm showing runoff from feedlot. Photo taken from southeast property corner looking to the northwest.

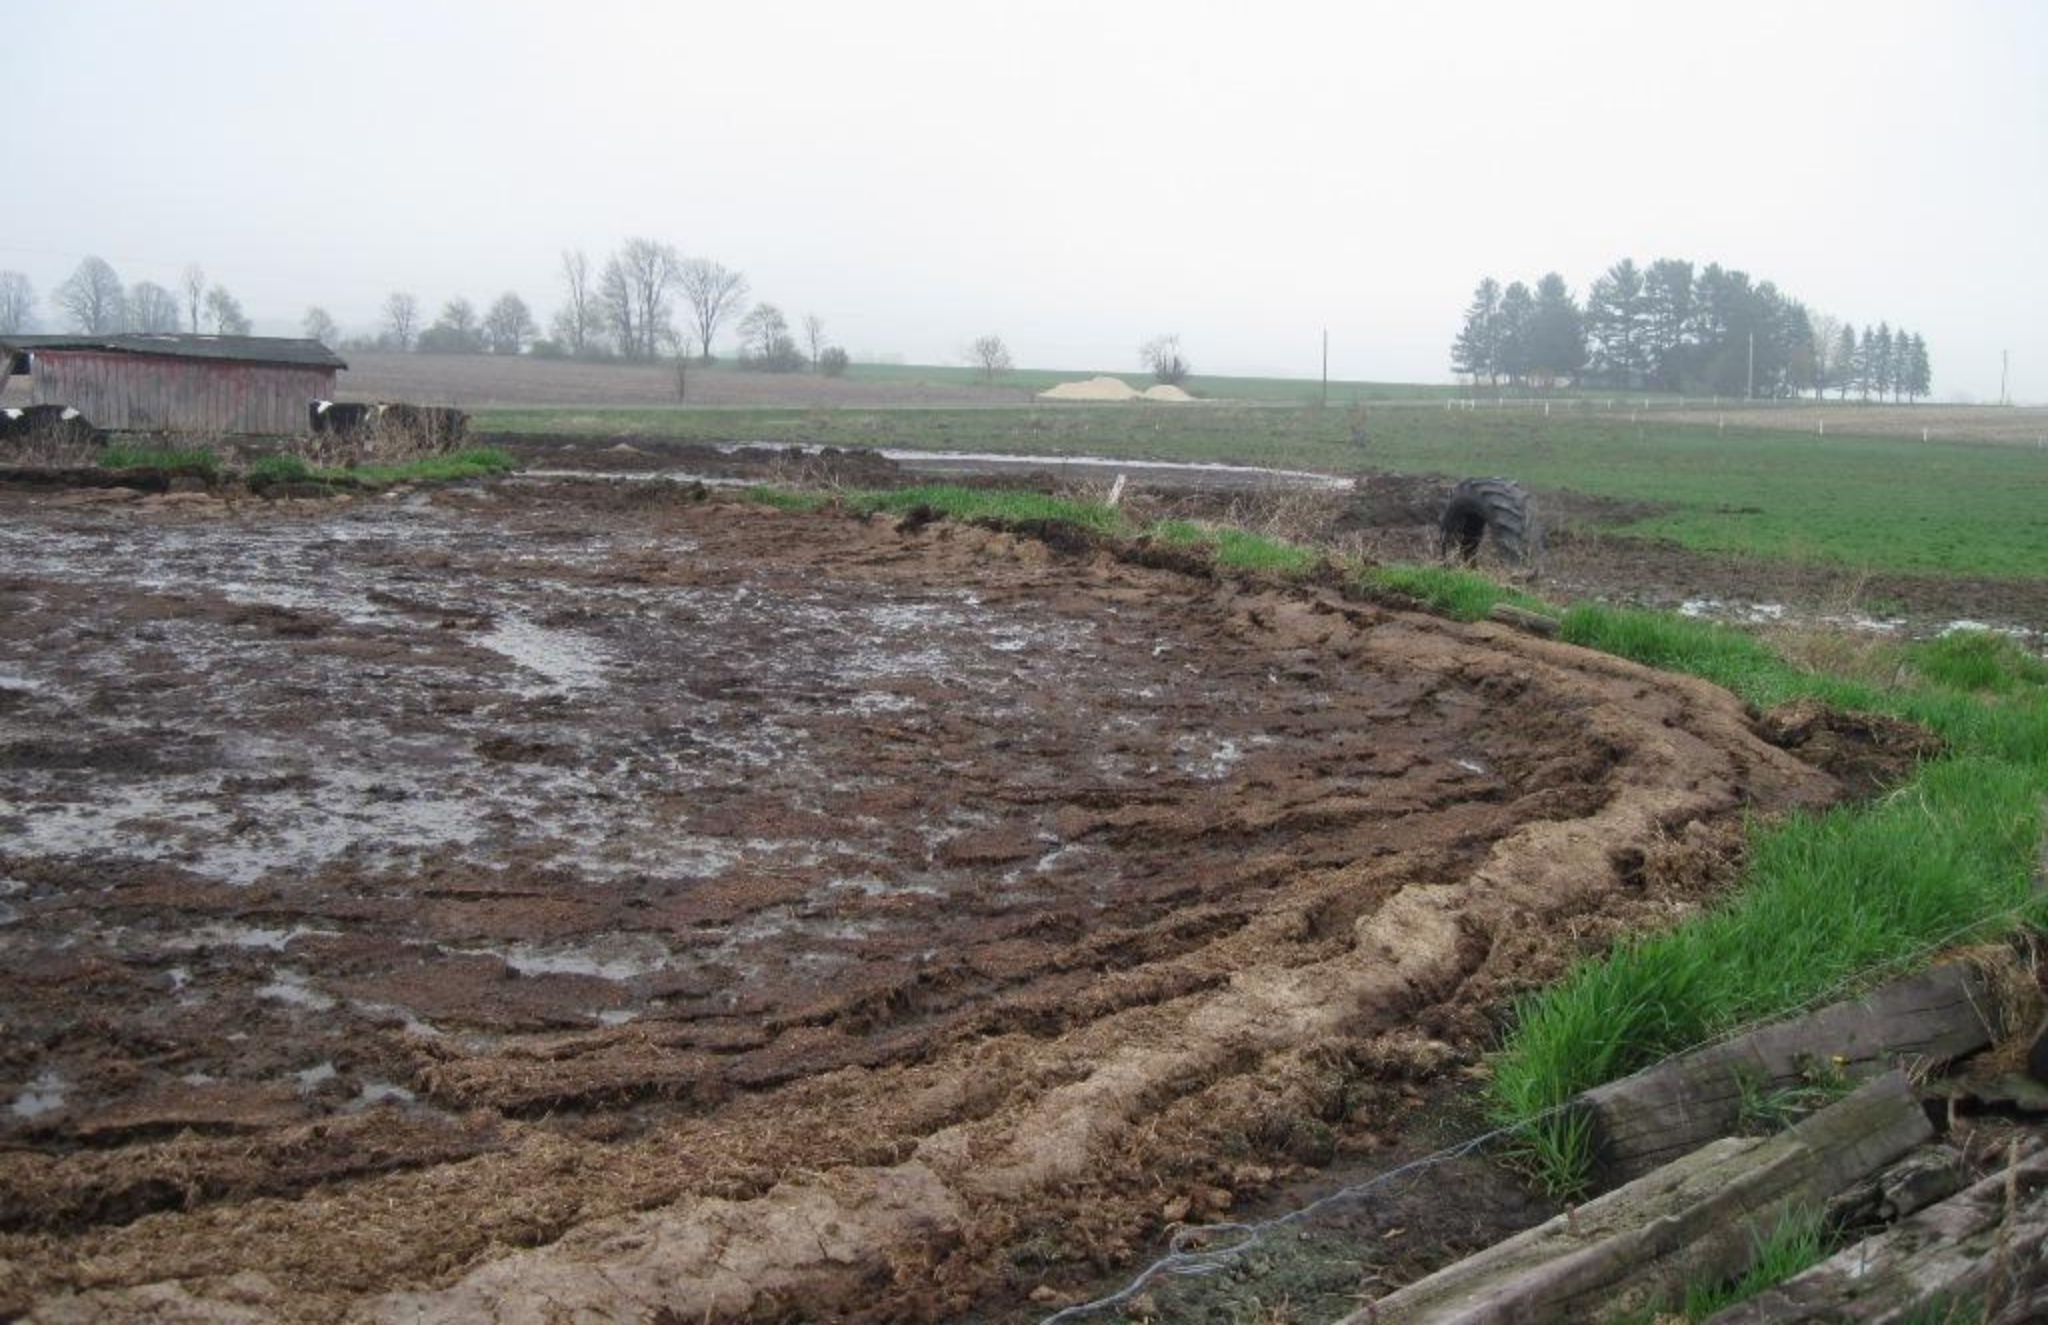
May 12, 2011-Russell Spindler manure storage facility at maximum capacity and overflowing again. If you look closely you can see a second "storage" facility has been constructed to catch manure that began flowing out of the pit for the second time this year. Photo was taken from the northwest corner of the existing manure storage facility looking to the southeast.

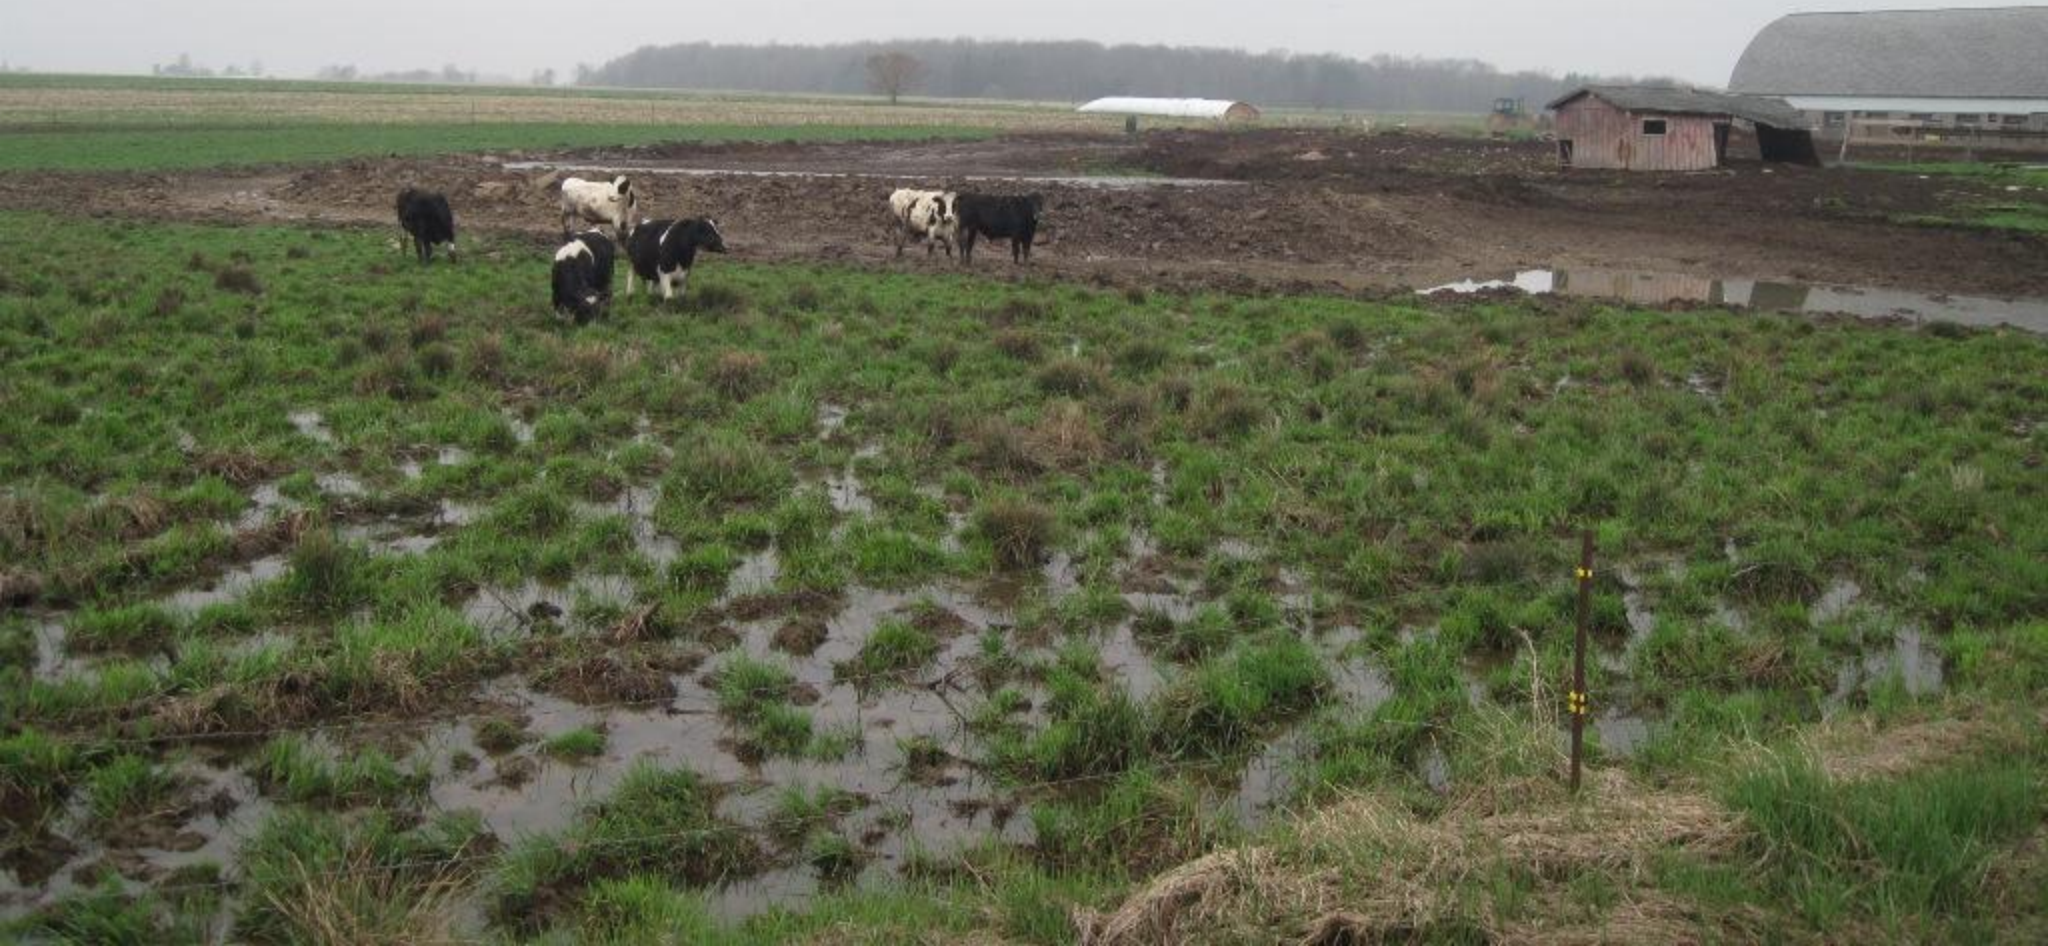
May 12, 2011-Russell Spindler farm. Picture of collection basin construct to catch manure flowing out of the manure storage facility. Basin is at capacity immediately after it was constructed. Photo taken from County Road M looking to the northwest.

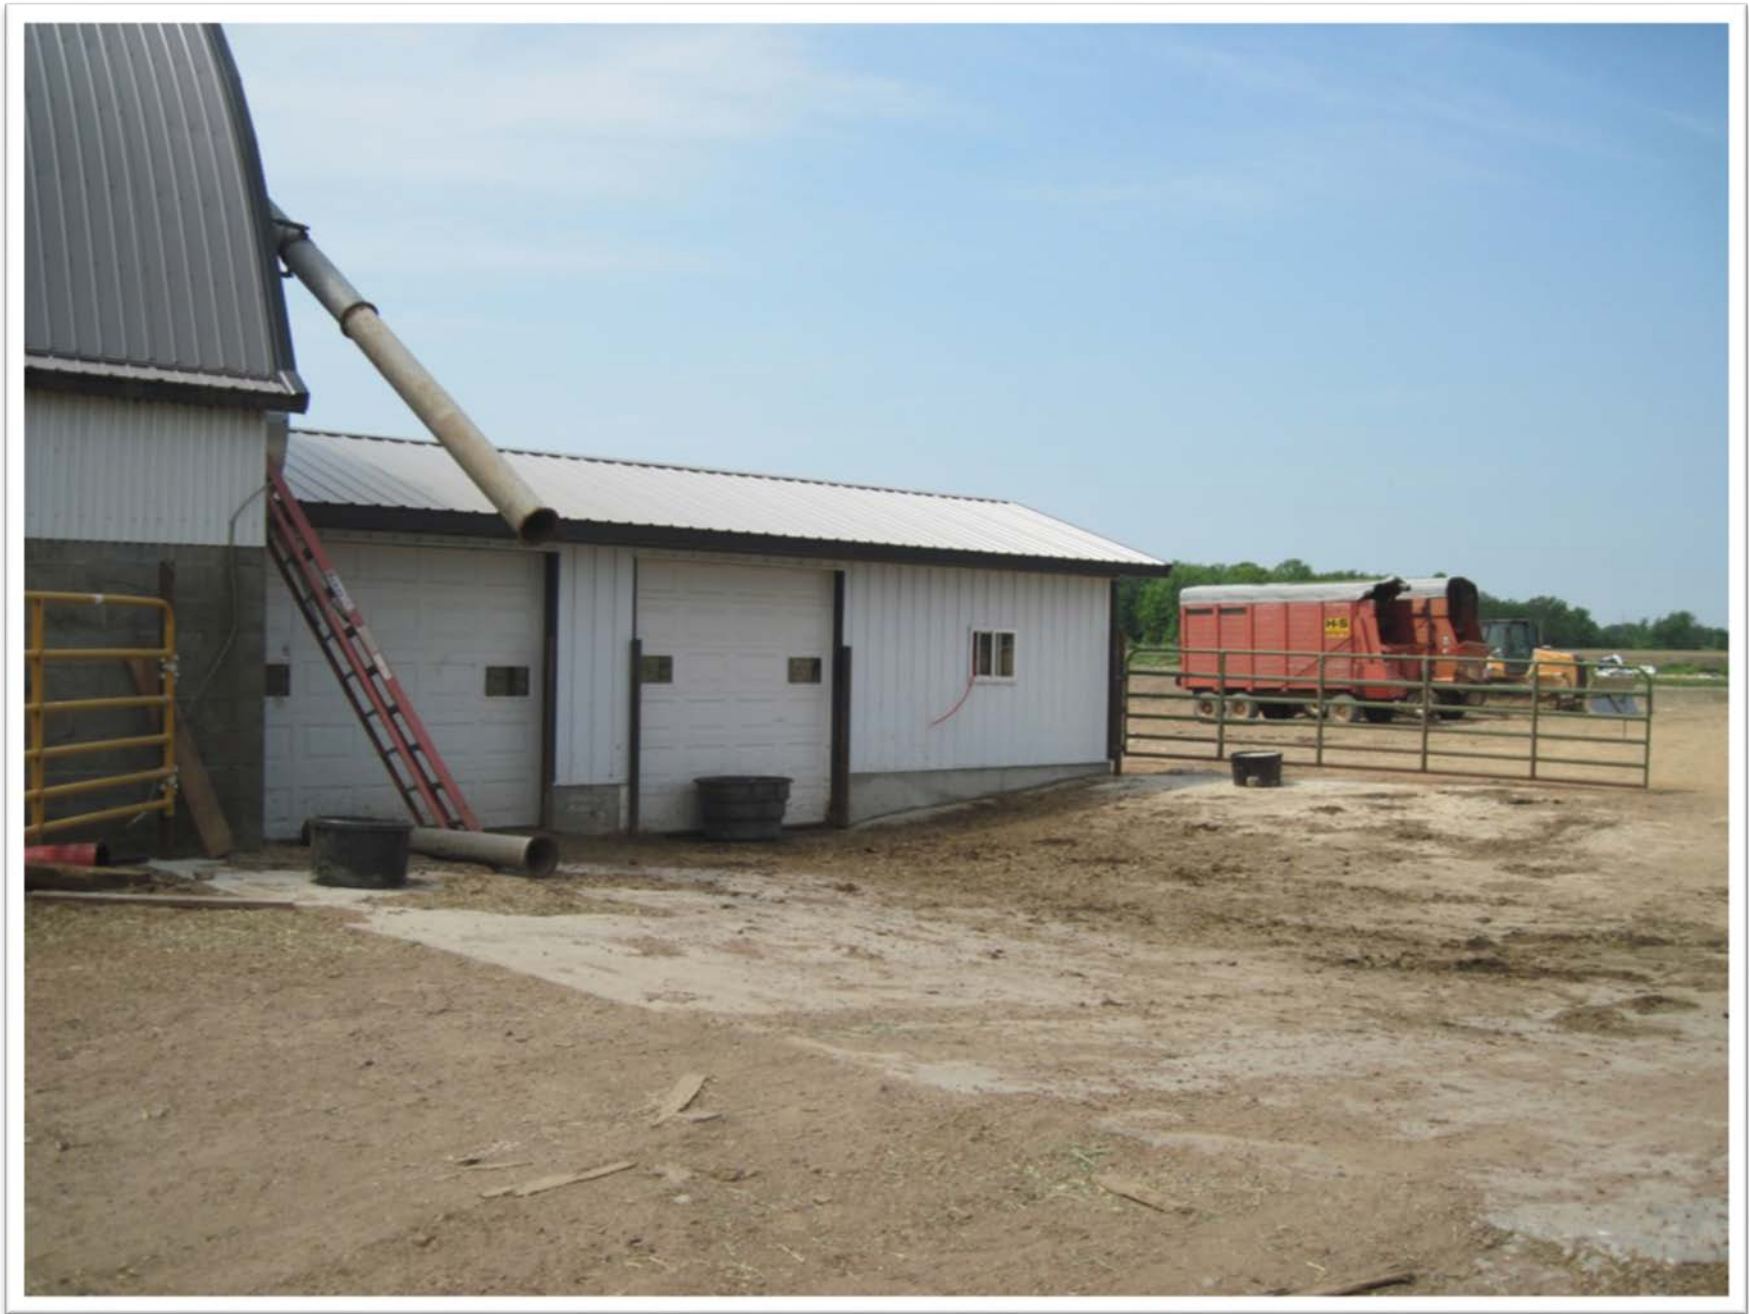
May 24, 2012 – Standing on the north side of the barn looking southwest at the machinery crossing installed to carry feedlot runoff water from the heifer/dry cow lot to the manure storage transfer so that it can be pumped to the manure storage facility.

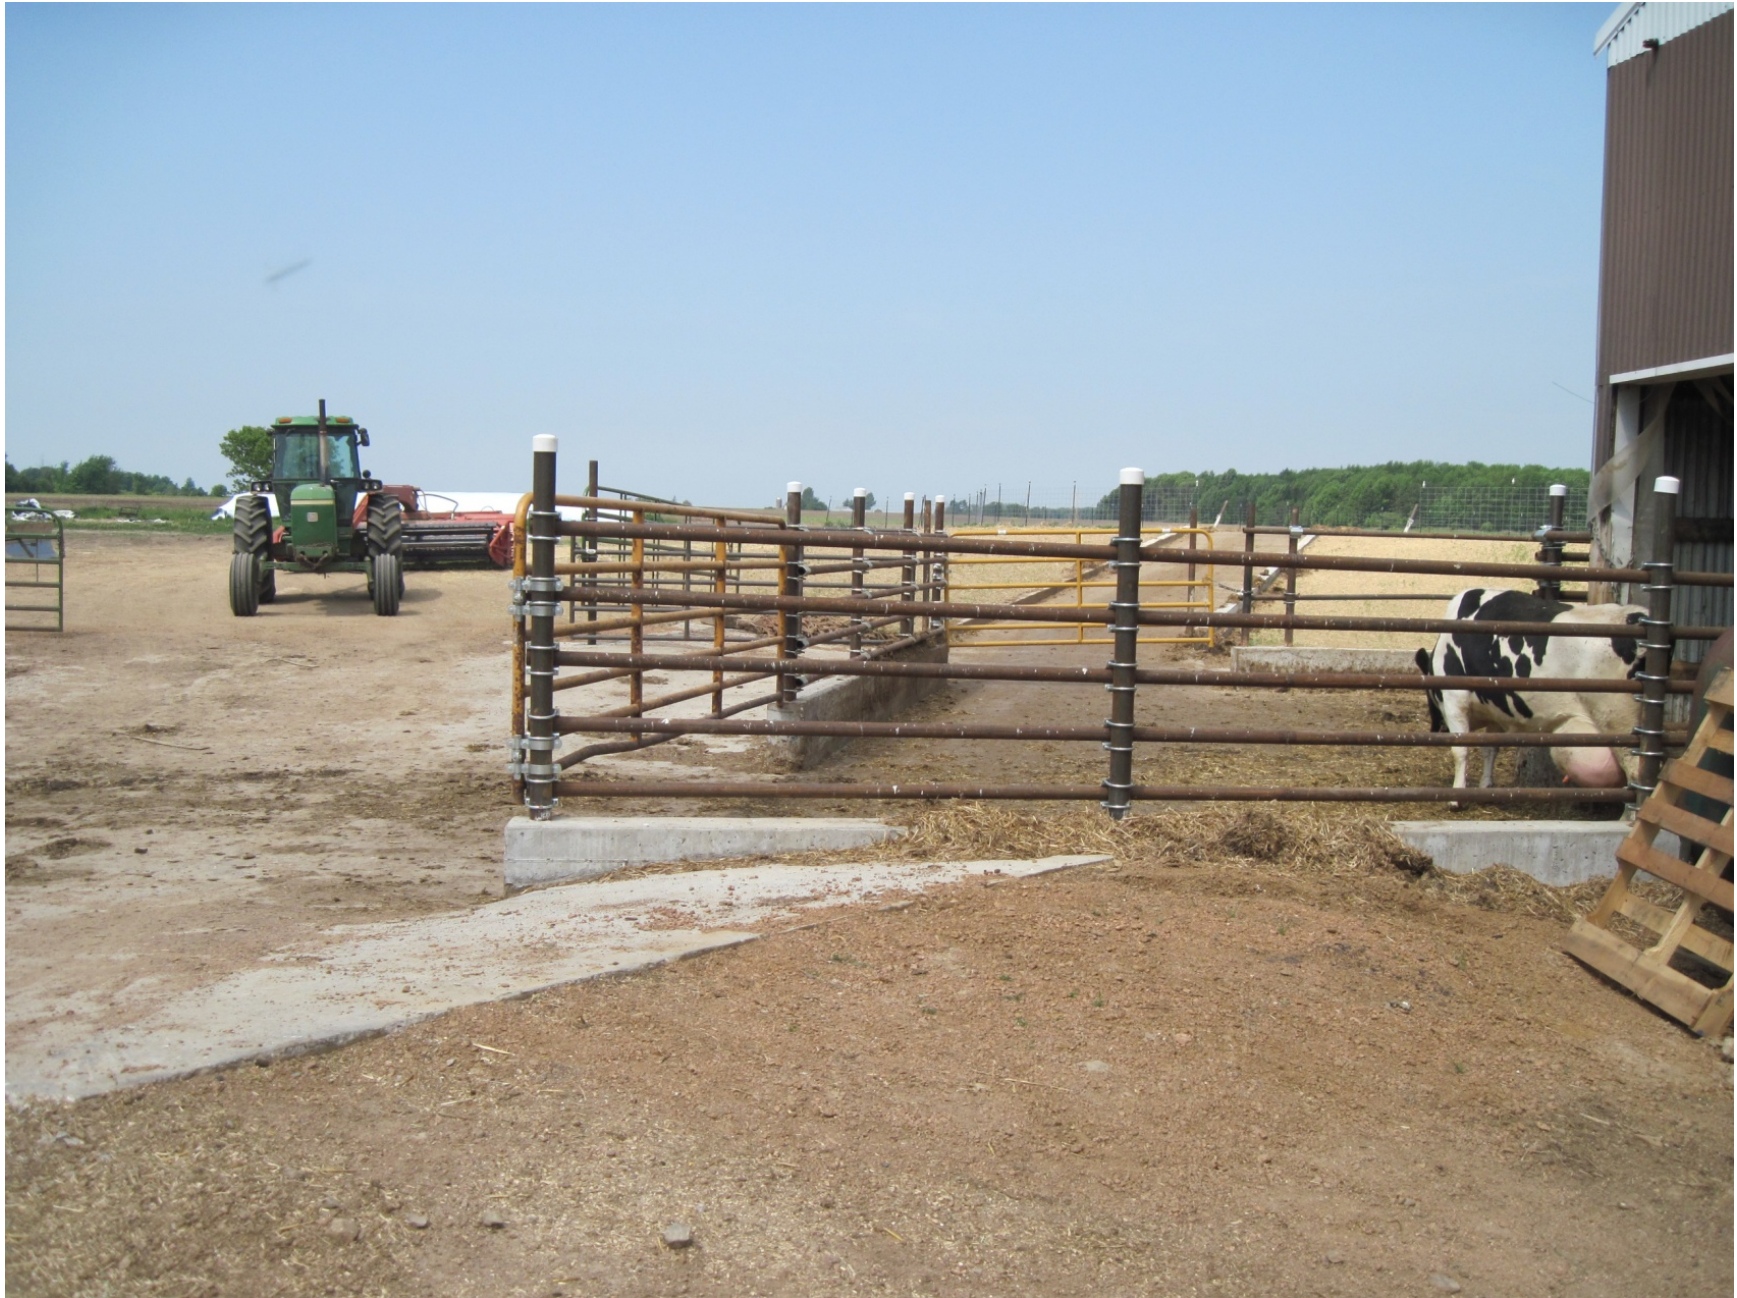
May 24, 2012 – Standing on the north side of the barn looking west at the machinery crossing where it meets the dry cow/heifer lot. You can also see the ramp to scrape solids into the manure storage facility.
