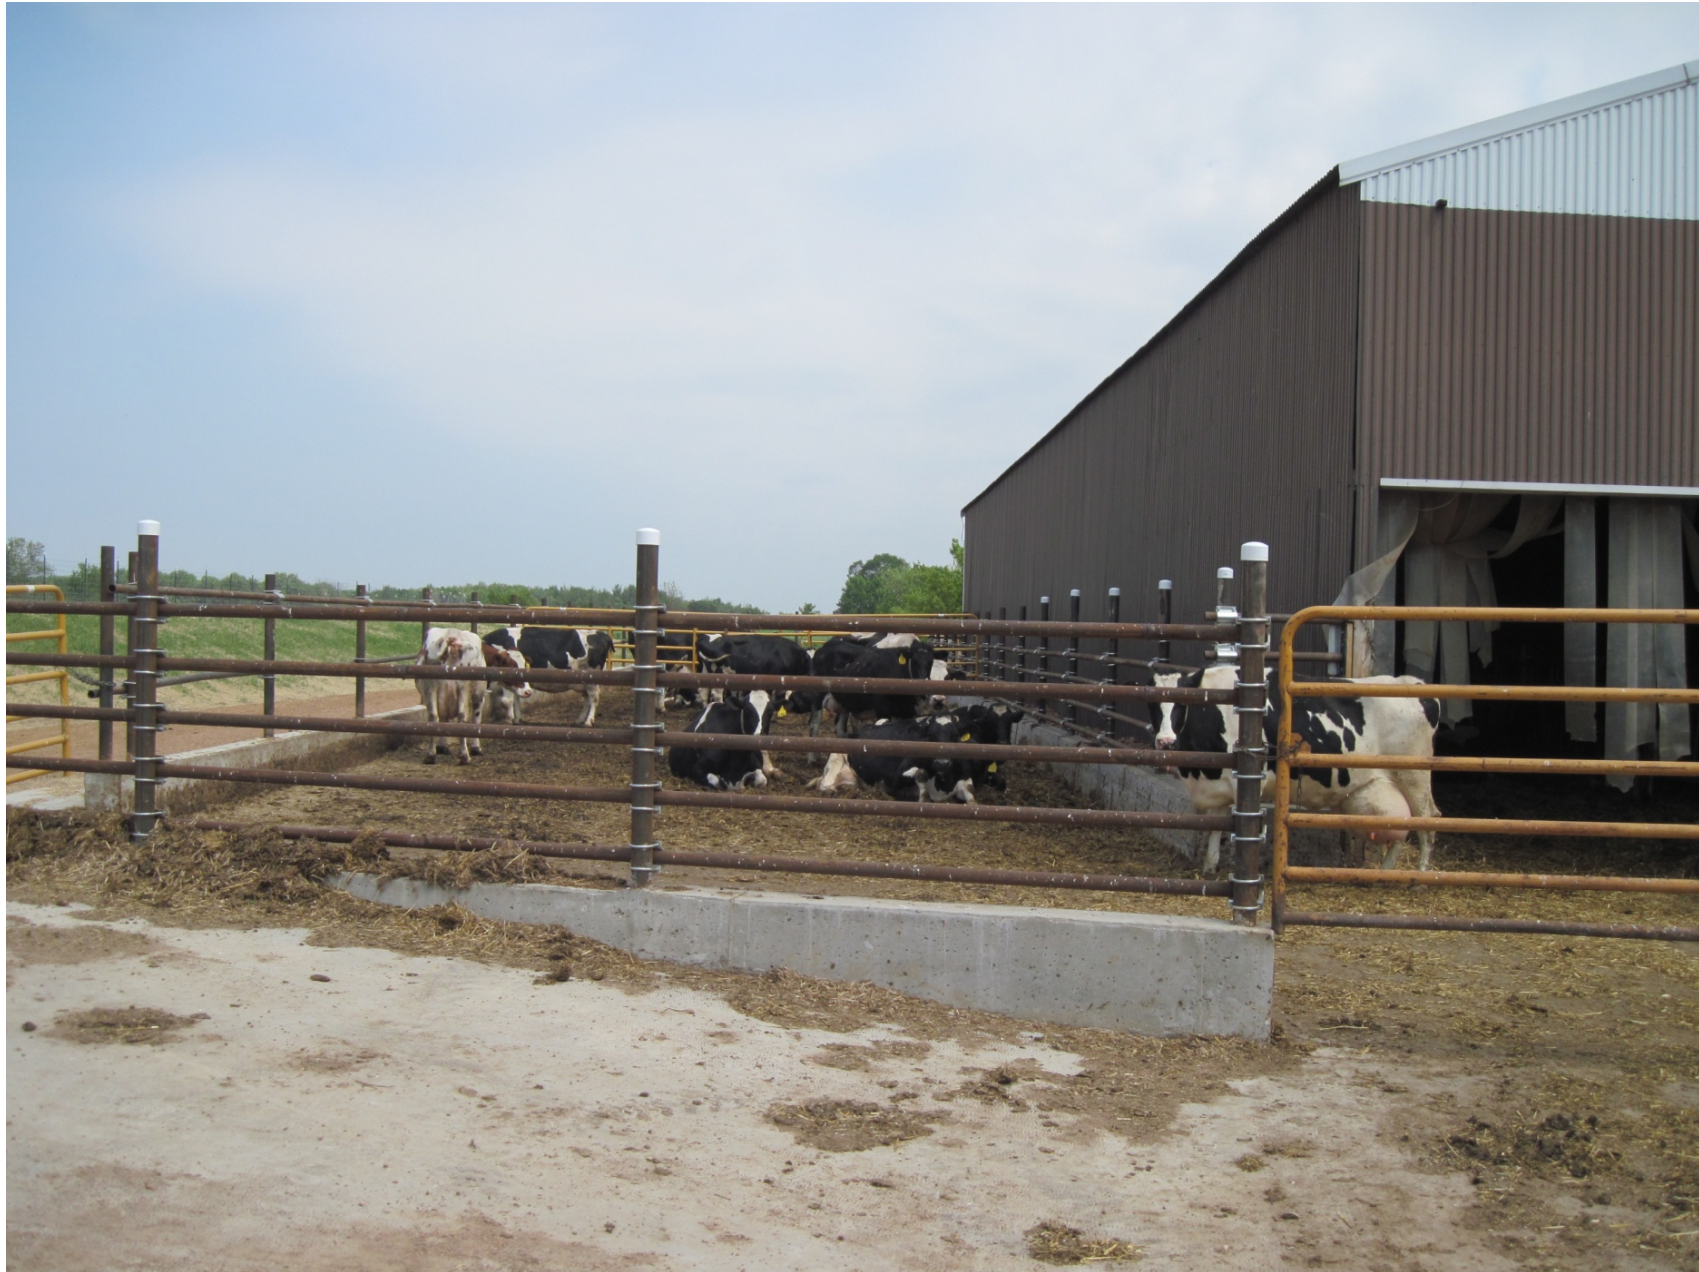
May 24, 2012 – Standing on the machinery crossing on the southwest side of the of the dry cow/heifer lot looking north. You can see between the east wall of the lot and the west side of the building there is a tiled rock envelop designed to catch any roof runoff and transport it underground to the waterway north of the machine shed.

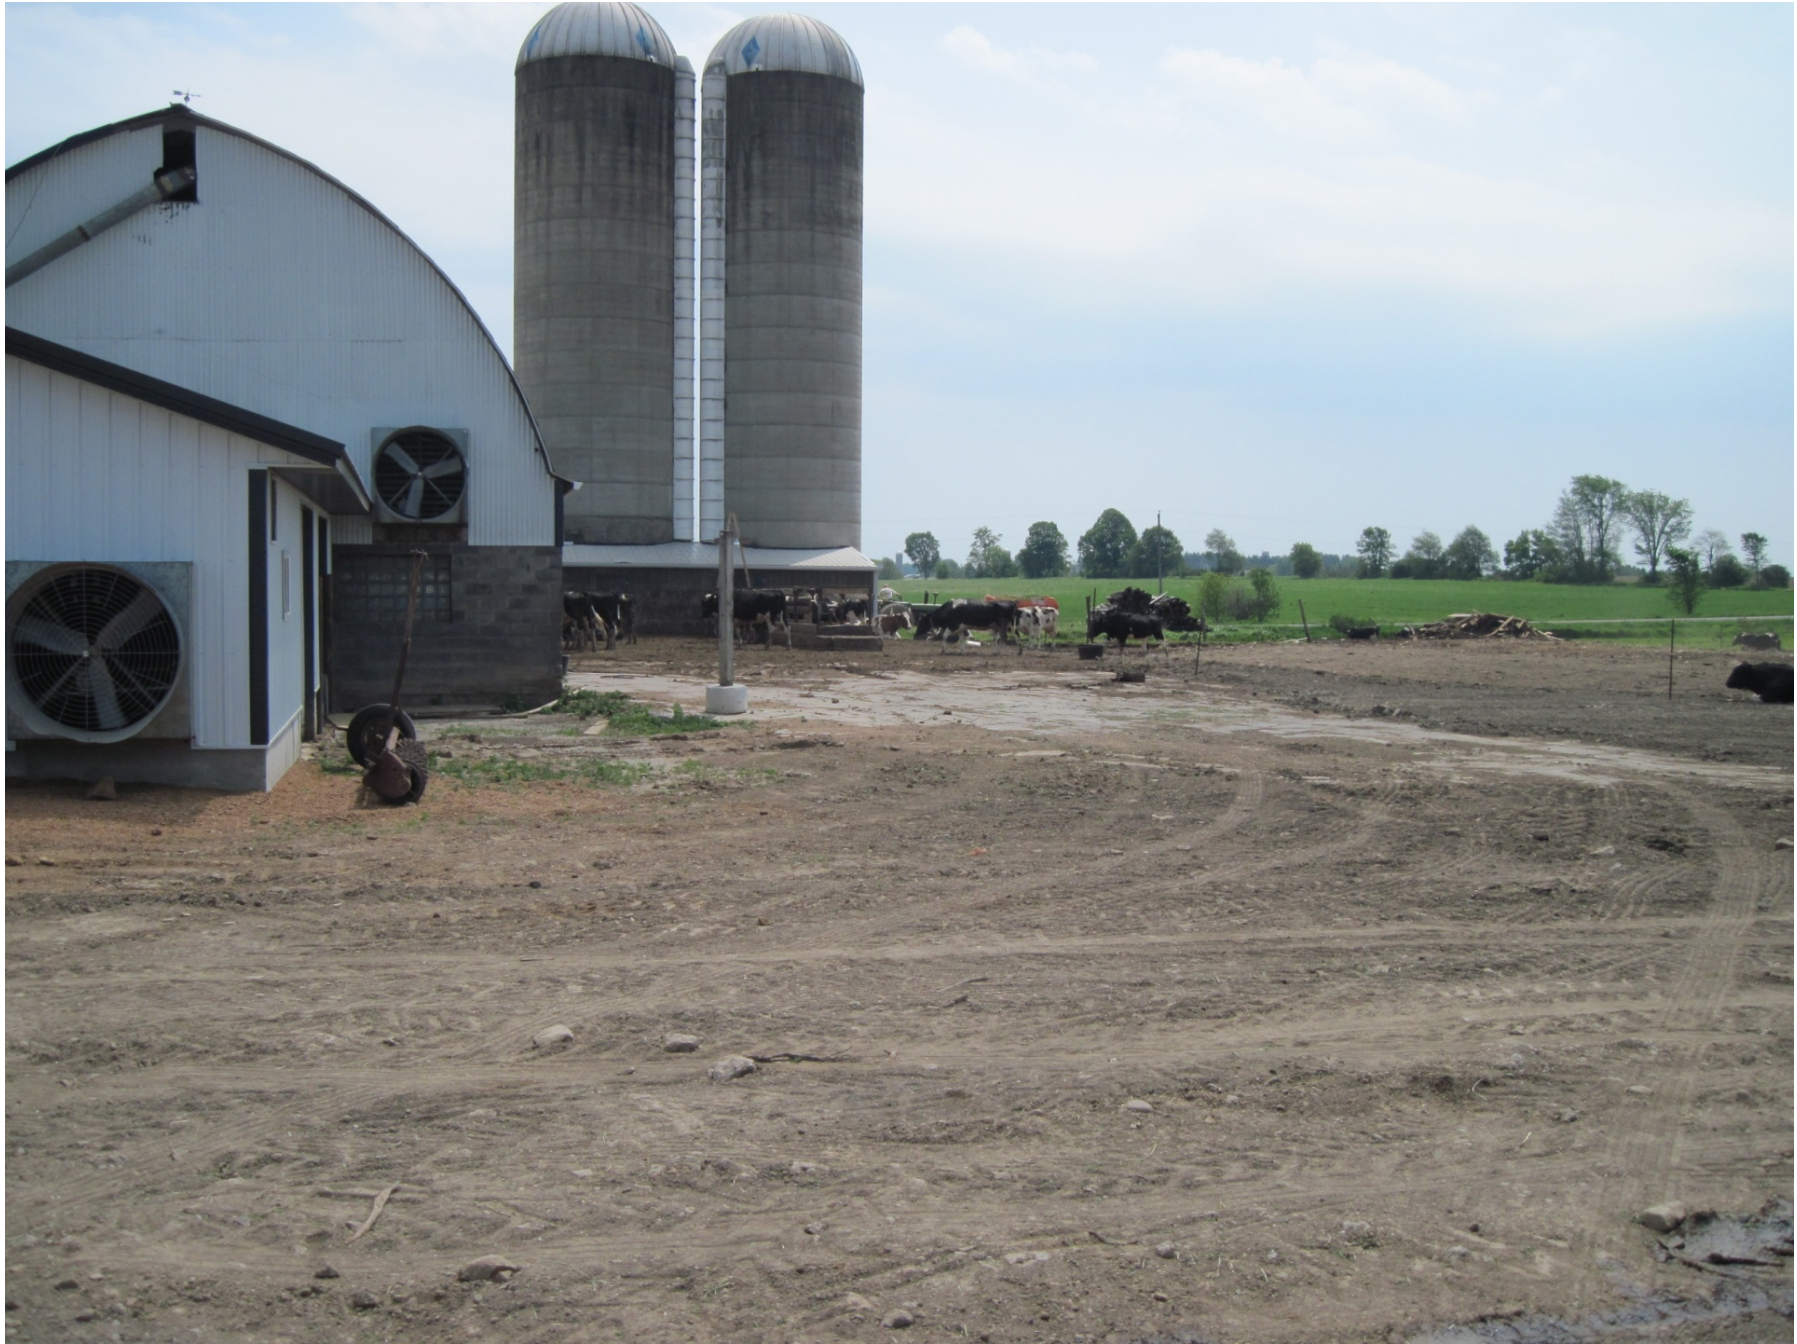
May 24, 2012 – Standing on the west side of the barn looking east, southeast over the area where the failing manure storage facility has been closed.

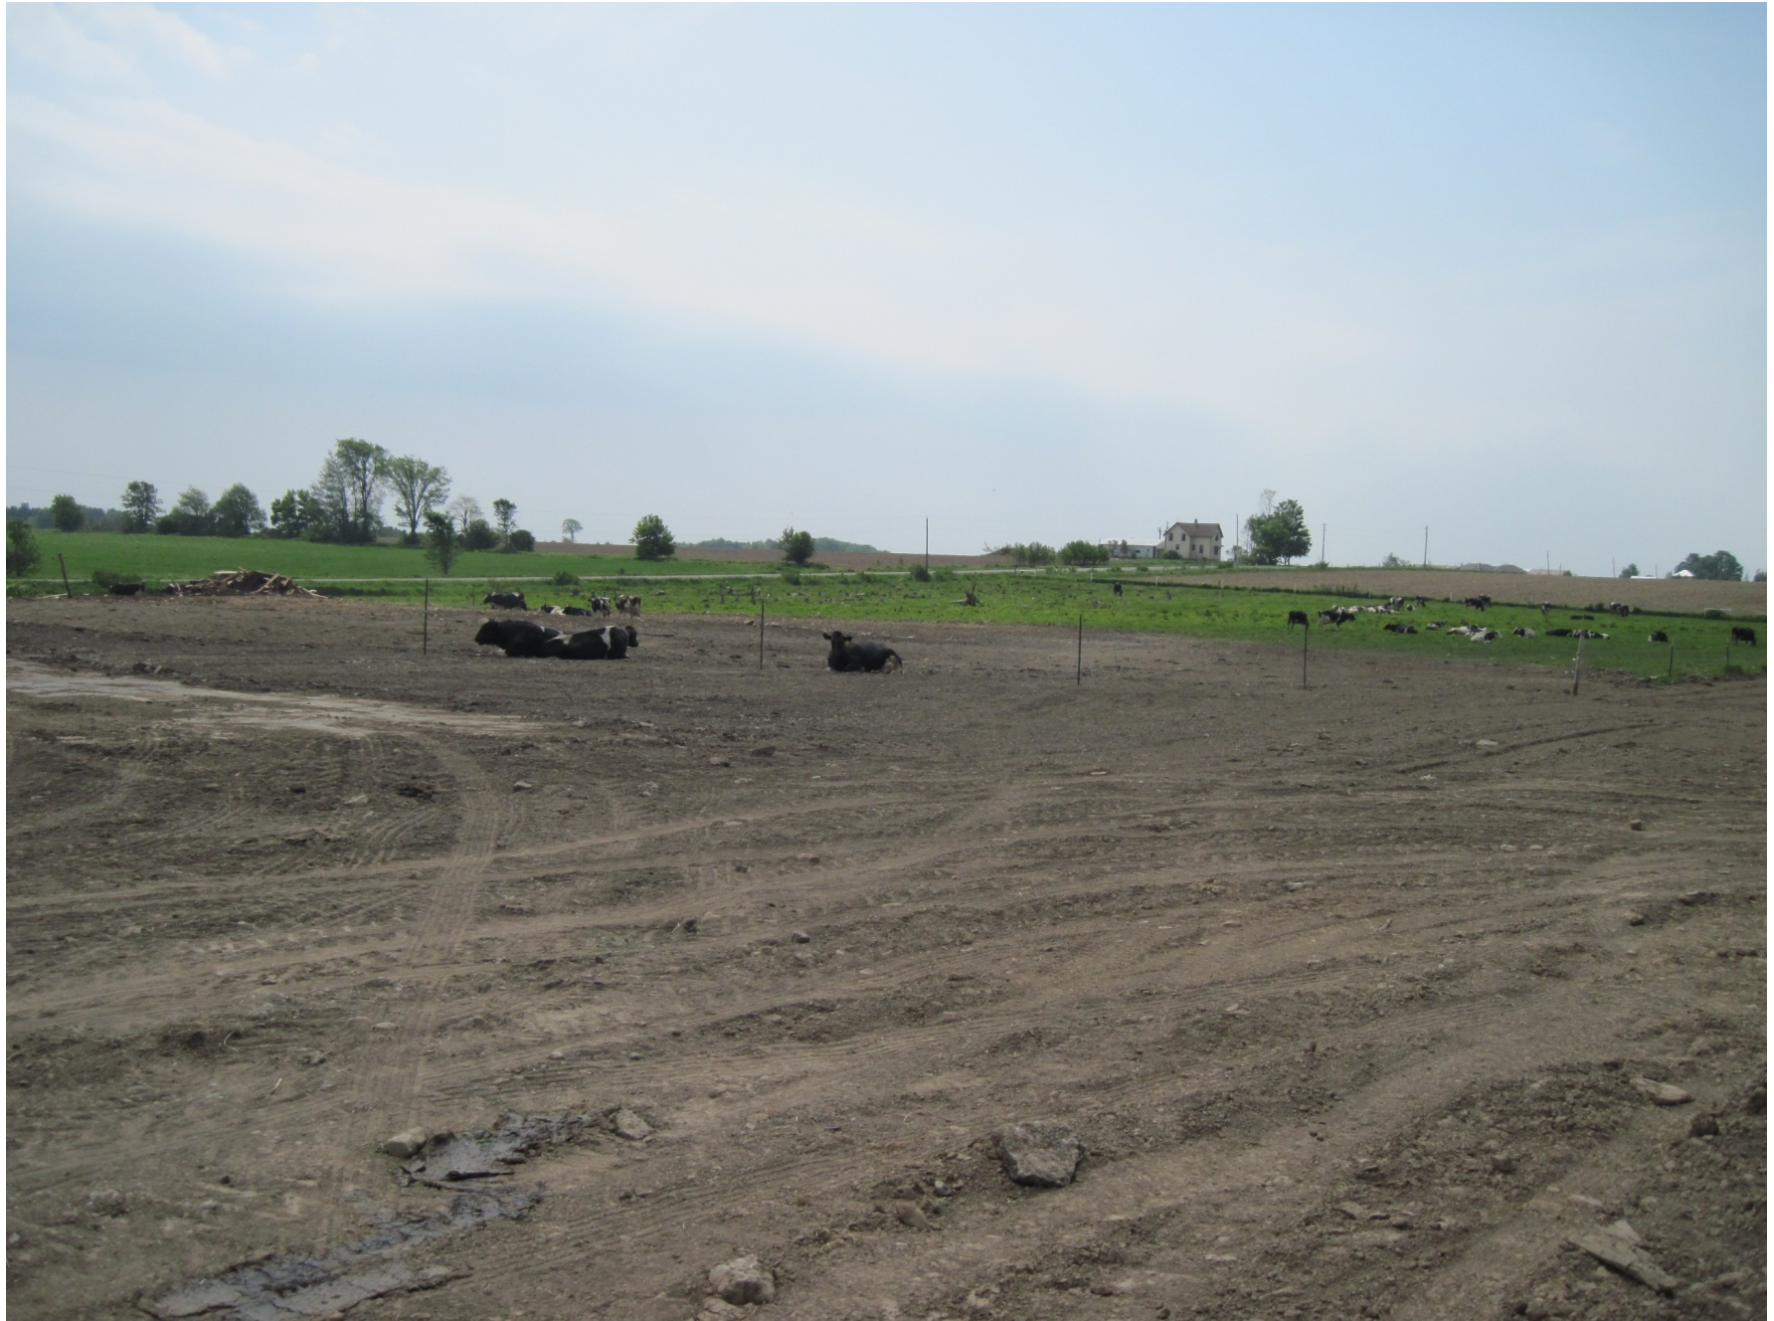
May 24, 2012 – Standing on the west side of the barn looking southeast over the area where the failing manure storage facility has been closed. You can also see that the cattle have been fenced from the wetland area to restrict access.

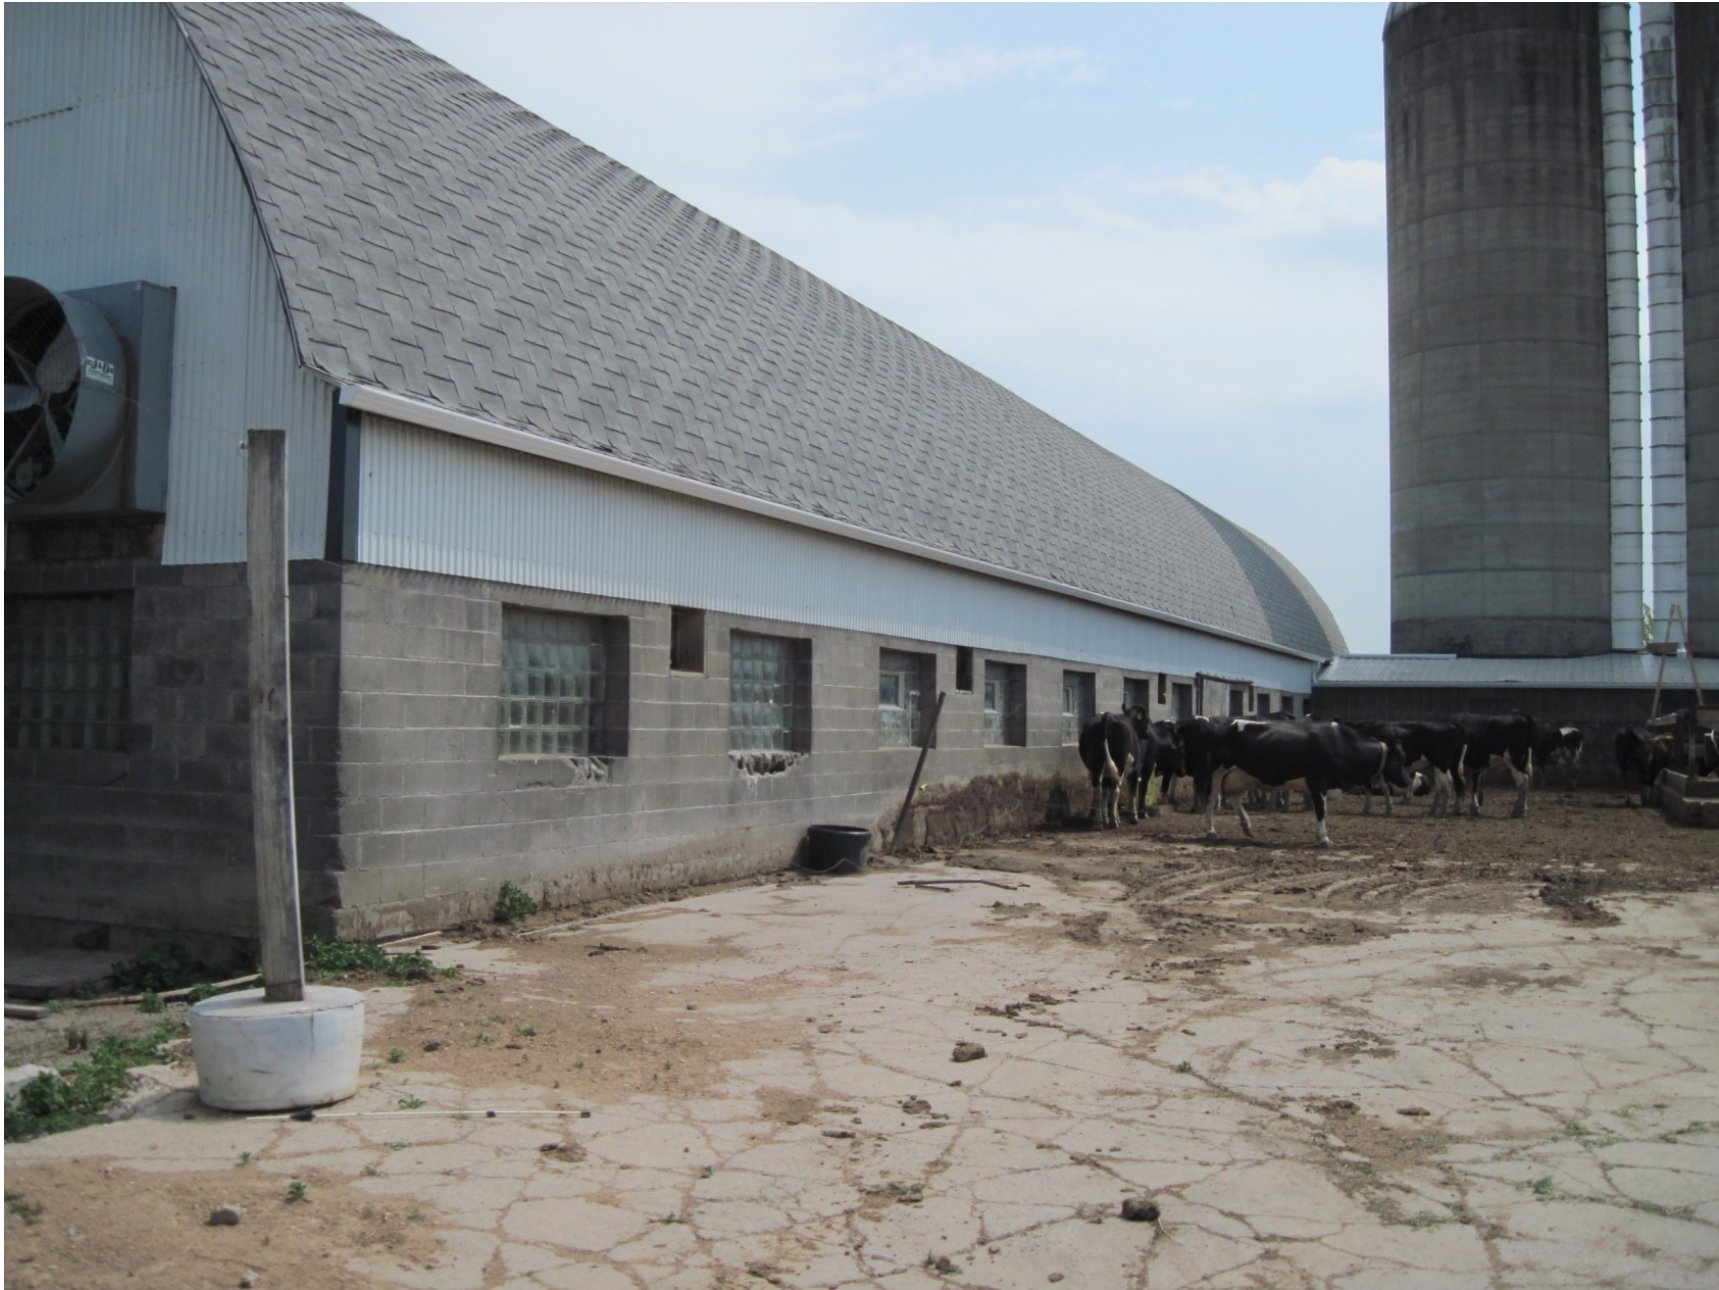
May 24, 2012 – Standing on the southwest side of the barn looking northeast over the barnyard on the south side of the barn. Since this feedlot is in a SWQMA, all clean water needs to be diverted. Roof gutters were used to catch and divert clean water.

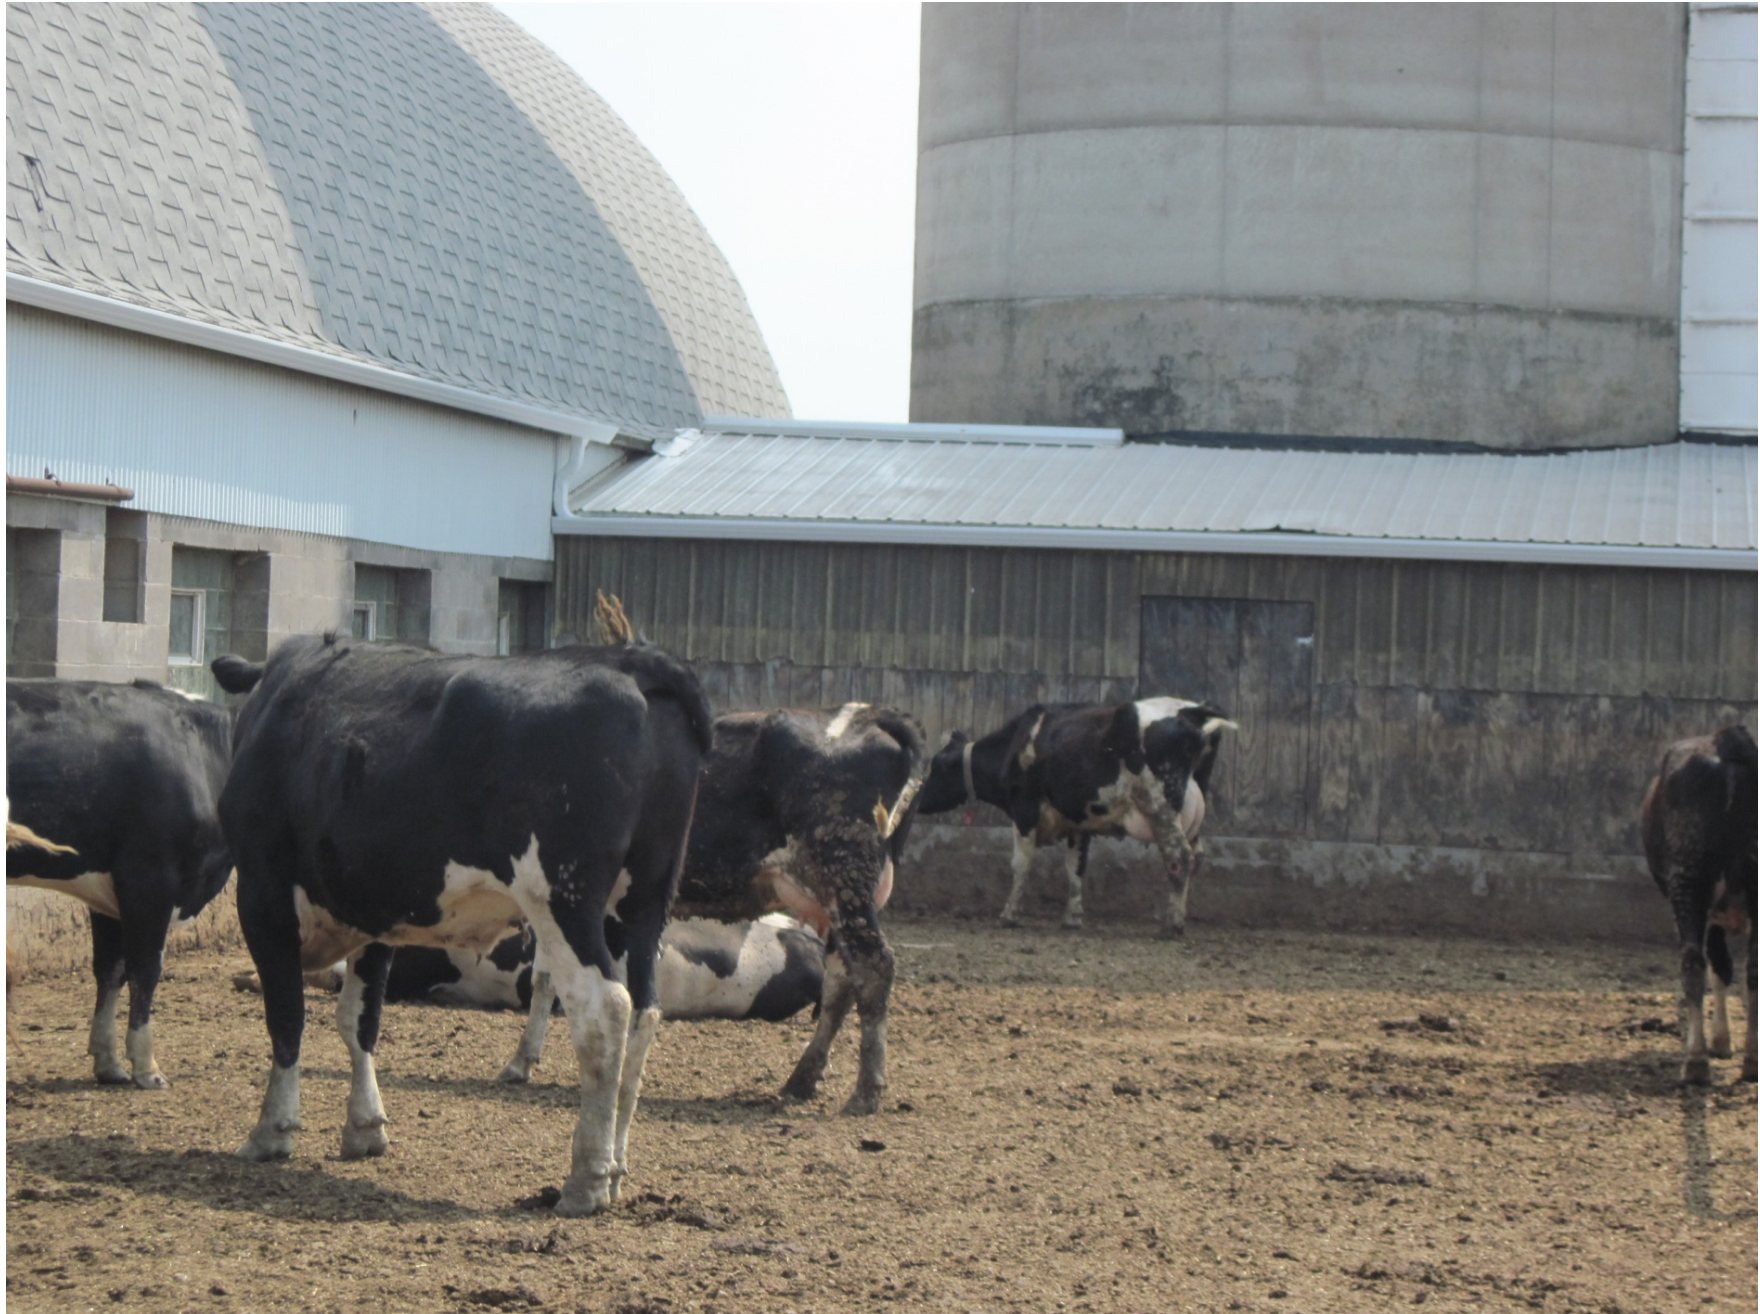
May 24, 2012 – Standing on the south side of the barn, on the feedlot, looking northeast at the gutters along the south side of the barn. Since this feedlot is in a SWQMA, all clean water needs to be diverted. Roof gutters were used to catch and divert clean water.

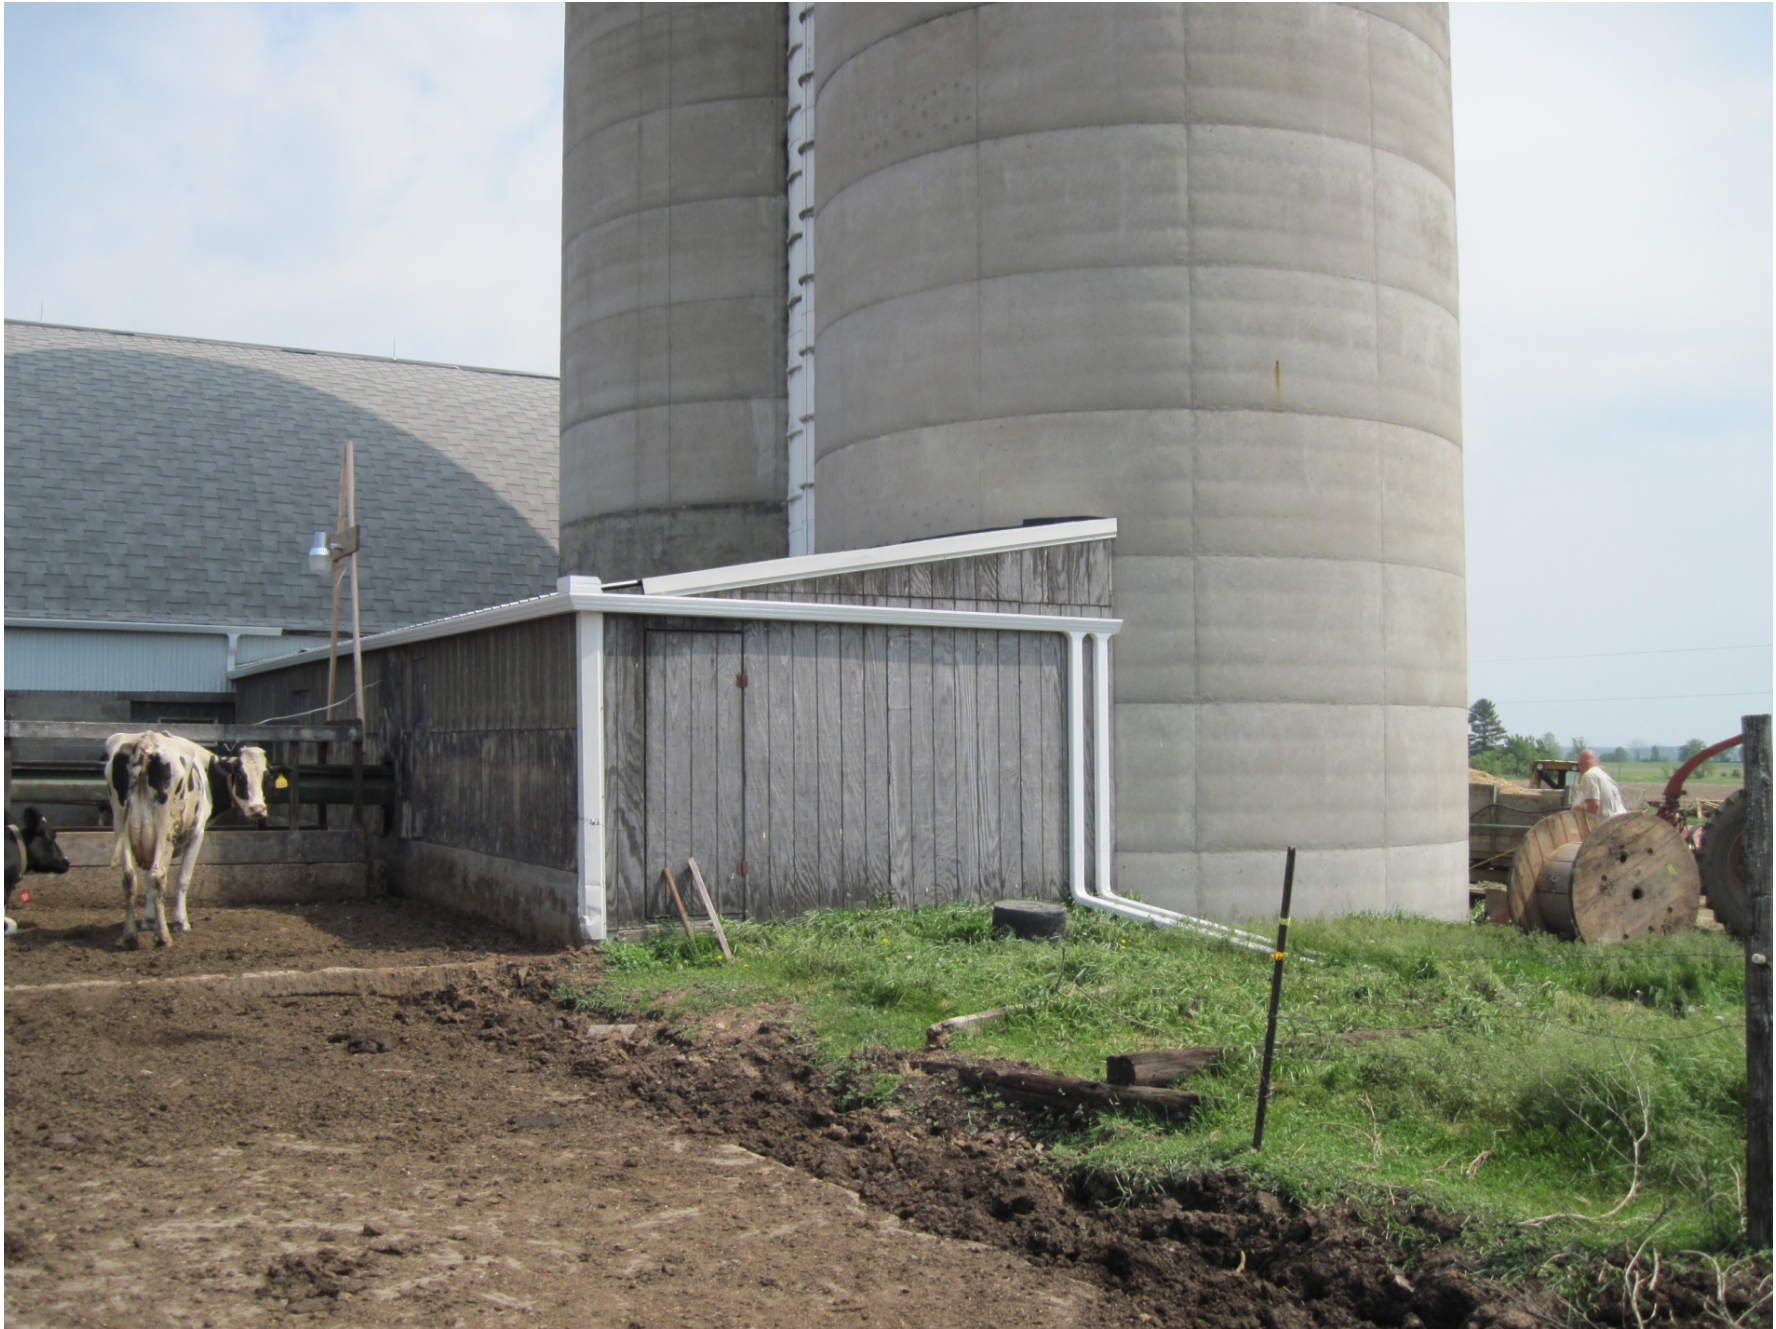
May 24, 2012 – Standing on the south side of the barn, east side of the feedlot, looking northeast, you can see that the roof gutters outlet to a stable vegetated area. Since this feedlot is in a SWQMA, all clean water needs to be diverted. Roof gutters were used to catch and divert all the roof water.

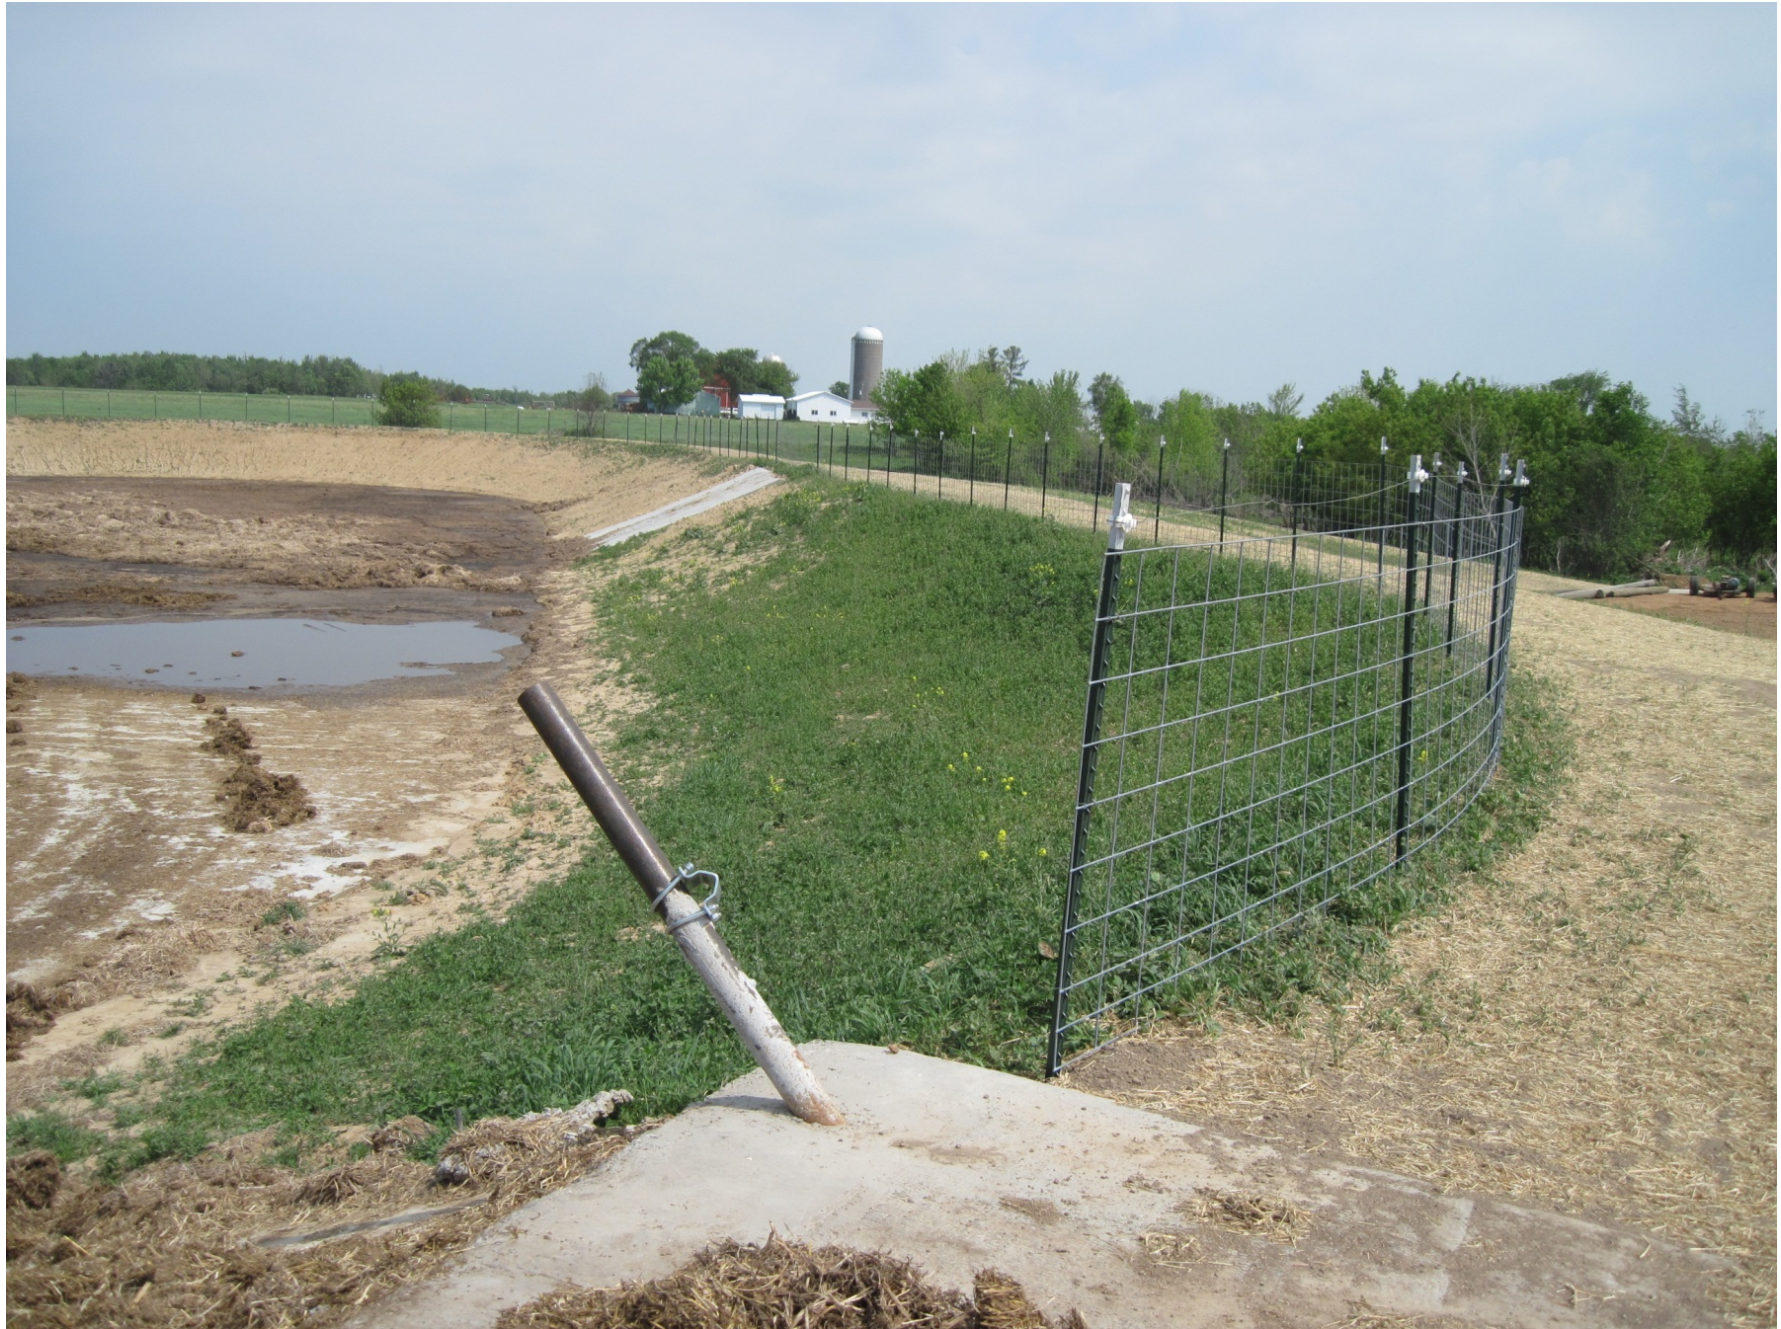
May 24, 2012 – Standing on the feedlot push-off ramp, on the southeast side of the long term manure storage facility, looking to the north along the east side of the storage. Fence is up and seeding on the dikes is just starting to come up.

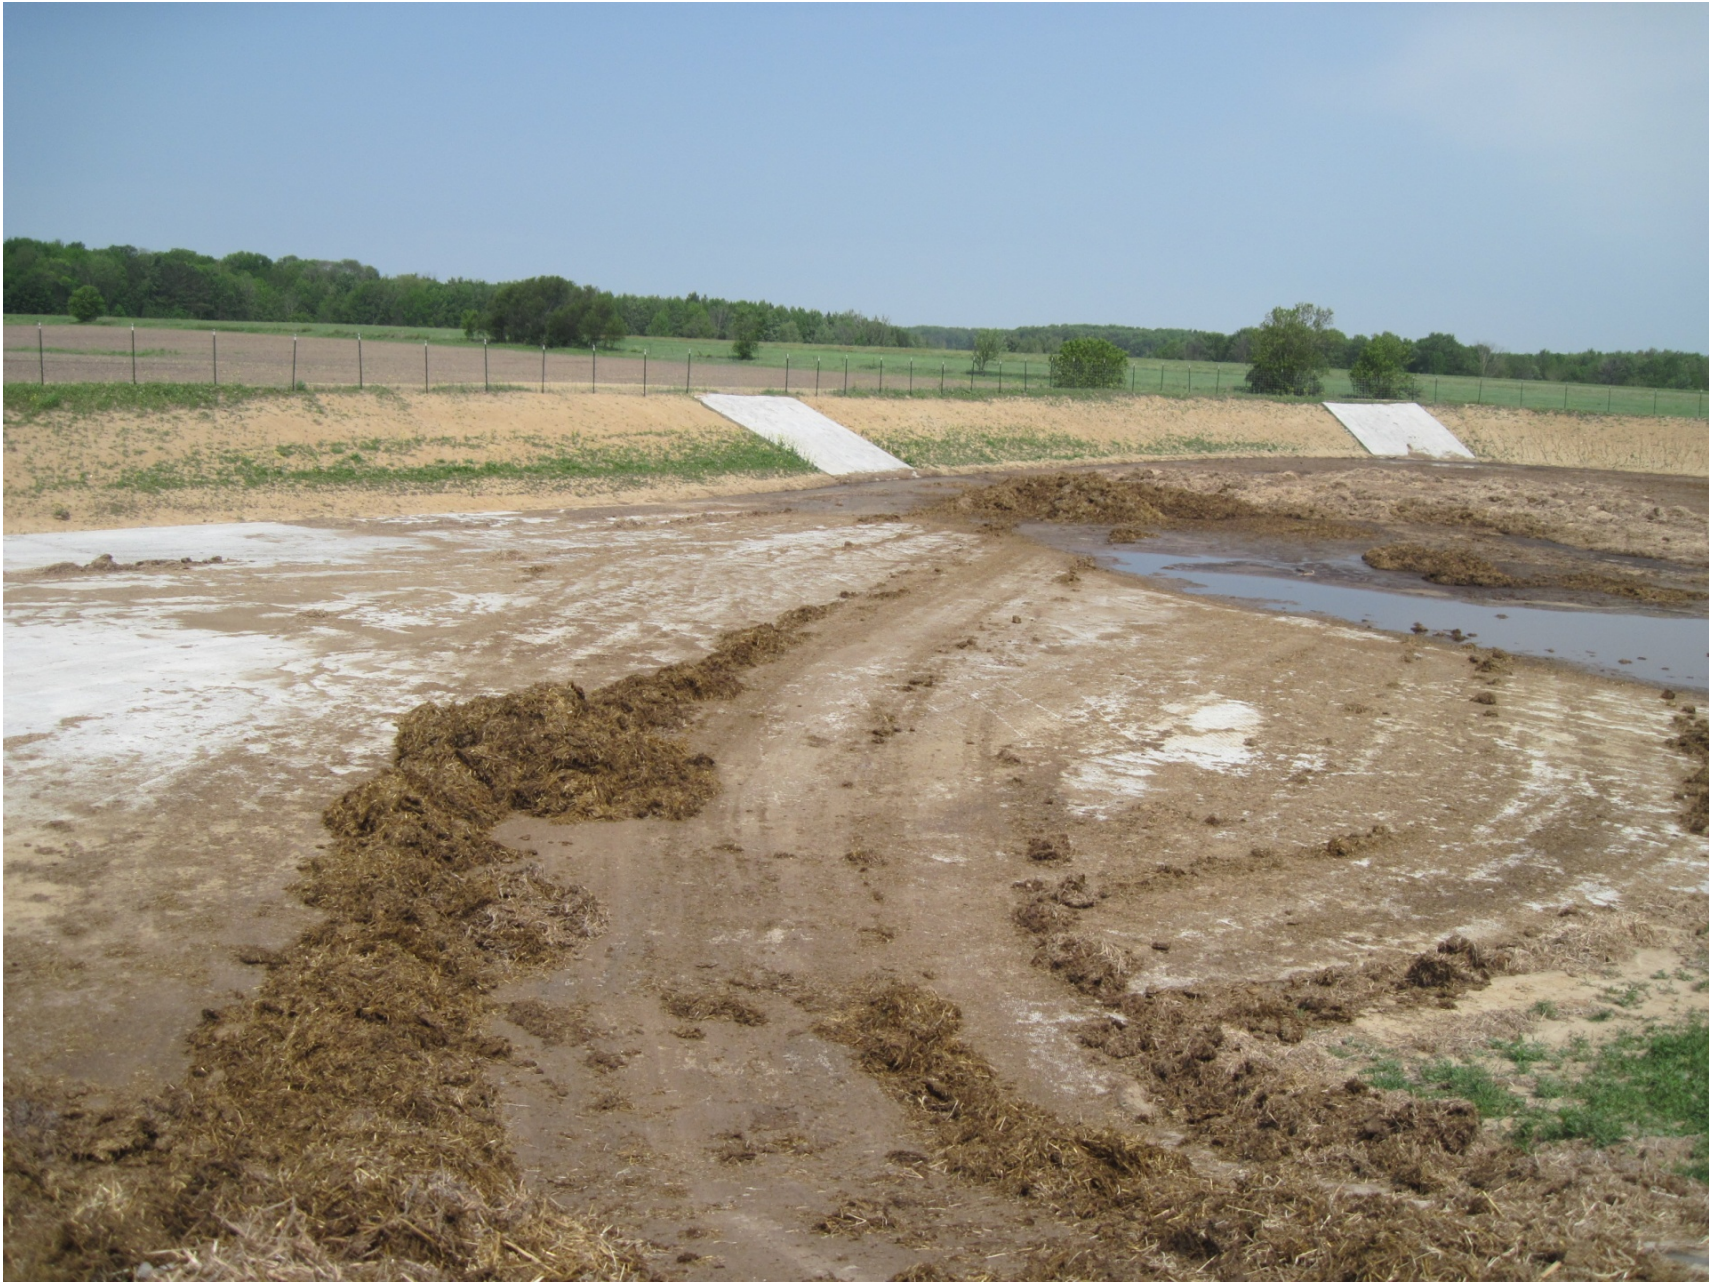
May 24, 2012 – Standing on the feedlot push-off ramp, on the southeast side of the long term manure storage facility, looking to the northwest, notice the concrete floor with earthen side slopes. The facility was emptied in spring and only had 3 months of accumulation. Fence is up and seeding on the dikes is just starting to come up.

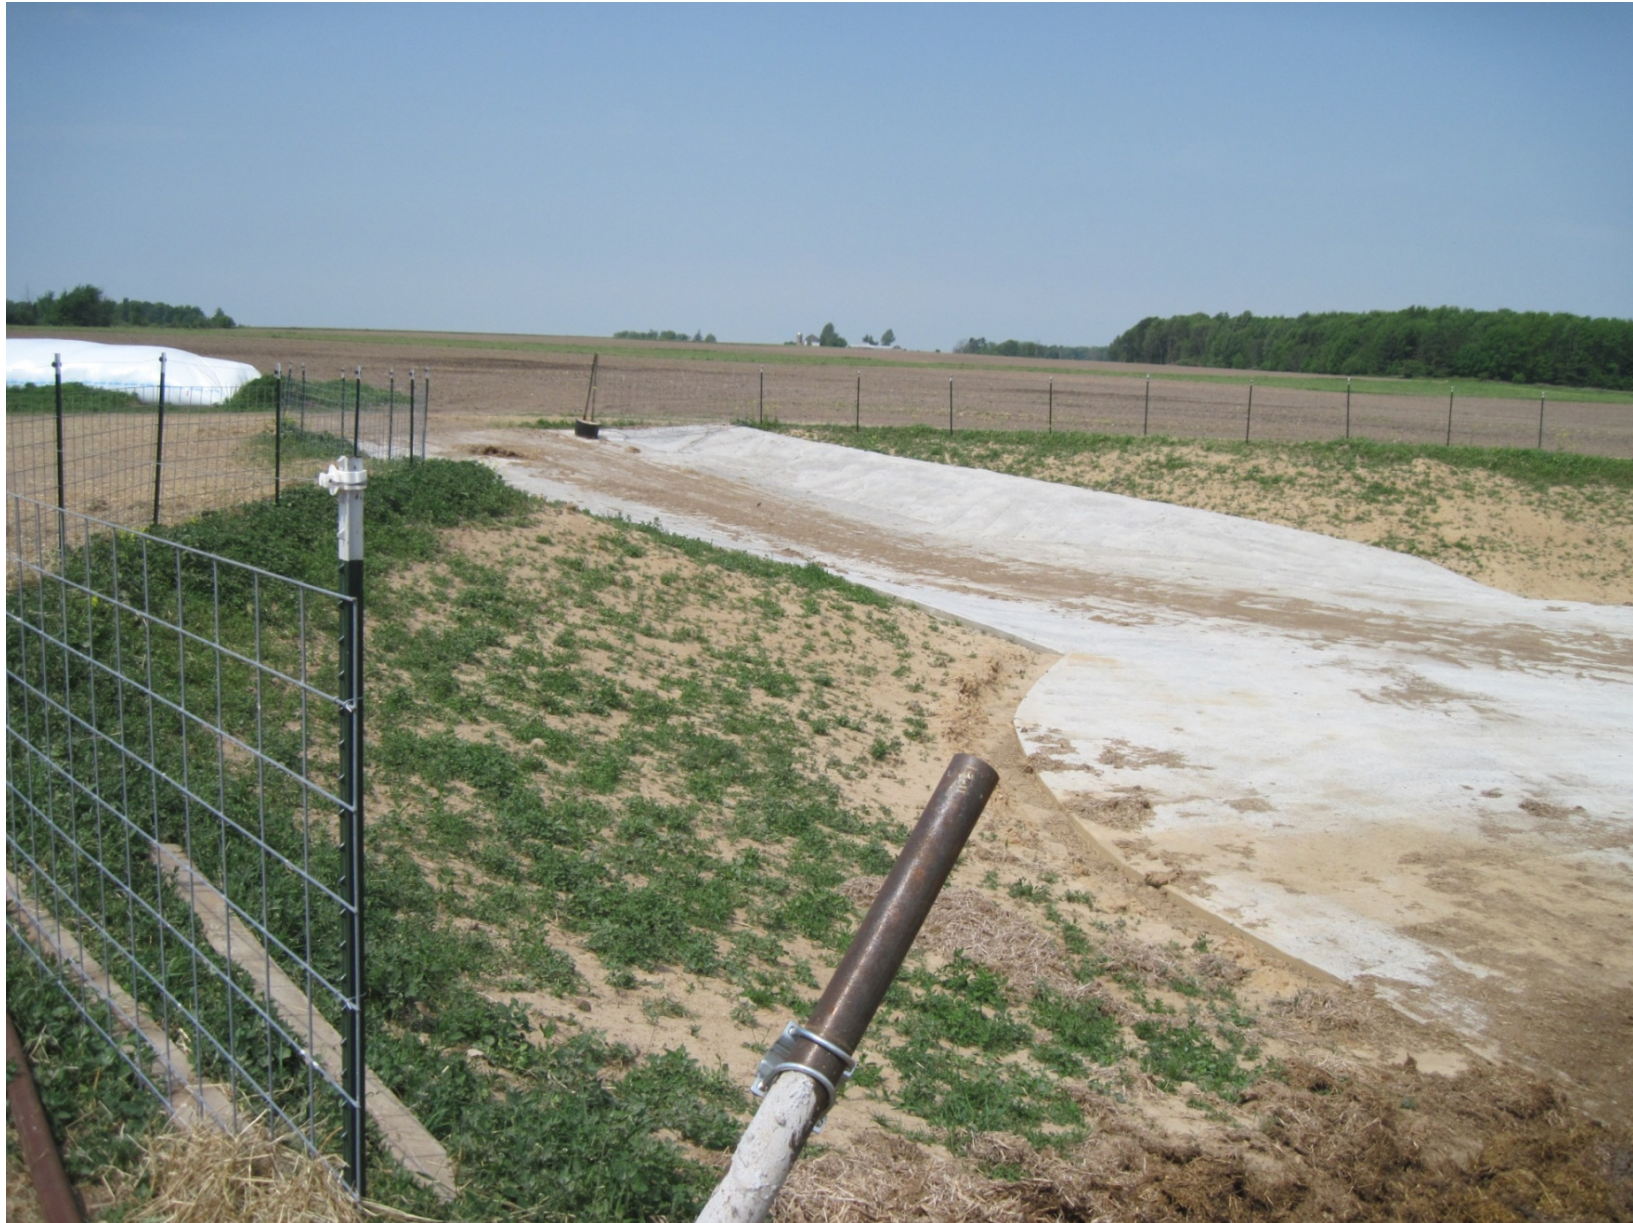
May 24, 2012 – This photo is taken standing on the feedlot push-off ramp, on the southeast side of the long term manure storage facility, looking to the west at the drive in ramp off the southwest corner of the manure storage facility. The floor of the facility is sloped from south to north, north being the deepest end of the facility. Fence is up and seeding on the dikes is just starting to come up. The push off bar will be installed when the level of the manure reaches the floor at the south end of the facility.
