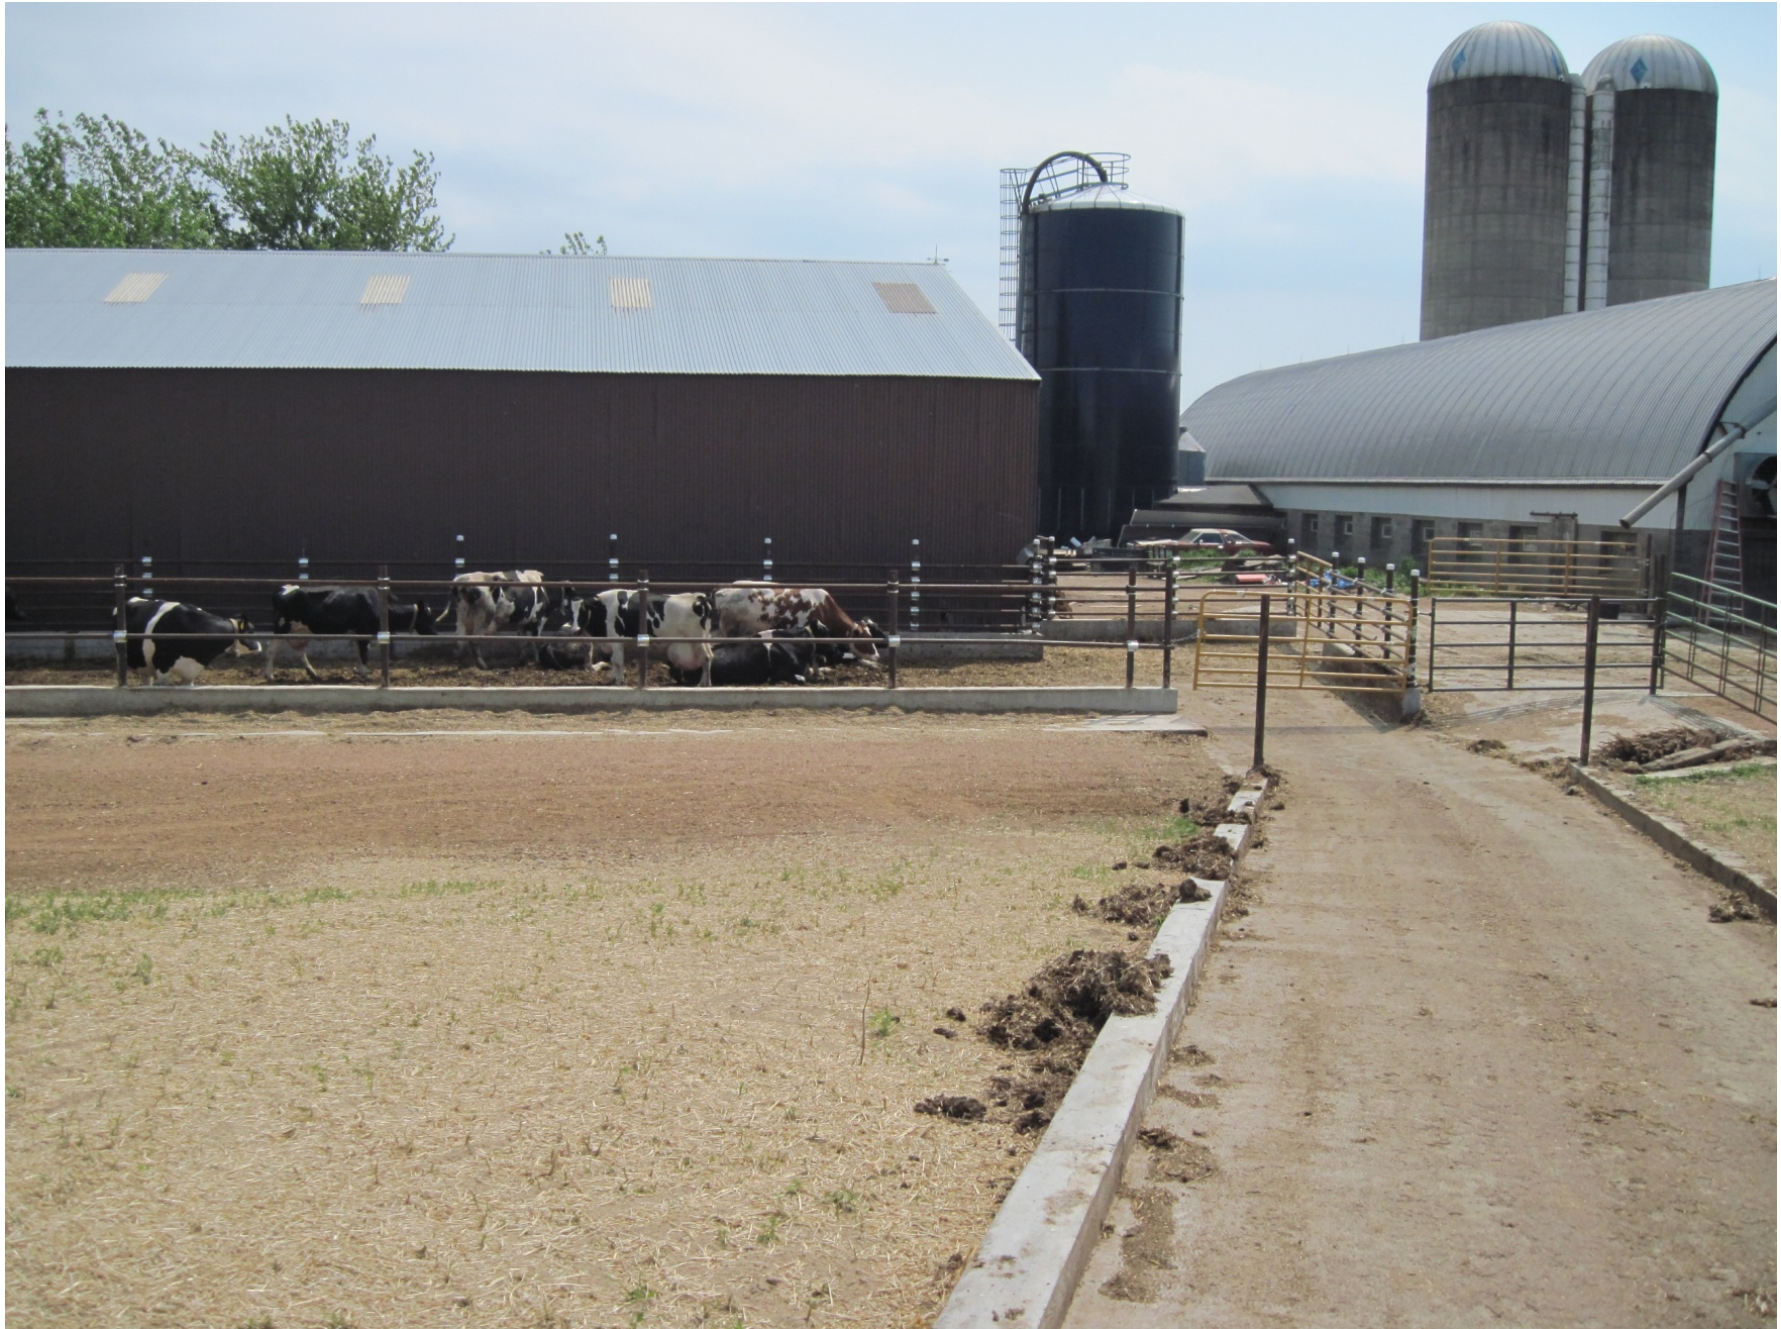
May 24, 2012 – This photo is taken standing on the feedlot push-off ramp, on the southeast side of the long term manure storage facility, looking to the east at the dry cow/heifer lot on the west side of the machine shed.

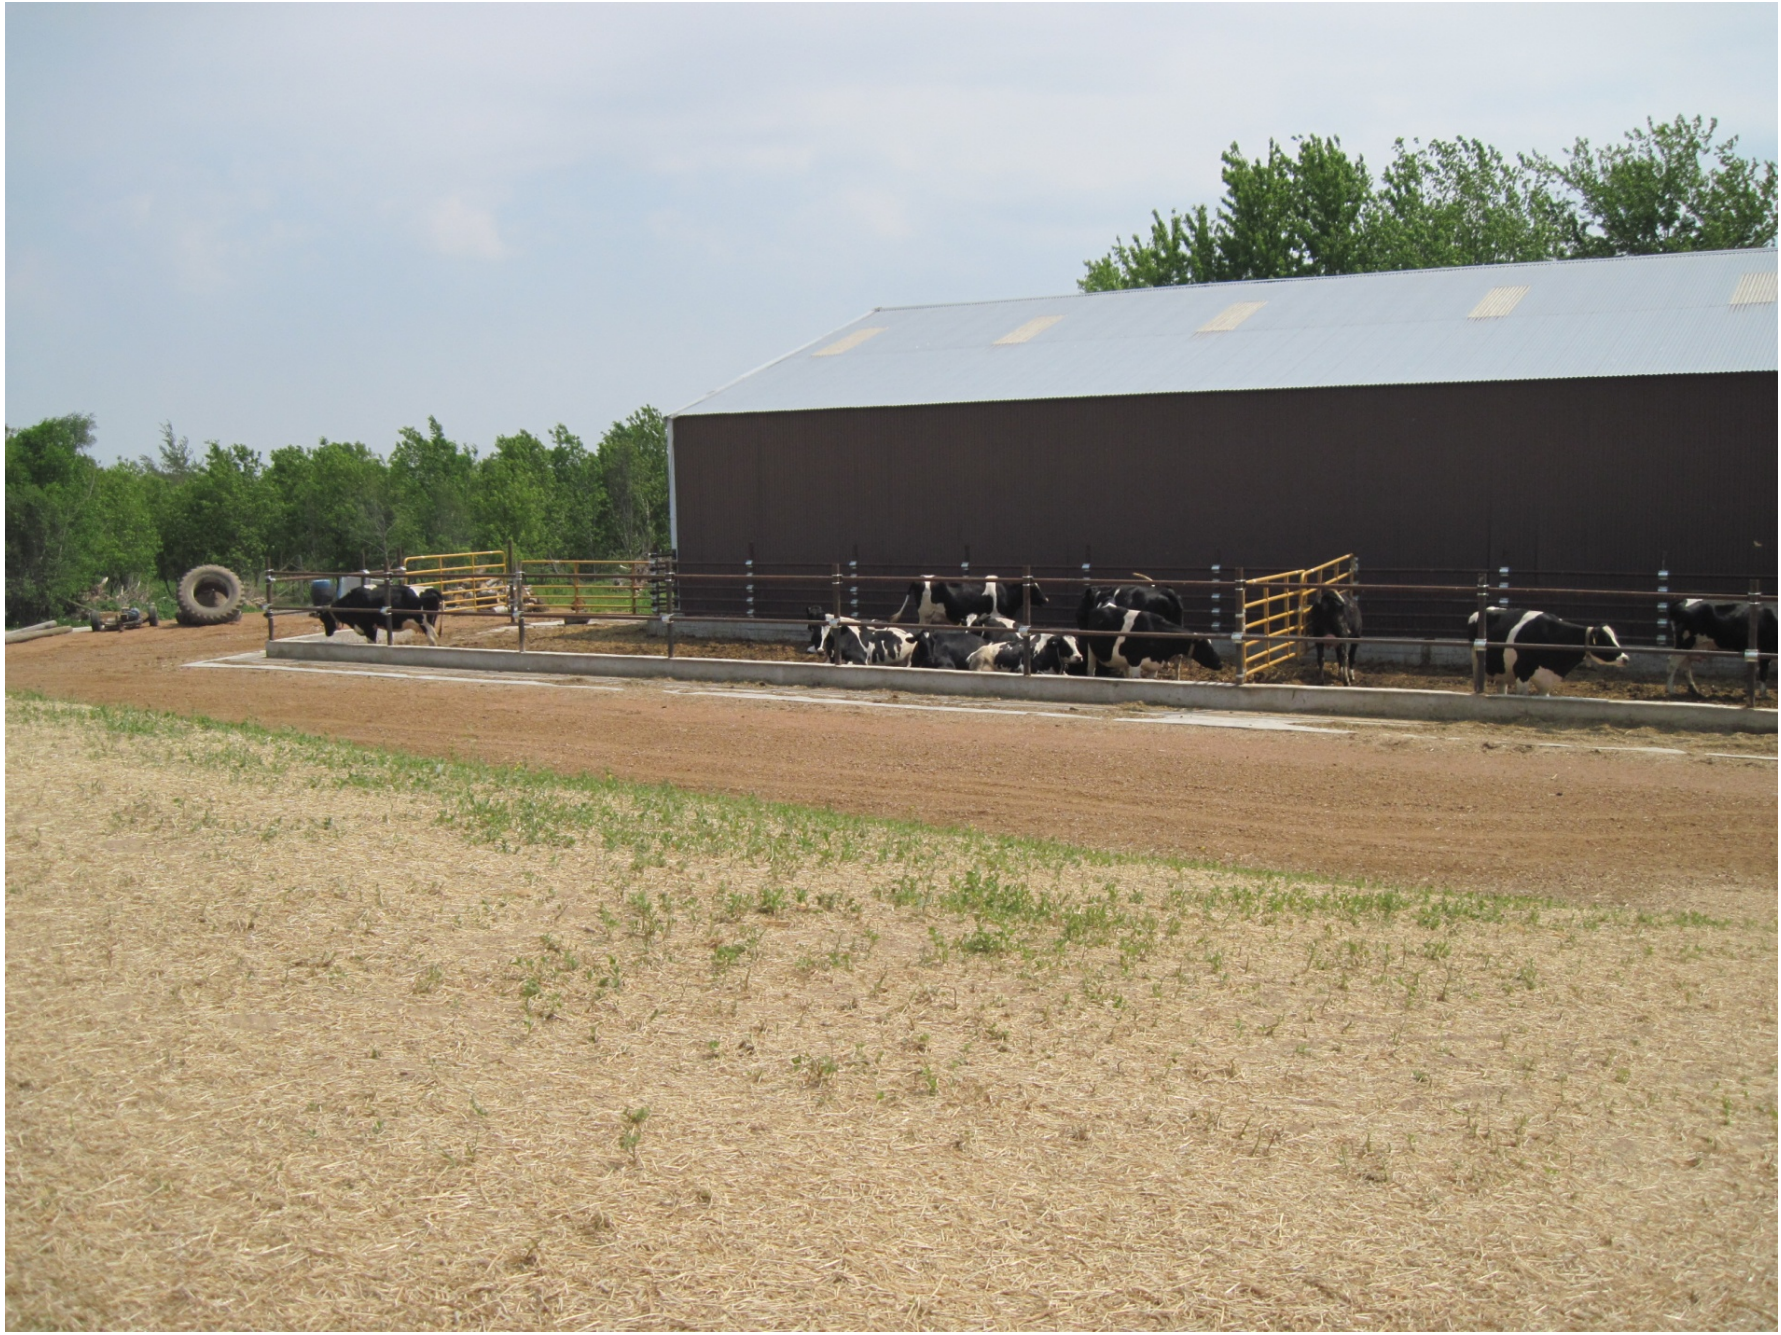
May 24, 2012 – This photo is taken standing on the feedlot push-off ramp, on the southeast side of the long term manure storage facility, looking to the northeast at the dry cow/heifer lot on the west side of the machine shed.
