2012 Lake Puckaway EPS Planting Report

Andrew Sabai

November 2012

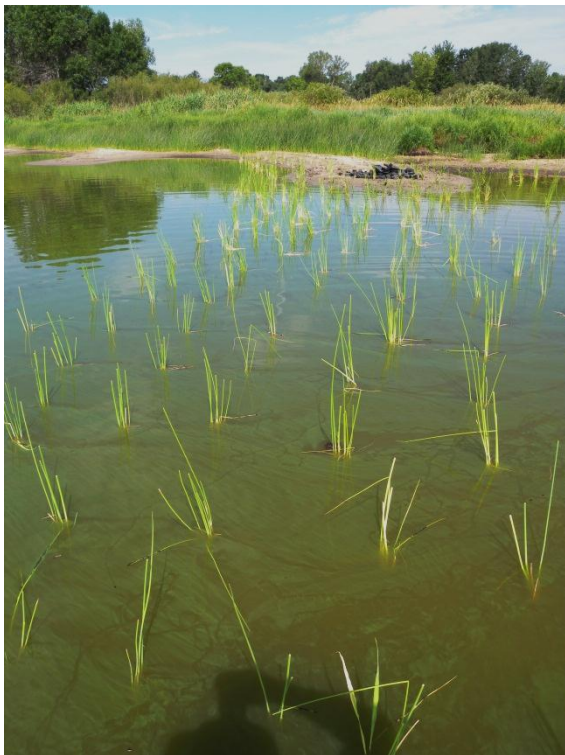
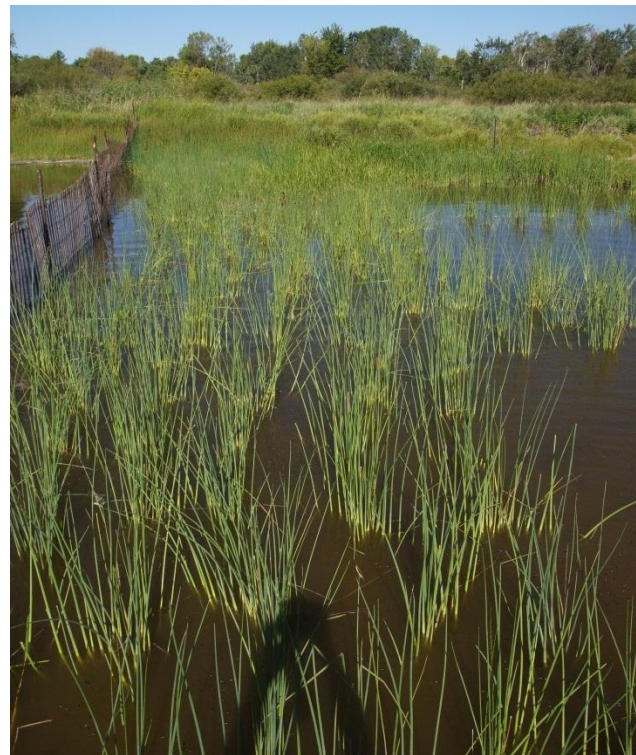
Figure 2 and 3. Site 2a Left photo taken just after planting and before the fence installed, July 8. Right photo Sep. 6, 2012

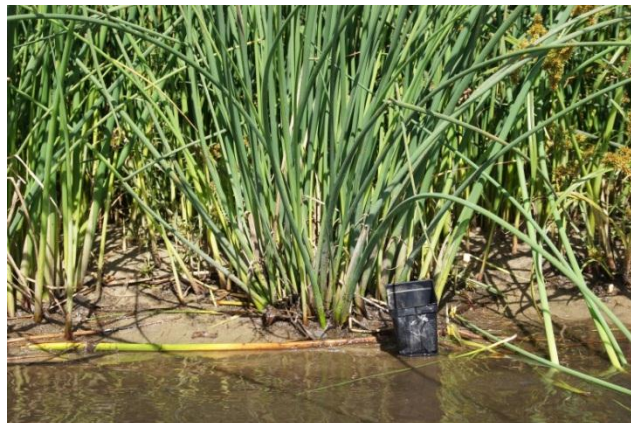
Figure 4. Softstem bulrush plant with the pot it came in 72 days after planting

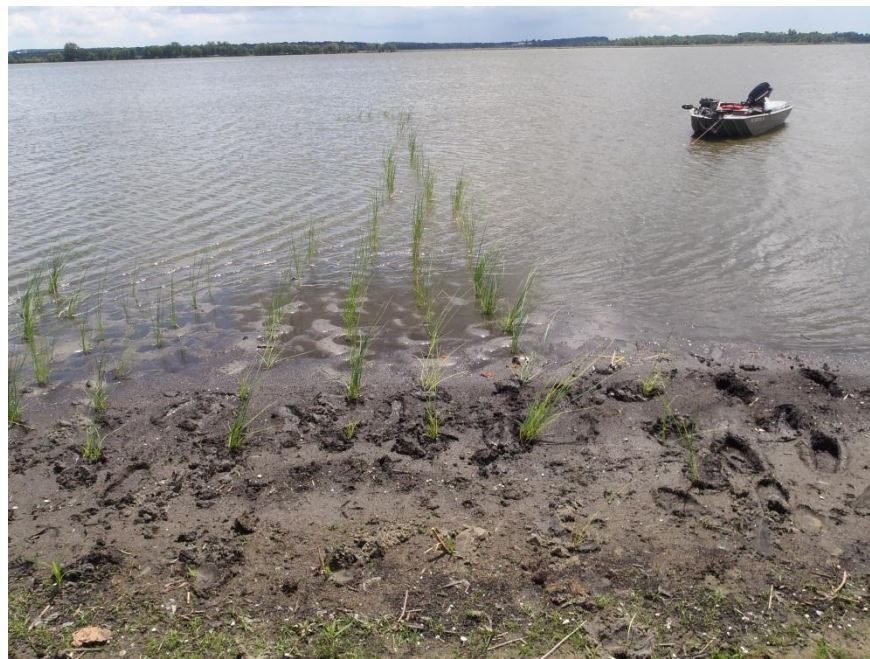
Site 8 - July 27, 2012: Not all sites were a success. Site 8 experienced a 90% loss by Oct 21, 2012 due mainly to wind storms.

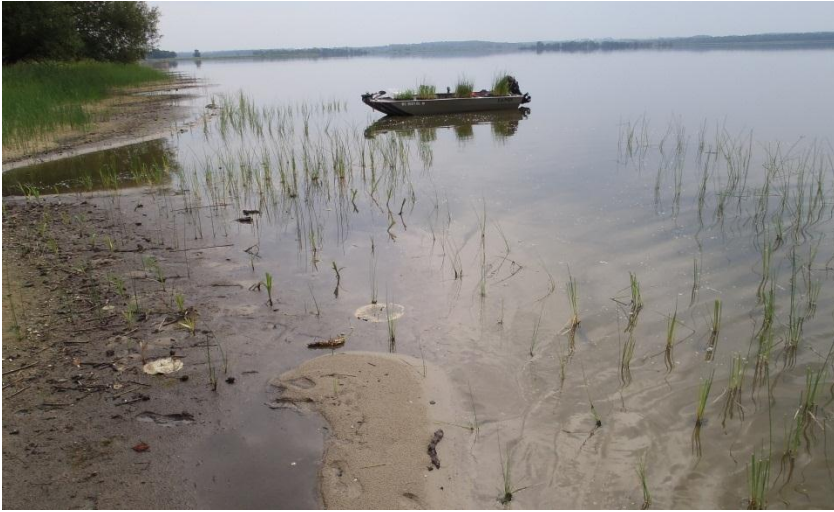
Site 3 – July 27, 2012 Planting in progress

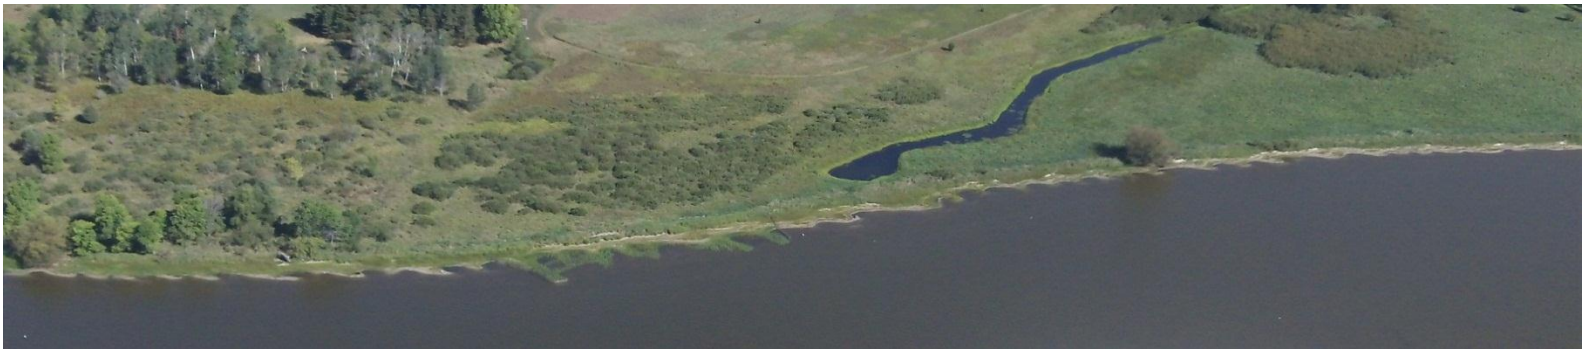
North shore of East Basin sites 2a, center, and 2b, left, September 10, 2012. Site 2b, planted later in the season and not as far into the lake, is less visible. Photo courtesy Paul Gettelman.

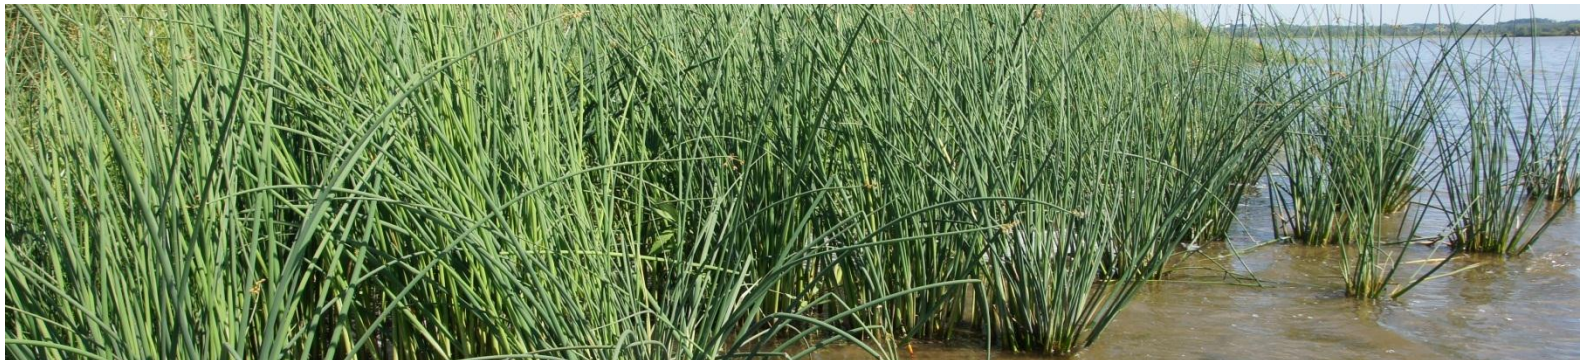
Site 1 - hard and softstem bulrushes August 22, 2012.
