Project Name Meyer Groundwater Improvement and Protection	Grant Number TRC- MA-08000-04 MA05-08000-04
Governmental Unit Name Calumet County Land and Water Conservation Department	Governmental Unit Type (city, village, town, etc.) County
Watershed Name South Branch Manitowoc River	Watershed Code MA05
DNR Water Management Unit (River System) Name Manitowoc	Water Body Identification Code (WBIC) (if applicable)

BARNYARD AND OLD EARTHEN STORAGE - MEYER GROUNDWATER
PROJECT – TRC-MA05-08000-04

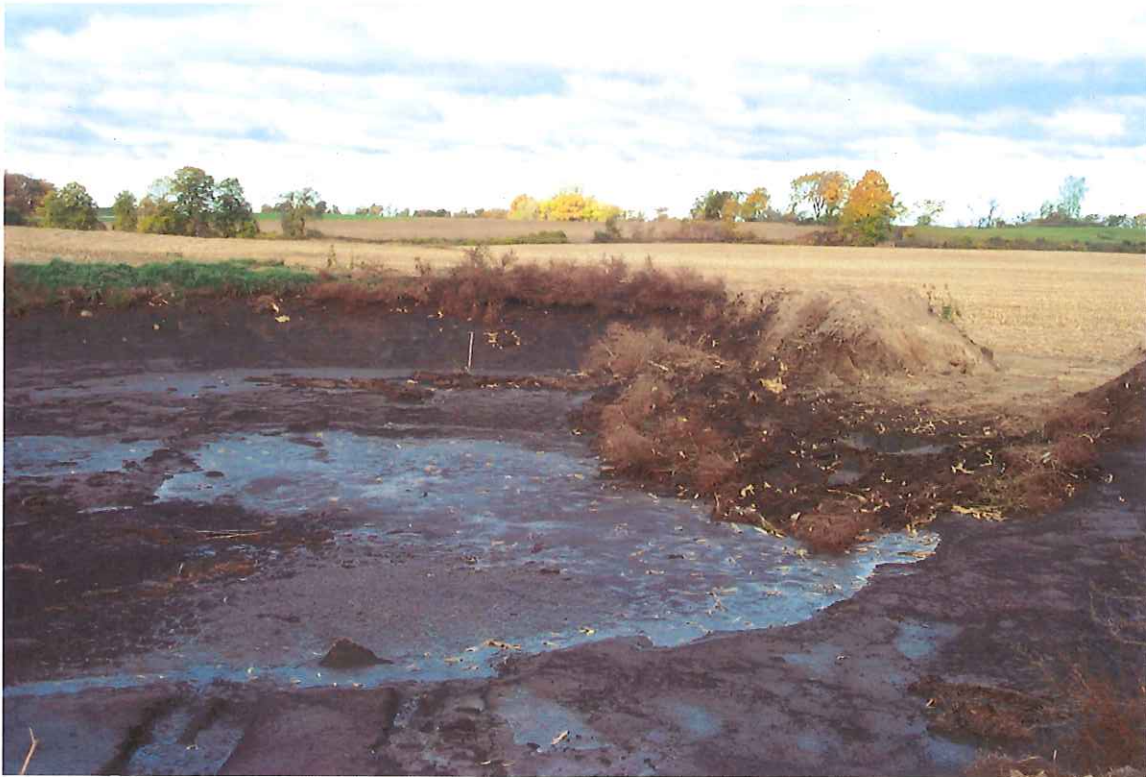
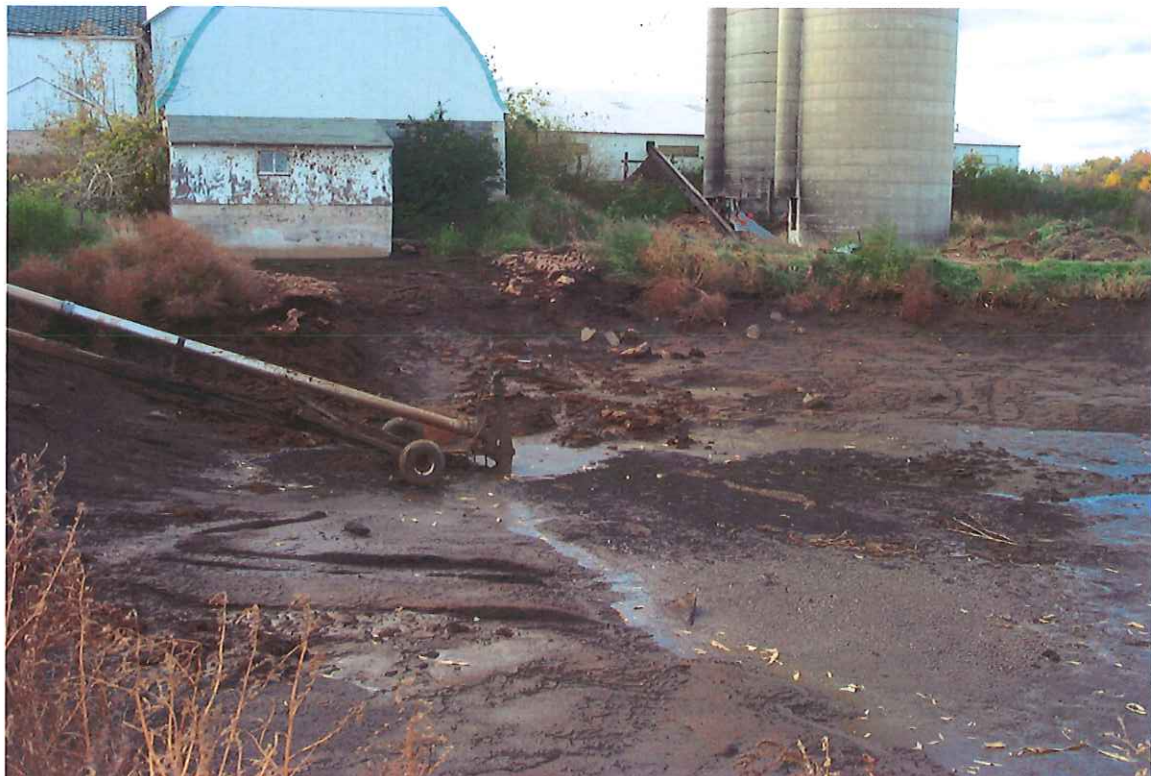
OLD EARTHEN STORAGE – MEYER GROUNDWATER PROJECT – TRC-MA05-08000-04

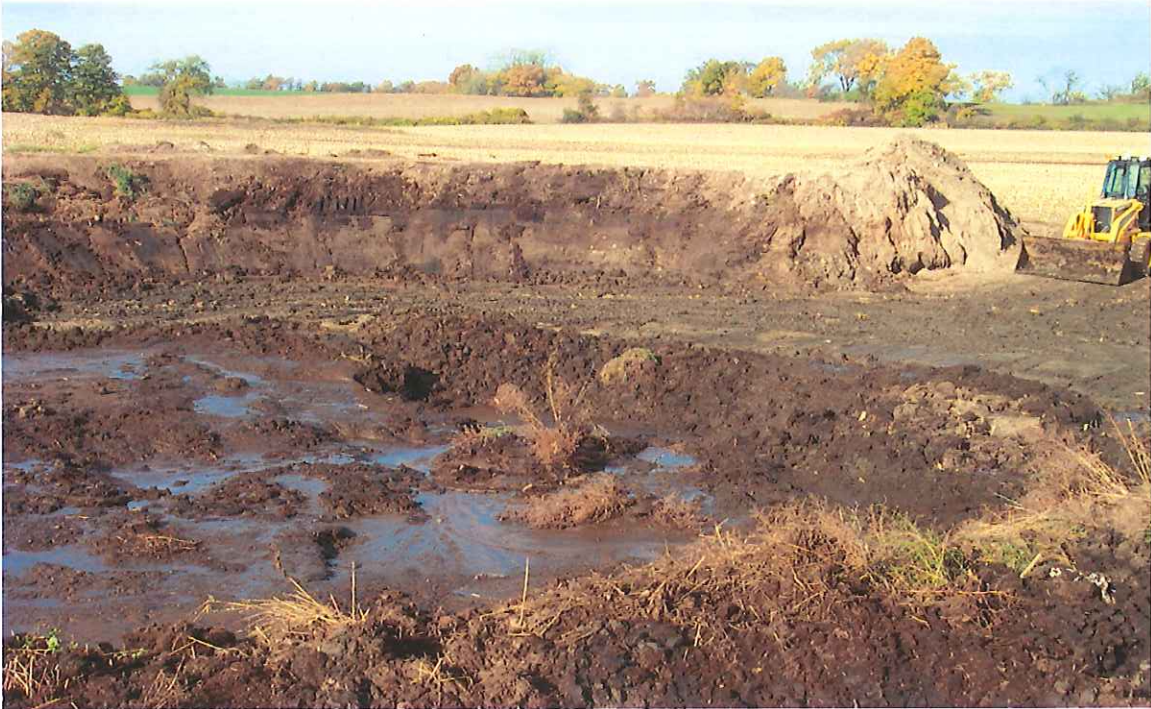
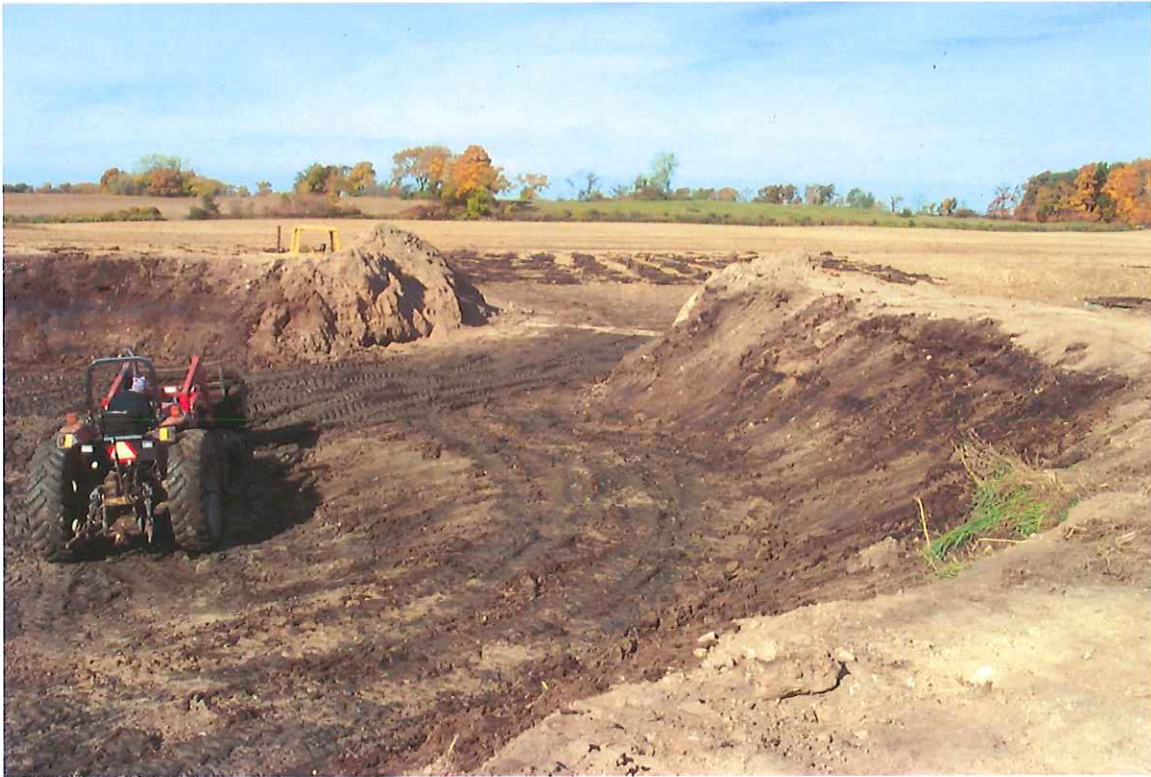
MANURE SOAKED BOTTOM AND SIDEWALLS AND STORAGE CLOSURE
MEYER GROUNDWATER PROJECT – TRC-MA05-08000-04

Pre-project evaluations included direct observations of bedrock depth on the project site and of the soil beneath the earthen storage and water testing of private wells on-site and downslope of the site. Exposed bedrock was observed in at least 2 areas of the pasture/feedlot. Rocks on the surface in other areas indicated that bedrock was within 1 - 2 feet of the surface. Discussions with the landowner affirmed this. A shelf of bedrock was observed directly underneath the barn, about 20 feet south of the earthen manure storage. The bedrock extended above the surface of the manure storage. When the earthen manure storage was emptied, an observation pit was dug in the bottom of it. Large pieces of what appeared to be fractured bedrock were found 5 - 7 feet below the storage bottom. The soil in the side embankments and bottom of the storage was light textured and saturated with manure to a width/depth of up to 5 feet. Based on these observations, it is very likely that animal waste from the barnyard and manure storage were entering the bedrock. Since livestock were permanently relocated off of the site and the manure storage was properly abandoned, the pollutant loads from these sources to groundwater were eliminated at this site.
