Beauregard Lake Critical Habitat Designation Report

Douglas County, WI

Prepared by Alex Smith,
Northern Region Critical Habitat Coordinator

April 2013

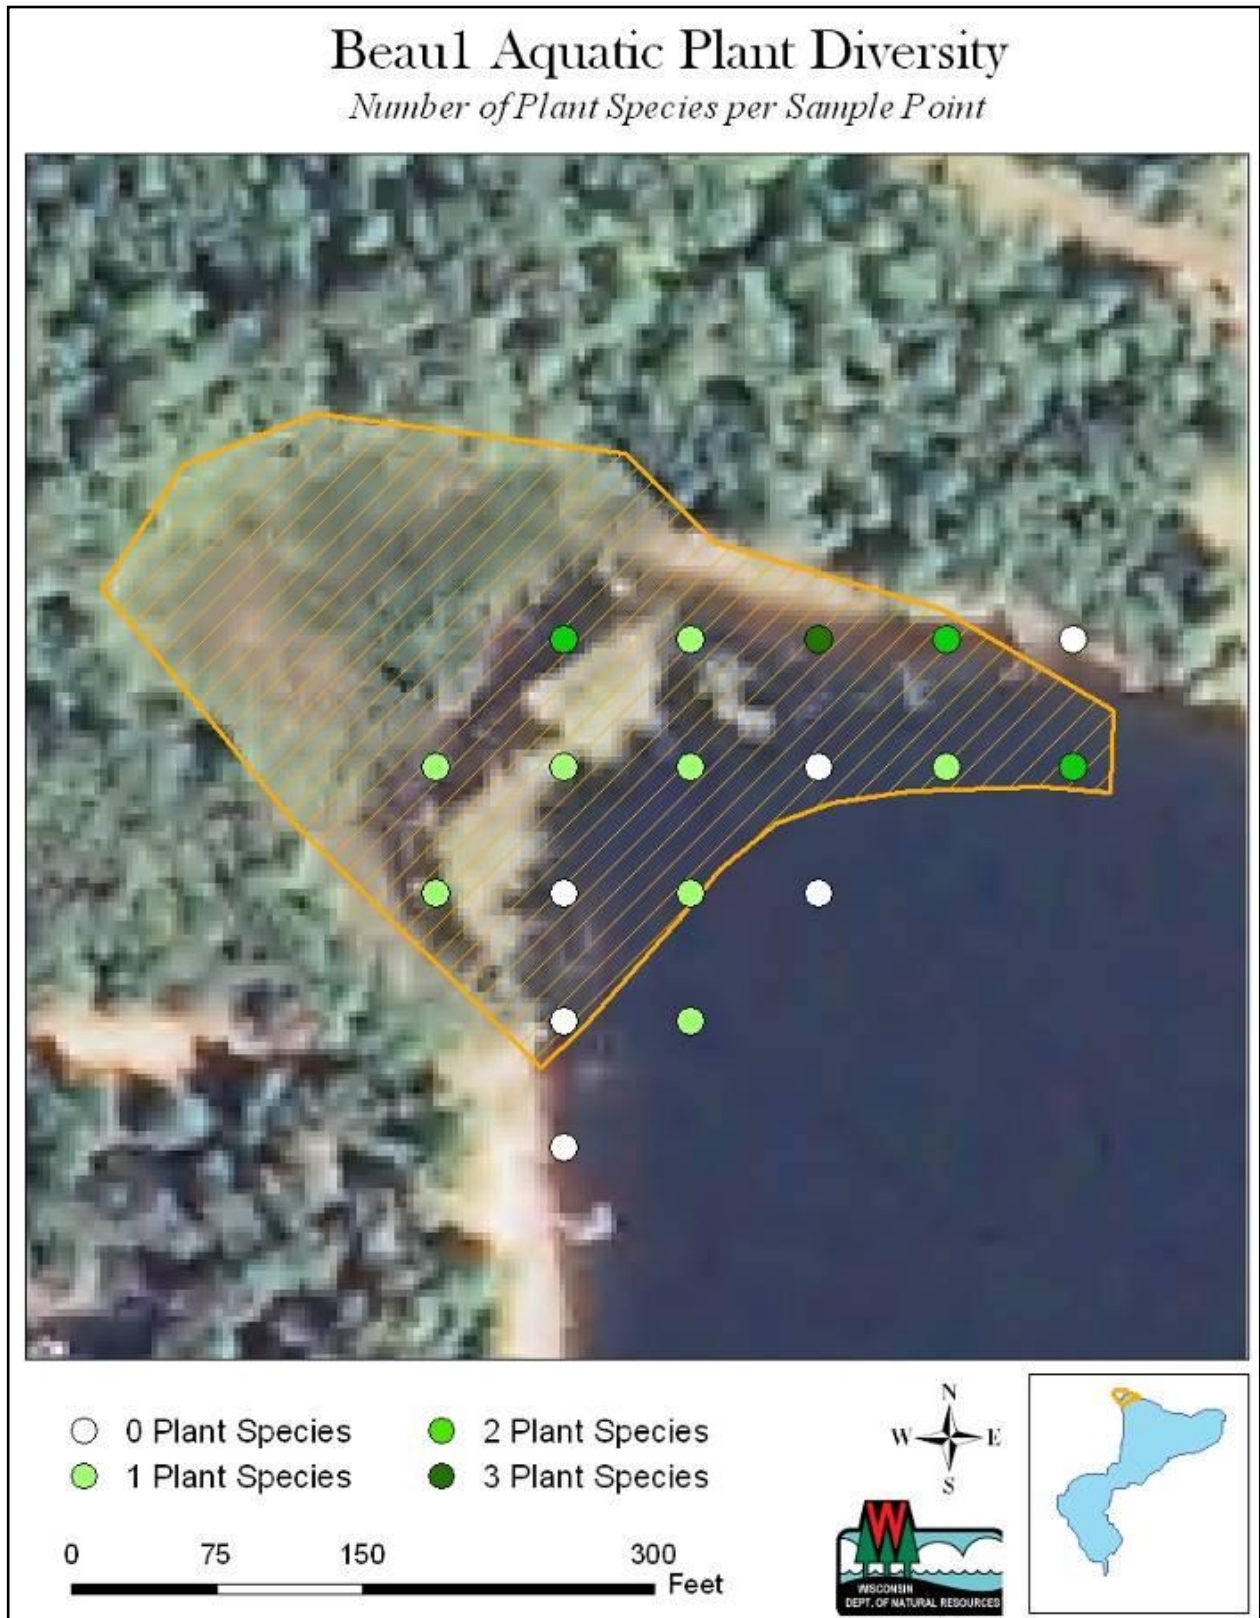
Figure 4. Beau1 Aquatic Plant Diversity

Critical habitat site Beau1 was designated a Sensitive Area because of its Emergent and Floating Leaf Vegetation and Extensive Riparian Wetland (Figure 4). Beau1 is 2.0 acres in size and is located in the Northwest bay near the public boat launch.

Aquatic Plants were sampled using a standardized Point Intercept method and a summary of the results can be found in Tables 3 and 4. Table 5 summarizes the current management practices within the Setback, Riparian, Bank, and Littoral Zones of Beau1.

Buffers and overhanging vegetation, bog fringe and floating, emergent and submersed aquatic plants should be left alone. Do not actively manage aquatic plants unless an aquatic invasive species should establish.

Leave fallen trees in the water unless they are impeding navigation. Implement Fish Sticks project. Contact local DNR Fisheries Biologist to investigate funding and technical assistance opportunities.

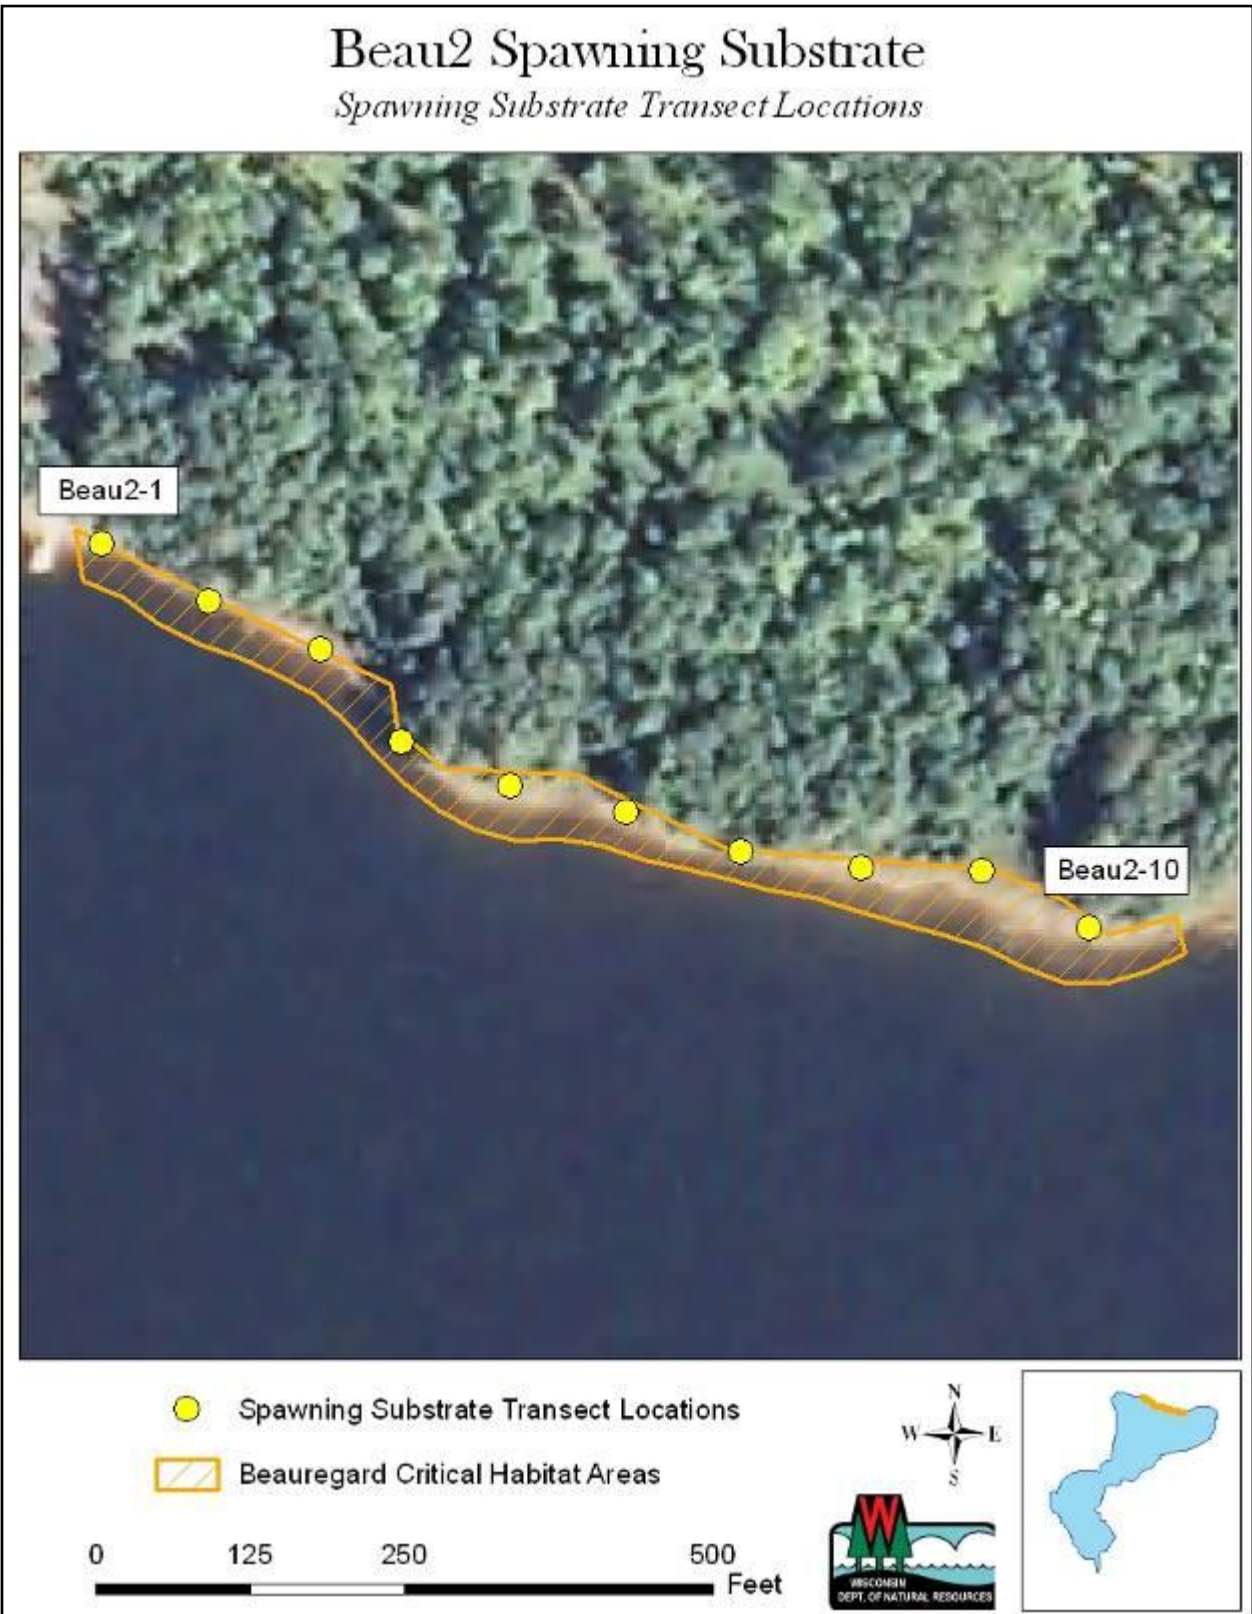
Figure 5. Beau2 Spawning Substrate Transects Map

Critical habitat site Beau2 was designated a Public Rights Feature because of its Spawning Substrate (Figure 5). Beau2 is 0.9 acres in size and is located along the Northern shore of Beauregard Lake.

Spawning substrate was sampled using a standardized transect method and the results can be found in Table 6. Table 7 summarizes the current management practices within the Setback, Riparian, Bank and Littoral Zones of Beau2.

Buffers, overhanging vegetation and fallen trees should remain to provide cover and prevent shoreline erosion which could cause undesirable increases in sedimentation on this valuable walleye spawning shoal, consisting of an abundance of cobble, gravel and sand.

Implement Fish Sticks project. Contact local DNR Fisheries Biologist to investigate funding and technical assistance opportunities.

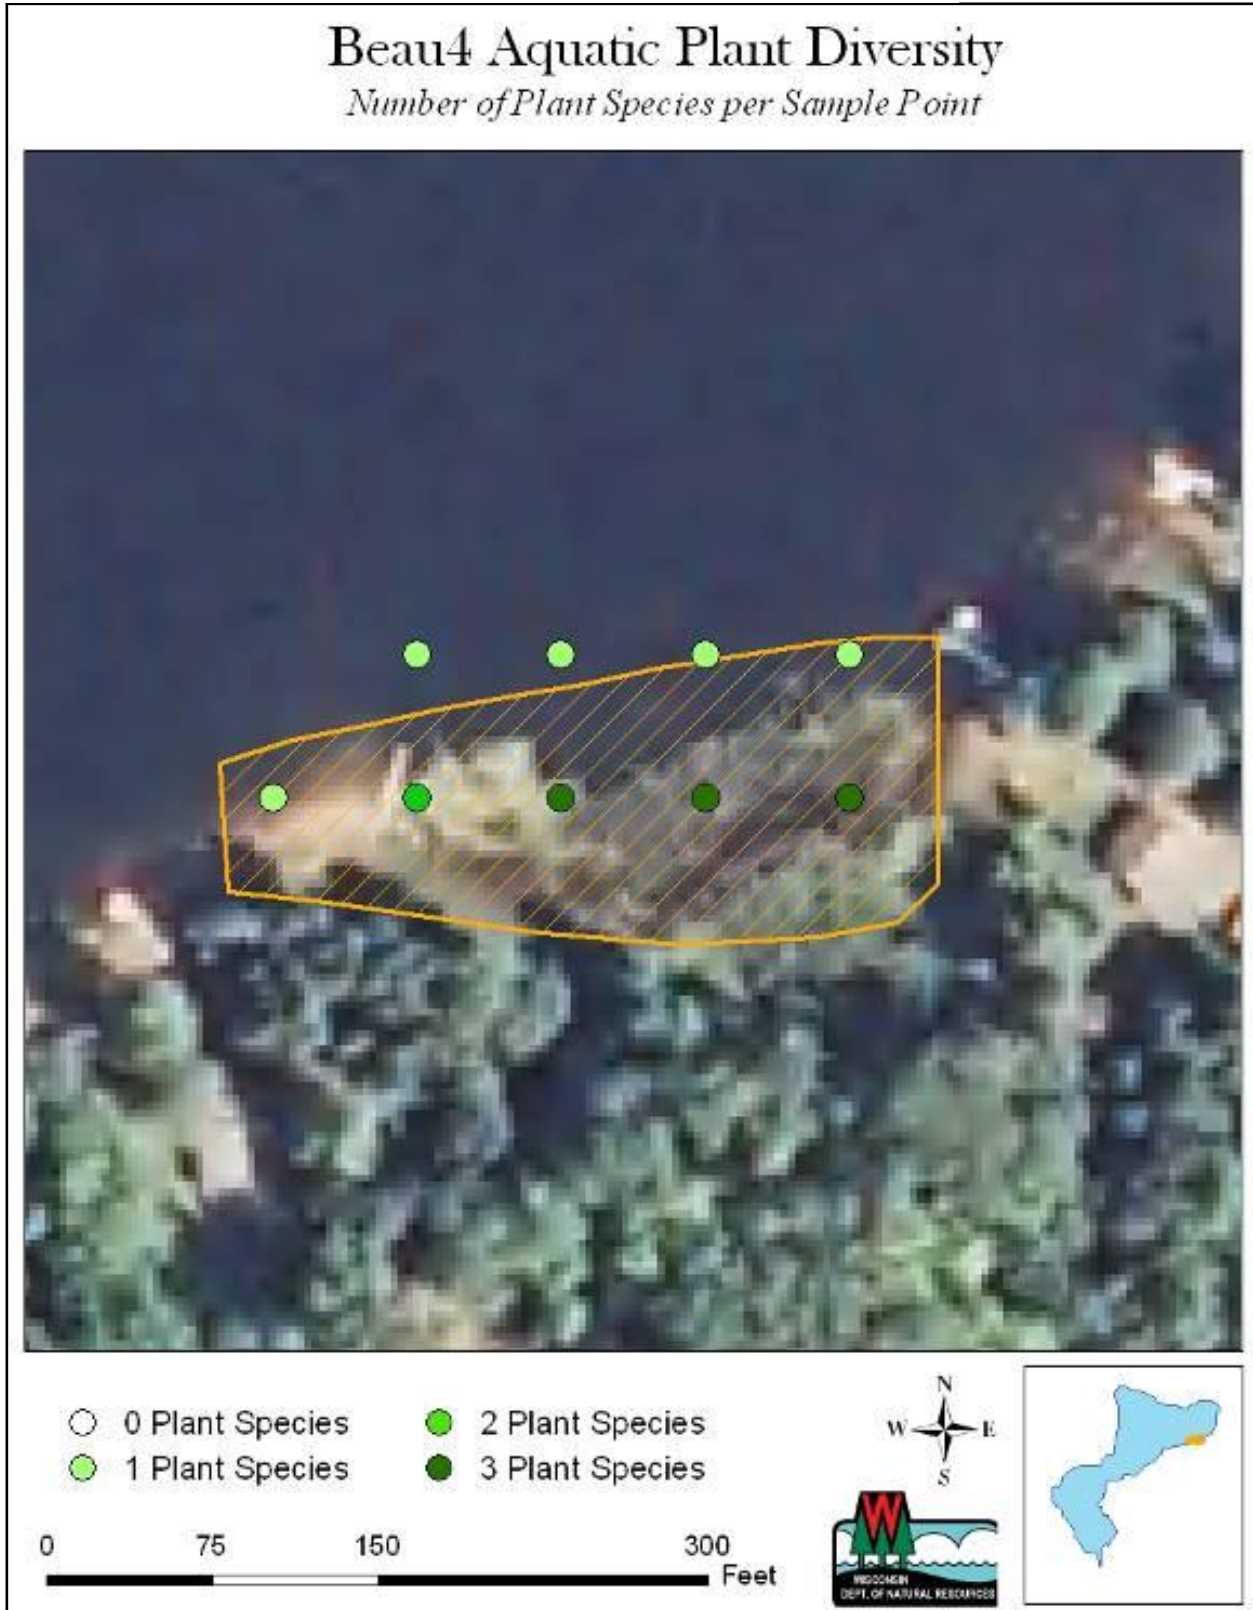
Figure 7. Beau4 Aquatic Plant Diversity Map

Critical habitat site Beau4 was designated a Sensitive Area because of its Emergent and Floating Leaf Vegetation and Extensive Riparian Wetland (Figure 7). Beau4 is 0.8 acres in size and is located along the Eastern shore of Beauregard Lake.

Aquatic Plants were sampled using a standardized Point Intercept method and a summary of the results can be found in Tables 11 and 12. Table 13 summarizes the current management practices within the Setback, Riparian, Bank and Littoral Zones of Beau4.

Buffers and overhanging vegetation, bog fringe and floating, emergent and submersed aquatic plants should be left alone. Do not actively manage aquatic plants unless an aquatic invasive species should establish.

The small amount of established lawn within 50 feet of the water's edge should be replanted with native vegetation to comply with Douglas County shoreland zoning ordinance, minimize erosion and pollution, and improve fish and wildlife habitat.

Leave fallen trees in the water unless they are impeding navigation. Implement Fish Sticks project. Contact local DNR Fisheries Biologist to investigate funding and technical assistance opportunities.

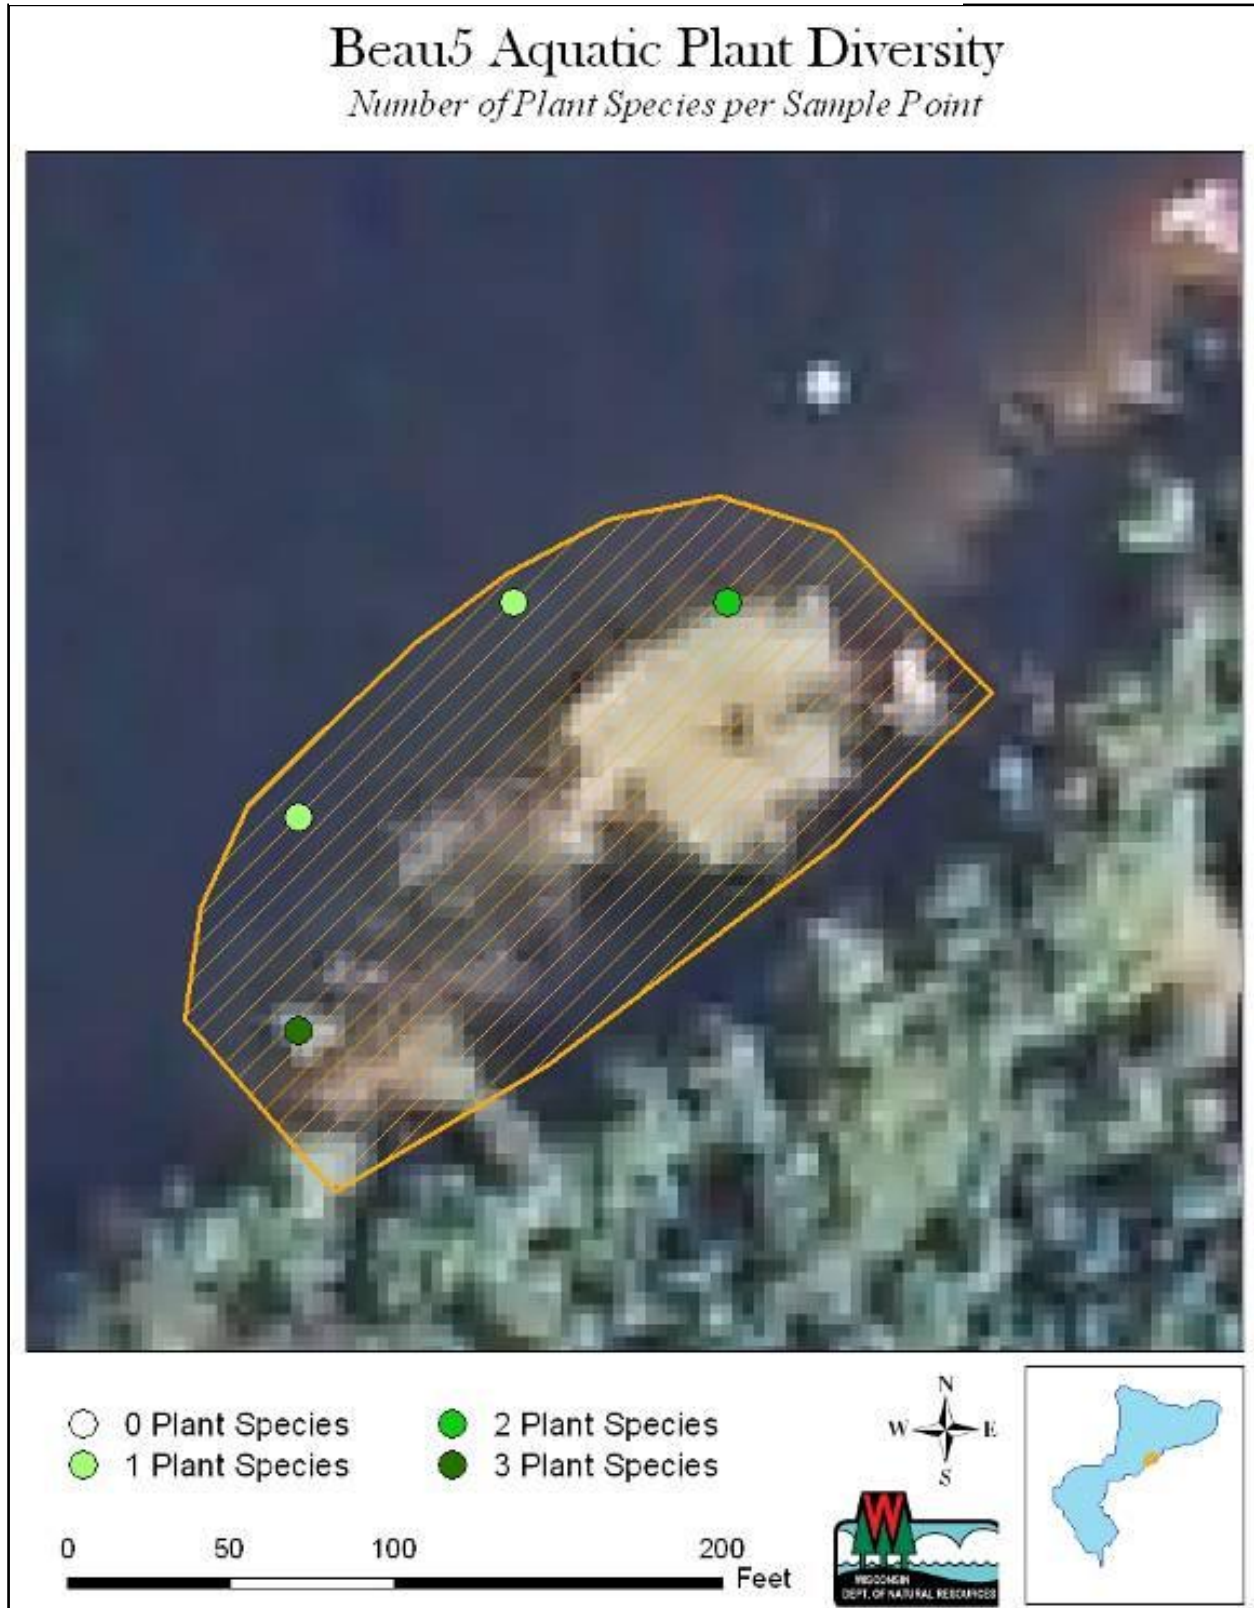
Figure 8. Beau5 Aquatic Plant Diversity Map

Aquatic Plants were sampled using a standardized Point Intercept method and a summary of the results can be found in Tables 14 and 15. Table 16 summarizes the current management practices within the Setback, Riparian, Bank and Littoral Zones of Beau5.

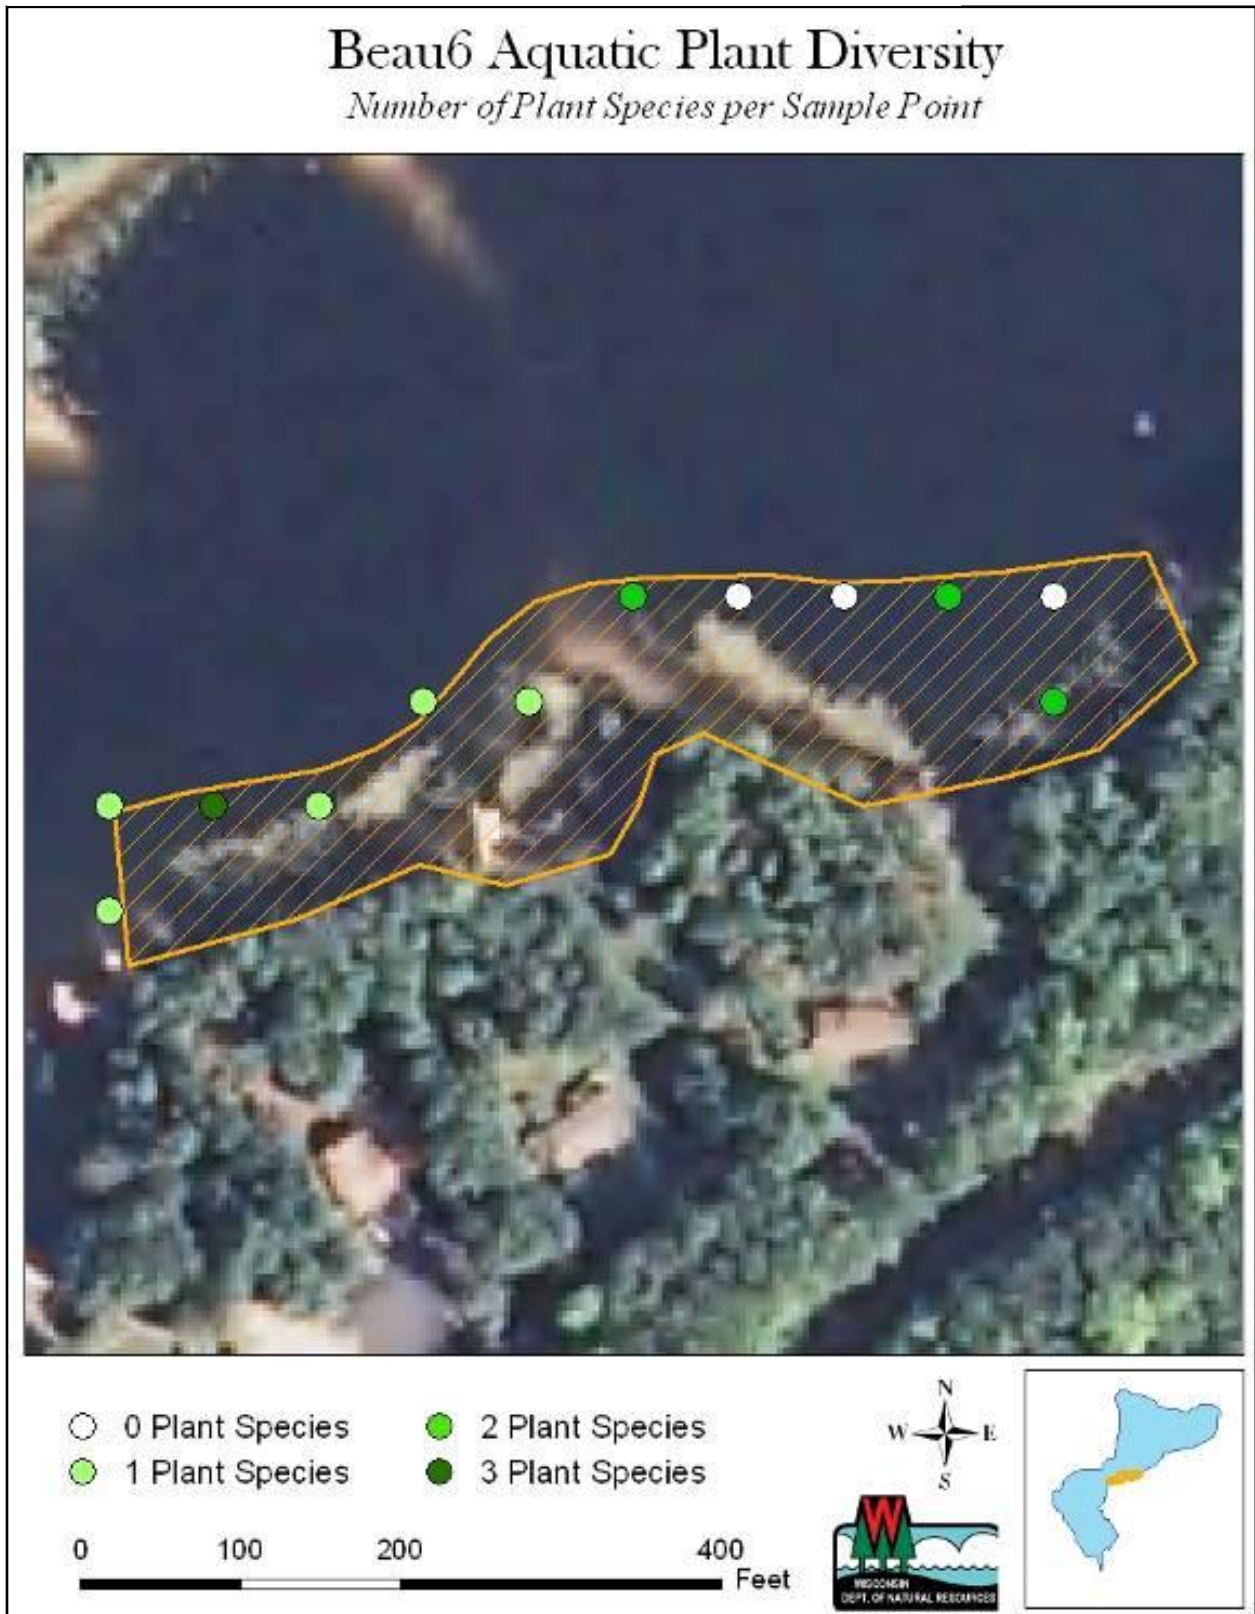
Figure 9. Beau6 Aquatic Plant Diversity Map

Aquatic Plants were sampled using a standardized Point Intercept method and a summary of the results can be found in Tables 17 and 18. Table 19 summarizes the current management practices within the Setback, Riparian, Bank and Littoral Zones of Beau6.

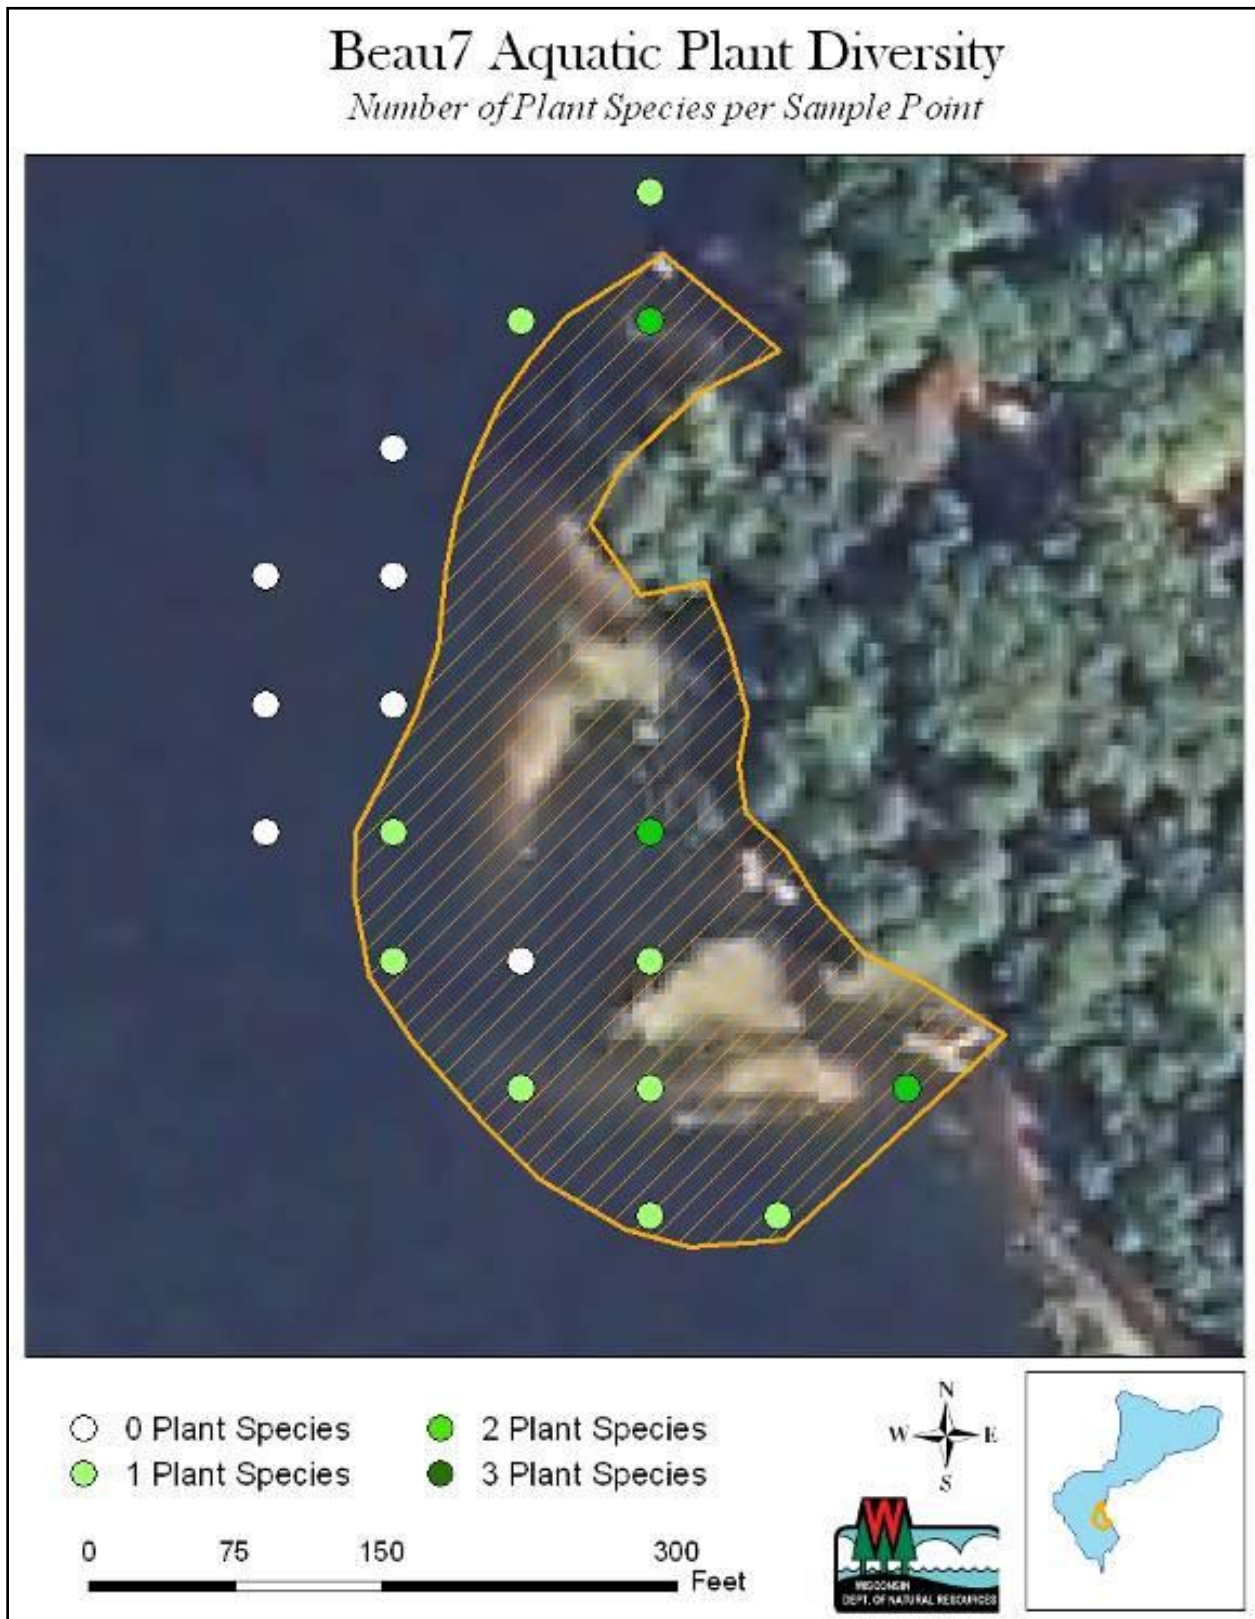
Figure 10. Beau7 Aquatic Plant Diversity Map

Aquatic Plants were sampled using a standardized Point Intercept method and a summary of the results can be found in Tables 20 and 21. Spawning substrate was sampled using a standardized transect method and the results can be seen in Table 22. Table 23 summarizes the current management practices within the Setback, Riparian, Bank and Littoral Zones of Beau7.

Buffers, overhanging vegetation and fallen trees should remain to provide cover and prevent shoreline erosion which could cause undesirable increases in sedimentation on this valuable walleye spawning shoal, consisting of an abundance of cobble, gravel and sand.

According to the shoreline inventory, there is riprap in Beau7, and it is not recommended because it could disturb spawning substrates. Alternative bank stabilization methods should be used instead of hard armoring like riprap.

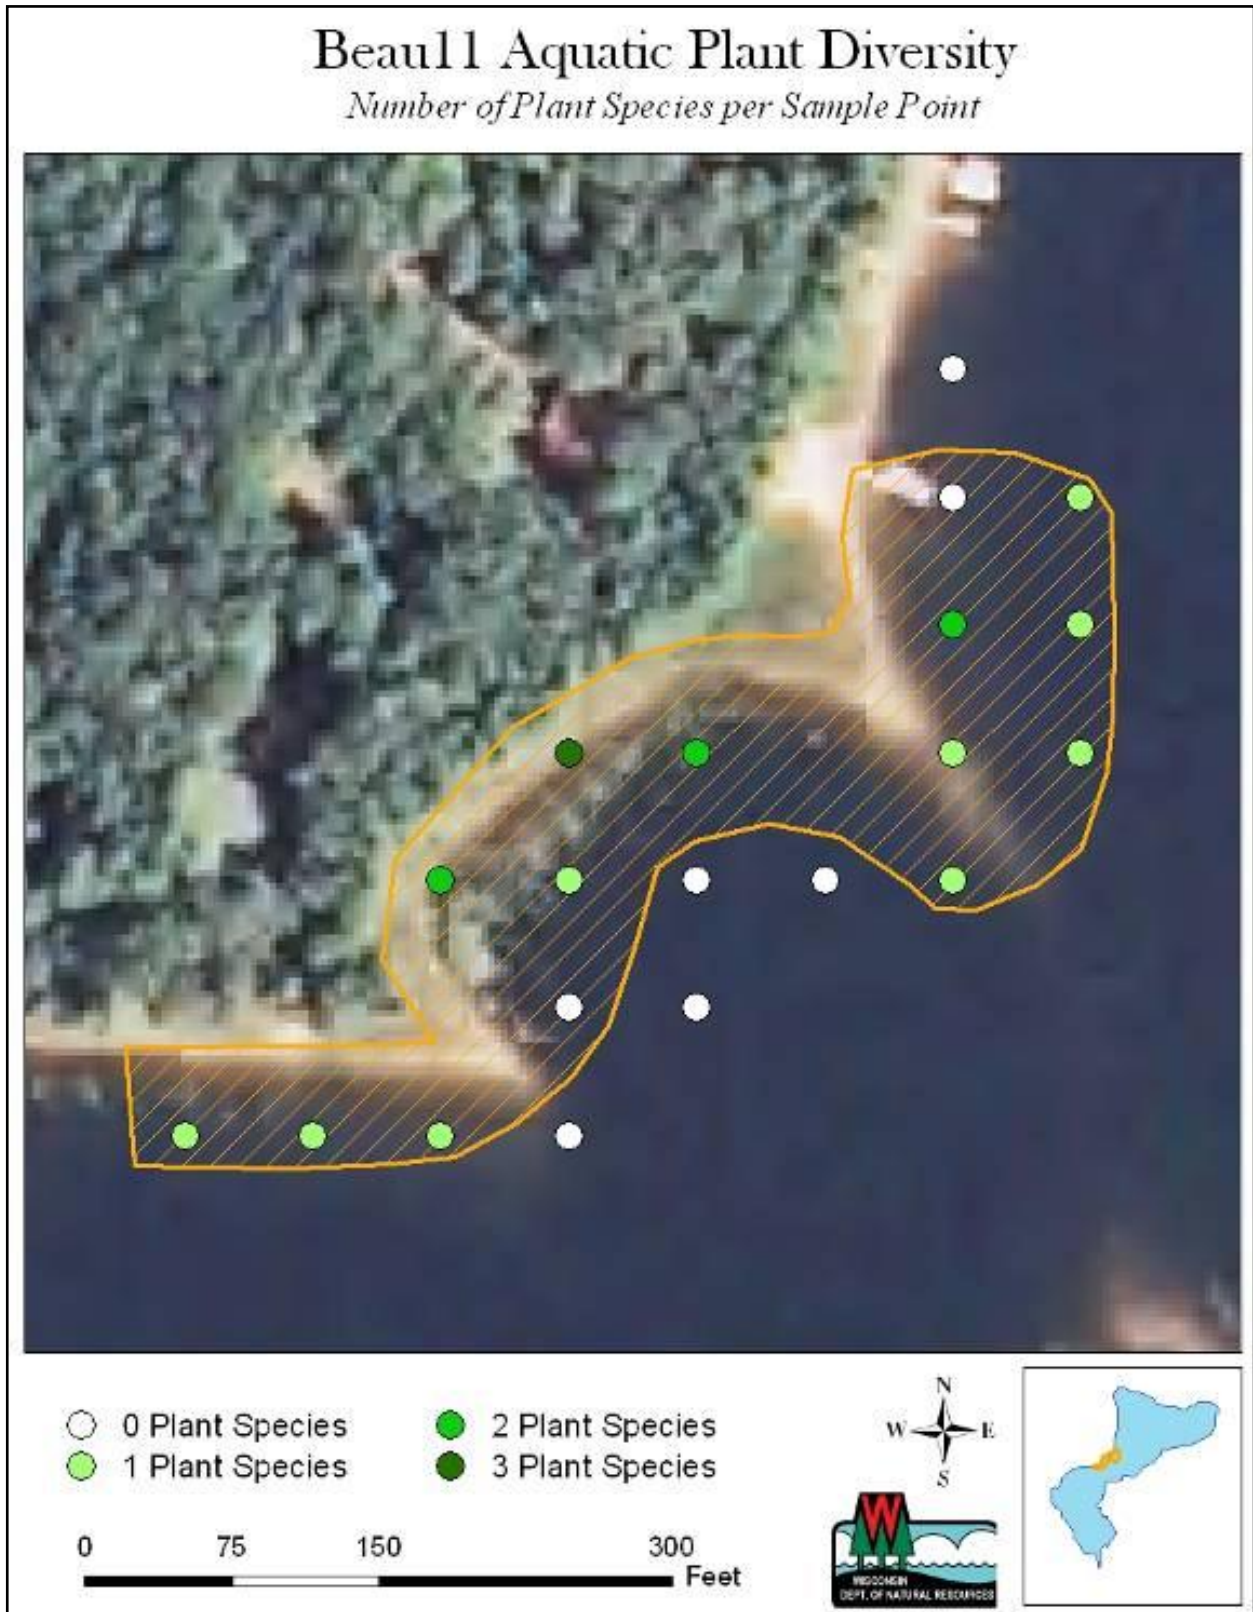
Figure 15. Beau11 Aquatic Plant Diversity Map

Aquatic Plants were sampled using a standardized Point Intercept method and a summary of the results can be found in Tables 32 and 33. Table 34 summarizes the current management practices within the Setback, Riparian, Bank and Littoral Zones of Beau11.

According to the shoreline inventory, there is a seawall in Beau11, and it is not recommended. The wave energy is moderate. Alternative bank stabilization methods should be used instead of hard armoring like riprap or seawalls.
