# Rehabilitation of the West Branch Sugar River

A Documentation for Removal  
from the  
State of Wisconsin's List  
of Impaired Waters

Wisconsin Department of Natural Resources  
South Central Region  
April, 2004

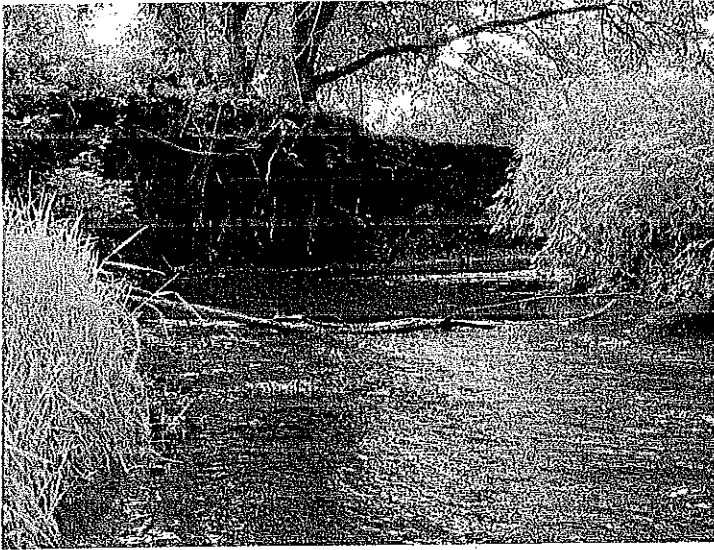
**Figure 2: West Branch Sugar River – Prerehabilitation Conditions**

Typical outside bend on the river. Steep eroding bank. Trees inadequate to hold soil in place.

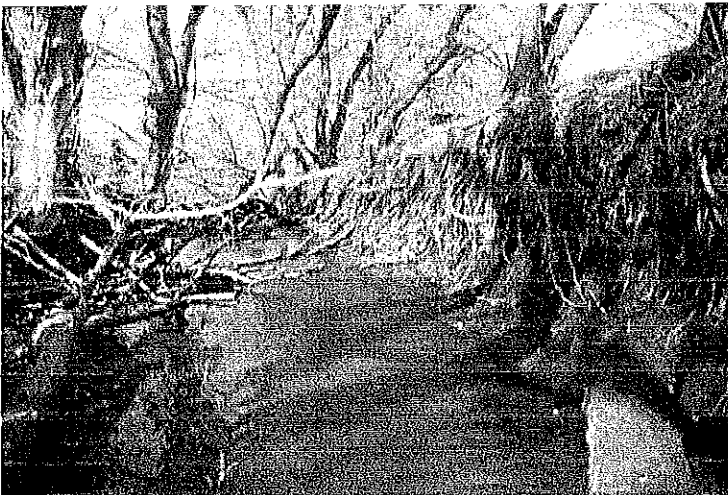
Typical corridor of box elders. Trees canopy shades out vegetation and tree roots themselves are unable to hold soil in place. Eventually the trees fall into the stream, furthering the erosion process.

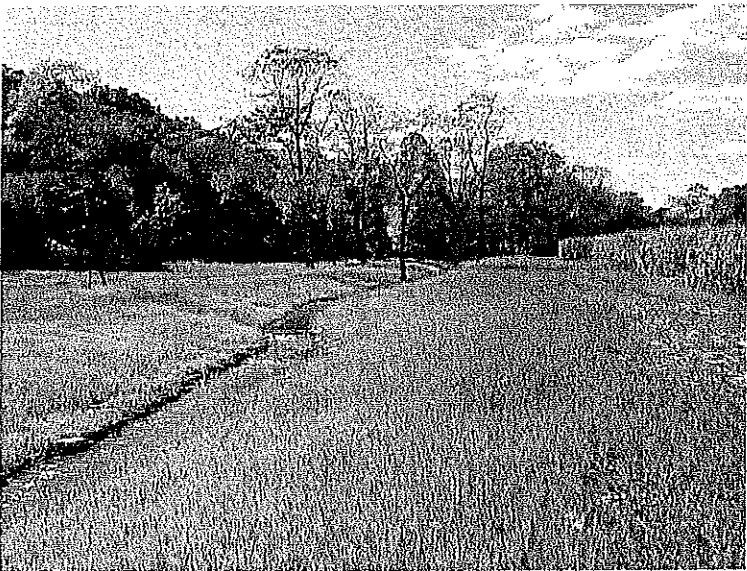
The newly established vegetation not only stabilizes the banks, but acts as a buffer and filter for runoff from surrounding agricultural fields

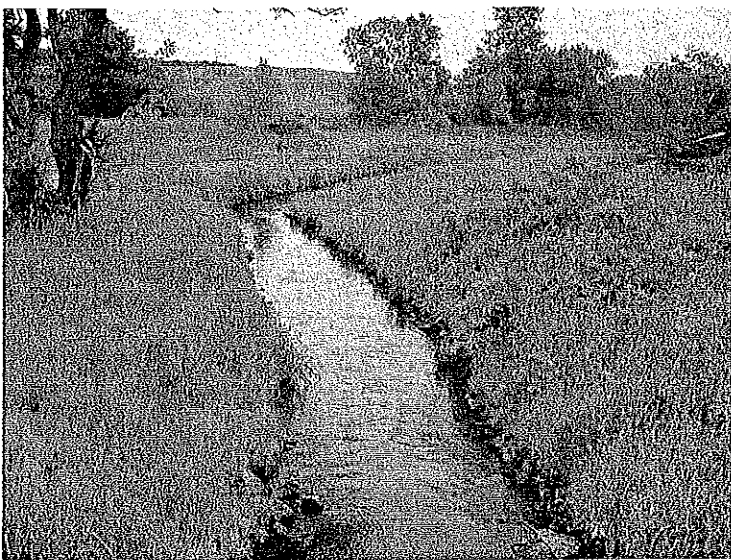
While habitat structures were placed in bends of the river, rock weirs were used on straight sections (foreground) to create plunge pools for creating deeper water areas.

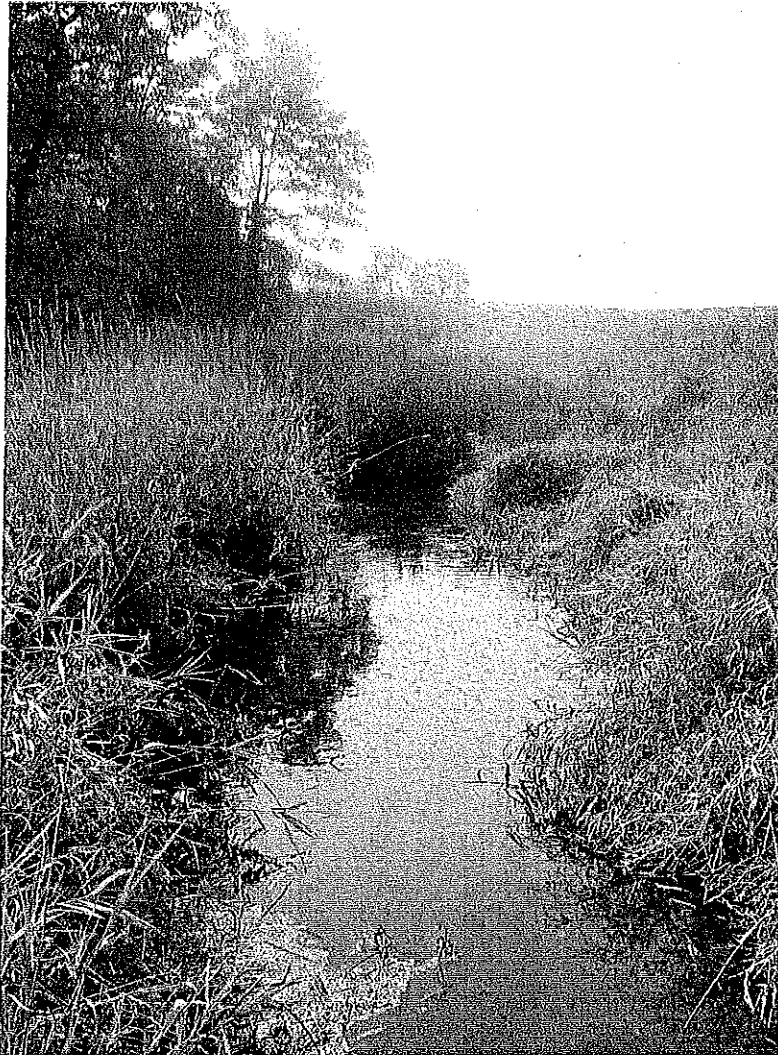
Figure 7: West Branch Sugar River – Post Rehabilitation, the Second Year

Two years after the project, grasses have become well established, stabilizing the shoreline, acting as a buffer for runoff, and providing cover and shade during the summer months over the narrowed river.

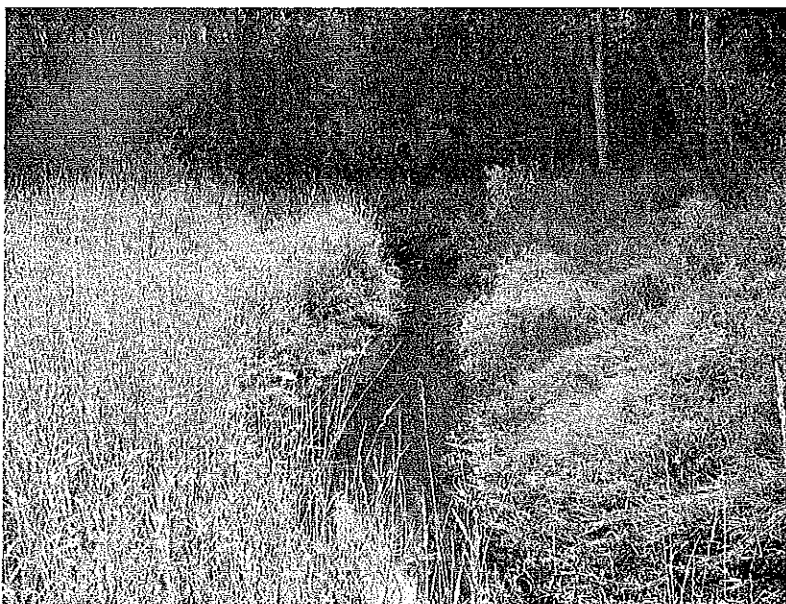
The well established grasses hide any evidence of the “work” that was performed on the river.
