Final Report

Project Name: Hoard-Curtis Scout Camp Lakeshore Restoration
Project No.: LPT-365-11
Grant Sponsor: Lake Ripley Management District
Contacts: Paul Dearlove, Lake Manager, LRMD (608-423-4537)
Joel Winn, Treasurer, Hoard-Curtis Scout Camp (920-568-5404)

PHASE I

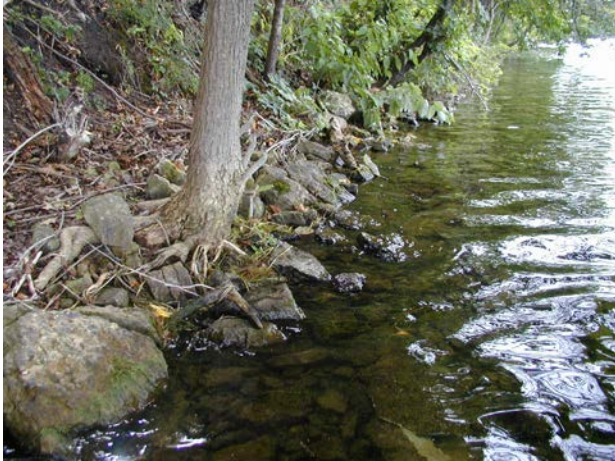
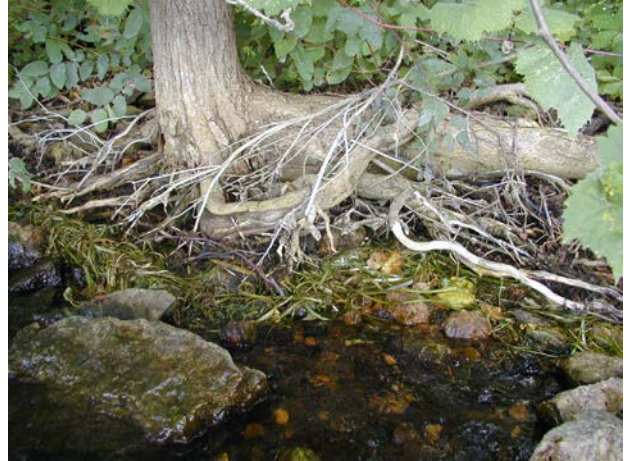
Hoard-Curtis Scout Camp's eroding shoreline prior to installation of rock riprap (2008)

Phase I of the Hoard-Curtis Scout Camp's lakeshore restoration started on September 7, 2010, and was completed on October 5, 2010. This phase entailed protecting 870 feet of eroding shoreline through the installation of rock riprap. The work was performed by Rodney Zuerner of CHILS Landscaping for a total installed cost of \$69,000. Equipment used for the installation included a backhoe (to bury and position the larger "toe" rocks), bobcat (for minor grading and moving of smaller material), dump truck (to transport material to and from the site), and an amphibious "Weasel" (to bring material to work areas along the shore). Work consisted of the following:

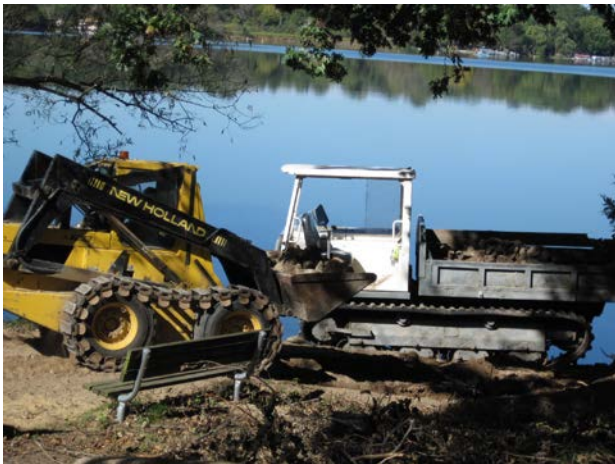
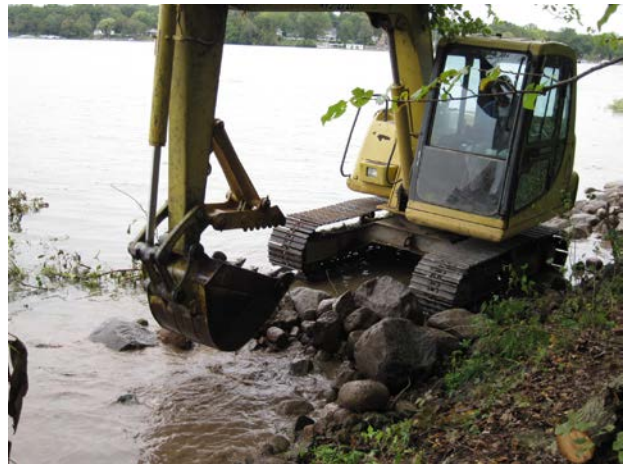
Equipment used to transport material and install the rock (9/2010)

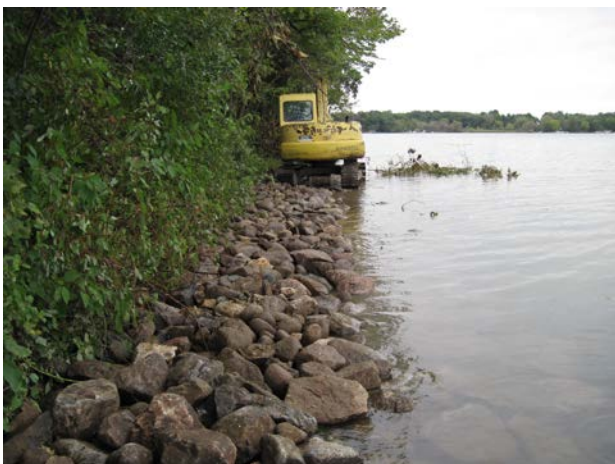
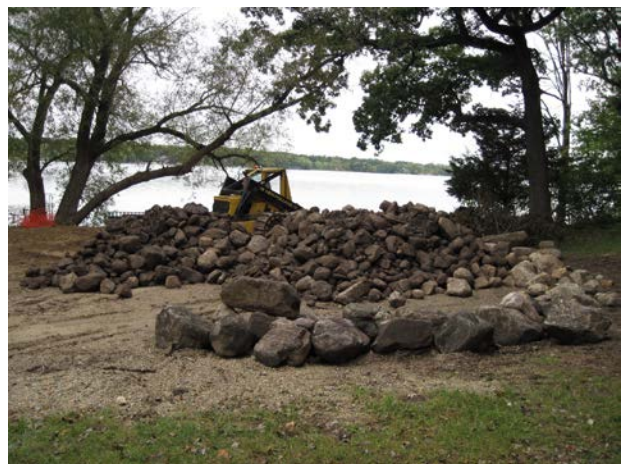
Left: Equipment access restricted to rock shelf to minimize disturbance to lakebed (9/2010)
Right: Sand beach staging area for equipment access and stockpiling of materials

2. A 4-ft.-wide by 16-in.-deep lakebed trench was excavated parallel to and several feet waterward of the shoreline. Equipment access to the lake was through the scout camp beach. Trench excavation occurred only in the area that was within reach of the bucket arm. This was to avoid unnecessarily running the equipment in the water until a rock base was created. Existing vegetation and steep banks prevented overland equipment access. Gravel spoils were used as base material, when appropriate, between the trench and shoreline bank before placement of riprap.

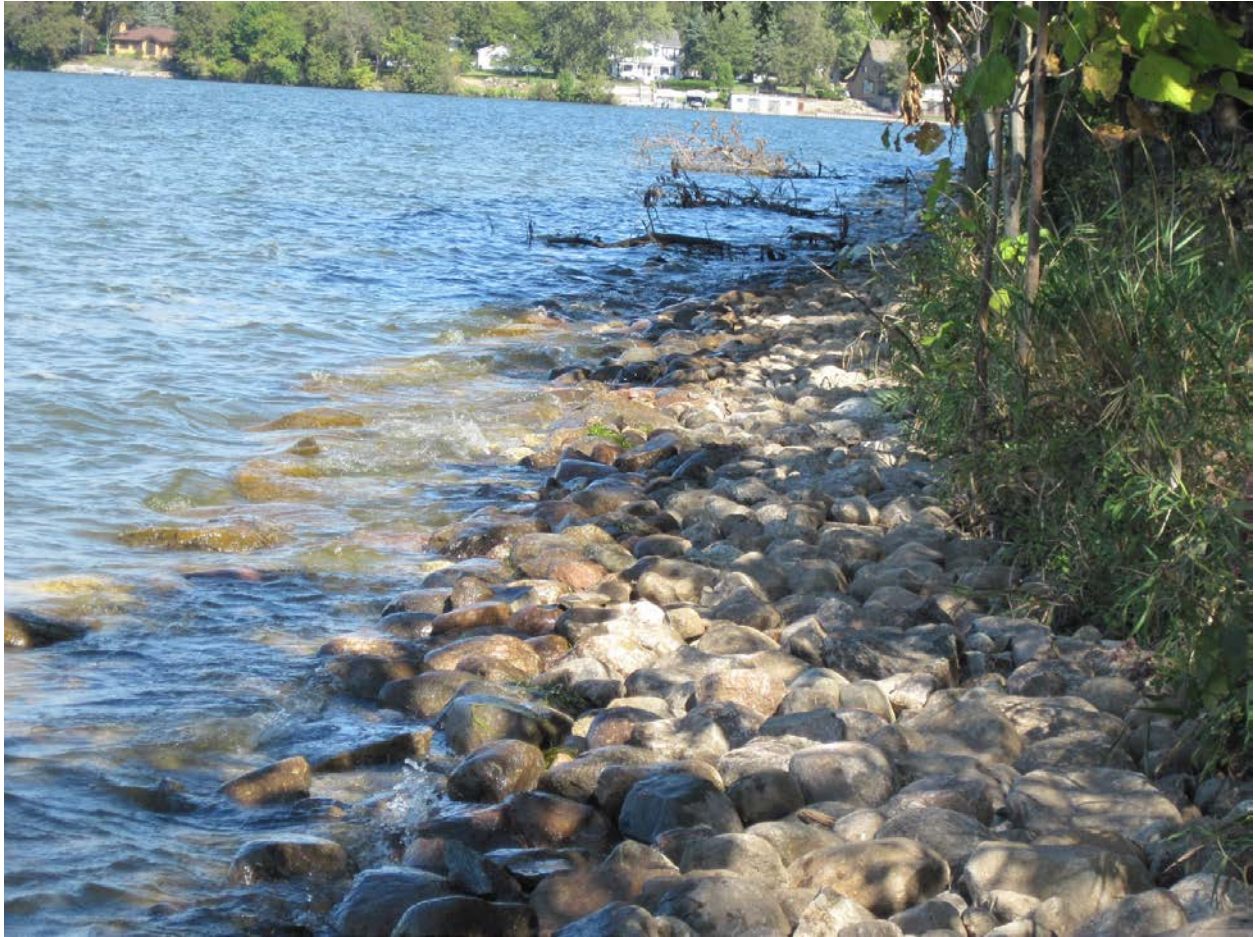
Picture of shoreline upon completion of riprap installation (9/2010)

3. 24-inch glacial boulders and washed gravel bedding material were stockpiled at the scout camp beach located immediately off Island Lane. About 4 inches of gravel bedding was placed in the excavated trench for base support and to prevent rock settling. This was followed by the placement of two parallel rows of boulders in the trench. Tops of the boulders were set at or just below the water surface.

4. Glacial fieldstone riprap (3-18-inch diameter) was then placed behind the counter-sunk boulders, creating a 4:1 or flatter rock slope up to the existing bank, and extending no greater than one foot above the normal high water level. A geotextile underlayment was deemed unnecessary and not installed (decision made in consultation with DNR permit issuer based on site conditions).

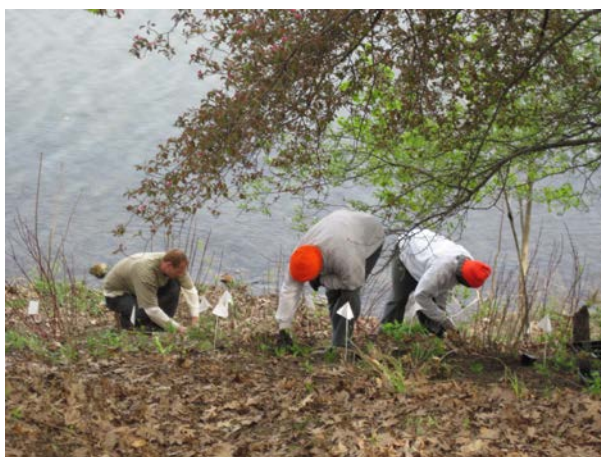
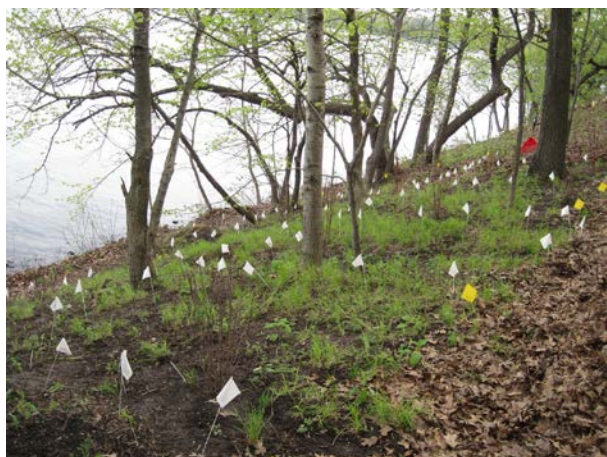
Pictures are included on the following pages showing the sequence of the Phase II – IV project work. Volunteers help install and flag native plantings, cut and haul invasive brush, and provide support during a prescribed woodland burn (Fall 2010-Spring 2011).

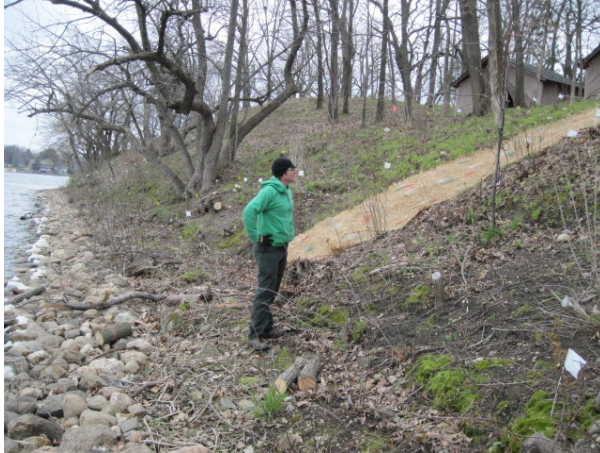
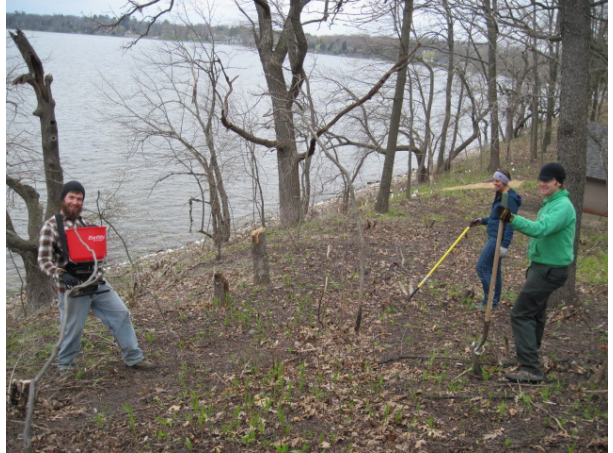
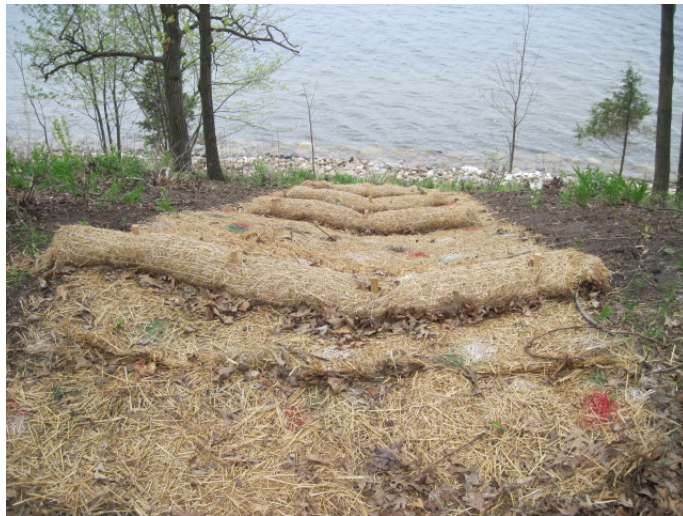
Staff from Good Oak Ecological Services perform selective tree thinning, broadcast a native woodland seed mix, and install erosion matting (Winter-Spring 2011).

1. Invasive brush was removed by hand cutting, with all stumps getting sprayed with an herbicide as a follow-up control measure. Honeysuckle and buckthorn were cleared within a 70-ft. strip along the entire 870-ft. shoreline. This included cutting and chipping all non-native shrubs and small trees, as well as a small number of native shrubs deemed as aggressive. Stumps were then treated with an herbicide to prevent re-sprouting.
2. A Jefferson County shoreland zoning permit was applied for and received to conduct selective tree thinning. Selective tree thinning targeted less than 12-inch-diameter trees not appropriate for an oak woodland (i.e. basswood, mulberry, aspen, cherry, hemlock and red cedar), or that were growing too

4. Inter-seeding of 60,900 sq. ft. was performed. Work included broadcast-spreading 11.8 pounds of a woodland inter-seeding mix in bare soil areas within the 70-ft. buffer zone along the lakeshore. The native seed mix was purchased from Agrecol LLC. It consisted of two grasses, two sedges, and 20 forbs.

5. Erosion matting and cover-crop seeding was performed on erosion-prone slopes. SC150 coir fiber erosion matting and “sediment-stop” straw rolls were installed on steep slopes and washout areas to hold soil in place during seed establishment. A fast-growing seed mix was applied to exposed soil areas. The seed mix consisted of six pounds each of annual oats and Canada wild rye.

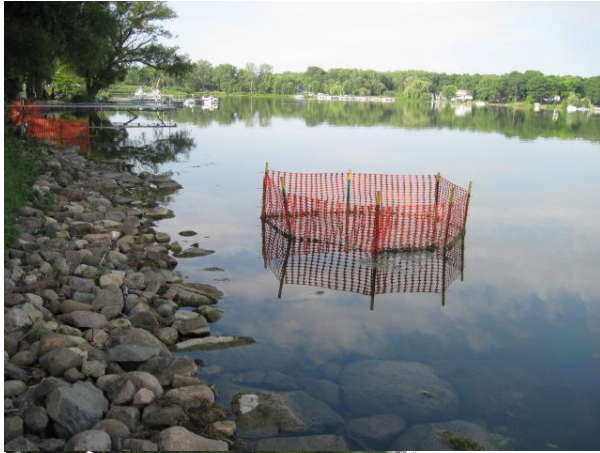
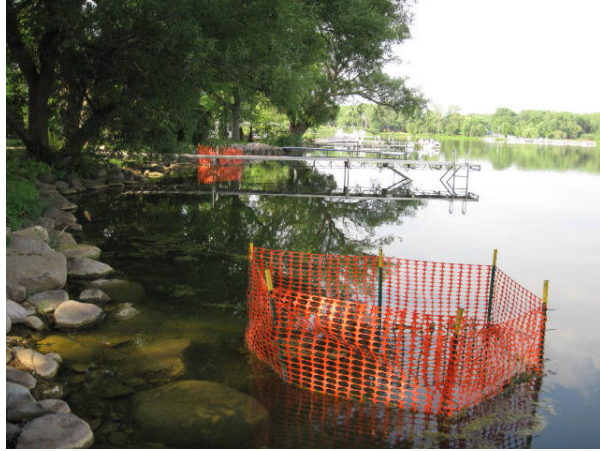
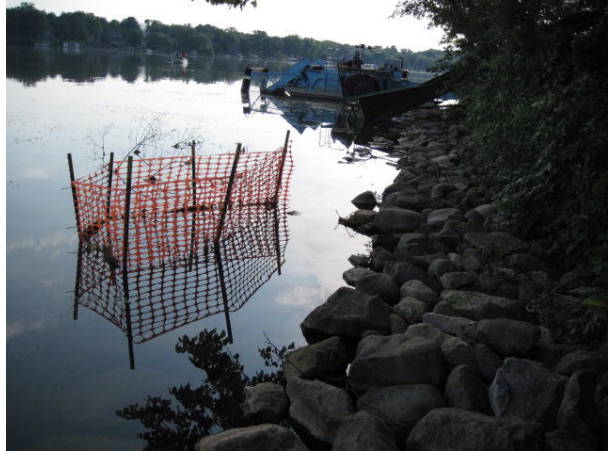
Six “pods” of aquatic plants are installed at various locations along the shoreline (Summer 2011).

6. Six “pods” of aquatic emergent shoreline plants were installed at various locations along the lakeshore in front of the rock. Each pod consisted of 32 native emergent aquatic plants, such as rushes, bulrushes and bur reeds. Temporary snow fencing was used to protect the “pods” from grazing and wave action during summer plant establishment. The fencing was then removed in the fall. All the above work (#1-6) was performed by Good Oak Ecological Services and volunteers.

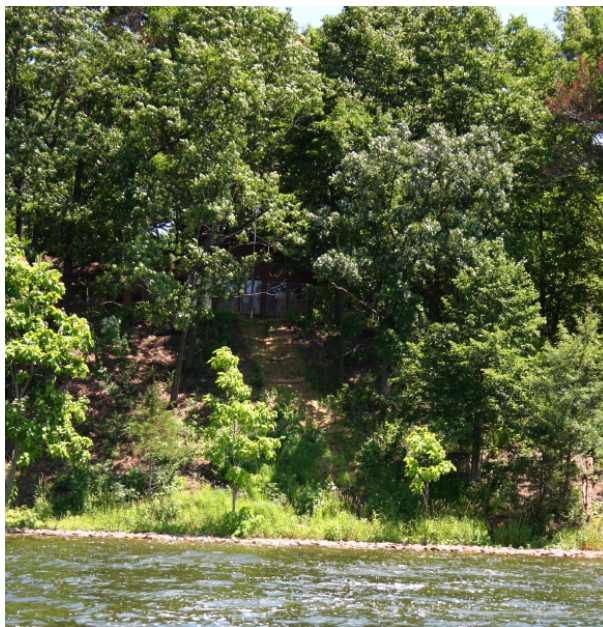
The restored lakeshore as it appeared in summer of 2011.
